NASA Technical Memorandum 103875

# Tiltrotor Research Aircraft Composite Blade Repairs— Lessons Learned

Paul S. Espinosa and David R. Groepler

December 1991

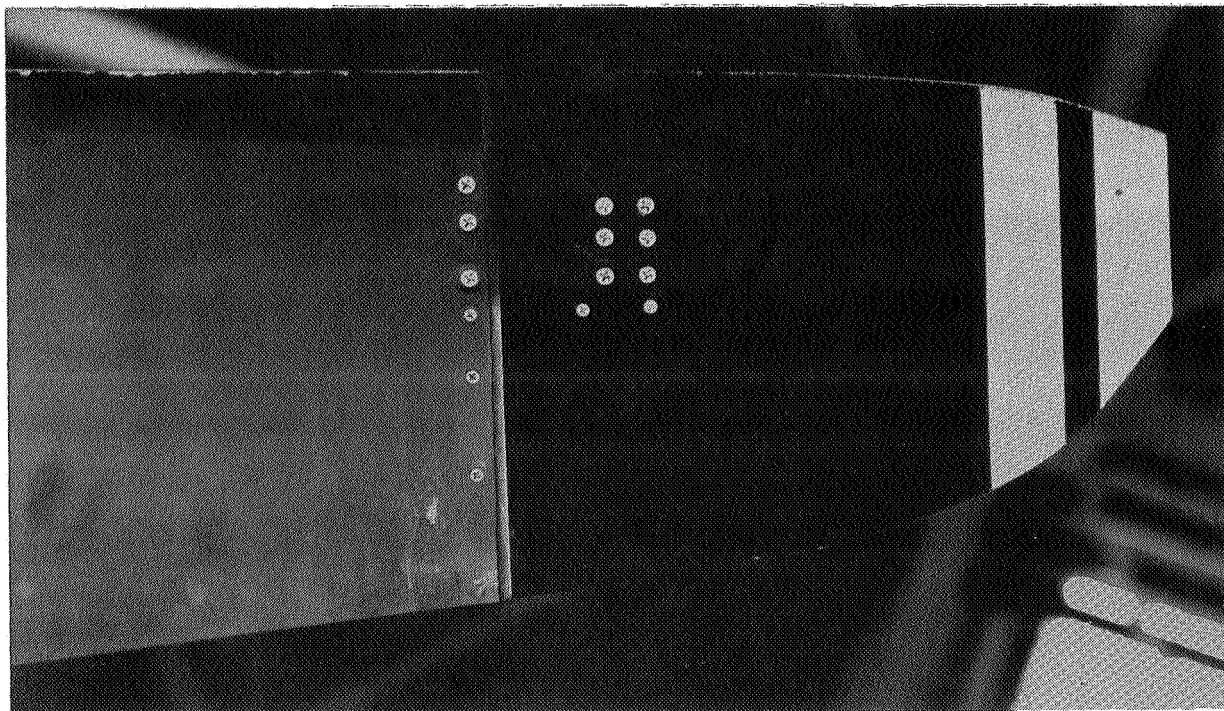
FIGURE 8. Retaining-screw locations on end of blade and tip cover

Another tip cover with the same airfoil and planform but with no twist (called the “alternate tip”) replaced the baseline tip later in the testing program. This design has a solid honeycomb core throughout except for a small cavity that fits over the spar-extension weight block when the tip is placed on the blade. Both tips are retained by screws that attach to inserts located in the blade main spar and spar extension. A view of the tip assembly showing the retaining screw locations is presented in figure 8.

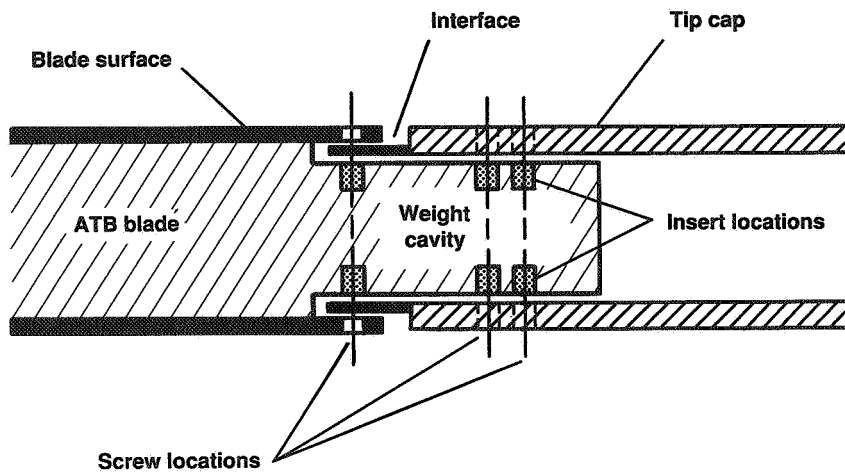
FIGURE 13. Interface of blade and tip cover

**2.5.1 Description of the problem**– One case of misalignment of mated composite parts occurred, with the alternate tips. They had been initially fitted to the blades in 1987 prior to flight, and then were returned to the manufacturer for completion and finishing; they had not been installed on the blades for over two years. Figure 13 shows how the tip cap fits over the weight cavity onto the blade. When the tips were to be installed on the blades they would no longer fit because of interference at the interface, which resulted in the screw holes not lining up with the screw insert locations on the spar. It appeared that either the ends of the blades had changed shape during flight testing, or the mating contour of the tips had been changed during the finishing process. Modifications (by the addition or removal of material) of the alternate tips were required to fit them on the blades, and no further fitting problems were encountered.
