NASA Technical Memorandum TM 103826

Debris/Ice/TPS Assessment And Photographic Analysis For Shuttle Mission STS-48

November 1991

Gregory N. Katnik
NASA/Kennedy Space Center

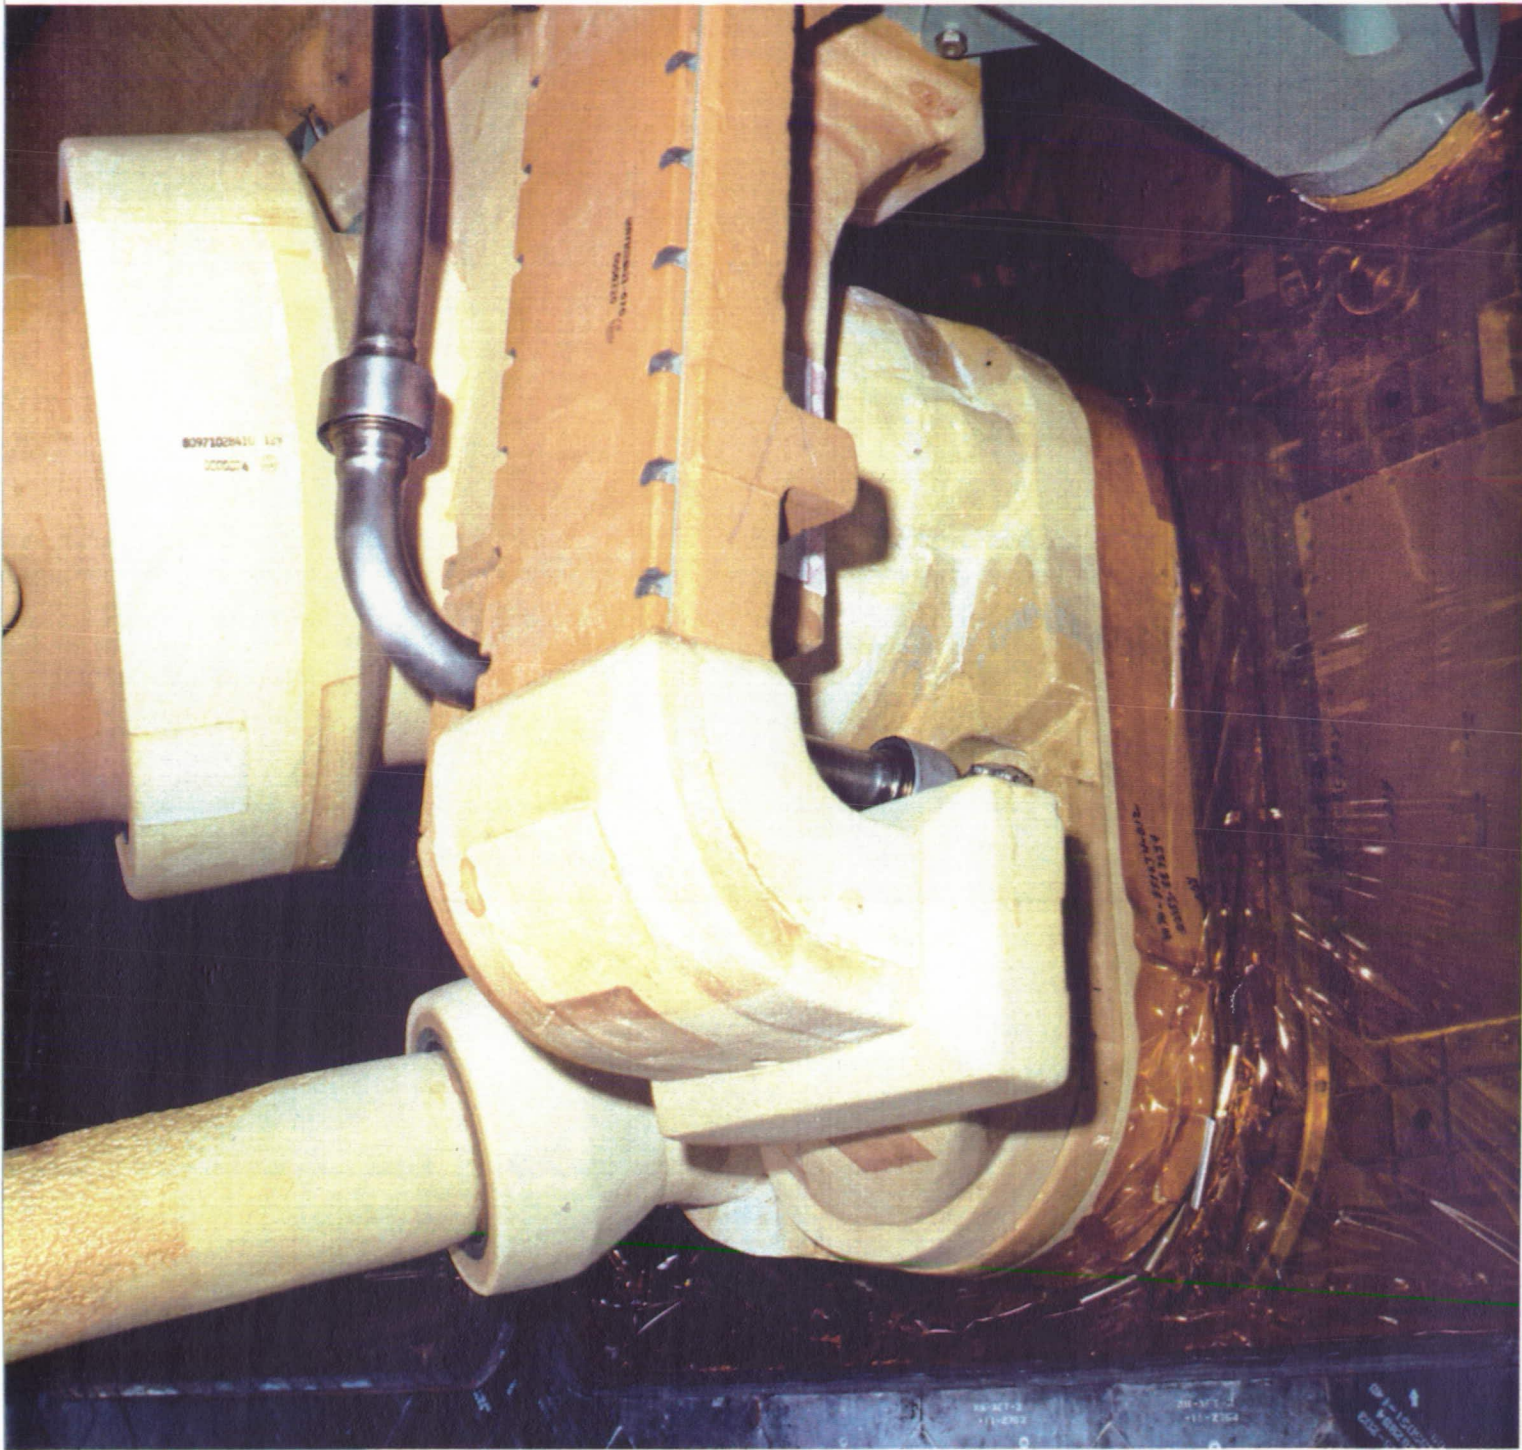
Overall view of the LH2 ET/ORB umbilical

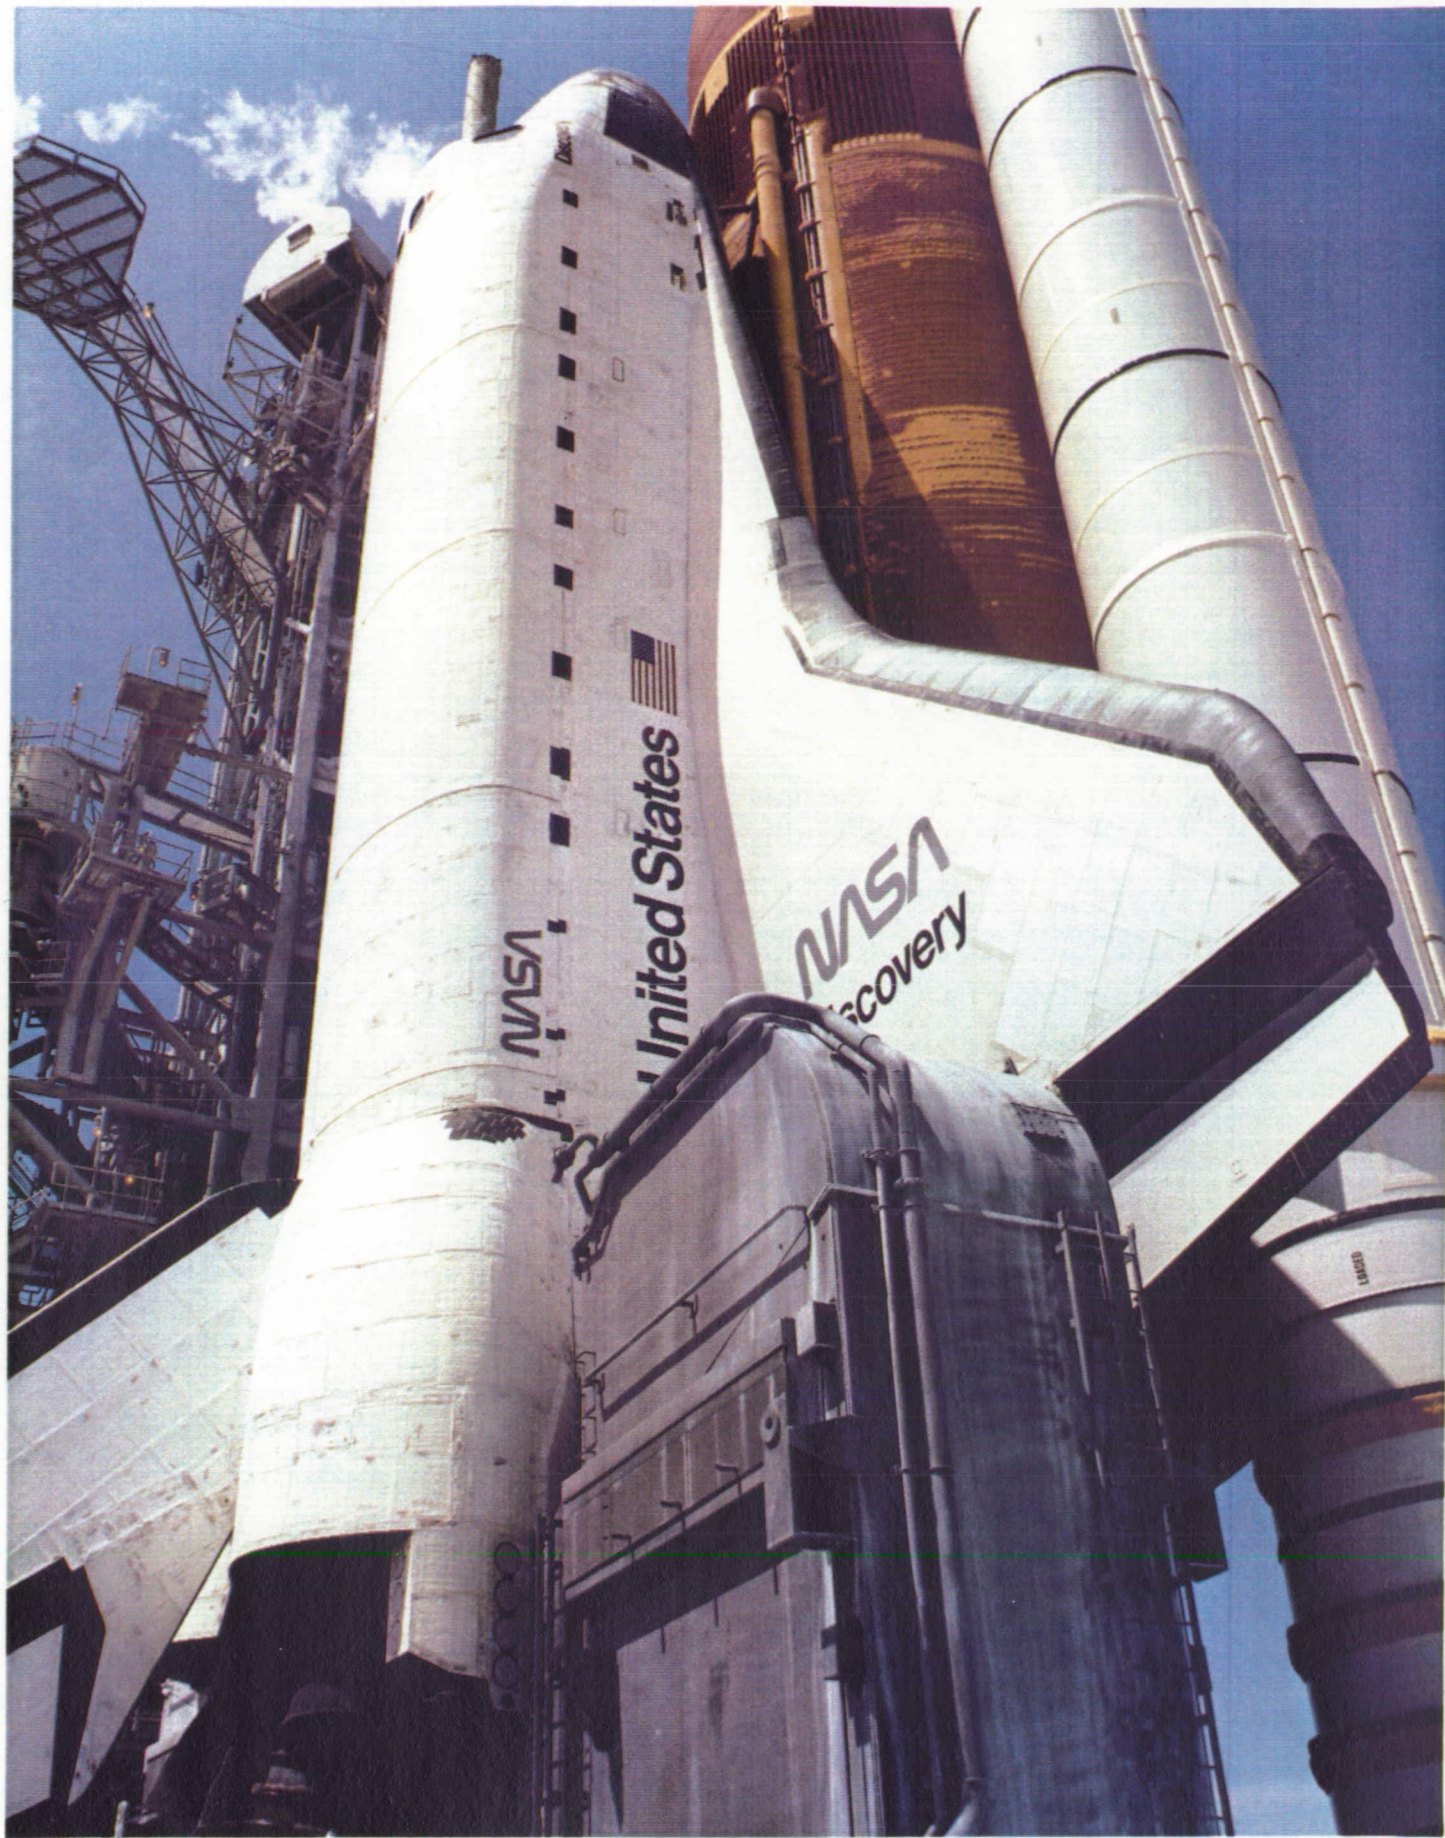
Overall view of OV-103, ET-42 (LWT 35), and BI-046 SRB's

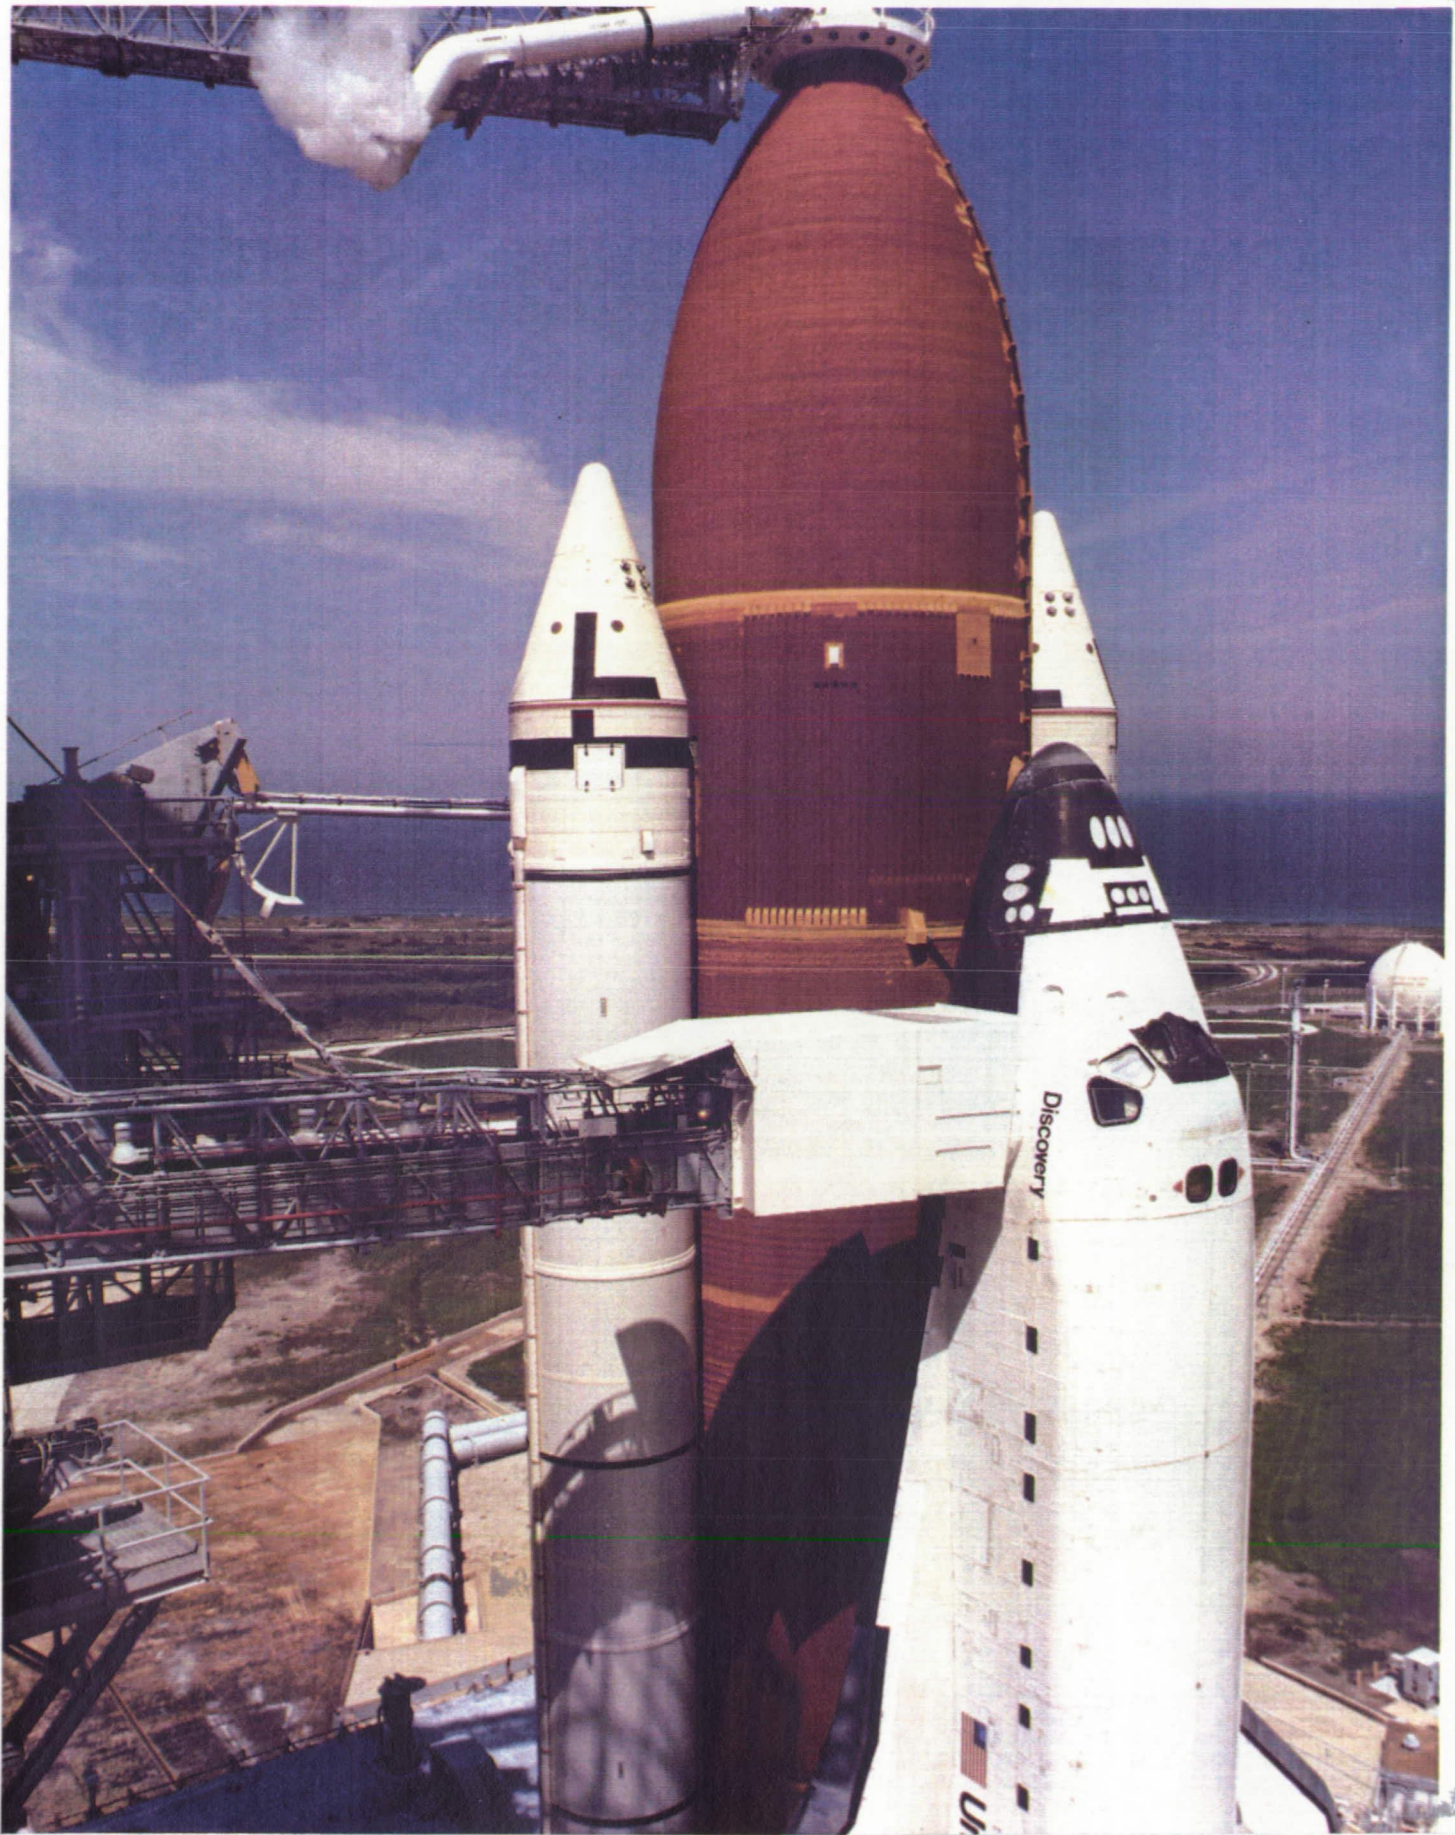
There were no TPS anomalies or ice/frost accumulations on the External Tank acreage

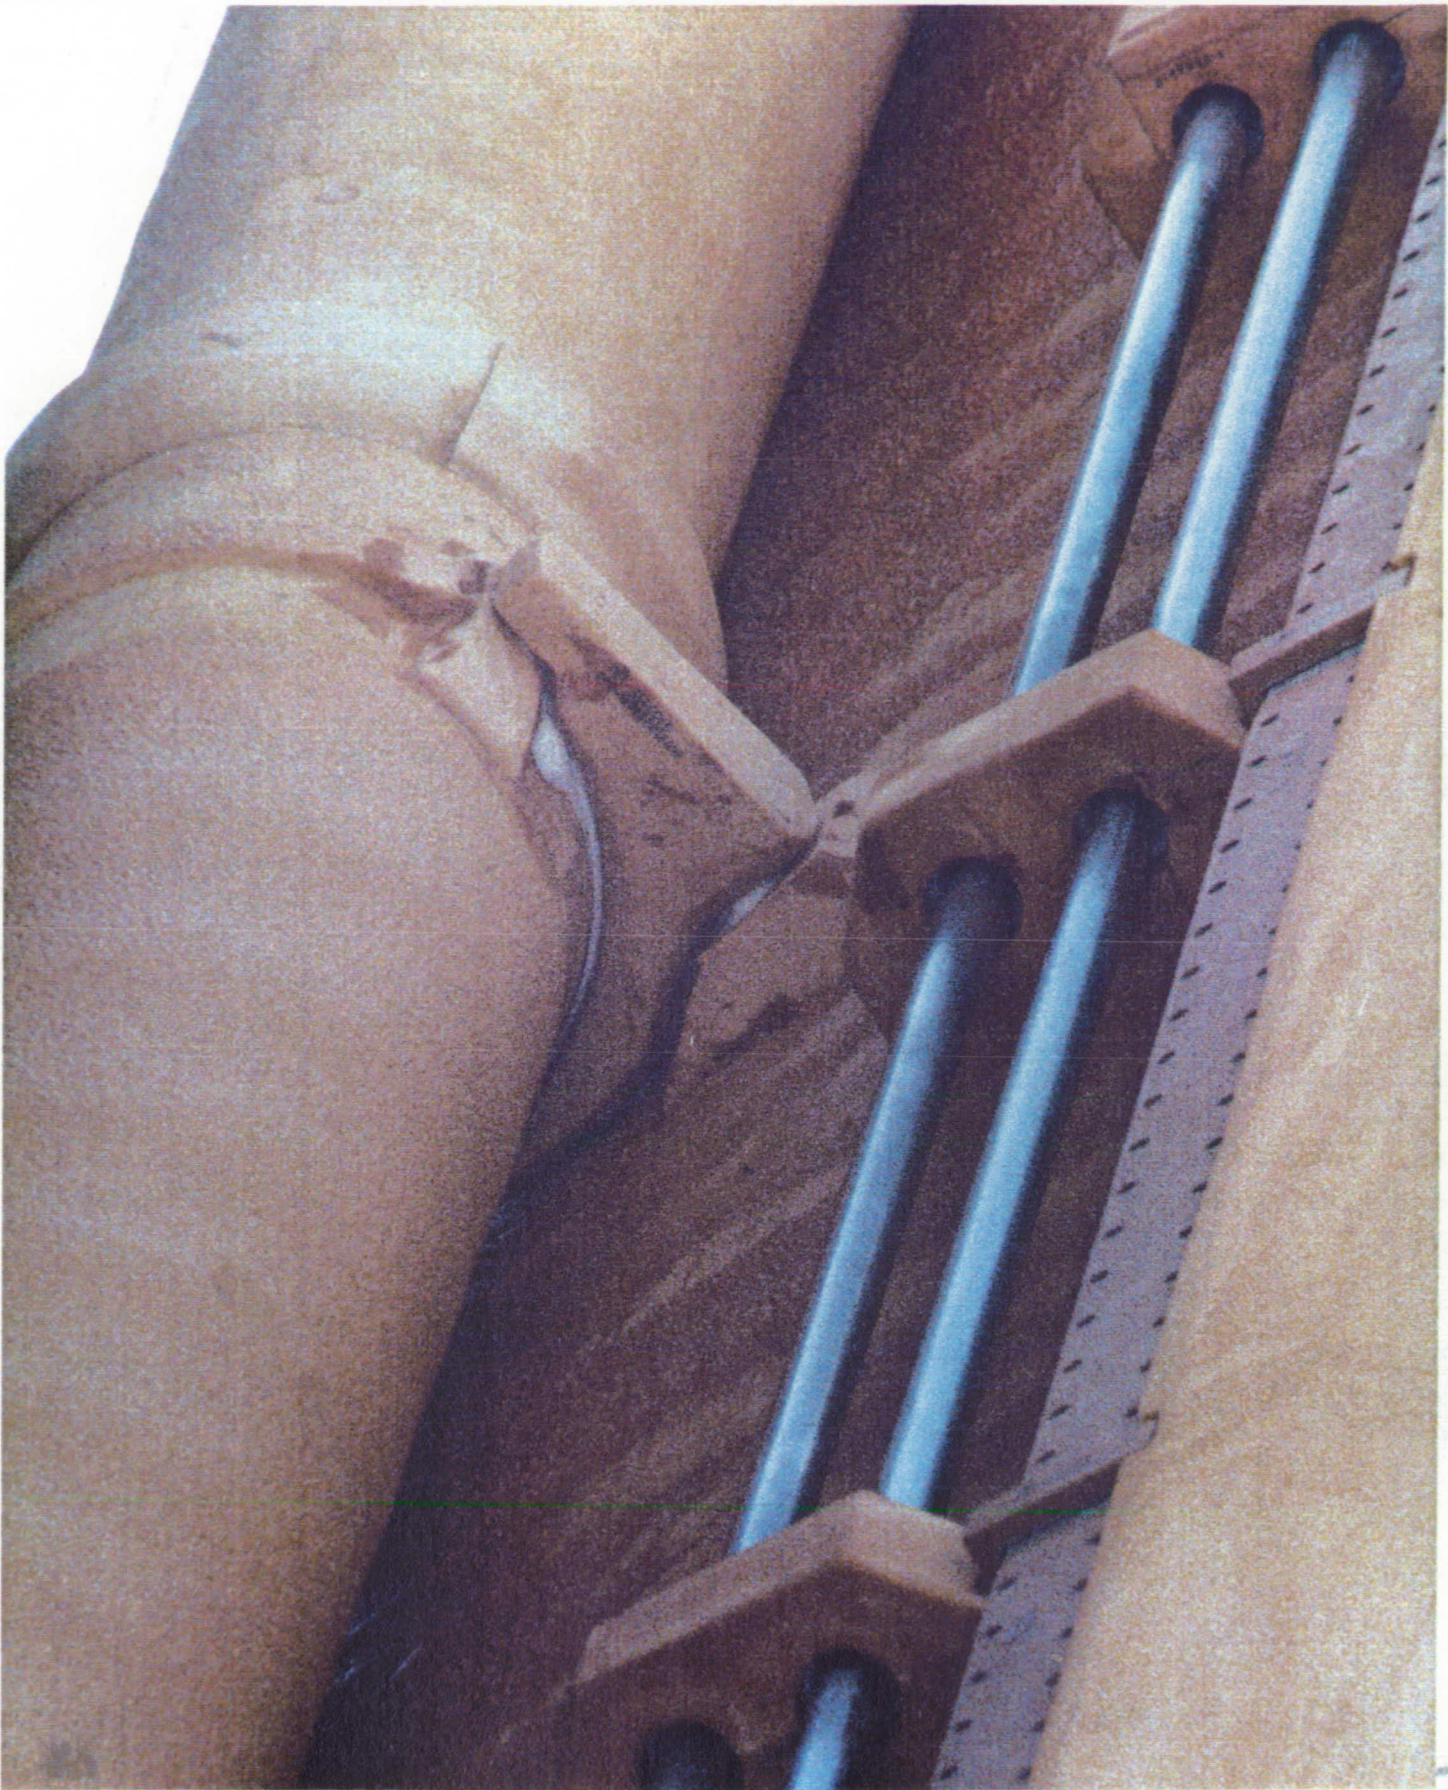
Ice/frost formations in the L2 feedline support brackets were typical

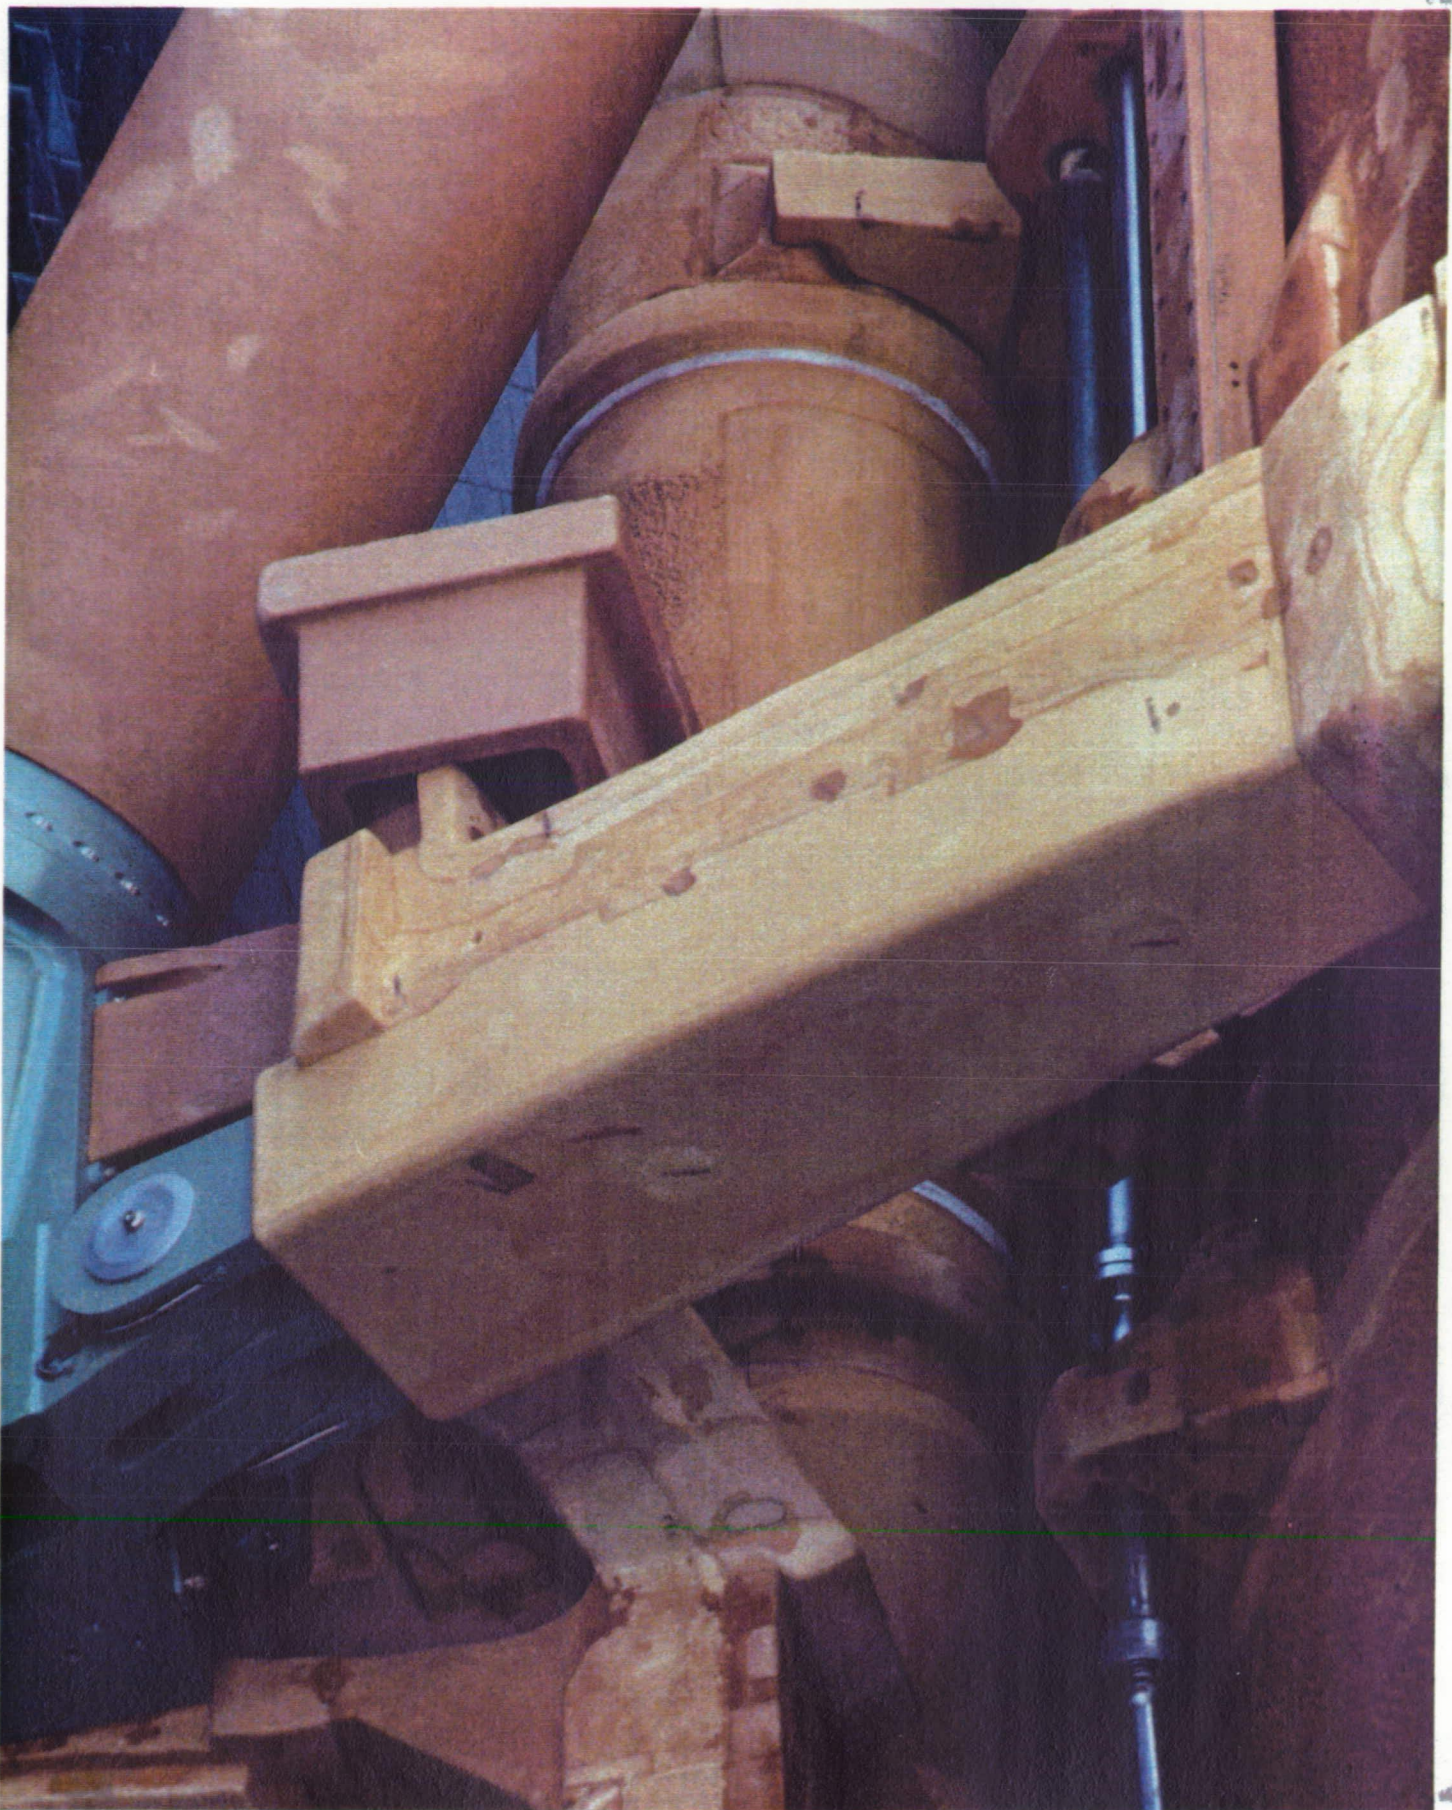
Ice/frost formations in the L02 feedline lower bellows and support brackets were typical

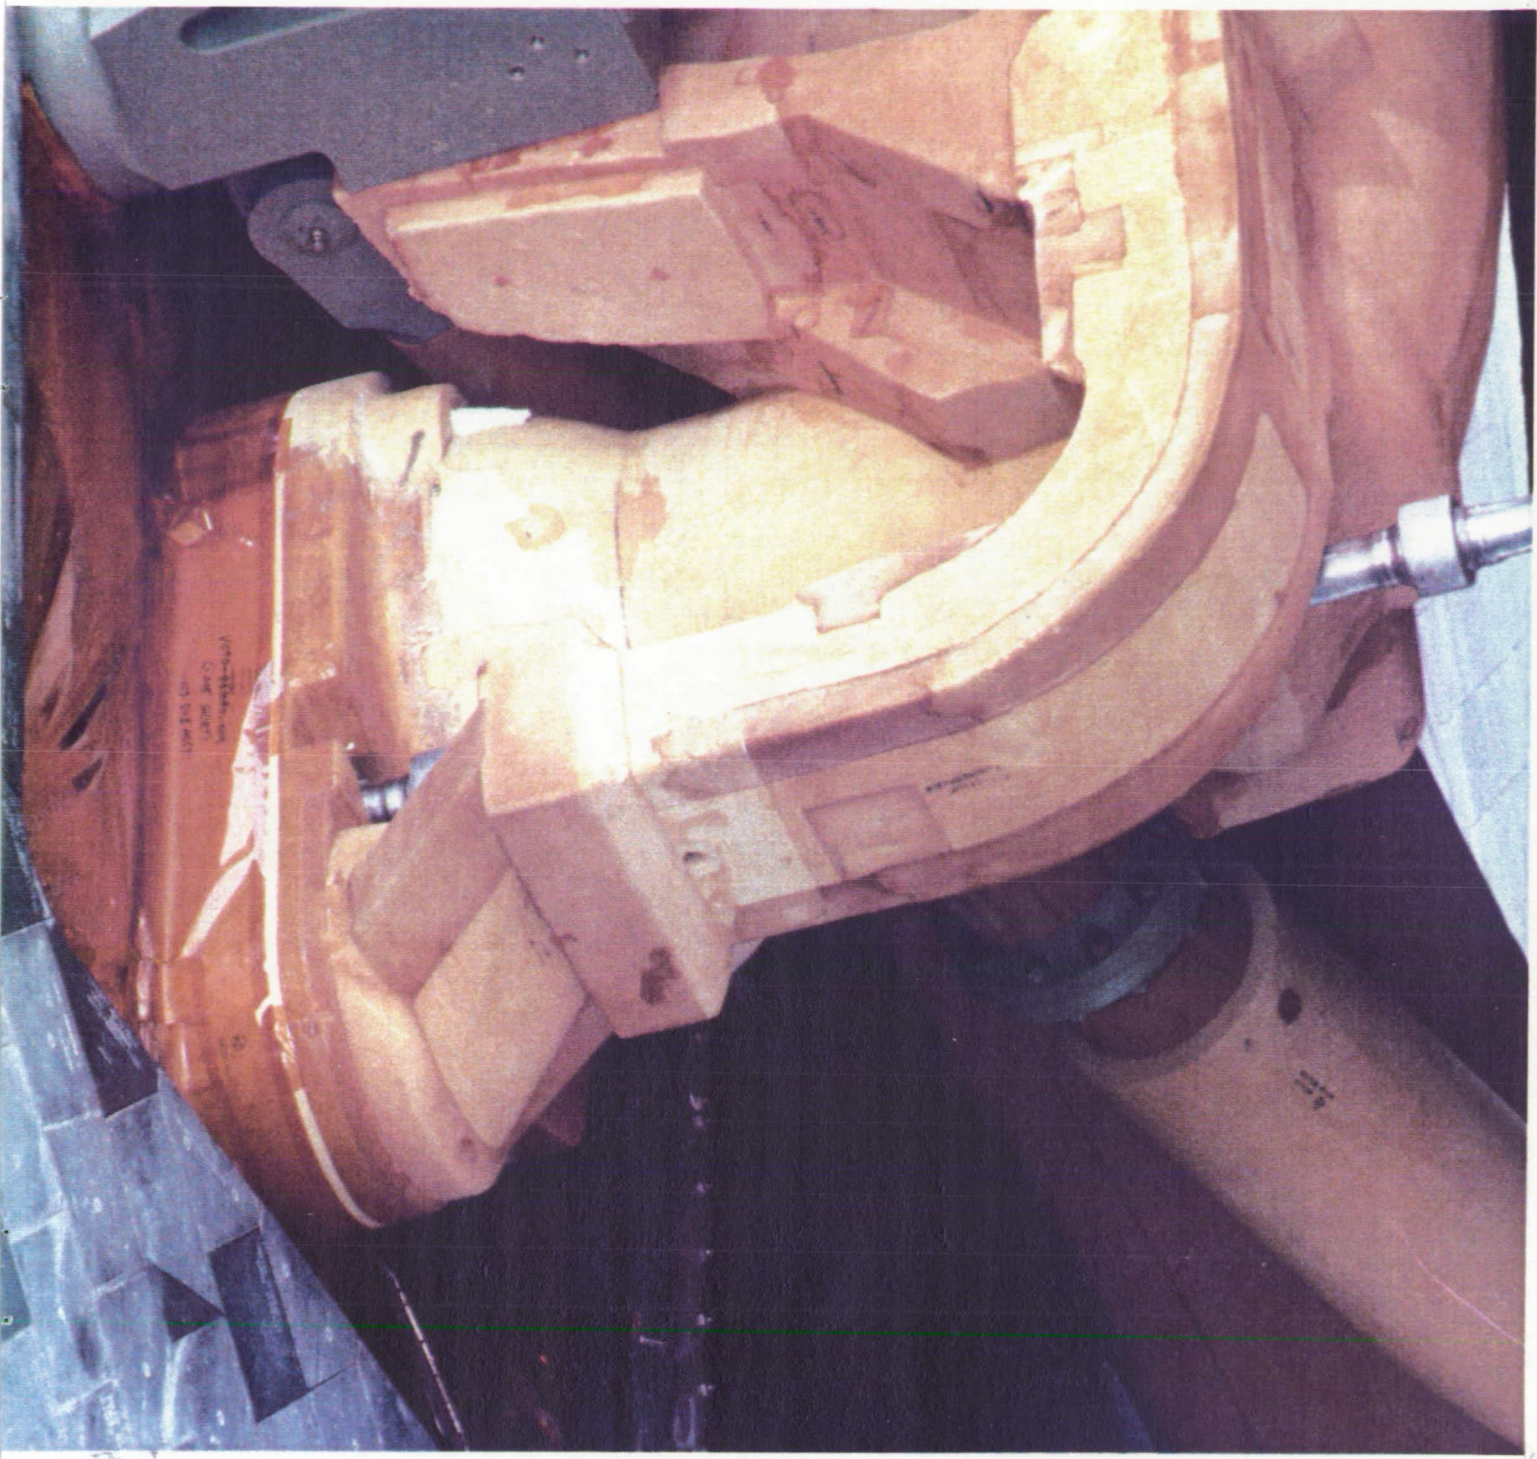
Overall view of the L02 ET/ORB umbilical. Ice/frost fingers on the pyro canister purge vents were typical. There were no acreage TPS anomalies or ice/frost accumulations.

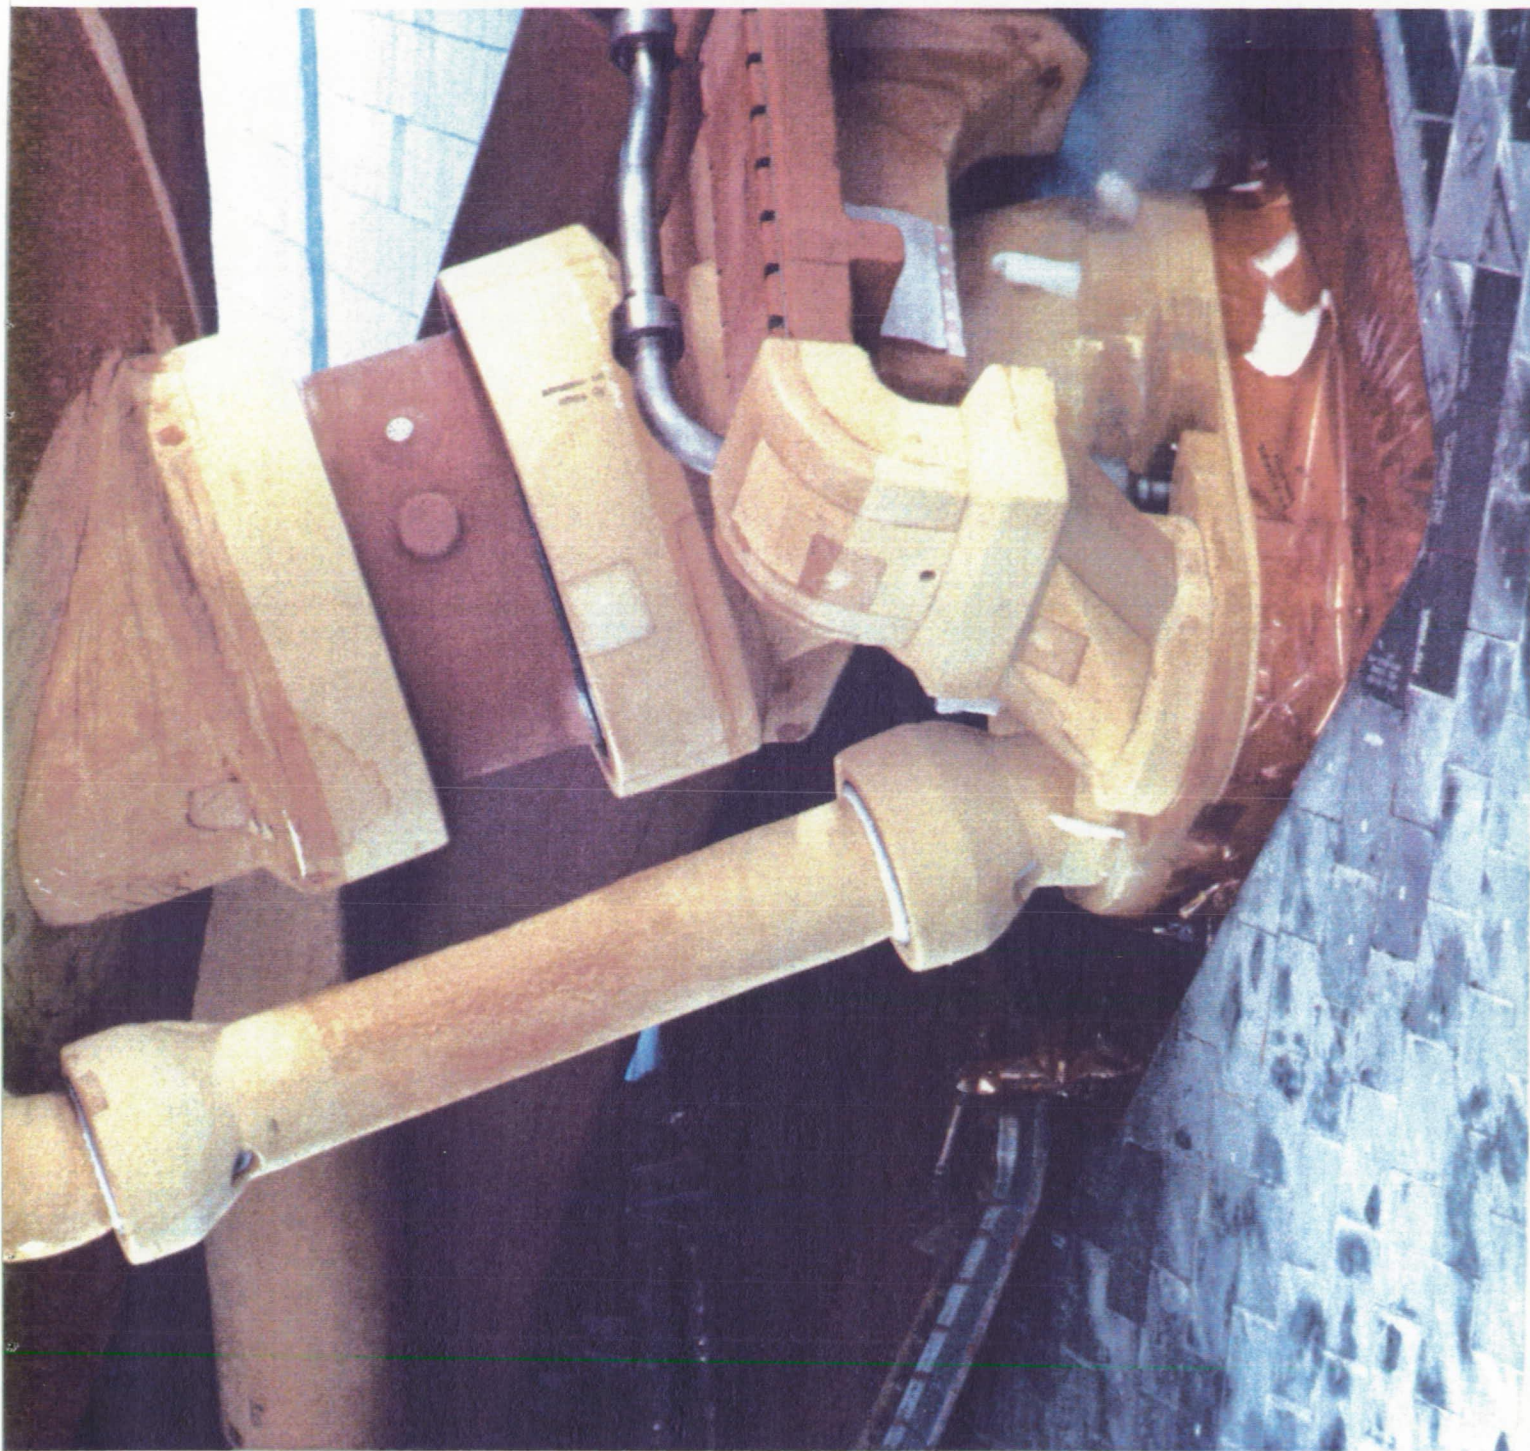
Overall view of the LH2 ET/ORB umbilical. There were no unusual vapors emanating from the umbilical nor any evidence of cryogenic drips. Ice/frost accumulations on the umbilical out board side and on the purge vents were typical. Ice/frost in the recirculation line bellows and burst disks was typical.

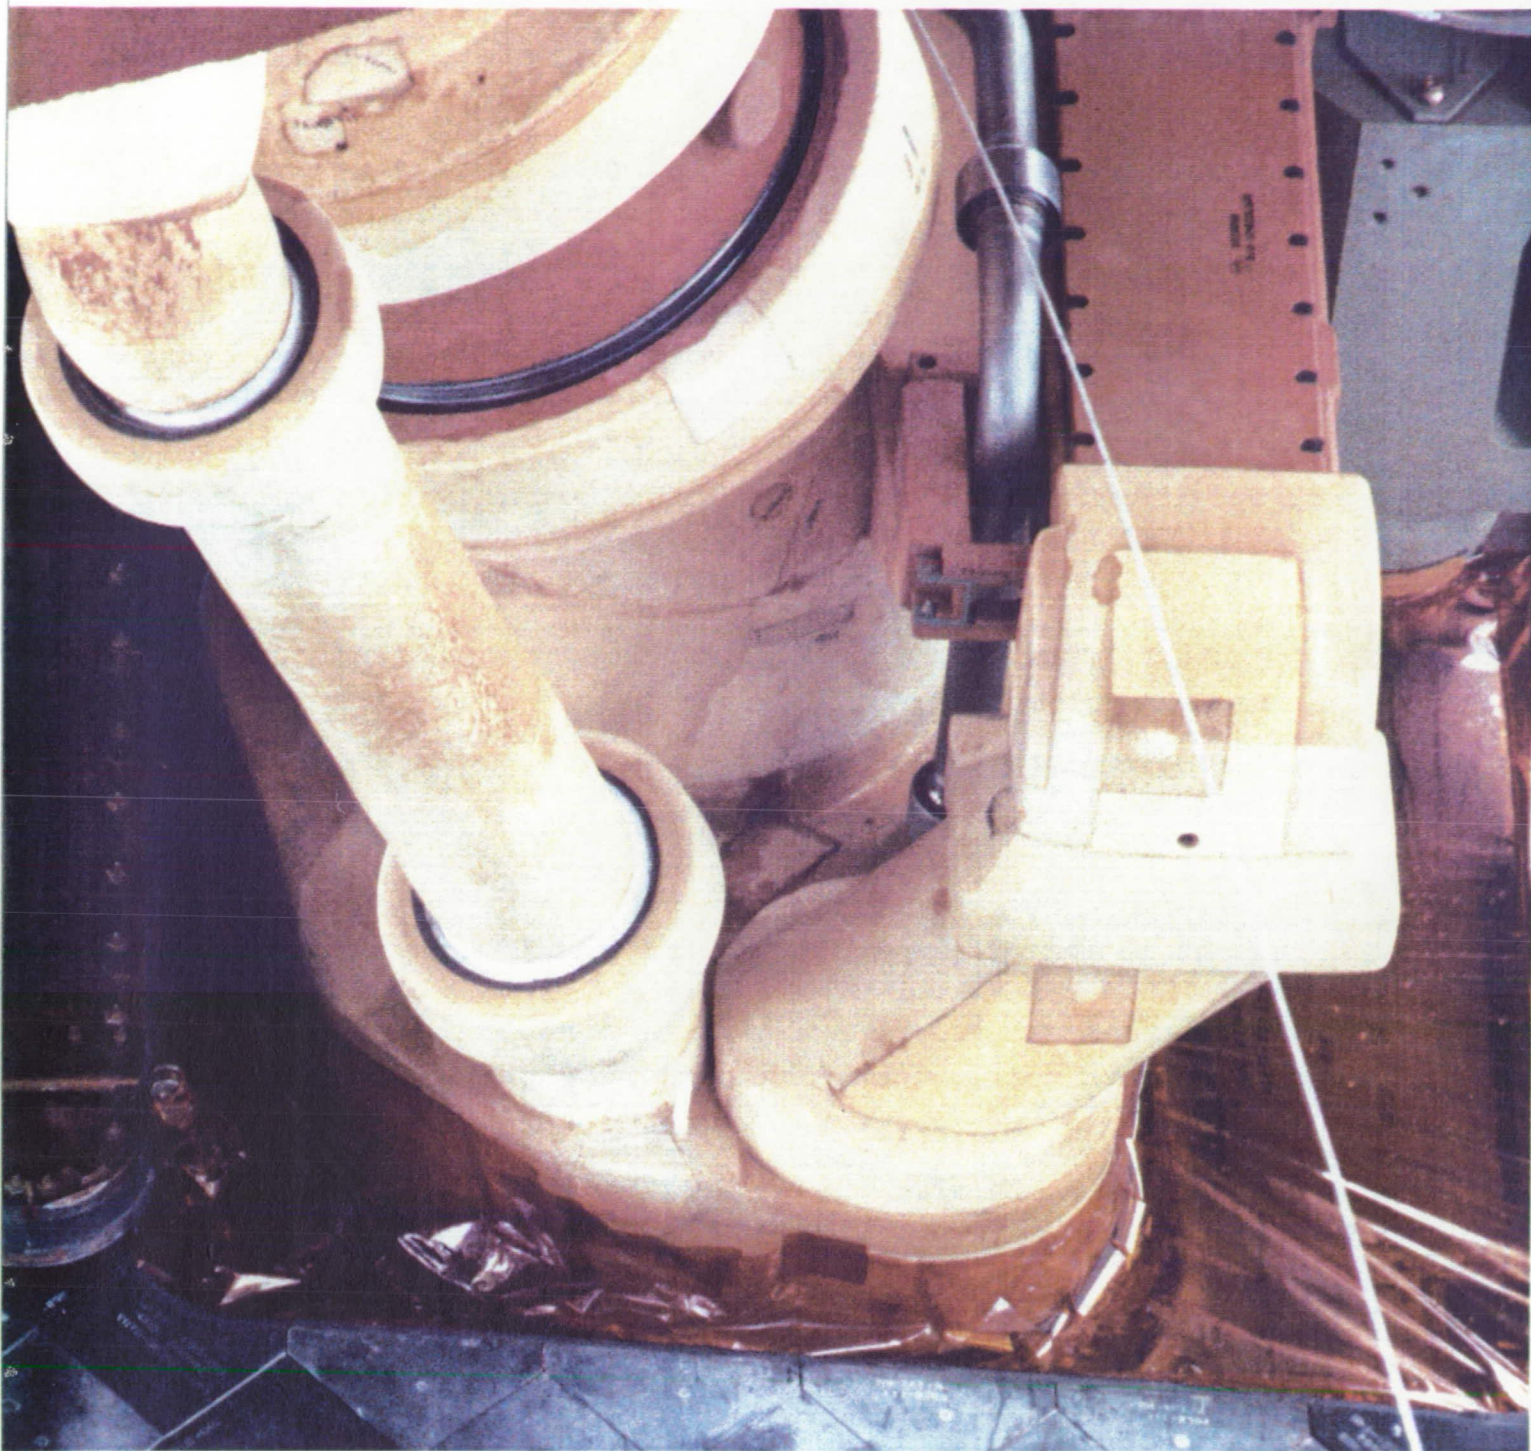
Less than usual ice/frost had accumulated on the inboard and aft sides of the LH2 ET/ORB umbilical. Ice/frost formations on the lower plate gap purge vent and in the LH2 recirculation line bellows were typical. The LH2 feedline bellows, cable tray vent hole, and 17-inch flapper valve actuator tool access port closeout exhibited no ice or frost accumulations.

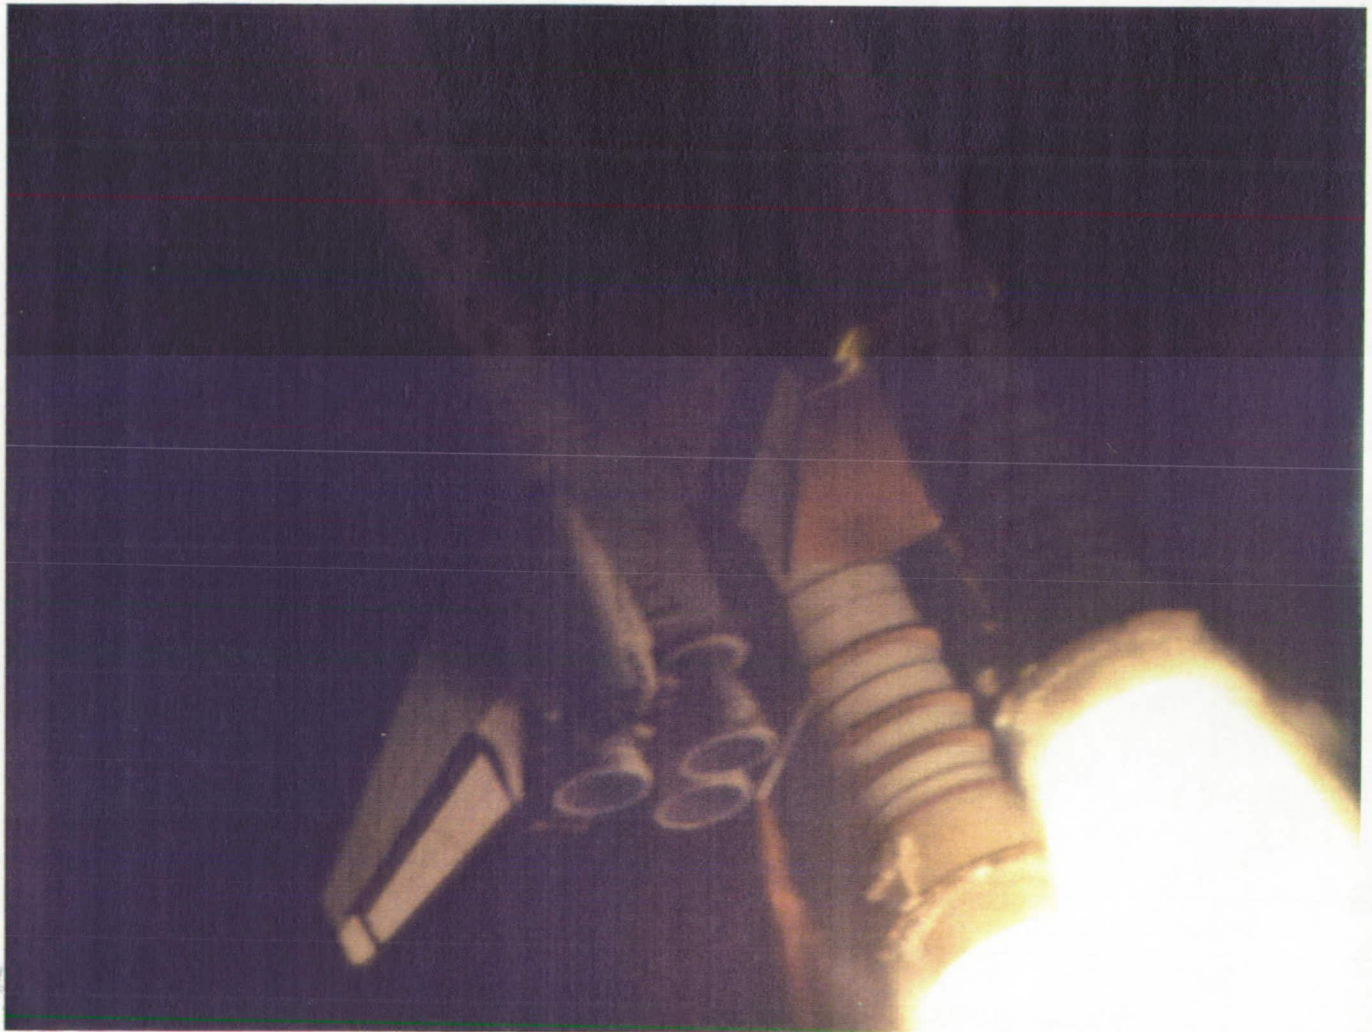
Orange flashes within the SSME plume itself may be
indicative of fuel impurities.

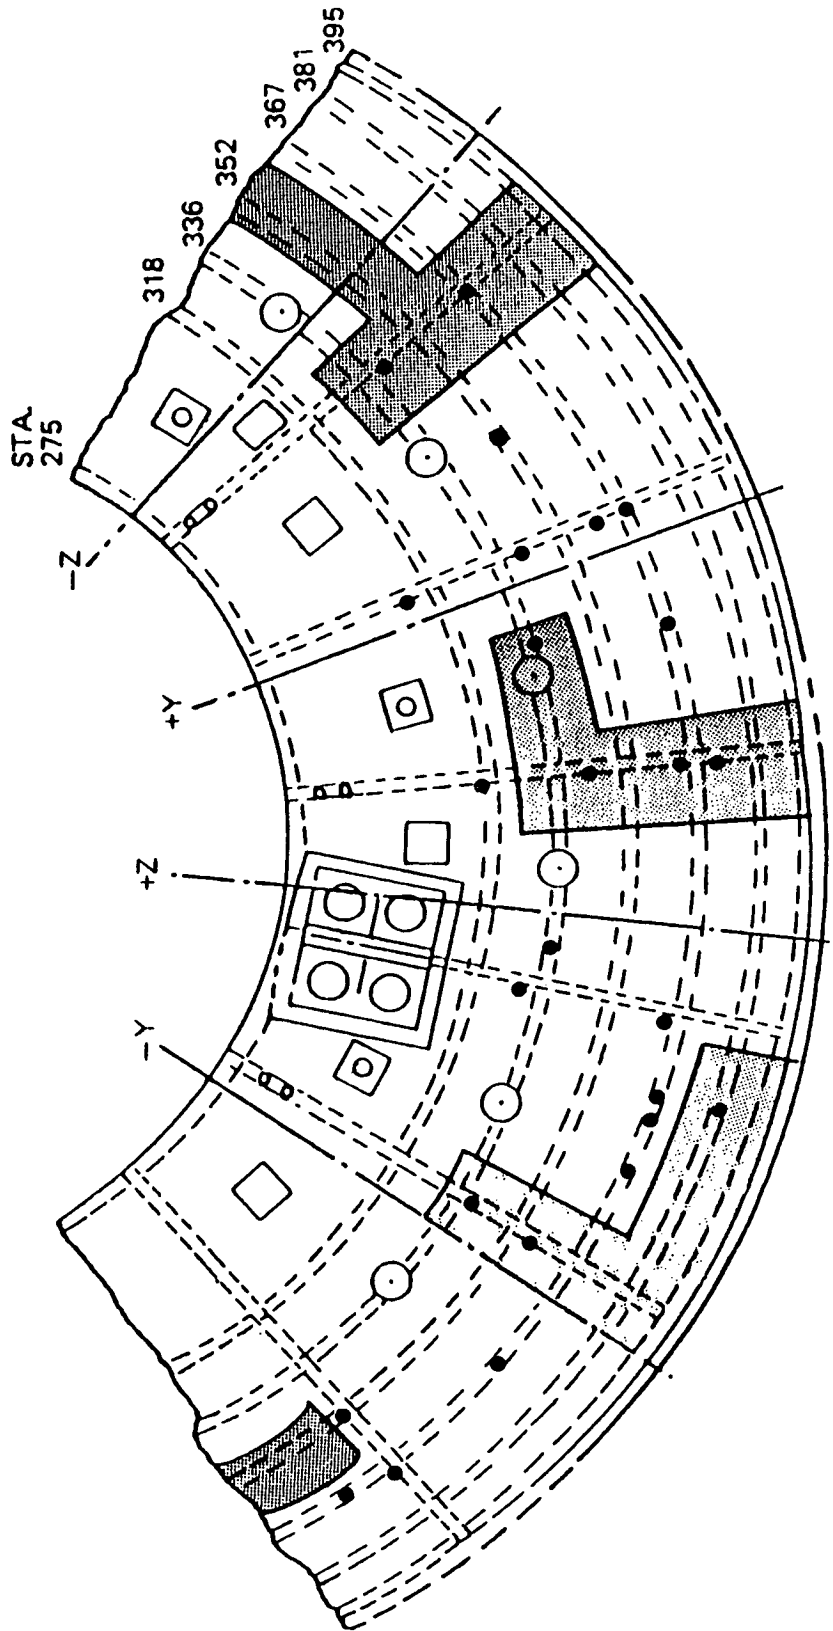
FIGURE 5. RIGHT SRB FRUSTRUM

The RH frustum had no areas of missing TPS but had 26 MSA-2 debonds over fasteners. There was minor localized blistering of the Hypalon paint (Figure 5). All BSM covers were locked in the fully opened position.
