NASA Technical Memorandum TM 103826

Debris/Ice/TPS Assessment And Photographic Analysis For Shuttle Mission STS-48

November 1991

Gregory N. Katnik
NASA/Kennedy Space Center

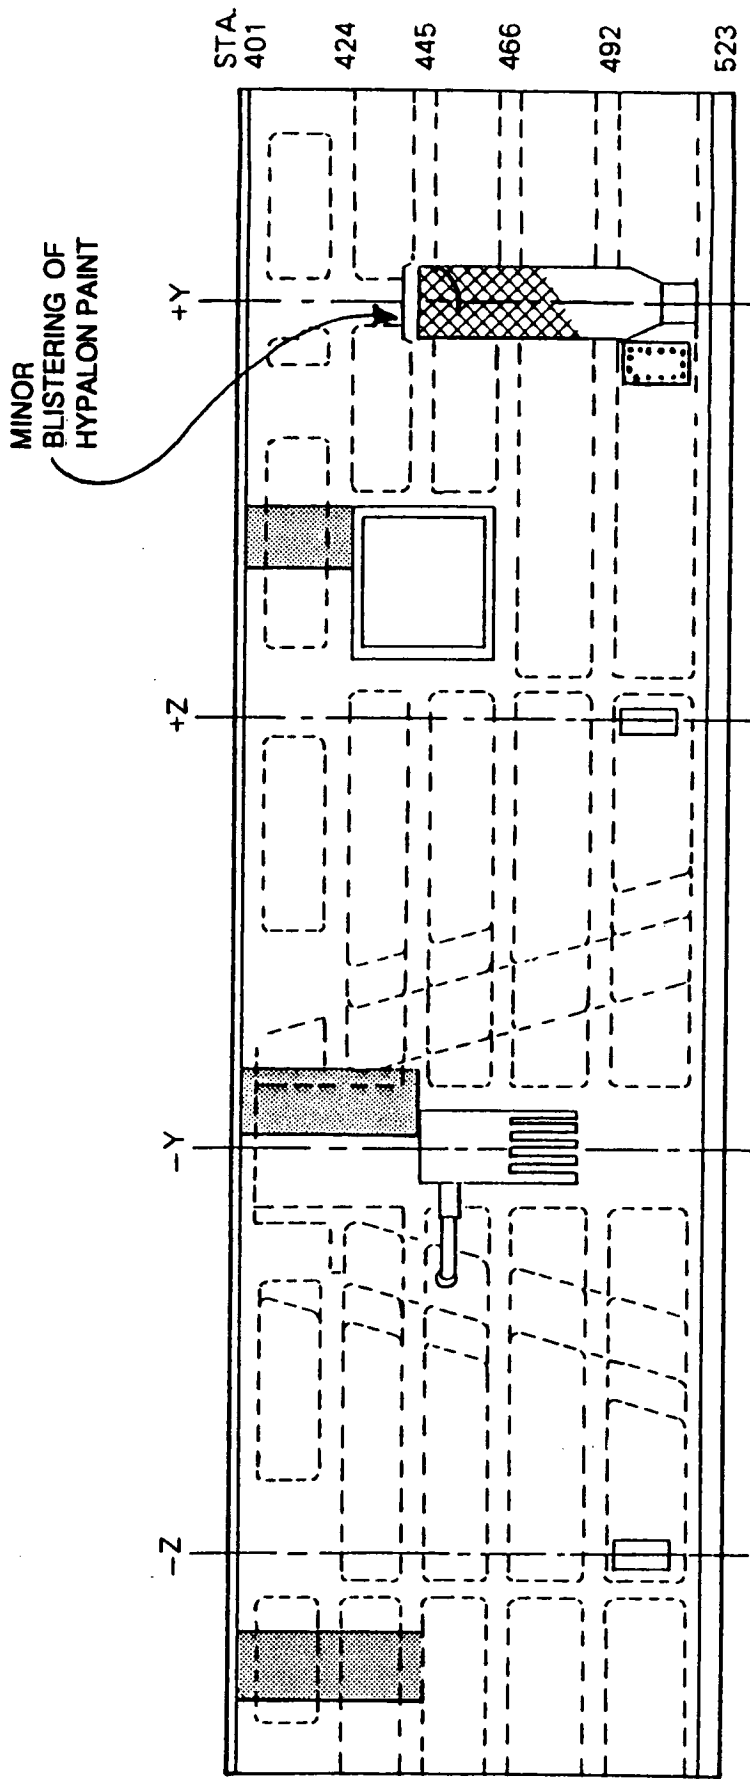
FIGURE 6. RIGHT SRB FWD SKIRT

The RH forward skirt exhibited no debonds or missing TPS. The phenolic plates on both RSS antennae were intact. The forward separation bolt and electrical cables appeared to have separated cleanly. No pins were missing from the frustum severance ring. Minor blistering of the Hypalon paint occurred forward of the ET/SRB attach point (Figure 6).

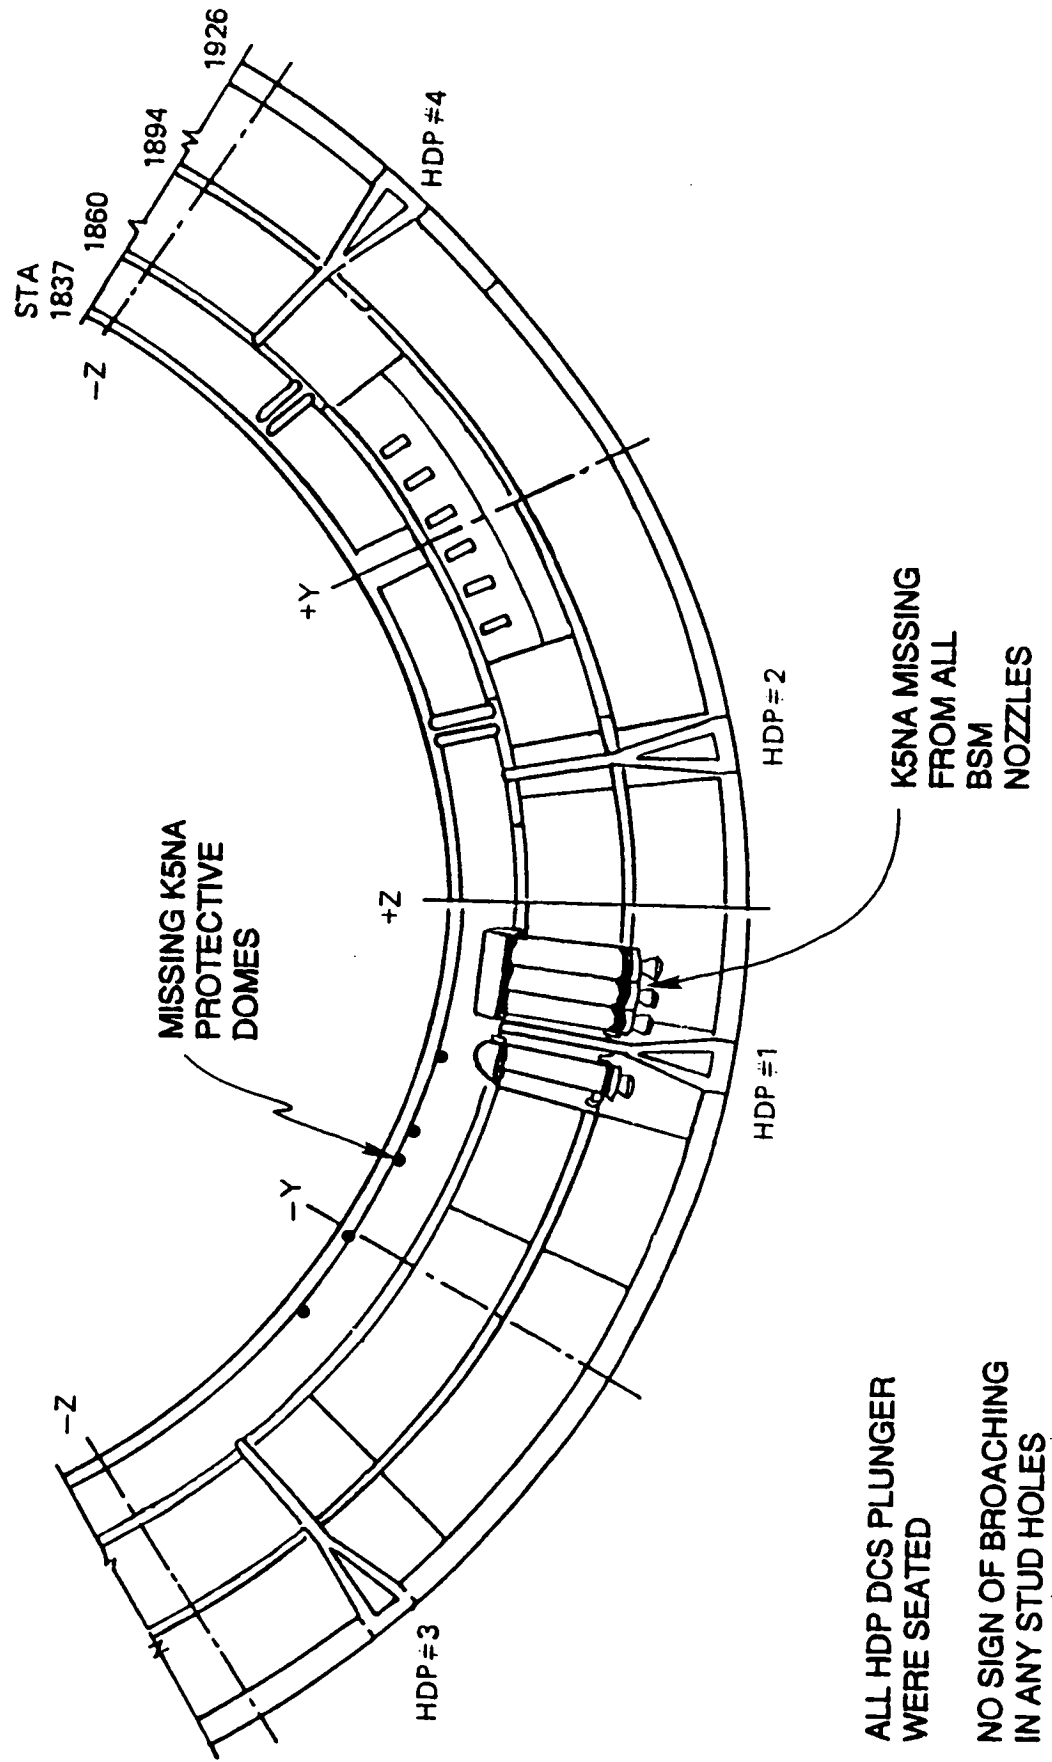
FIGURE 7. RIGHT SRB AFT SKIRT EXTERIOR TPS

The phenolic material on the kick ring was delaminated. Five K5NA protective domes between HDP #1 and #3 were lost from bolt heads on the aft side of the phenolic kick ring prior to water impact (sooted substrate). The aft skirt acreage TPS was in good condition (Figure 7). K5NA was missing from all aft BSM nozzles.

All four HDP Debris Containment System (DCS) plungers were seated. This was the third flight utilizing the optimized link. There was no sign of broaching in any of the stud holes. HDP #3 and HDP #4 EPON shim sidewall material was lost prior to water impact. MSFC will review the bonding process.

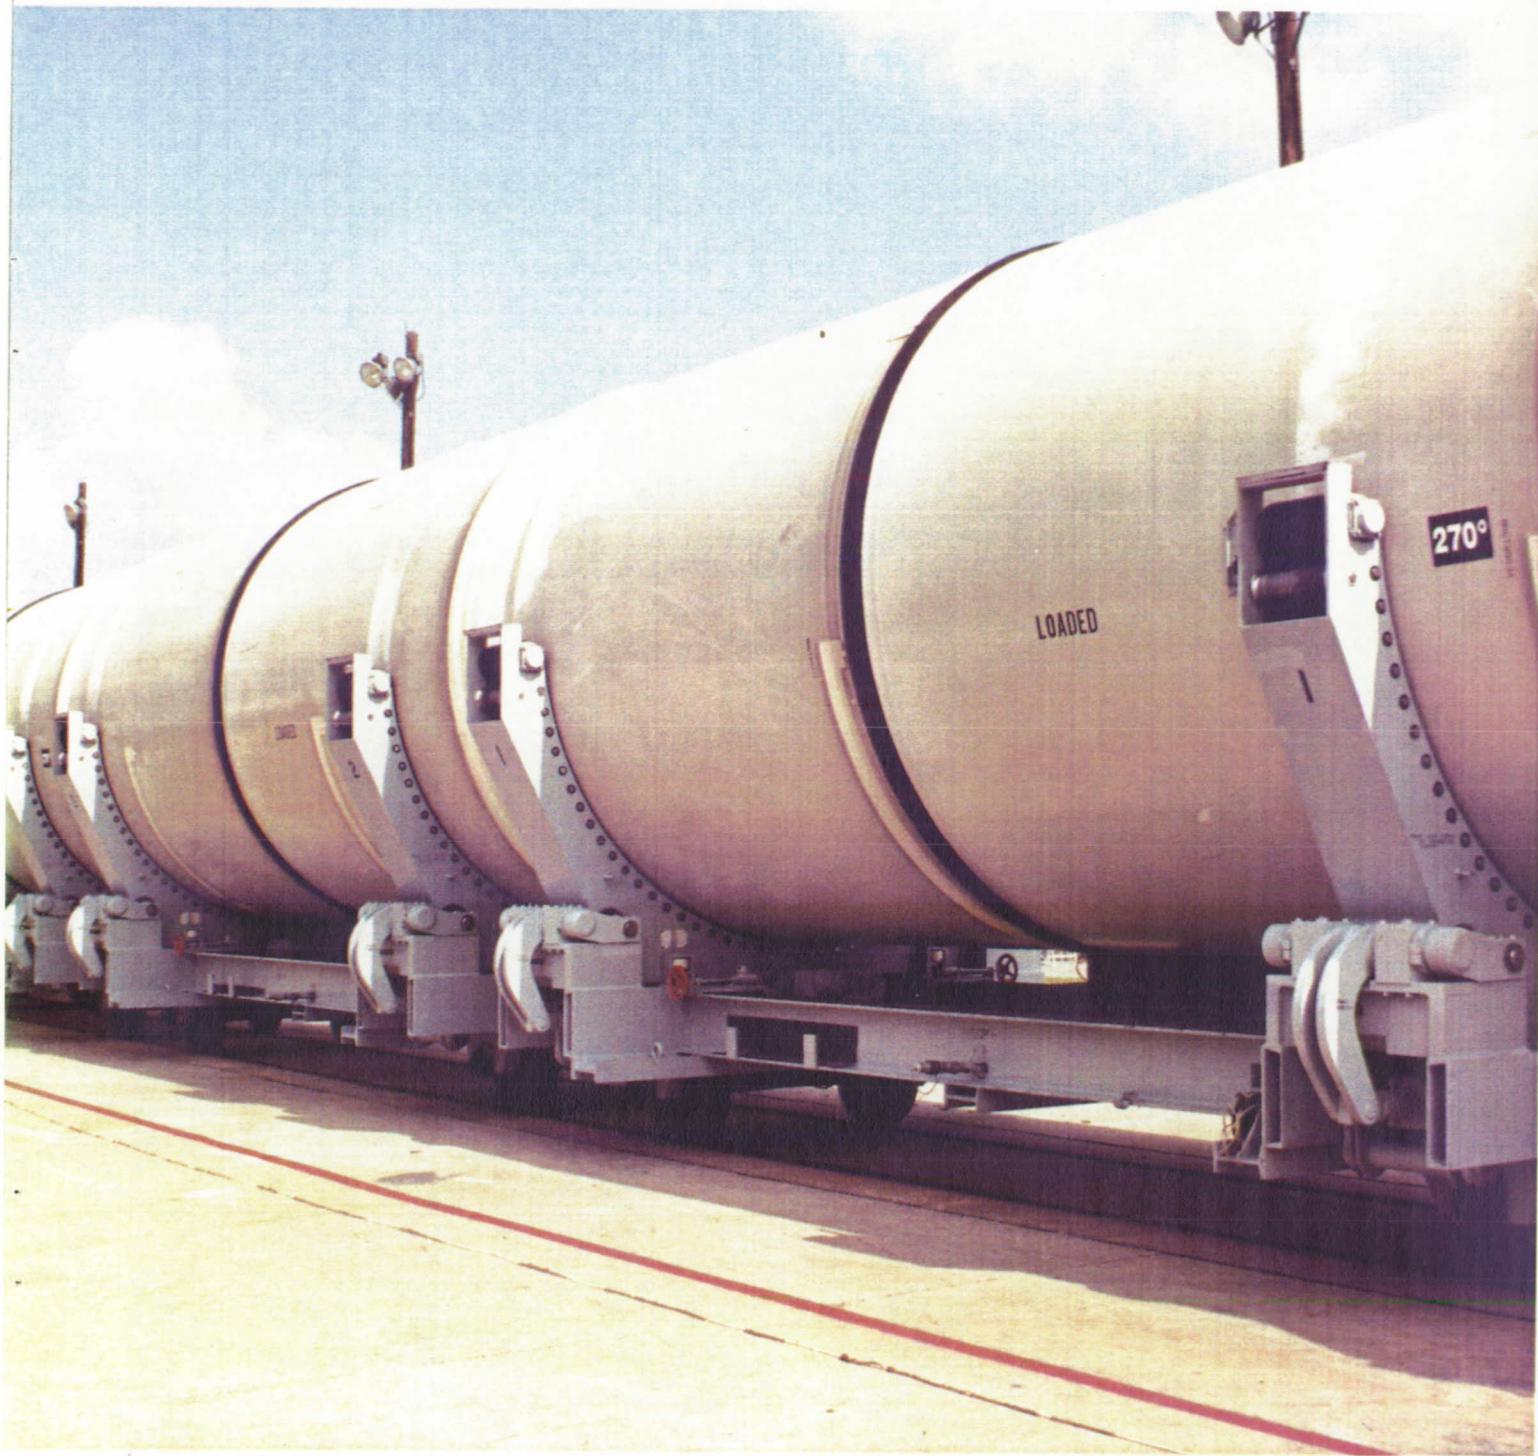
Overall view of the RH SRM cases. The Field Joint Protection System closeouts were generally in good condition.

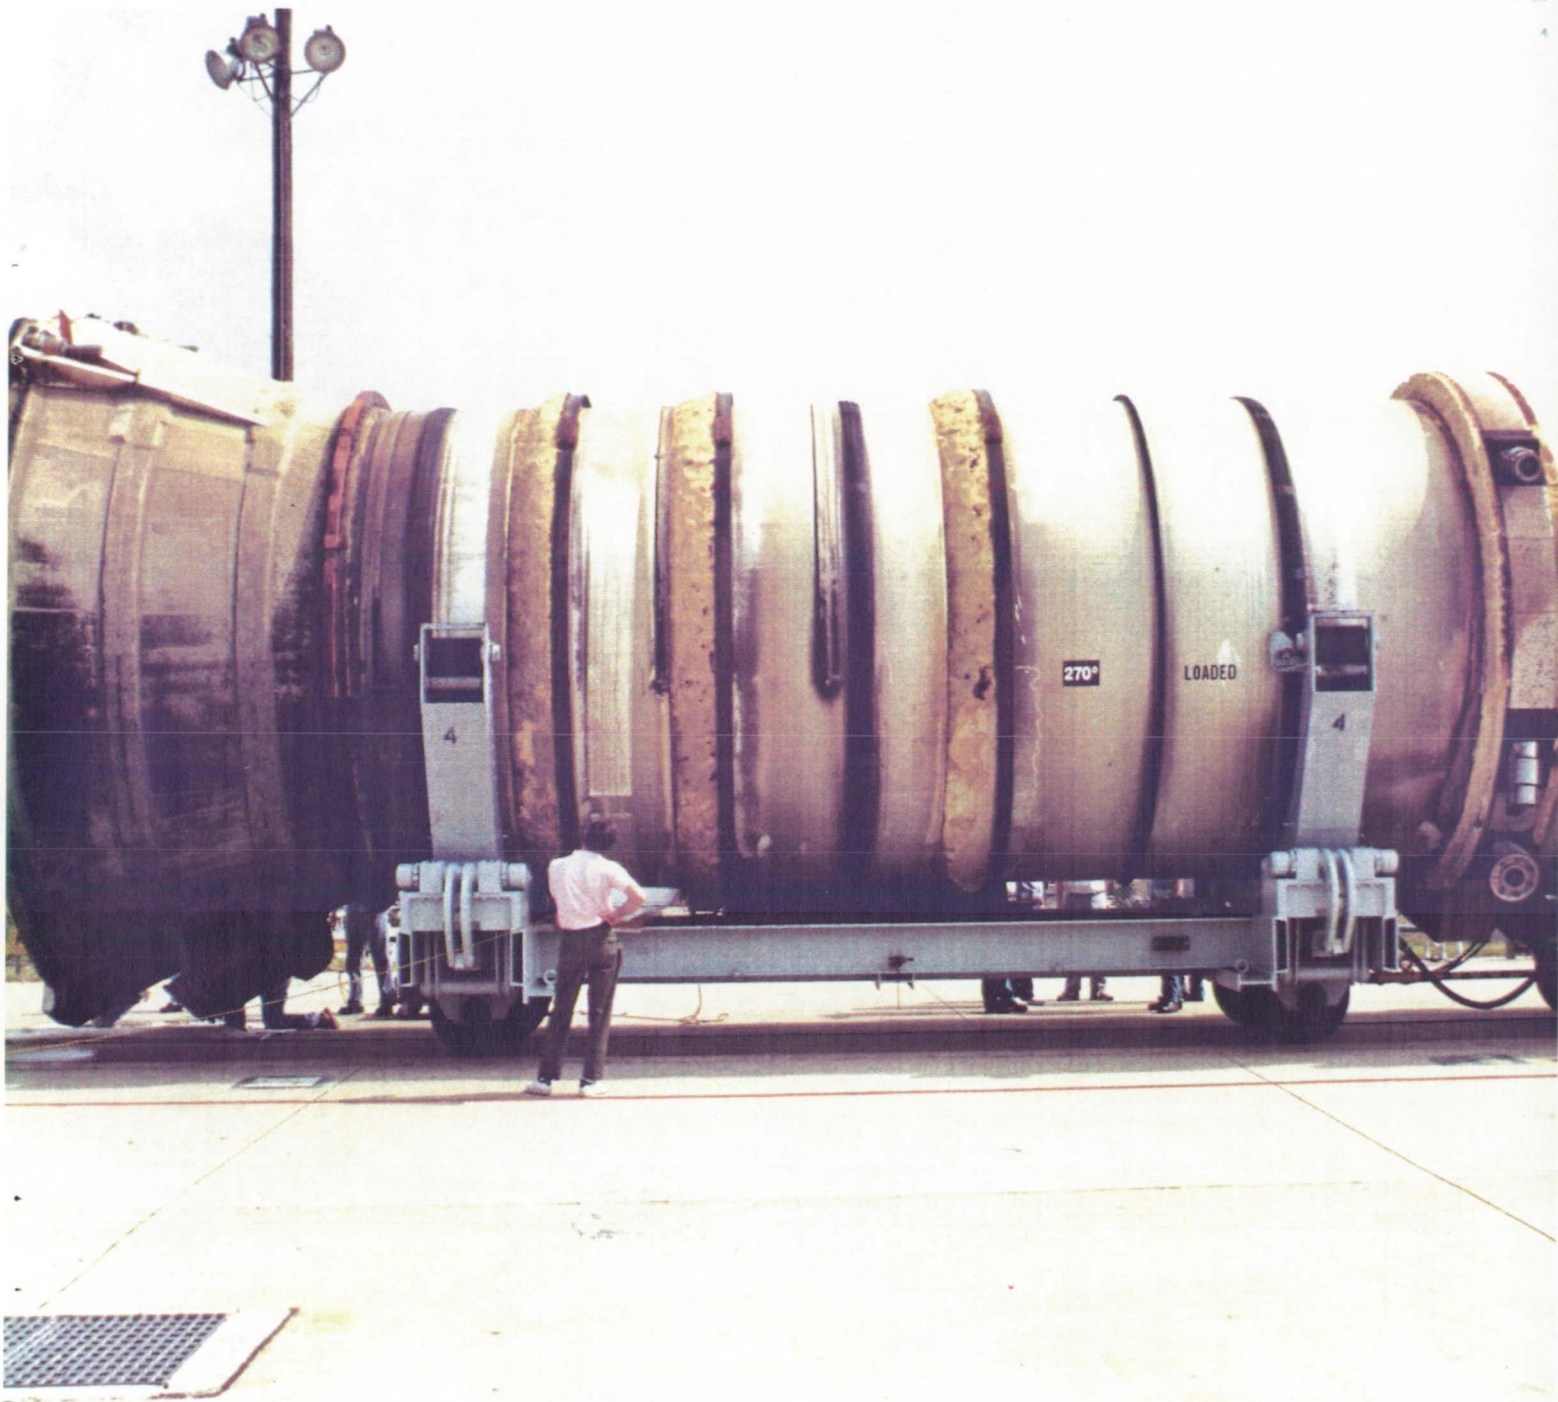
Post flight condition of the RH aft booster. The aft skirt
areage TPS was sooted but in good condition.

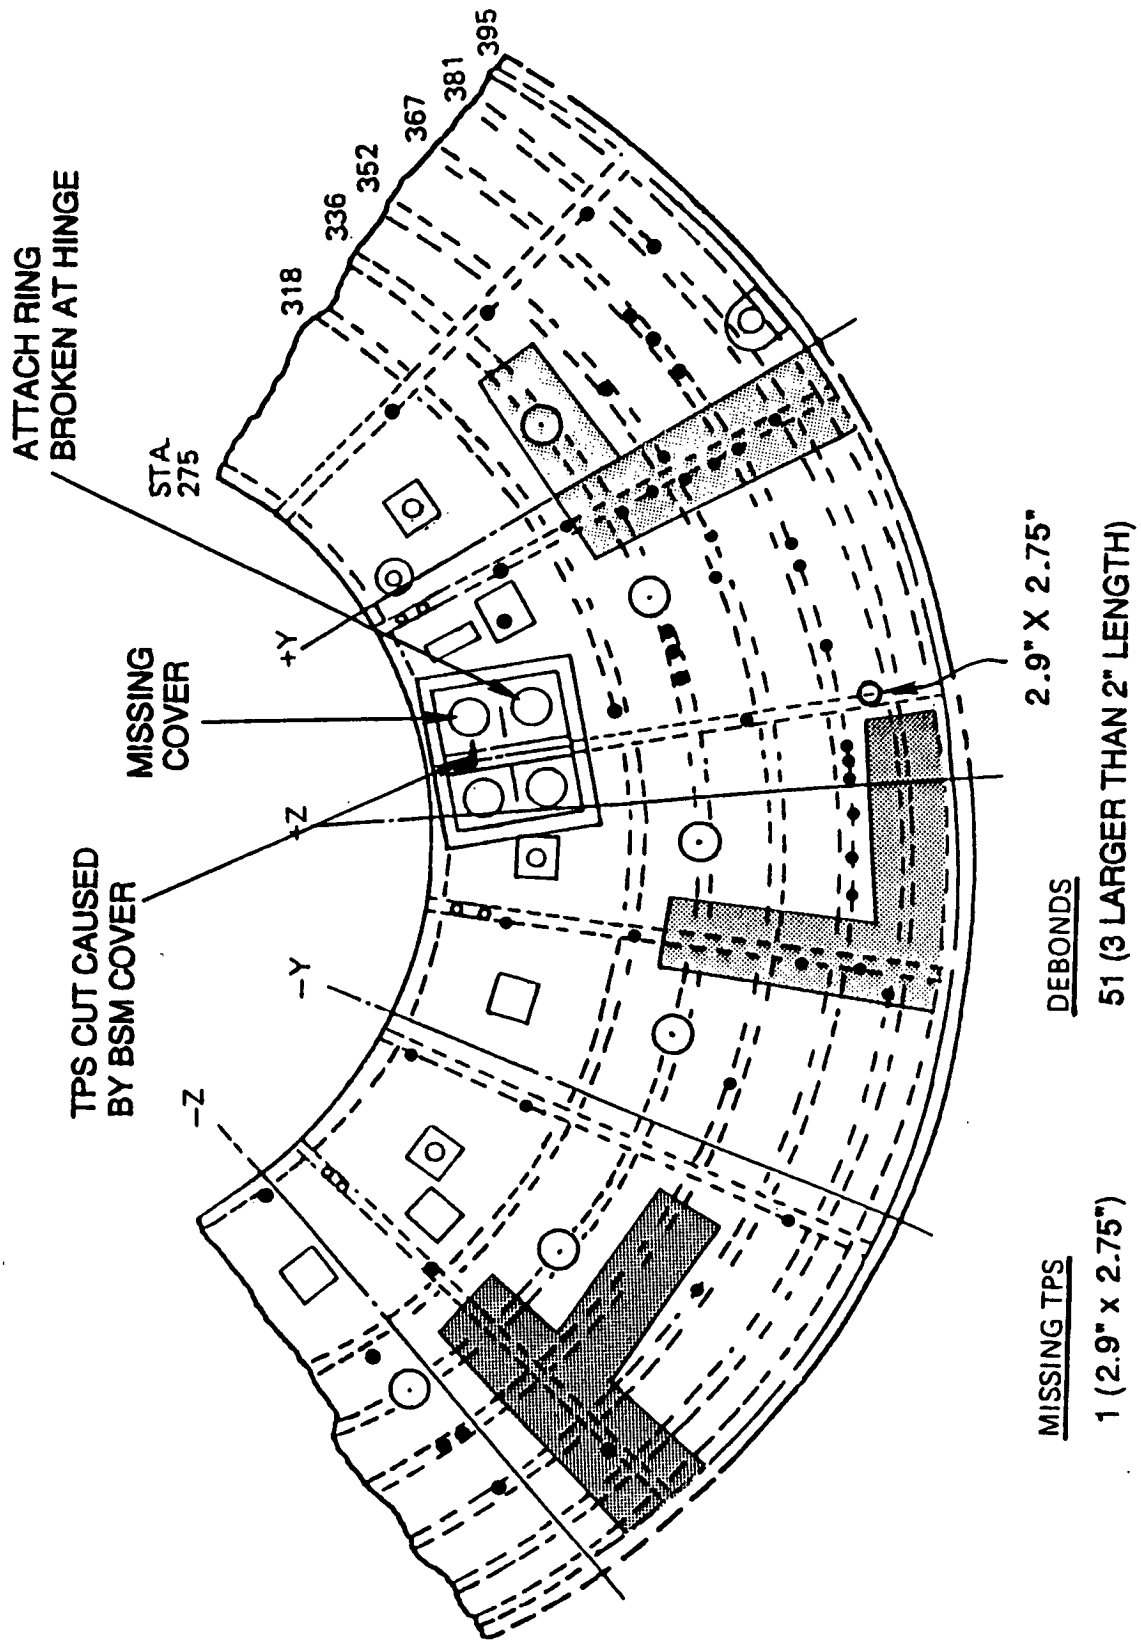
FIGURE 8. LEFT SRB FRUSTUM

The LH frustum had 51 MSA-2 debonds over fasteners (Figure 8). A 2.9"x2.75" area of MSA-2 was missing from two fasteners on the stiffener below the BSM's near the 381 ring. The MSA-2 had separated completely from the substrate. The MSA-2 fracture edges and surrounding Hypalon paint were not sooted/charred, the exposed MSA-2 material was clean, and no unusual heating effects were visible. Samples were taken for laboratory analysis at MSFC. There was minor localized blistering of the Hypalon paint on the acreage areas of the frustum.

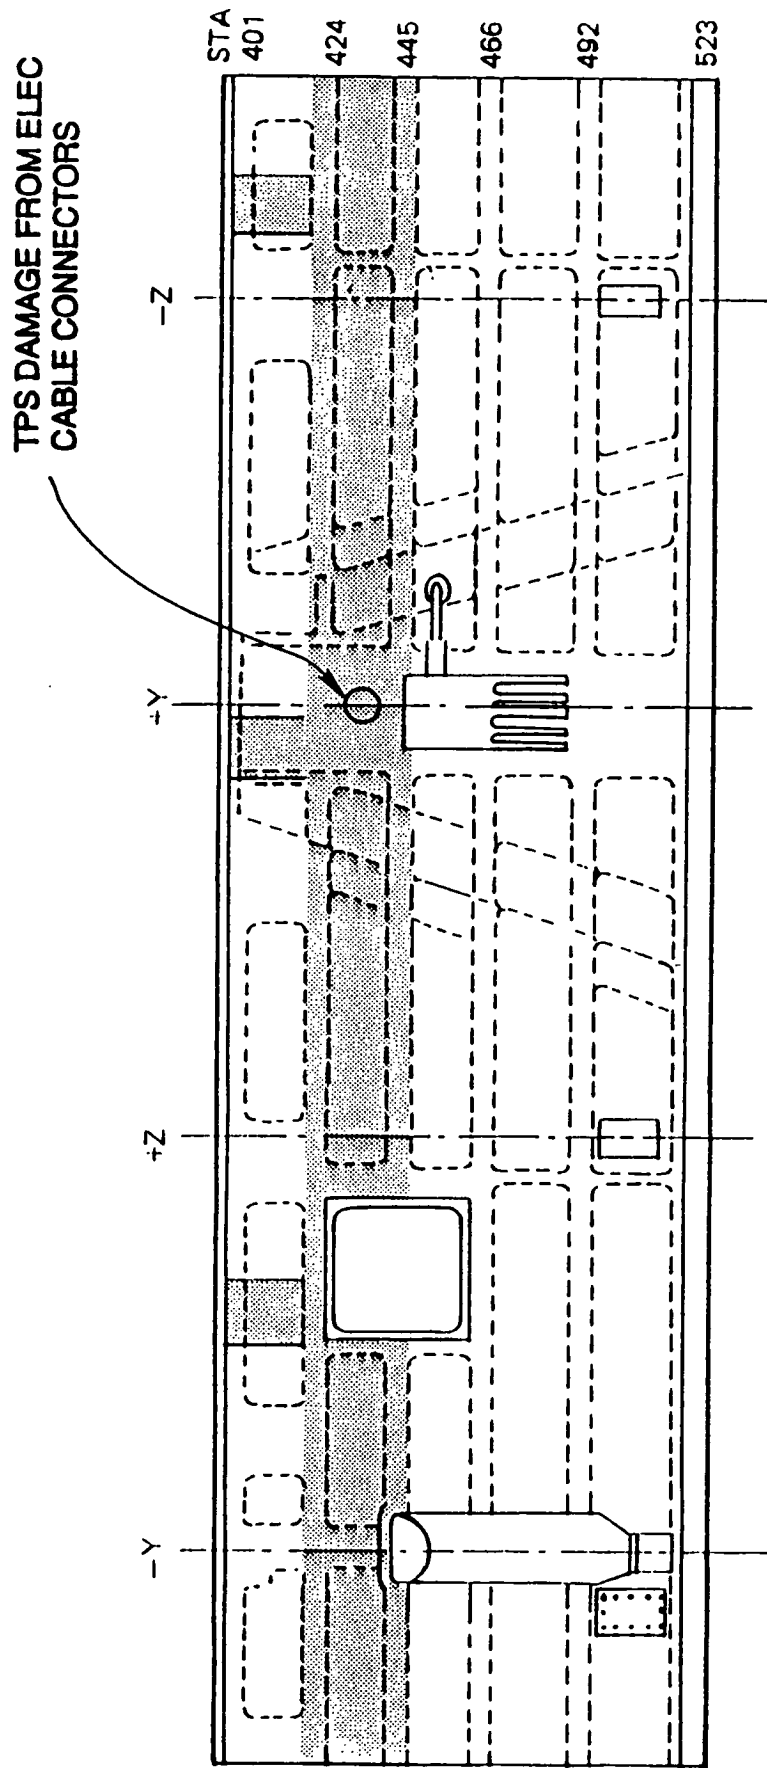
FIGURE 9. LEFT SRB FWD SKIRT

The LH forward skirt exhibited no debonds or missing TPS. The phenolic plates on both RSS antennae were intact. The forward separation bolt and electrical cables appeared to have separated cleanly. No pins were missing from the frustum severance ring. Minor blistering of the Hypalon paint occurred forward of the ET/SRB attach point (Figure 9).

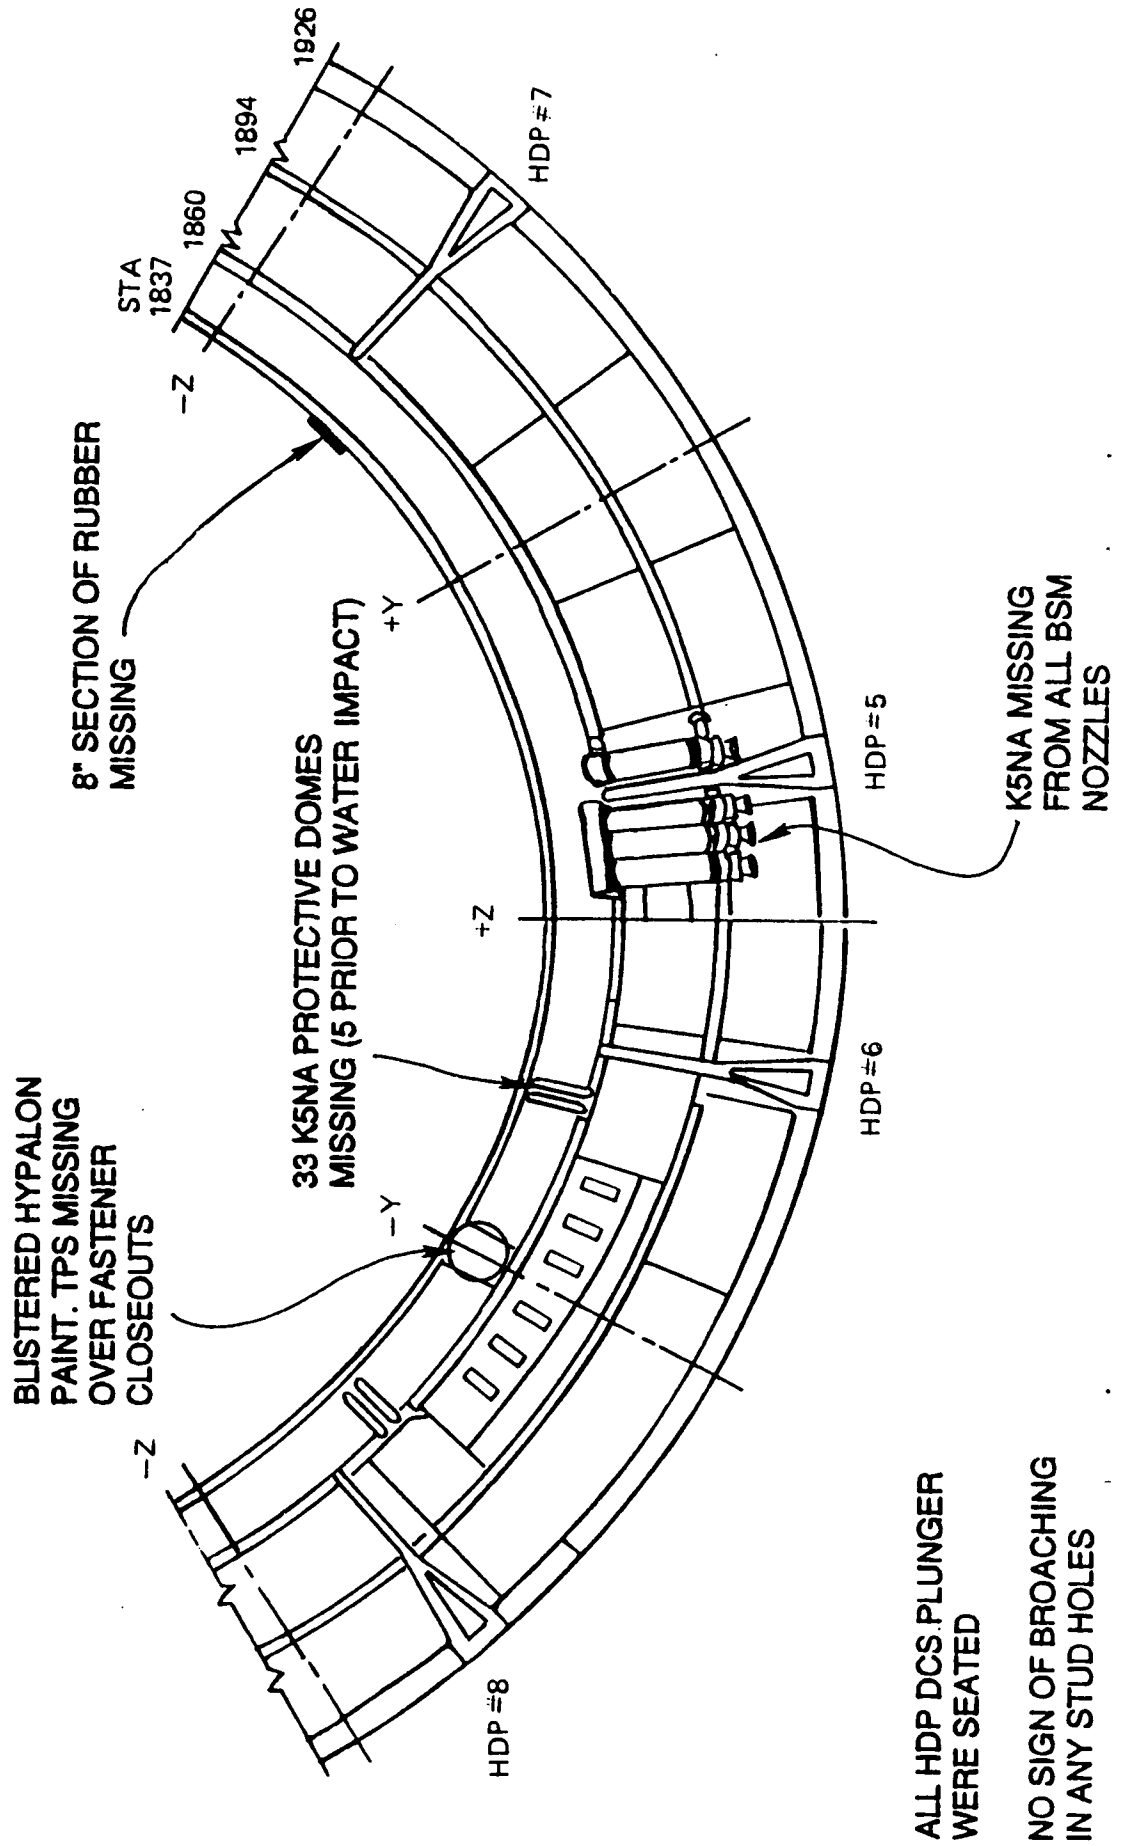
FIGURE 10. LEFT SRB AFT SKIRT EXTERIOR TPS

The phenolic material on the kick ring delaminated at several locations. Thirty-three K5NA protective dome were missing from bolt heads on the aft side of the phenolic kick ring. Five of these domes were lost prior to water impact (charred substrate). The aft skirt acreage TPS was in good condition. K5NA was missing from all aft BSM nozzles (Figure 10).

SOME LOCALIZED BLISTERING OF HYPALON PAINT AROUND PROTUBERANCES

ALL HDP DCS PLUNGER WERE SEATED
 NO SIGN OF BROACHING IN ANY STUD HOLES

All four HDP Debris Containment System (DCS) plungers were seated. This was the third flight utilizing the optimized link. There was no sign of broaching in any of the stud holes. HDP #7 and HDP #8 EPON shim sidewall material was lost prior to water impact. MSFC will review the bonding process.

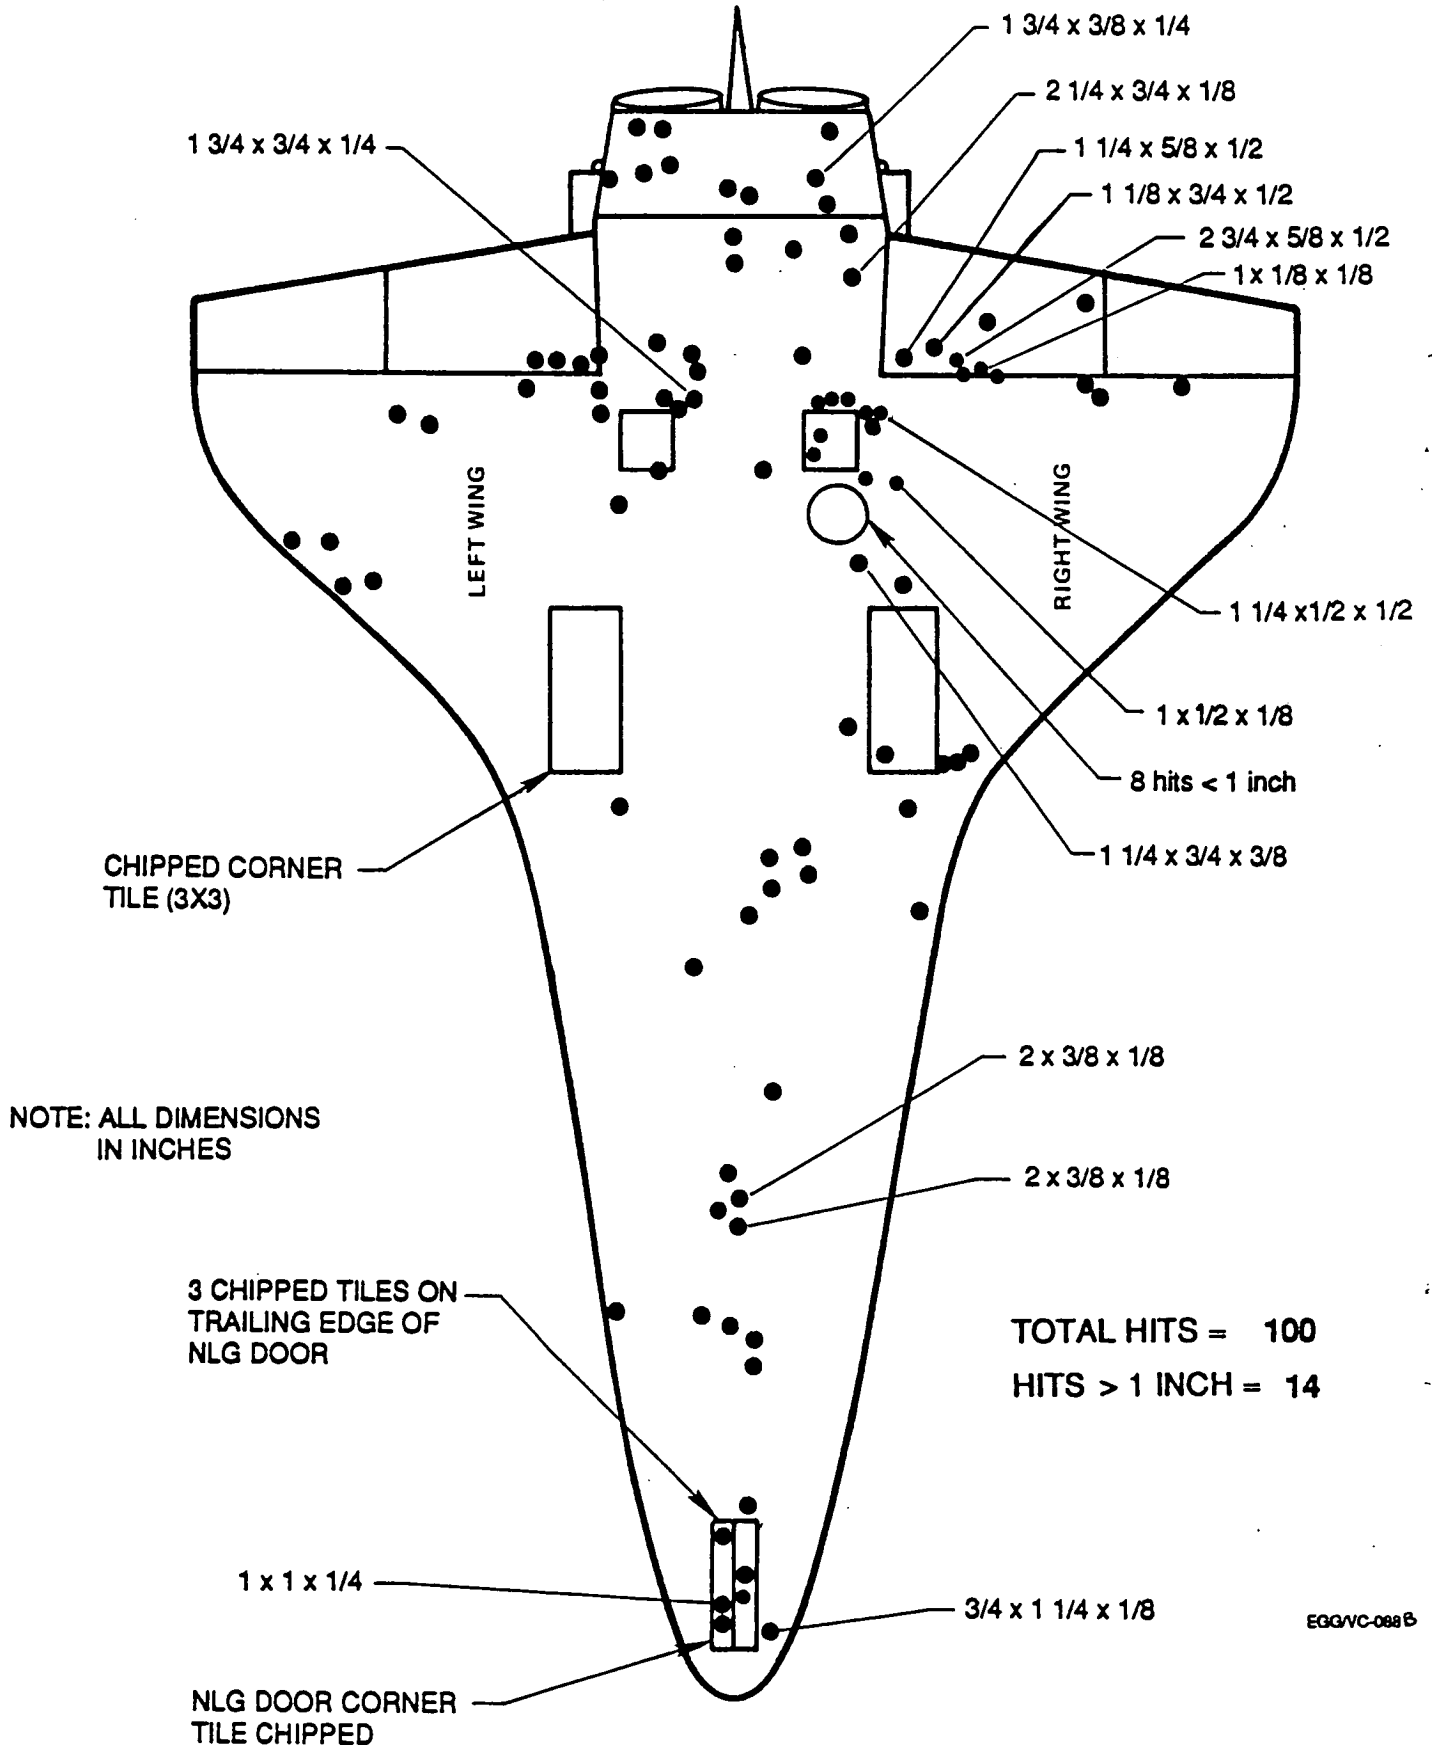
FIGURE 11. DEBRIS DAMAGE LOCATIONS

The Orbiter lower surface had a total of 100 hits of which 14 had a major dimension of one inch or greater. A comparison of these numbers to statistics from 30 previous missions of similar configuration (excluding missions STS-24, 25, 26, 26R, 27R, and 30R which had damage from known debris sources), indicates that the total number of hits was slightly greater than average and the number of hits one inch or larger was slightly less than average. Figures 11 - 14 map the TPS debris damage for STS-48.

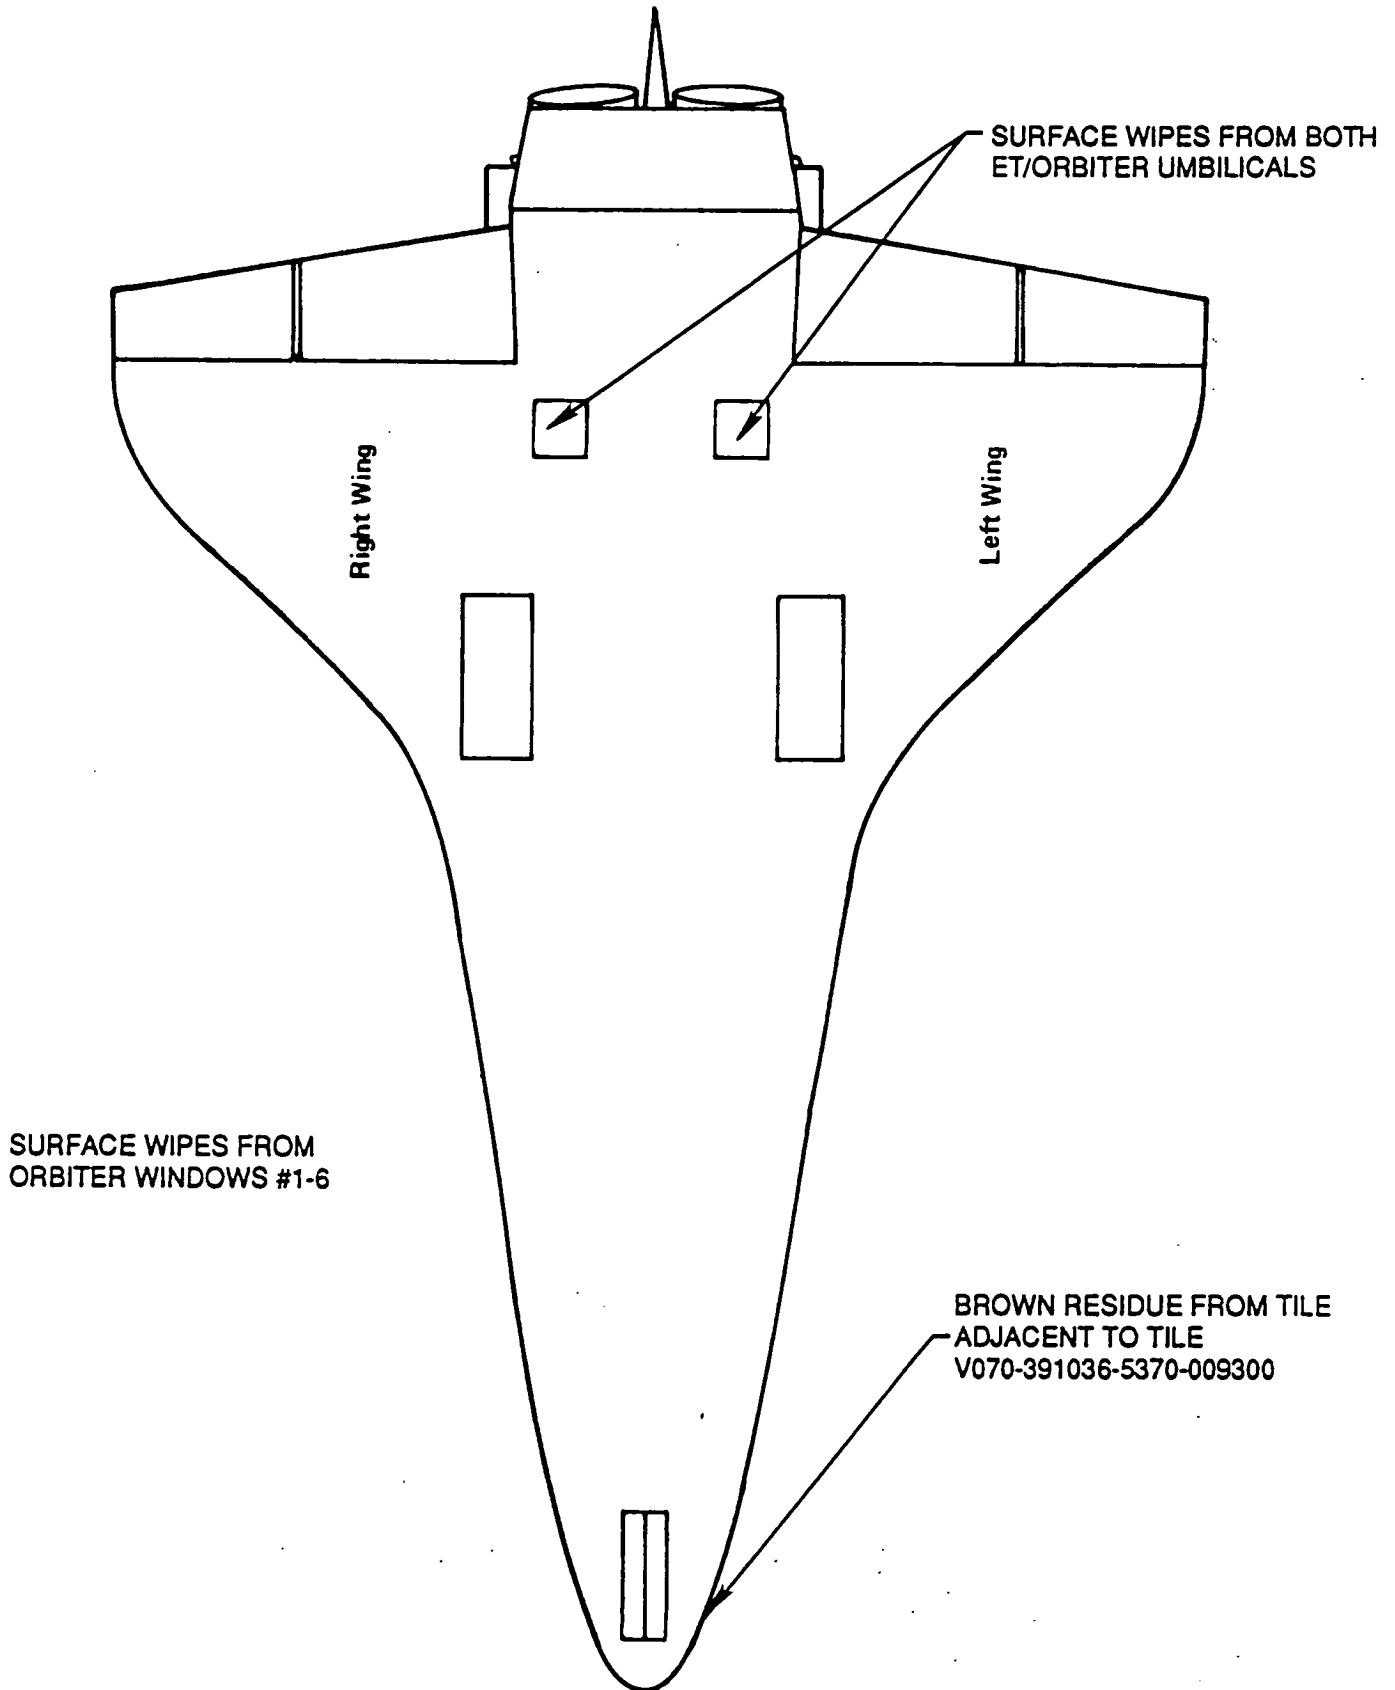
FIGURE 15.

Orbiter windows #1, #2, #5, & #6 were lightly hazed. Windows #3 and #4 exhibited moderate to heavy hazing and had numerous streaks. Laboratory analysis was performed on samples taken from all windows (reference Figure 15 and Section 9.0).

A total of 13 samples were obtained from Orbiter OV-103 during the STS-48 post landing debris assessment at Ames-Dryden Flight Research Facility (ADFRF), California (Figure 15). The 13 submitted samples consisted of 8 Orbiter window wipes (W1-8), 1 tile residue sample, and 4 samples from the LOX and LH2 ET/Orbiter umbilicals. The samples were analyzed by the NASA KSC Microchemical Analysis Branch (MAB) for material composition and comparison to known STS materials. Debris analysis involves the placing and correlating of particles with respect to composition, thermal (mission) effects, and availability. Debris sample results and analyses are listed by Orbiter location in the following summaries.

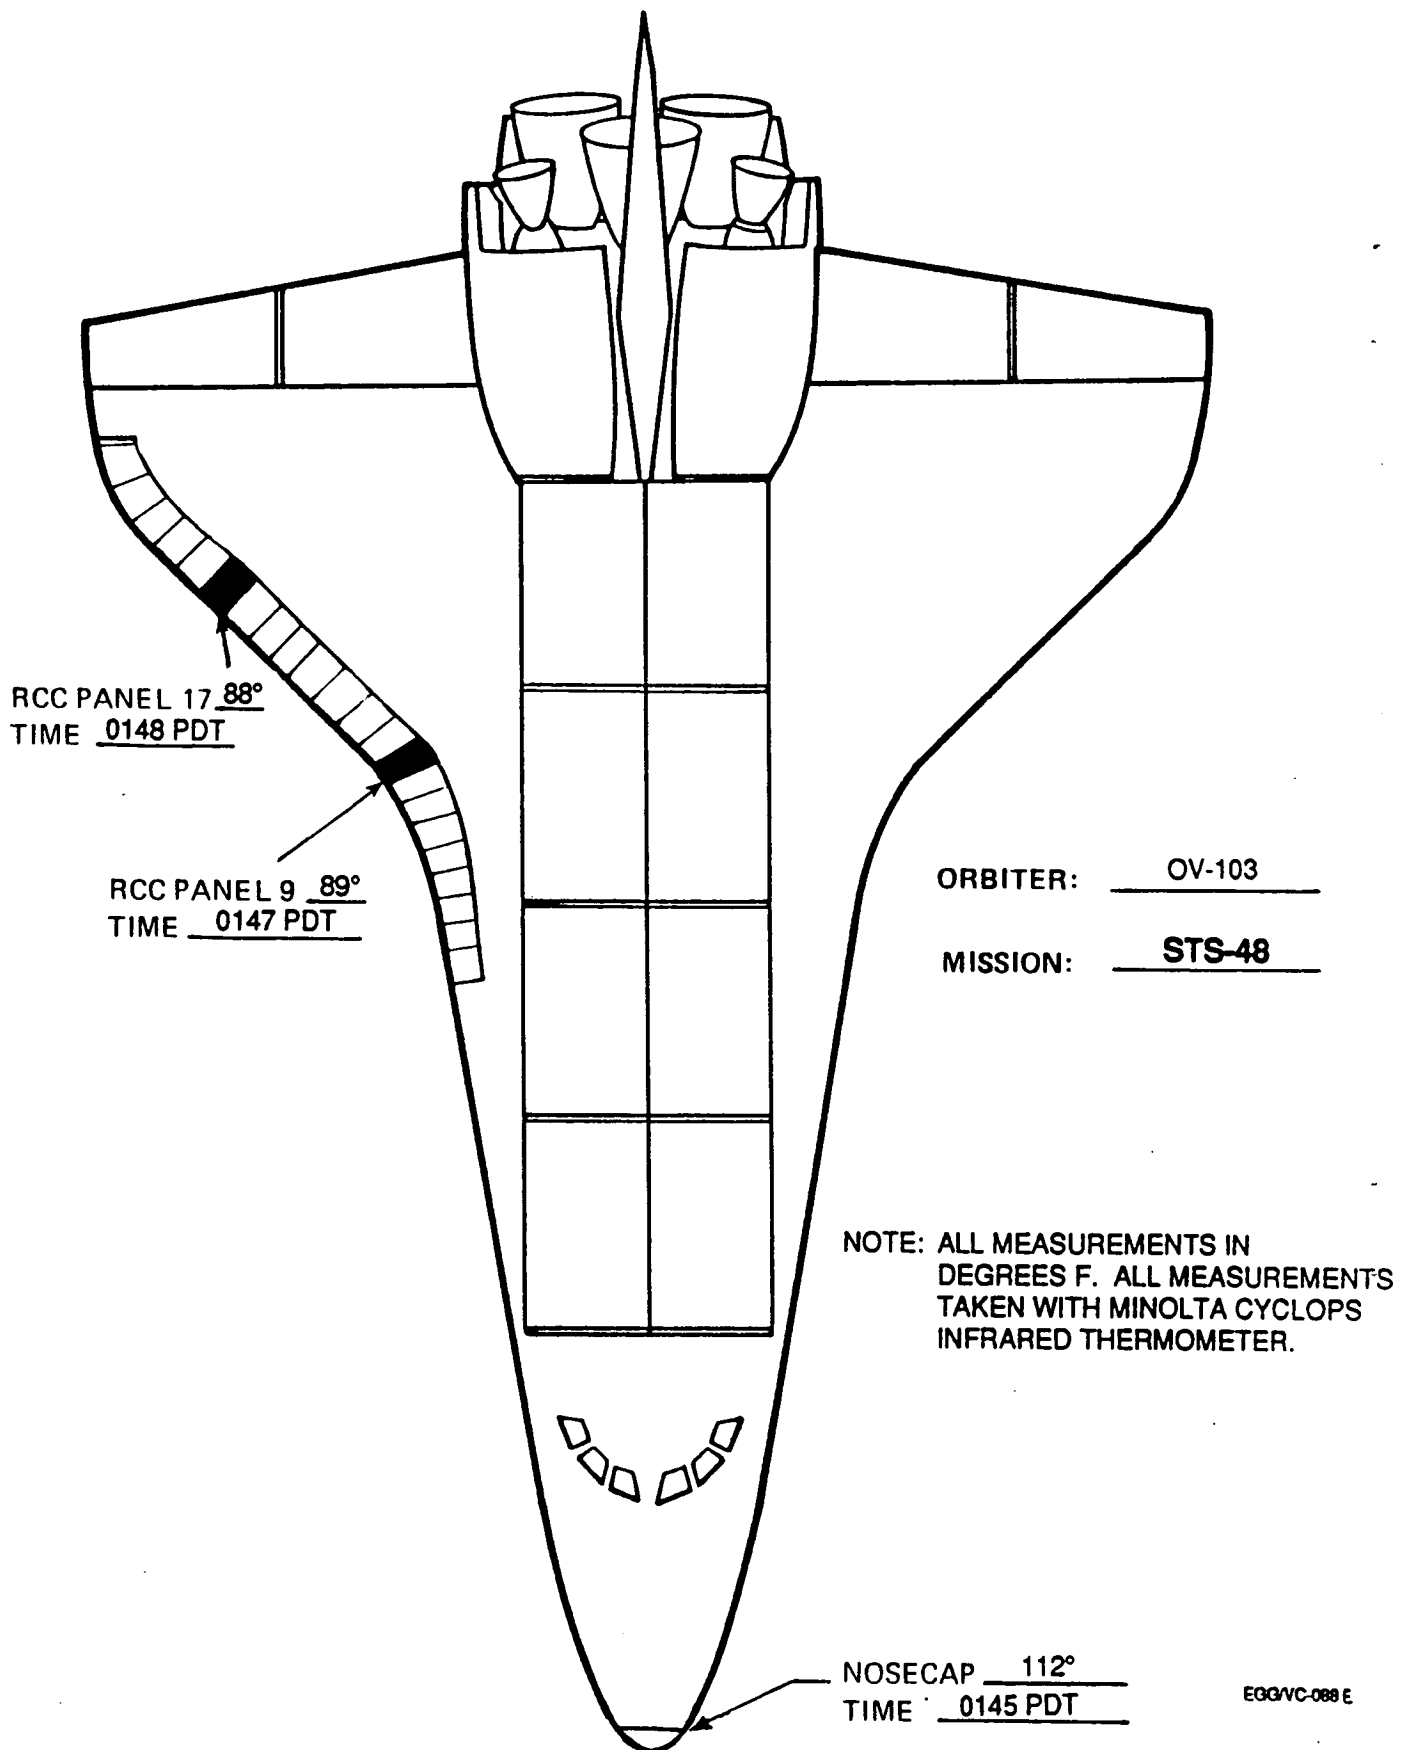
FIGURE 16. **STS-48 RCC TEMPERATURE MEASUREMENTS**

A portable infrared thermometer was used to measure the surface temperatures of three areas on the Orbiter TPS after landing (OMRSD V09AJ0.095). Seventy minutes after wheel stop, the Orbiter nose cap RCC was 112 degrees F, the RH wing leading edge RCC panel #9 was 89 degrees F, and the RH wing leading edge RCC panel #17 was 88 degrees Fahrenheit (reference Figure 16).
