NASA Technical Memorandum TM 103826

Debris/Ice/TPS Assessment And Photographic Analysis For Shuttle Mission STS-48

November 1991

Gregory N. Katnik
NASA/Kennedy Space Center

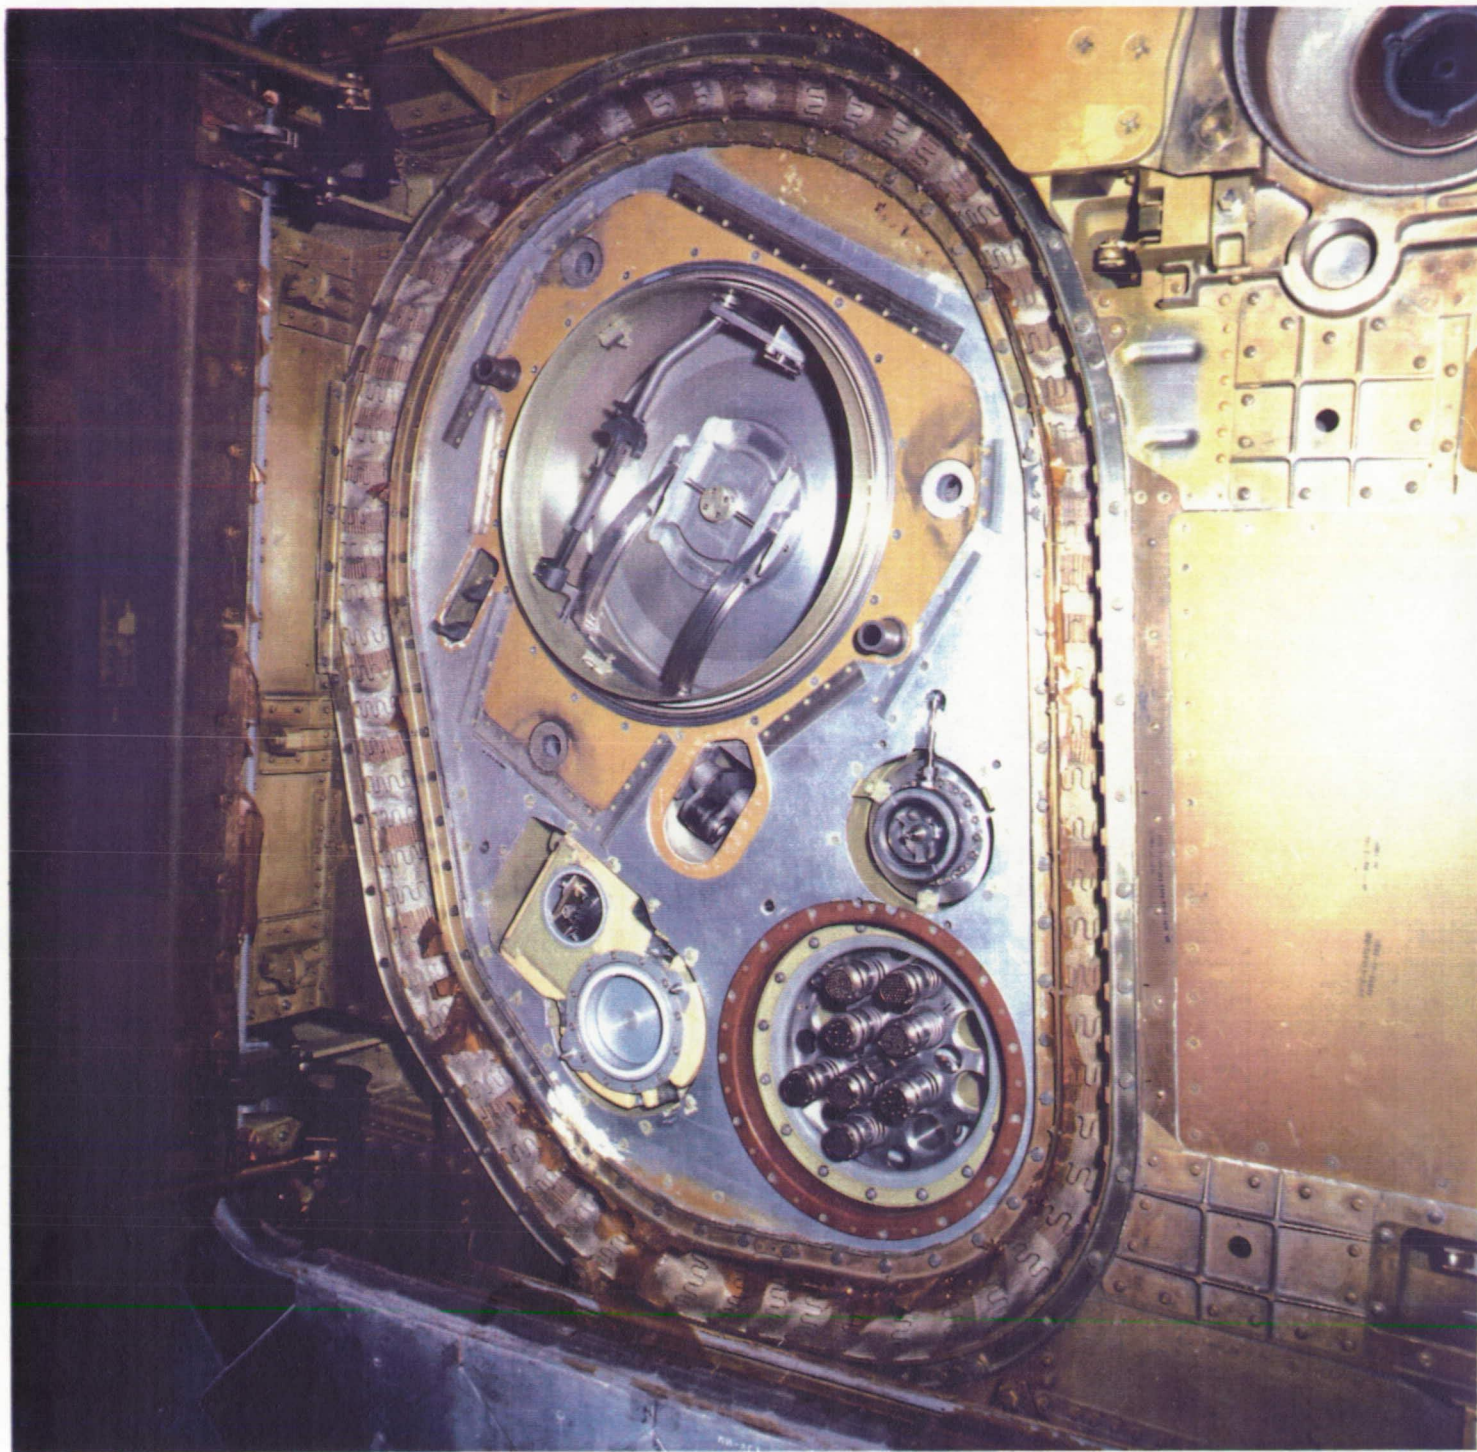
Overall view of the LH2 ET/ORB umbilical. The separation ordnance device debris plunger in EO-2 was seated and appeared to have functioned properly. There was no significant heat intrusion past the ET door thermal barrier.
