NASA Technical Memorandum 104532
AIAA-91-2123

Microanalysis of Extended-Test Xenon Hollow Cathodes

MICROANALYSES OF EXTENDED-TEST XENON HOLLOW CATHODES

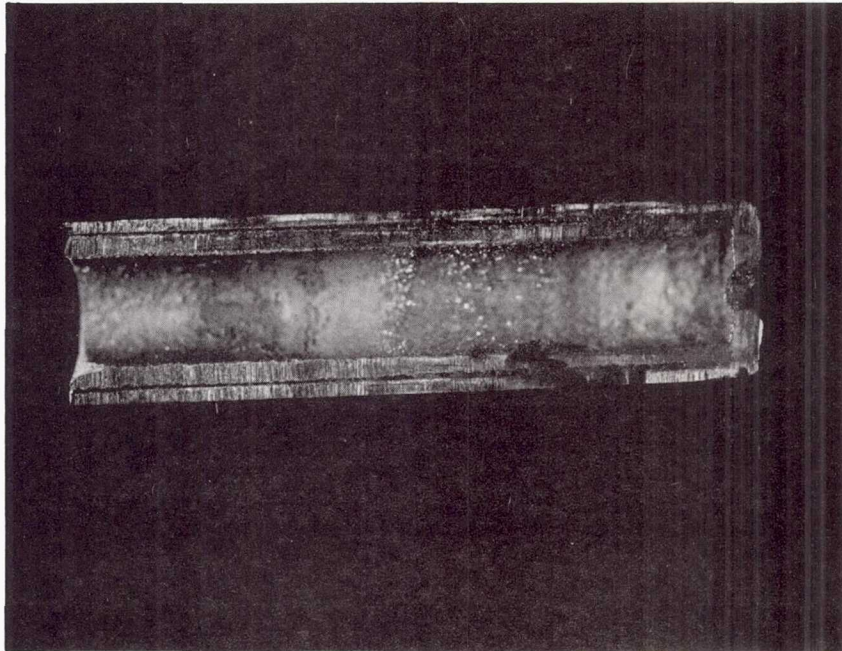
(a) TL-I Cathode

Figure 16. Sliced thruster life-test cathodes. Gas flowed from left to right.

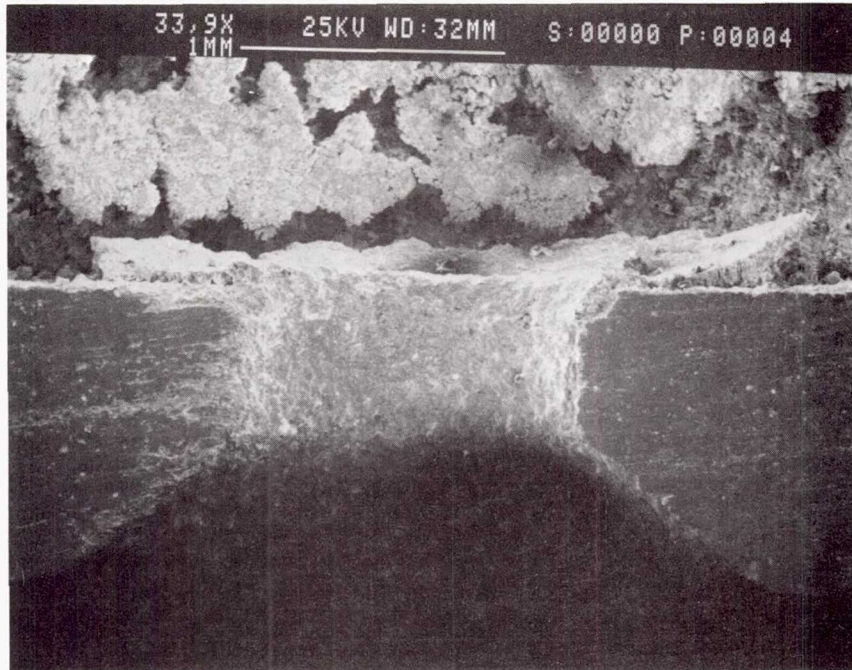
Figure 21. SE image of the orifice channel of cathode WT-I. Propellant flowed from top to bottom.

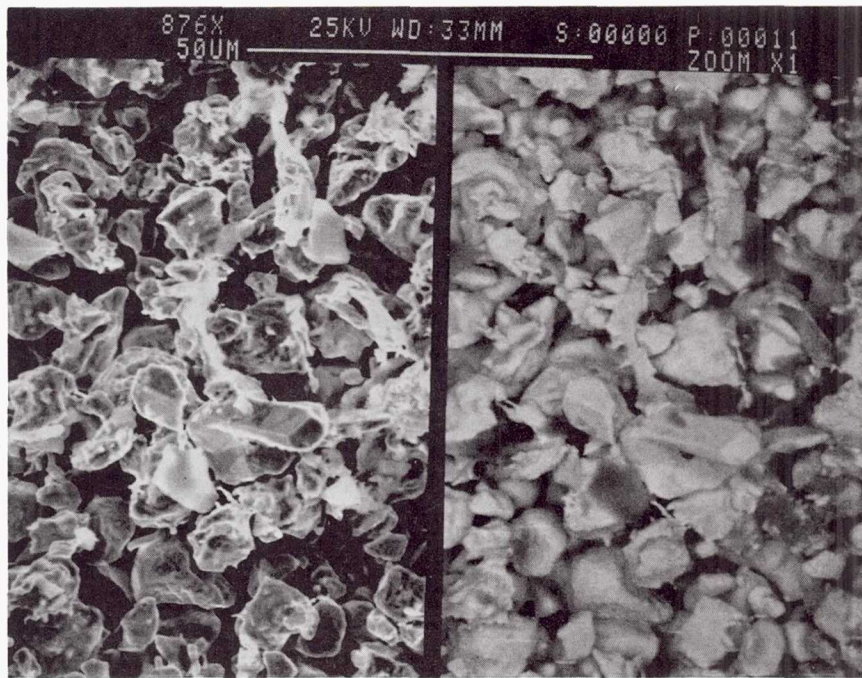
Figure 23. Surface of the second region of cathode WT-I insert, showing grain structures, SE image on the left and BSE image on the right.

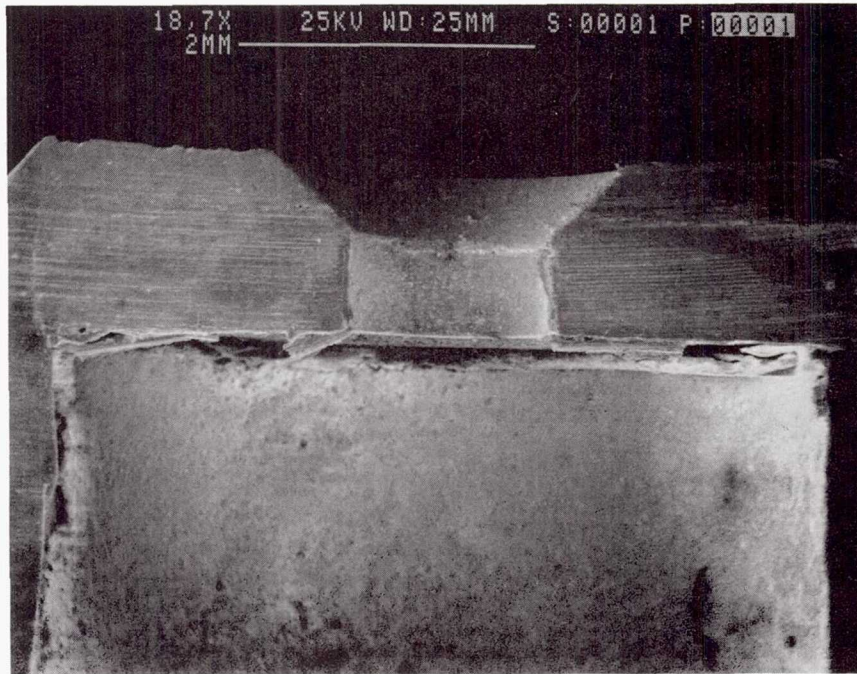
Figure 25. SE image of orifice of cathode WT-II. Propellant flowed from bottom to top.

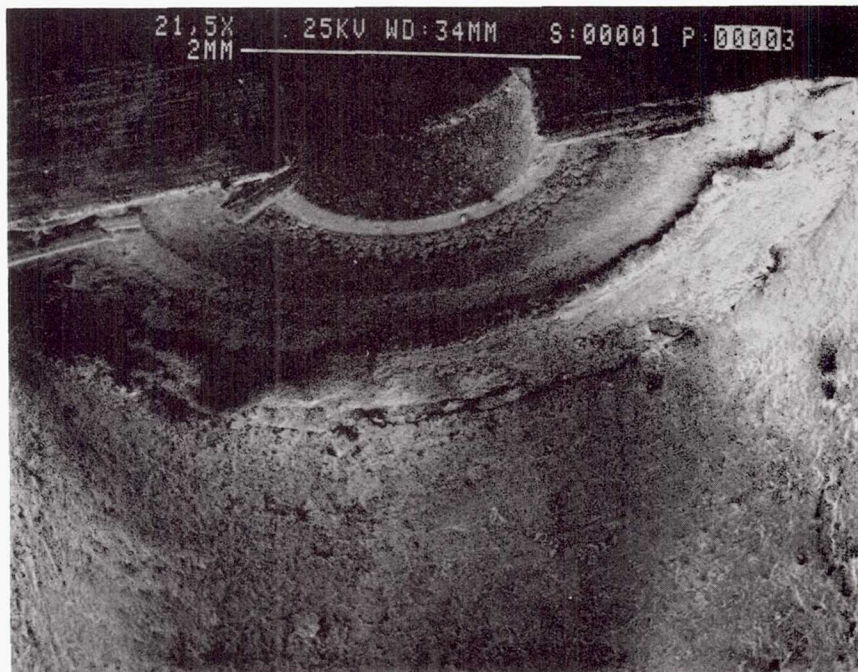
Figure 26. SE image of the inside of cathode WT-II tube without the insert. Propellant flowed from bottom to top.

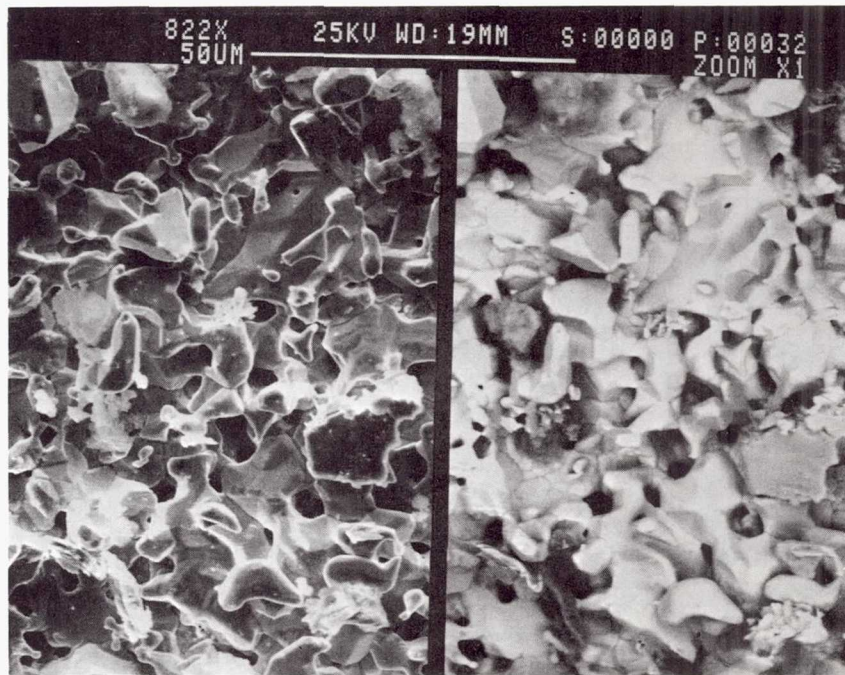
The insert surface condition was also found to be position dependent, with three distinct regions (see Fig. 18). The photograph in Fig. 27 shows the surface of the first region at the downstream end of the insert which had the structure of the sintered tungsten. Only tungsten was found in this region, indicating that all barium and its compounds had been removed from the surface during discharge operation. The second region, approximately 1.2 cm from the orifice plate, consisted of a darker band on the surface that was approximately 1.1 mm wide. The gray shading of the grains in the BSE image in Fig. 28 was a surface coating composed of tungsten, barium, calcium, oxygen, and trace amounts of aluminum and molybdenum. The white grains on top of the coating were tungsten. In the third region of the insert, the surface was also found to have a coating, though not as uniform as the second region, and which had much more material collected on top (Fig. 29). The coating, distinguished in the BSE image by the darker color, was composed of tungsten, barium, and trace amounts of calcium, aluminum and molybdenum, and was very similar to that of the second region though the signals for all elements other than tungsten were weaker. Oxygen was assumed to be part of this material. At the upstream end

Figure 27. Surface of the downstream end of cathode WT-II insert.

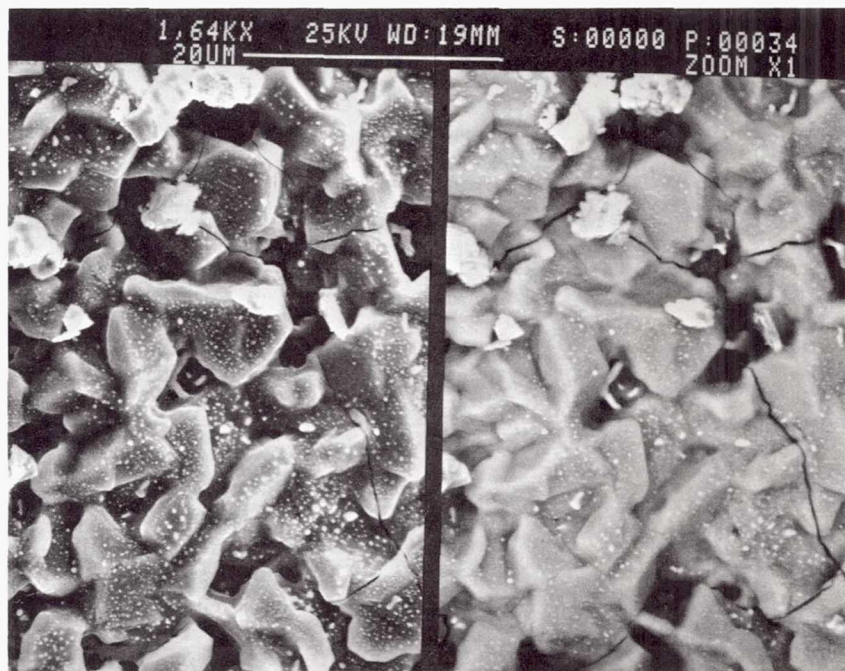
Figure 28. Second region on the insert surface of cathode WT-II.

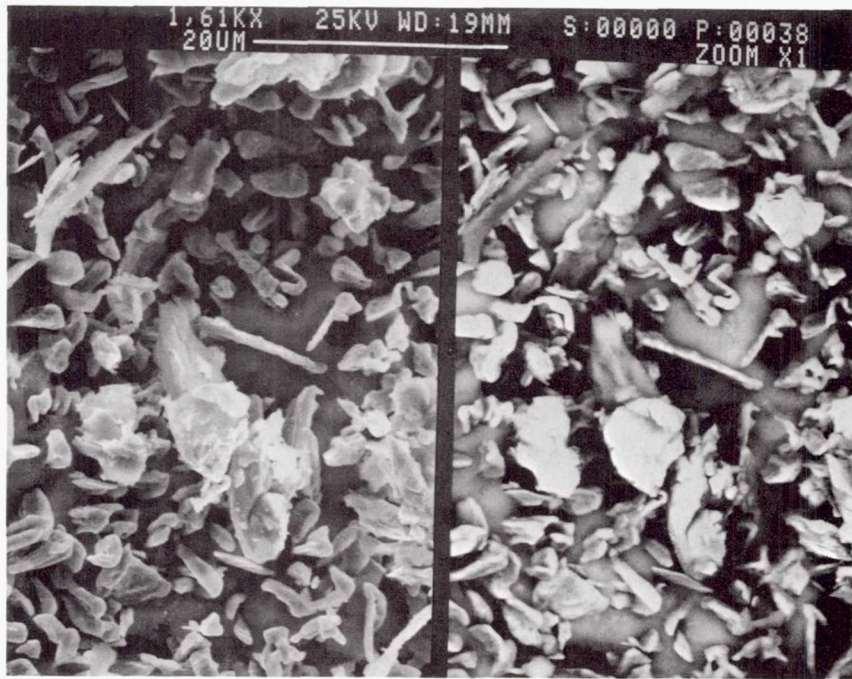
Figure 29. Surface of the upstream end of the cathode WT-II insert.

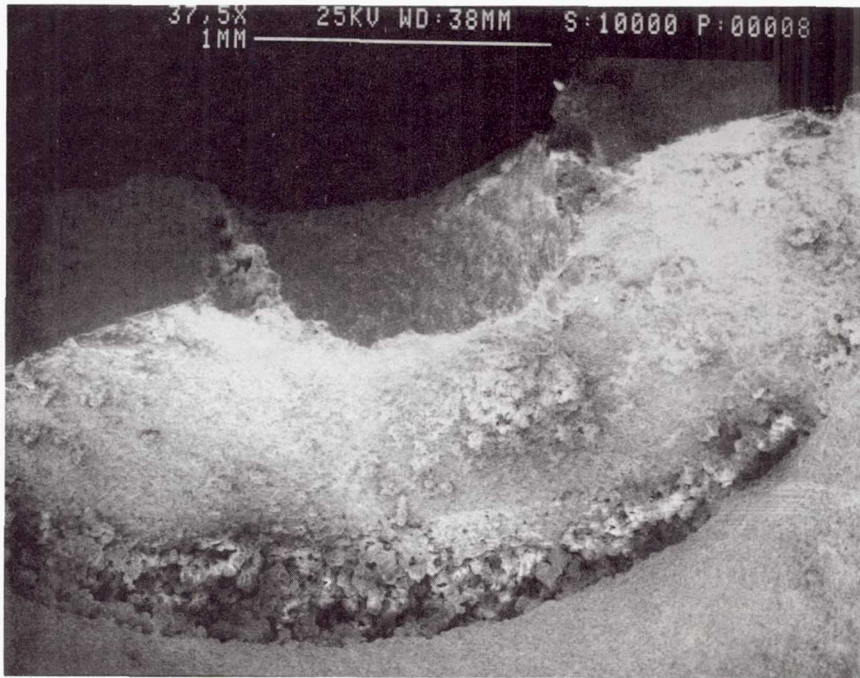
Figure 31. SE image of the inner surface of the cathode TL-I orifice plate. Propellant flowed from bottom to top.

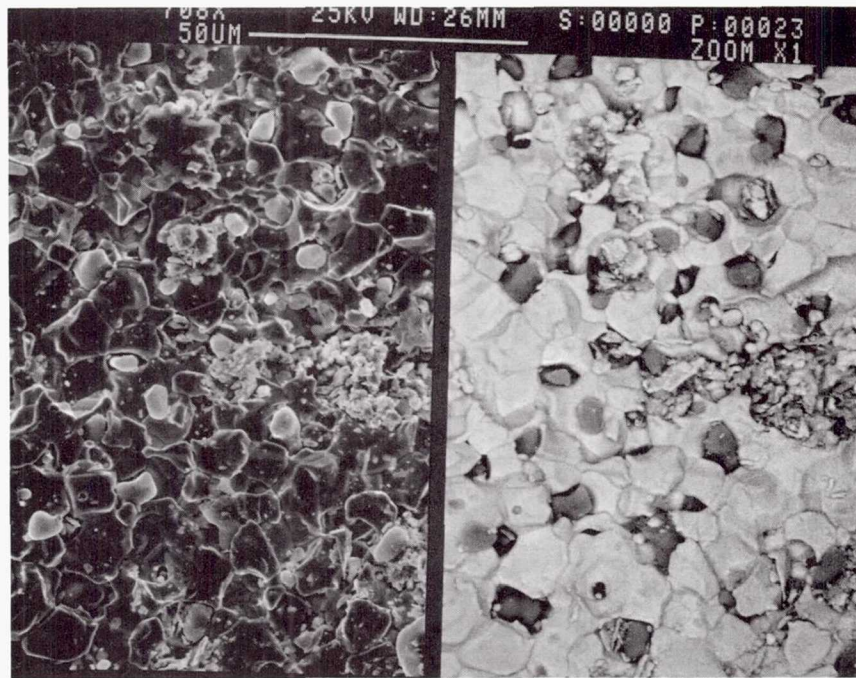
Three distinct regions were found on the insert surface as indicated in Fig. 19. Fig. 33 shows a photograph of the insert surface near the orifice plate. This first region exhibited the sintered grain structure of the tungsten matrix material and the BSE image shows that the surface was roughly homogeneous. EDS verified that tungsten was the primary element in this area, with only trace amounts of barium. This region gave way to a rougher surface which is shown in the photograph in Fig. 34. The surface was more porous with a large amount of barium compound among the grains, which was composed of tungsten, barium, and probably oxygen and was the darker material in the BSE image. The presence of the barium compound decreased and the occurrence

Figure 33. Surface in the first region of insert surface in cathode TL-I.

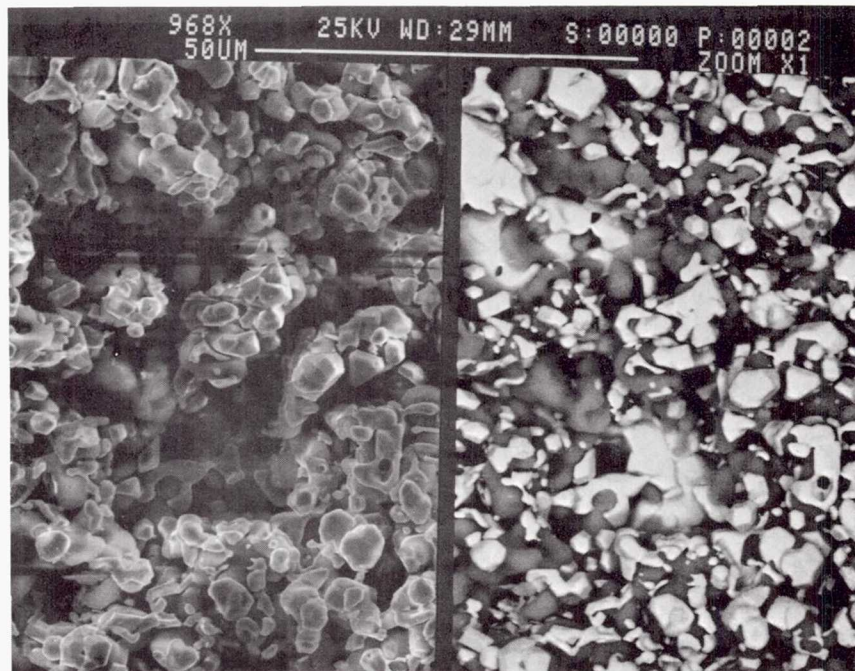
Figure 34. Surface of the second region on cathode TL-I insert.

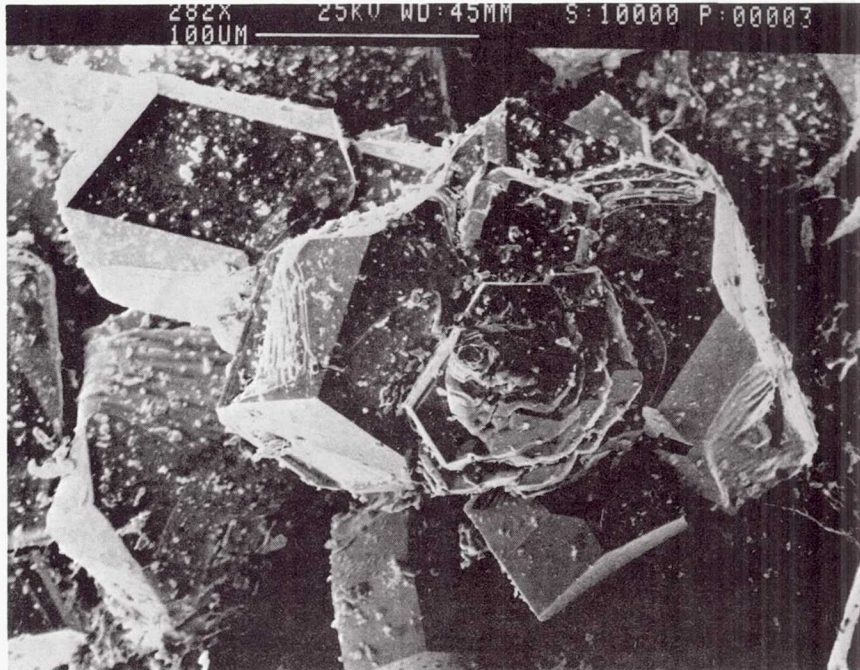
of larger, crystalline grains increased further upstream, which peaked at approximately 0.65 to 1.3 cm from the orifice plate. The deposited structures observed by the boroscope that had been removed by the slicing process probably came from this region. These tungsten deposits were examined separately with the SEM and were found to have a crystalline formation, as can be seen in the photograph in Fig. 35. The presence of the crystalline structures decreased further upstream.

Figure 35. SE image of deposited material obtained from cathode TL-I during slicing.

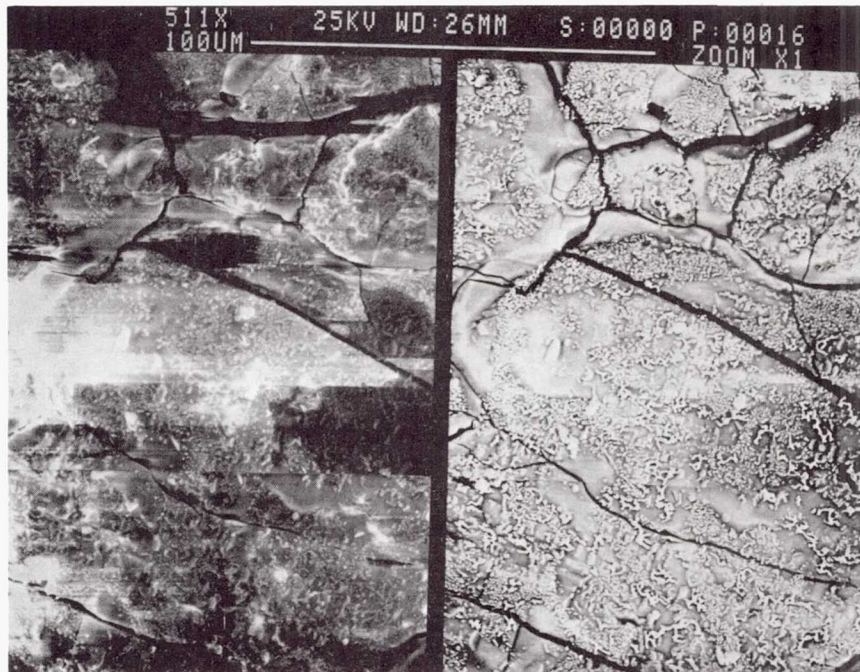
Fig. 36 shows a photograph of the surface of the third insert region. Large layer formations, which were composed of tungsten, barium, and oxygen with trace amounts of molybdenum, aluminum, and rhenium, covered the surface. Charging of the surface during examination indicated that it was nonconductive. The composition and behavior was similar to analogous layer structures seen in the SBJ1 wear-test cathodes and, as such, was assumed to be an oxide. The coverage of the surface material was nearly complete at the upstream end and small tungsten structures were scattered on top of the layer.

Figure 36. Surface of third region of the cathode TL-I insert.

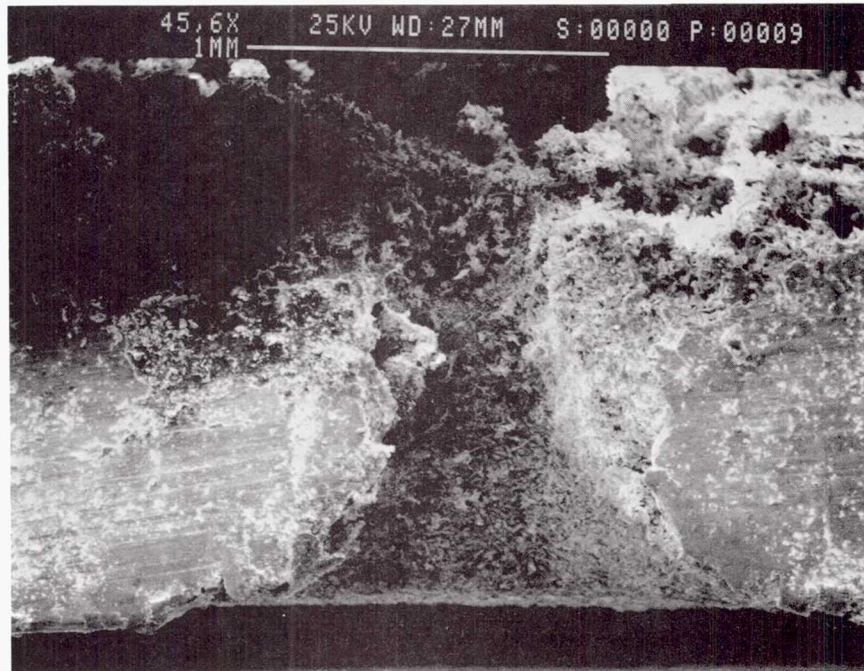
For the neutralizer cathode TL-II, the internal surface conditions were similar to cathode TL-I, with some differences. Fig. 37 shows a photograph of the orifice region. The chamfer and channel were substantially altered and showed deposition of material over both surfaces in a rough, grainy layer. The deposited material, which was determined by EDS to be tungsten, did not have the solid appearance of the orifices in the rest of the cathodes. The upstream side of the orifice plate suffered extensive damage and deposition of material. The entire inner surface was covered with deposited material as shown in the photograph in Fig. 38. The larger structures in the photograph were crystalline formations of tungsten metal. Compounds which were suspected of containing barium were found on this surface, among the tungsten formations, as indicated by the gray areas in Fig. 39.

Figure 37. SE image of the orifice region of cathode TL-II. Propellant flowed from top to bottom.

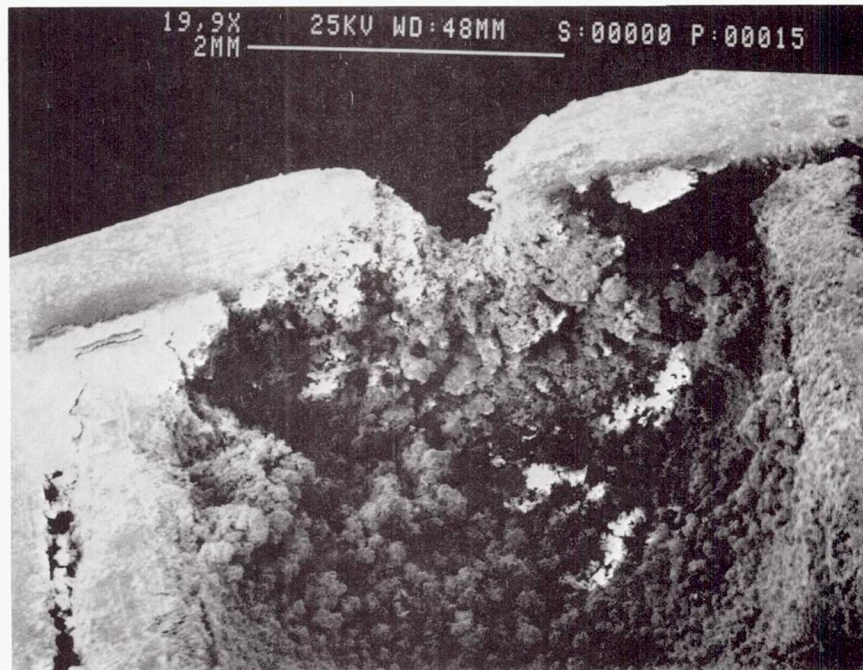
Figure 38. SE image of inner surface of the cathode TL-II orifice plate. Propellant flowed bottom to top.

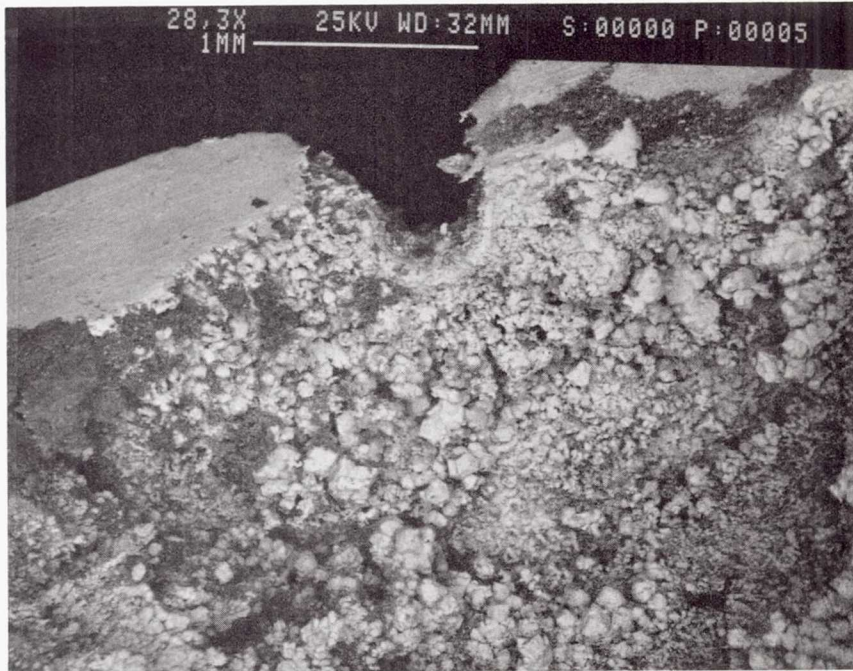
Figure 39. BSE image of inner surface of the cathode TL-II orifice plate. Propellant flowed bottom to top.

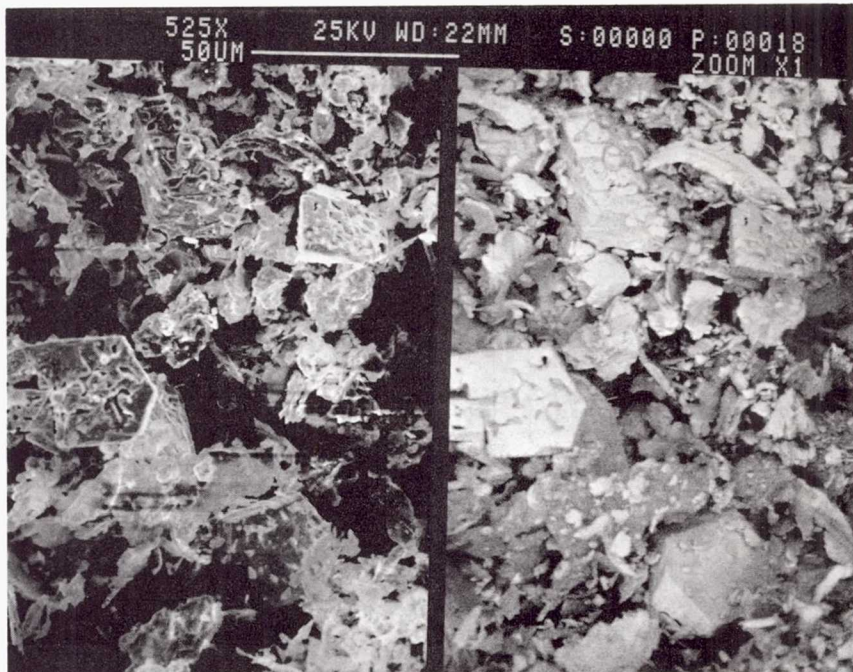
the region immediately next to the orifice was extremely rough, as can be seen in Fig. 40. The BSE image shows that the surface material was relatively homogeneous and EDS determined it to be tungsten. This region extended approximately 0.3 cm upstream of the orifice and was probably the region where the chunk of tungsten, formed as a cap over the orifice, was located inside the insert. This plug had a diameter of approximately 3.2 mm and is shown in Fig. 41.

Figure 40. Surface of first region of cathode TL-II insert.

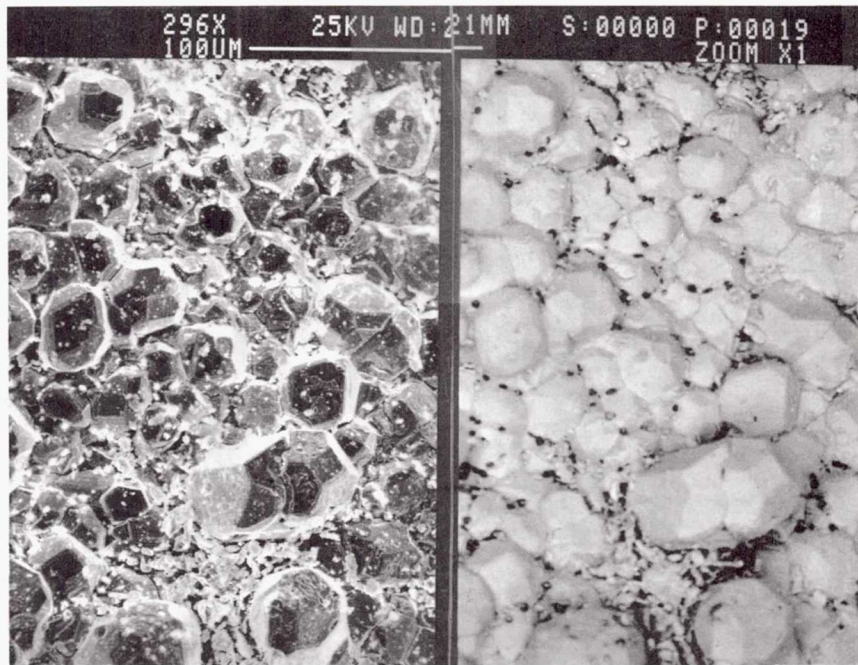
The remaining area of the insert surface was divided up into two regions (see Fig. 20). Upstream of the crystalline formations, the surface was composed of rough granular structures which were found to be primarily tungsten, with trace amounts of barium and aluminum (Fig. 42). In this region of the insert, a nonconductive material was found to have filled the insert-cathode tube gap; probably formed from impregnate migrating out of the insert pores. This material may account for affixing the insert in the cathode tube, like cathodes WT-I and TL-I. The white appearance of the material in the image on the left of Fig. 43 indicated that the material was charging. EDS determined that the material was composed of tungsten, barium, oxygen, and trace amounts of calcium, molybdenum, and aluminum. The BSE image shows the gap material as darker than the wall materials, which indicated that the compound was probably an oxide.

Figure 42. Surface of second region of the cathode TL-II insert.

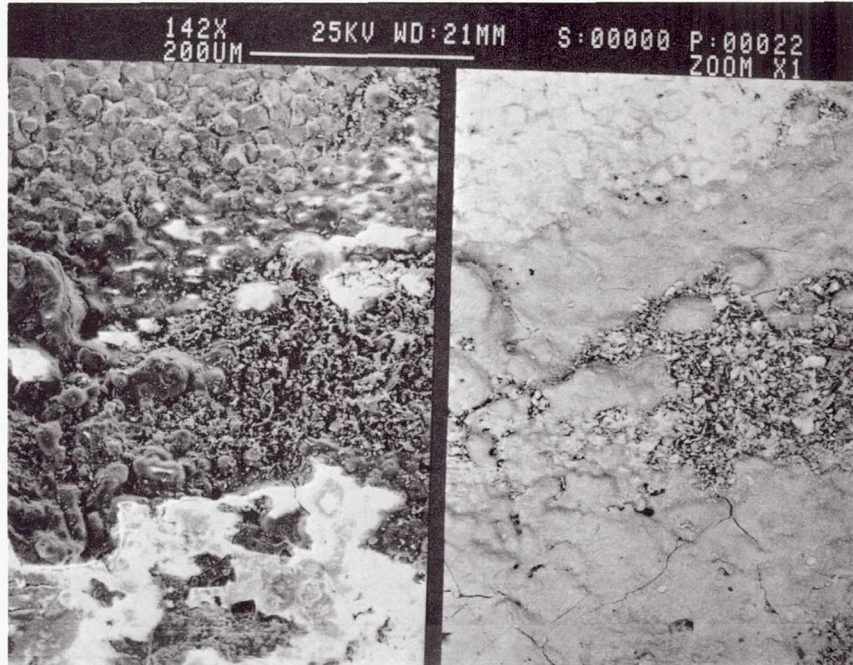
The final region of the insert surface was covered with a uniform layer, composed of tungsten, barium, calcium, and oxygen. The photograph in Fig. 44 shows the boundary where the surface coating began. It was very homogeneous under BSE and was similar to other layer formations observed on the other inserts. On top of this layer, small tungsten structures were found scattered. The nonconductive portions of this layer were not symmetric over the insert surface and neighboring regions of the layer did not charge under secondary electron emission even though they were composed of similar material. These layer structures were present to the end of the insert, but different elements were included in its composition. The tungsten grains on the surface became more numerous away from the boundary. Near the upstream end of the insert, the primary elements were molybdenum, rhenium, and small amounts of tungsten, barium, oxygen, and calcium. The composition changed again in the region next to the molybdenum collar

Figure 44. Surface of third region of the cathode TL-II insert.
