NASA Contractor Report 178246

Test Results for Composite Specimens and Elements Containing Joints and Cutouts

P. T. Sumida, R. C. Madan, and A. V. Hawley

August 1988

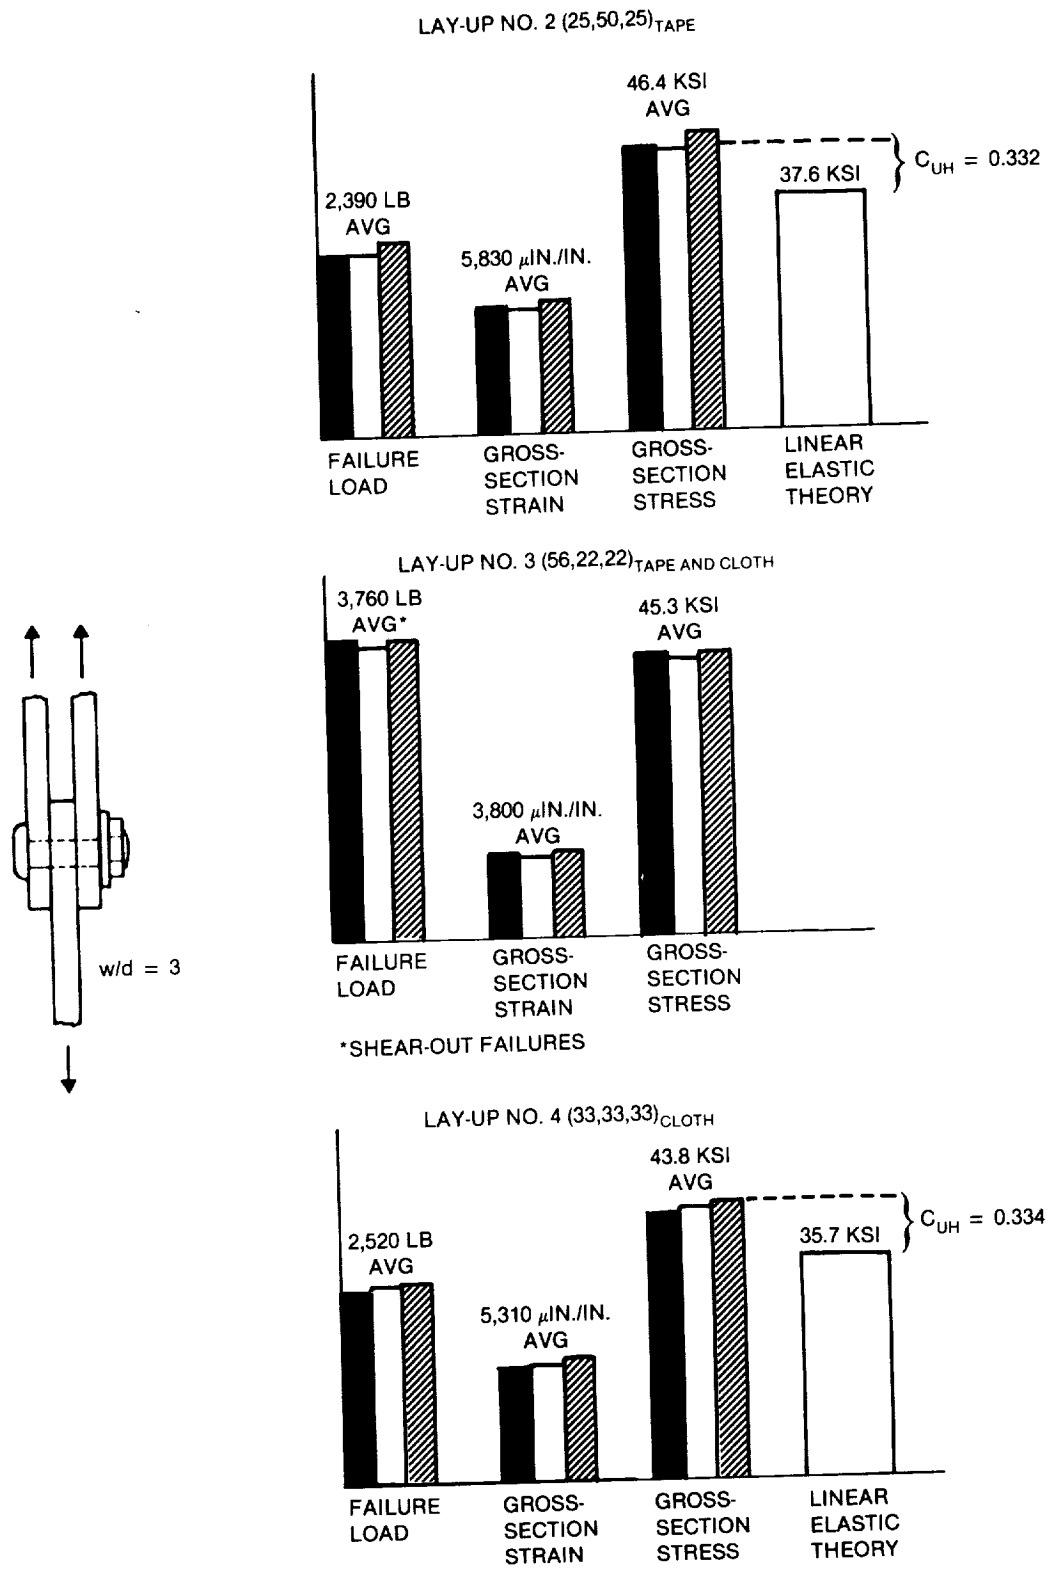
Figure 5-5. Narrow DLT Specimen (Loaded Hole) Test Results

A similar relief effect occurs for net-section tension failures of the narrow DLT specimens (also referred to as loaded-hole tension specimens) as occurs for the ULT specimens. Figure 5-5 summarizes these results and again shows comparisons to theoretical strengths assuming isotropic, linear elastic stress concentrations. Loaded-hole C-factors are given (for lay-ups No. 2 and 4) as the empirical constant which quantifies the relief effect. Again, the test results for lay-up No. 3 are unique. The narrow specimens failed in a shearout mode rather than in net-section tension.

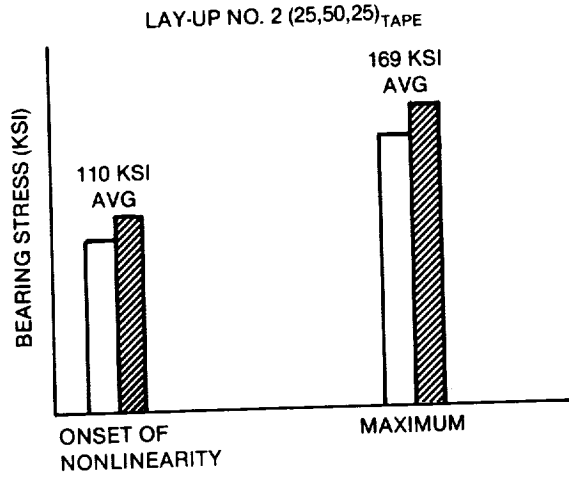
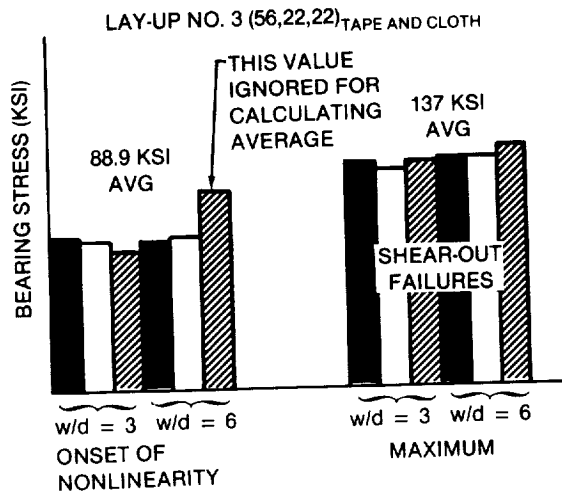
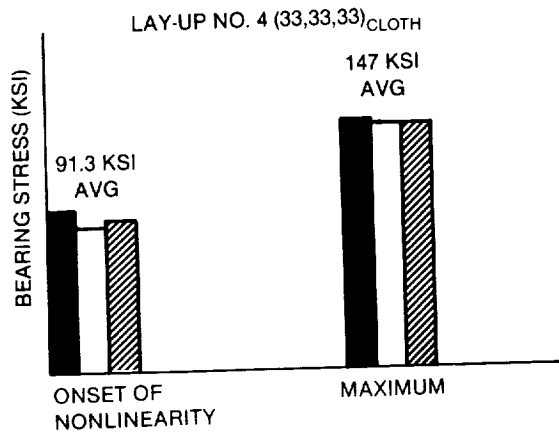
Figure 5-7. DLT Specimen Test Results (Bearing and Shear-Out Failures)

Figure 5-6 shows typical failures for each of the three wide DLT configurations. The -509 configuration (lay-up No. 2) clearly failed in bearing. The failure zone of the -507 configuration (lay-up No. 4) extends to the edge of the specimen, indicating edge effects could have been significant. (Edge distance for all of these specimens was 0.625 inch, which is just over $3d$). The -511 configuration (lay-up No. 3) appears to have failed in a shearout mode. Figure 5-7 summarizes the results of the bearing tests. Note that the narrow DLT configuration for lay-up No. 3 (-505) is included because of the similarity in failure mode with the -511 configuration.

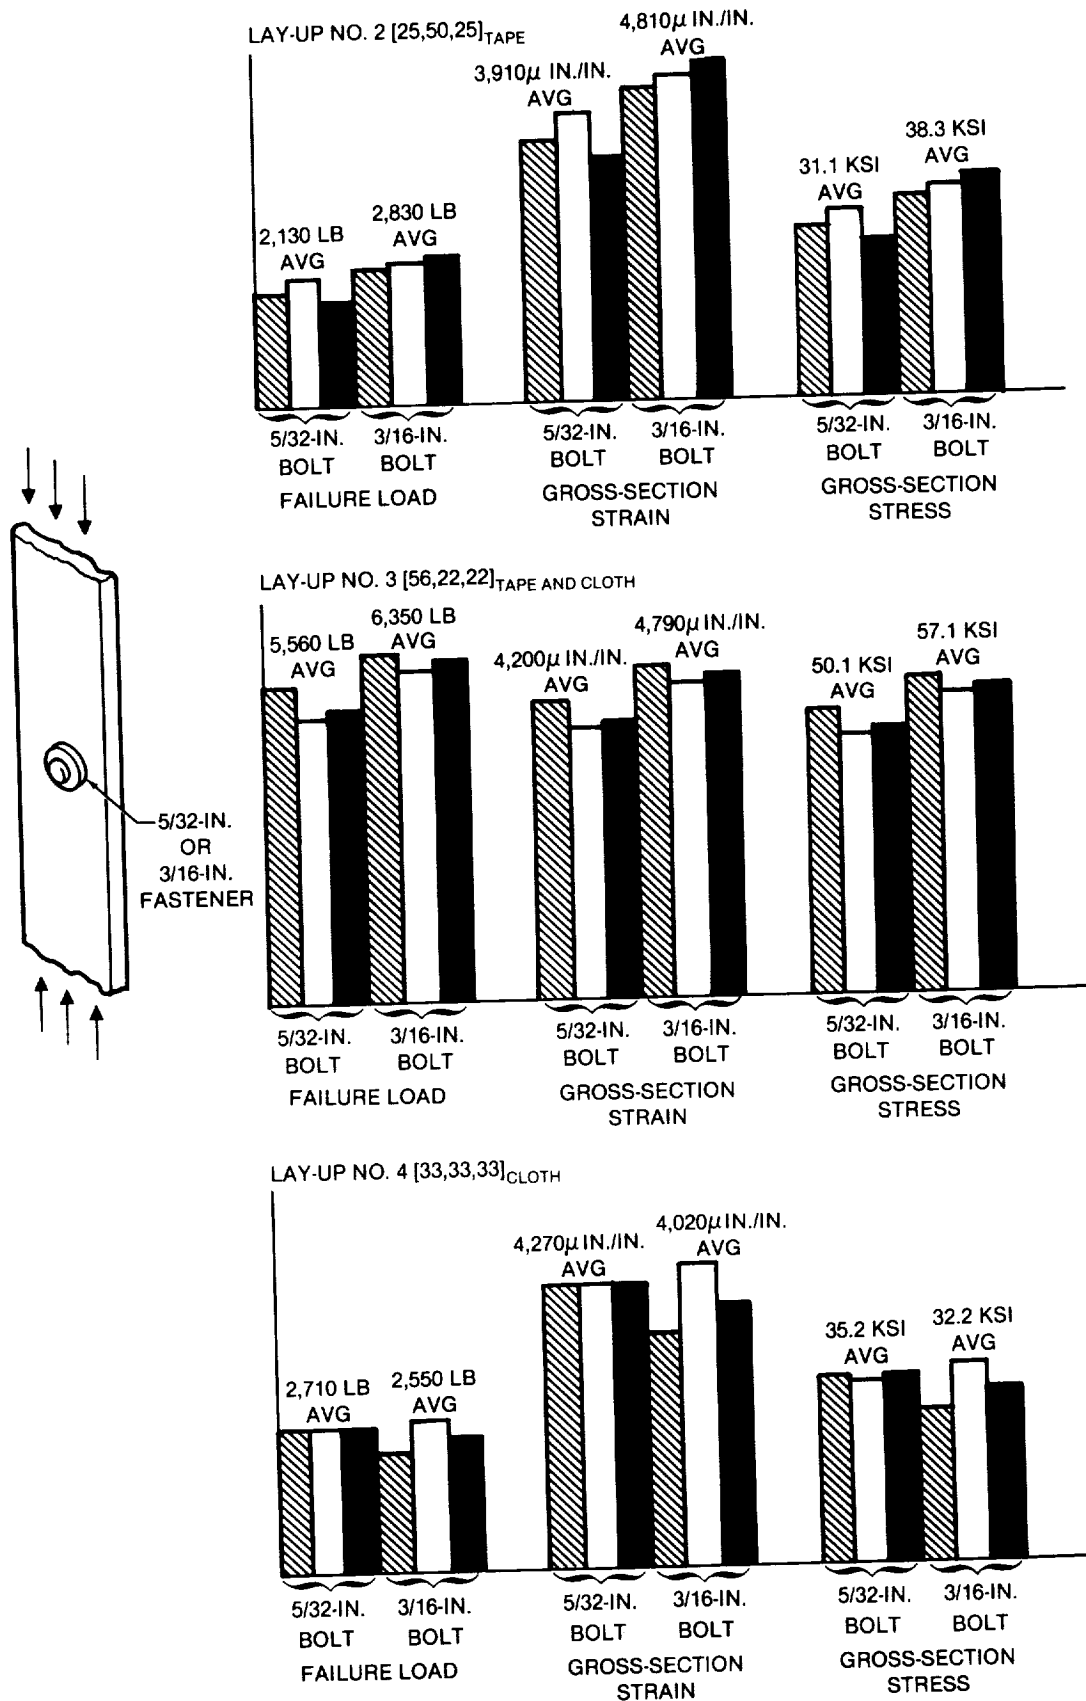
Figure 5-8. Unloaded-Hole Compression Specimen Test Results

A summary of the failure loads, gross-section stresses, and gross-section strains for the ULC specimens is given in Figure 5-8. Failures of the specimens tested with 5/32-inch fasteners tended to exhibit more damage through the hole. Failures of the specimens tested with 3/16-inch fasteners tended to show less damage at the hole, but tended to broom or buckle in front of the fastener (Figure 5-9).

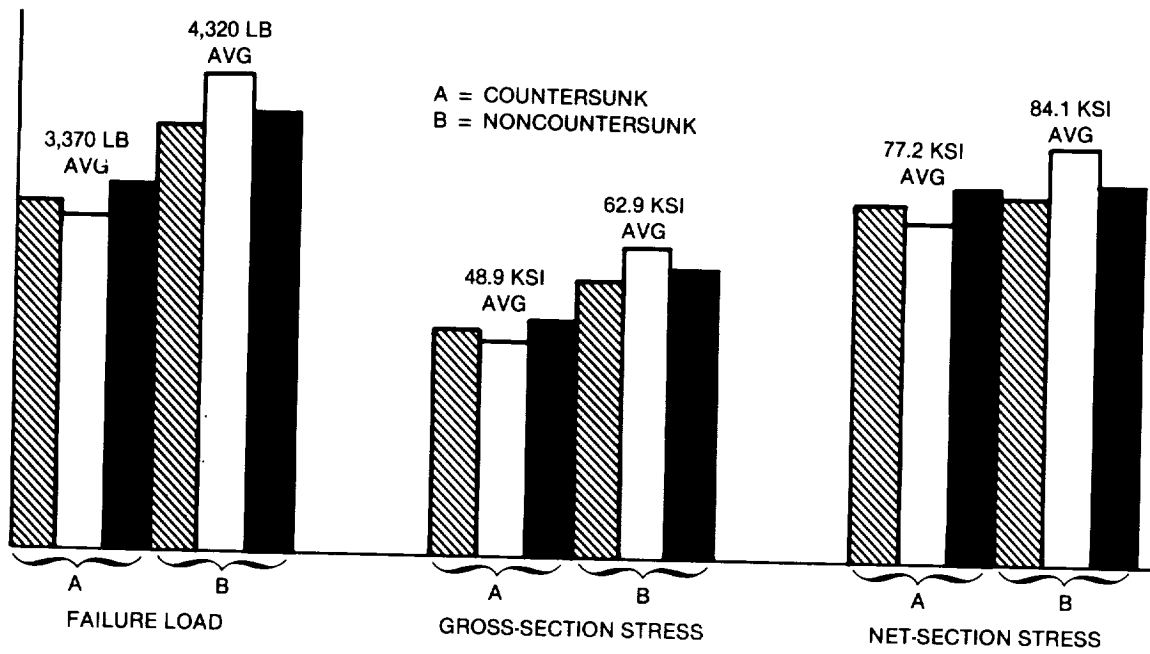
Figure 5-12. Unloaded-Hole Tension Specimen Results (Lay-Up No. 2, Countersunk)

The results of the ULT-507 configuration tests are presented in Figure 5-12. Comparisons are shown between this configuration and its noncountersunk counterpart (ULT-503). As indicated, failure load and gross-section stress are down by an average of 22 percent. Net-section stress, however, shows considerably less reduction (only 8 percent).

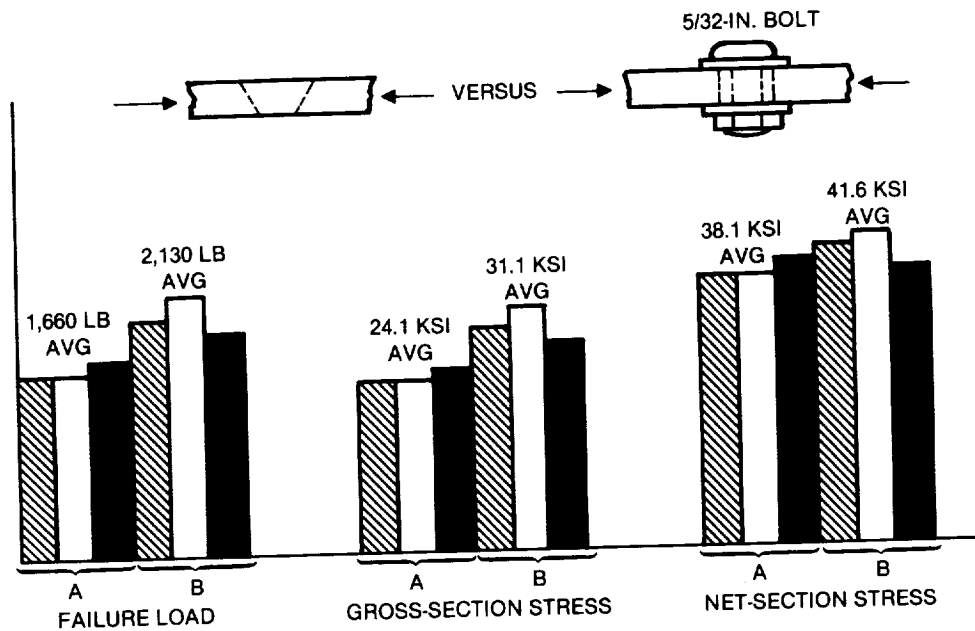
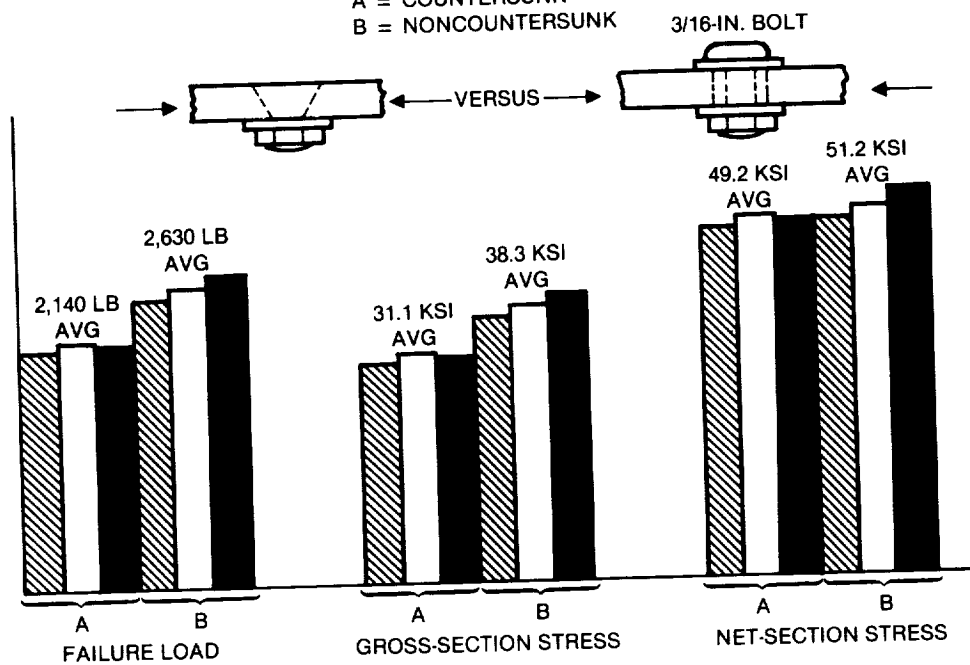
Figure 5-13. ULC Specimen Test Results (Lay-Up No. 2, Countersunk)

The results of the countersunk ULC tests are presented in Figure 5-13. The -515 and -521 ULC specimens were tested with 5/32-inch and 3/16-inch protruding head fasteners to simulate loose fit and net fit bolts, respectively. The -525 configuration was tested *without* a fastener and the -527 configuration with a 3/16-inch countersunk bolt to simulate the same situations for countersunk fasteners. Comparisons of the failure loads of the -525 and -515 configurations again reveal an average drop of about 22 percent. Likewise, net-section stress comparisons show a much smaller drop: about 9 percent. Similar comparisons for the -527 and -521 configurations indicate the countersinks have less effect for the net fit case, demonstrating drops of 19 percent and 4 percent, respectively, for the average gross-section and net-section strengths. Figures 5-14 and 5-15 show typical failures for the two countersunk ULC configurations.

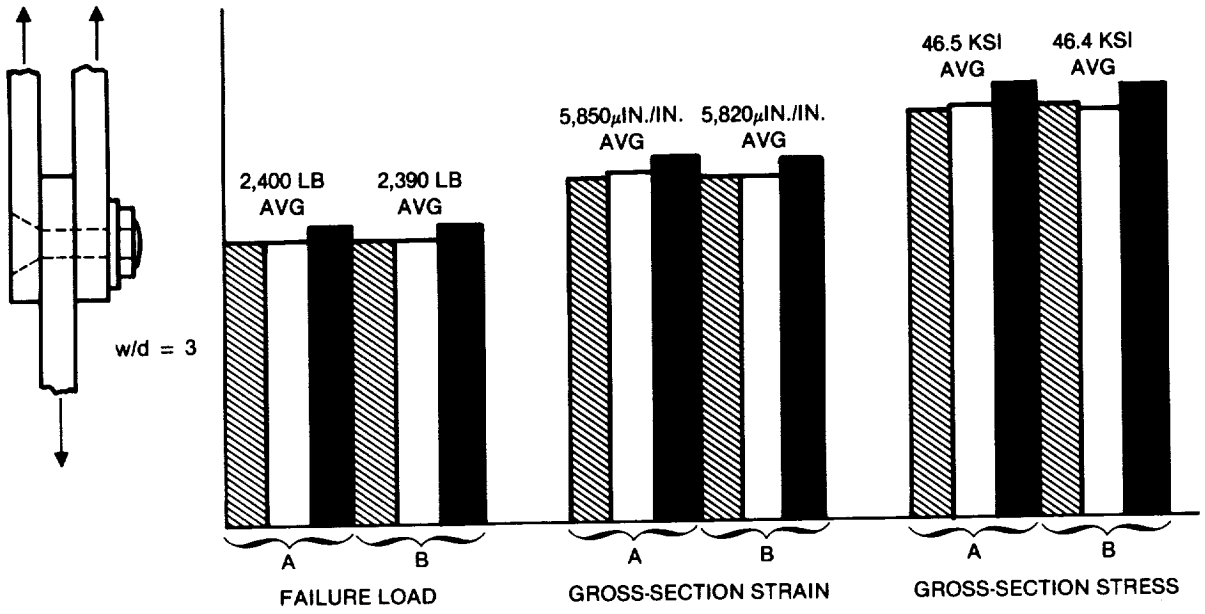
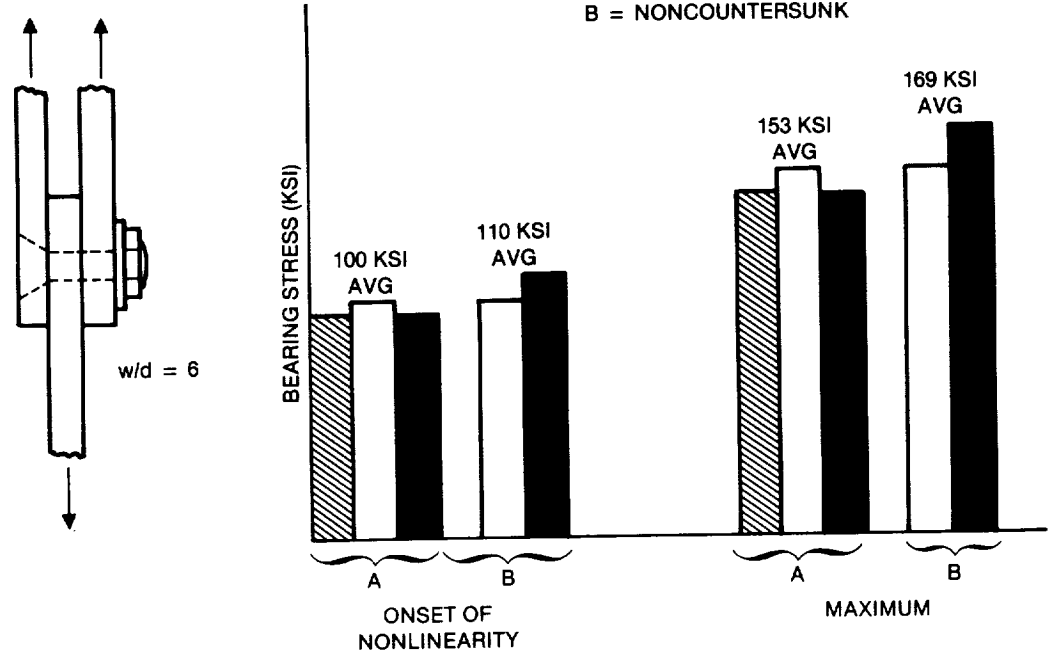
Figure 5-16. DLT Specimen Test Results (Lay-Up No. 2, Countersunk Fastener)

All of the DLT and DLC specimens failures occurred in the center member rather than in either of the splice plates. Therefore, the effect of using countersunk fasteners would be expected to be minimal. Figure 5-16 gives a comparison of countersunk and noncountersunk test results for both the narrow and wide DLT specimens. As can be seen, virtually no change in strength was evidenced for the narrow specimens (which failed in net-section tension). Bearing strengths on the other hand (from the wide DLT specimens), demonstrated a reduction of about 12 percent when countersunk fasteners were used. Figure 5-17 presents a similar comparison for the DLC specimens.

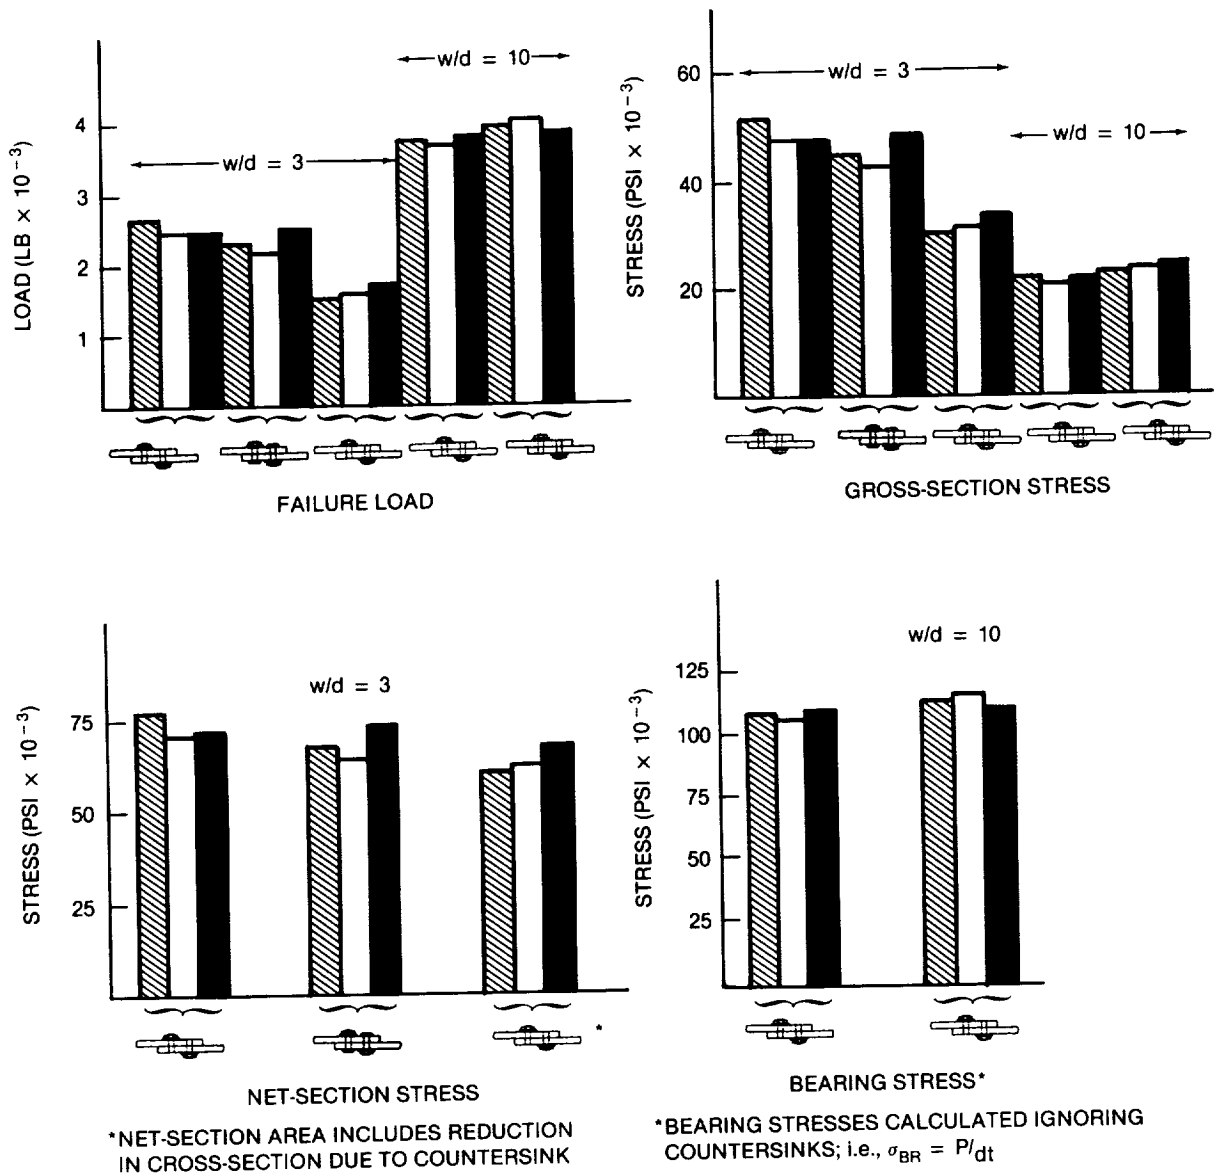
Figure 5-18. SLT Specimen Test Results

The single-lap tension specimens (SLT) were designed to provide coupon level data for single shear joints. Figure 5-18 summarizes the SLT test results. All of the narrow specimens failed in net-section tension at one of the "bearing + bypass" locations. In the case of the -507 configuration, the net-section stresses shown account for the area removed by the countersink. (This was the only configuration that was countersunk at the failure location.)

Comparison of the data from the -501 and -507 configurations reveals an overall drop in strength of almost 36 percent (or a reduction in net-section strength of about 14 percent) due to simply flipping the fasteners. The critical location in one case (-501) was through a noncountersunk hole, and, in the

other, (-507) was through a countersink. Comparison of the -501 and -505 data suggests the countersunk configuration is actually stronger than the noncountersunk configuration (again, as long as the critical "bearing + bypass" location is not in a countersunk member). This is thought to be a result of the reduced eccentricity of the countersunk connection. The test results of the -503 and -509 (wide) SLT configurations were very similar. These specimens failed as a combination of the fasteners pulling through the laminate and failure of the fastener heads. Considerable fastener rotation and hole deformation was also evident. Although the failures were not pure bearing failures (like those seen for the wide DLT and DLC specimens), Figure 5-18 includes nominal bearing stresses (ignoring the countersinks) for reference and comparison. Load/deflection properties were also recorded for the -501, -503, and -505 configurations.

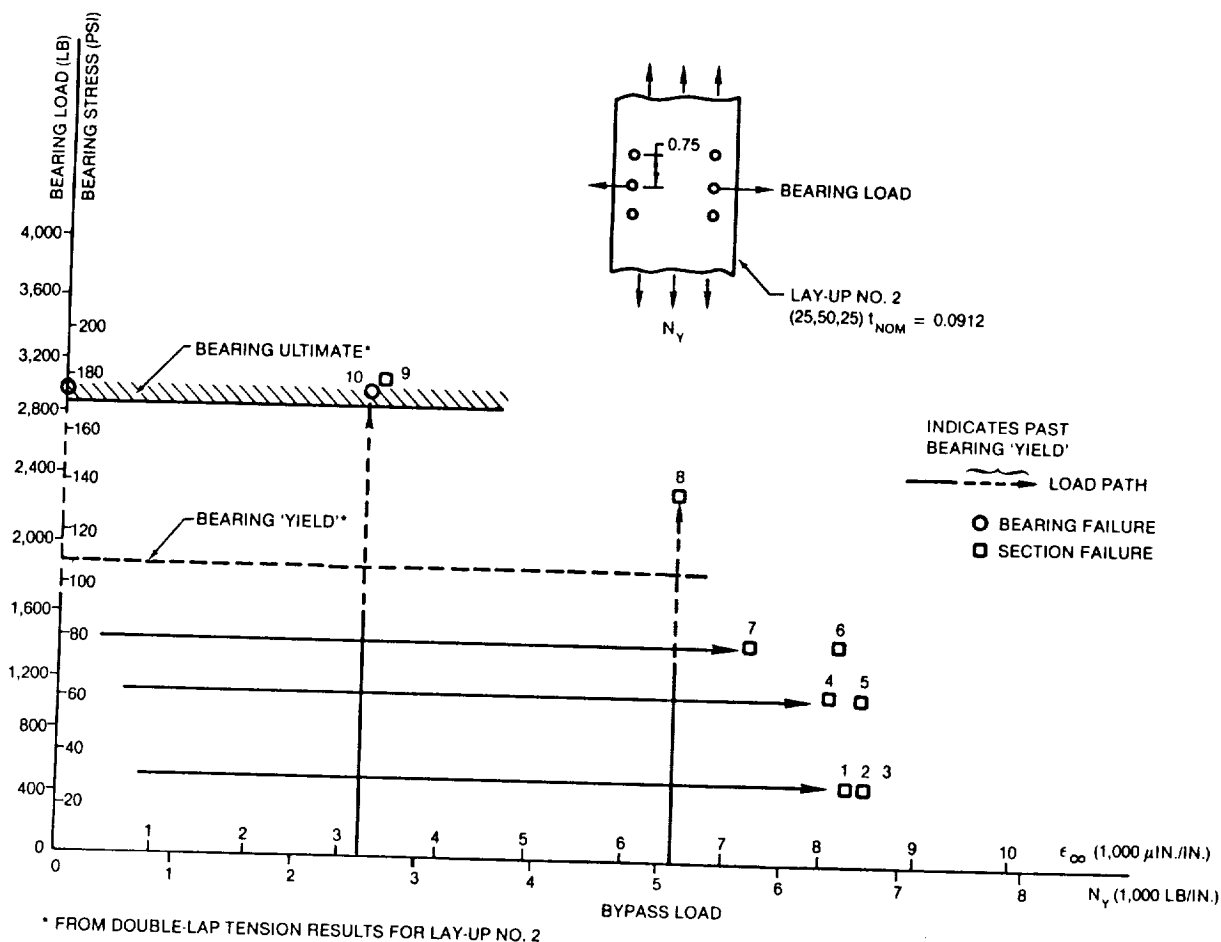
Figure 5-19. BAS Specimen Test Results

The results of the biaxial tests are summarized in Figure 5-19. These data indicate that bearing stresses of up to 60 ksi had virtually no effect on the orthogonal bypass strength. Likewise, specimens 6 and 7 show only a small loss in bypass strength at 80 ksi bearing. Specimen 9 indicated that an orthogonal bypass load of 2,500 lb/in. (roughly 3,300 $\mu\text{in./in.}$ gross-section strain) had no effect on either the onset of non-linearity (bearing yield) or the ultimate bearing strength. The only specimen which demonstrated any significant interaction was specimen 8, and this is at levels of bearing (140 ksi) and bypass (6,500 $\mu\text{in./in.}$ gross-section strain).

It should be reiterated that only the middle of the three rows of fasteners was loaded in bearing. Thus, the effective bolt spacing for bearing loads was closer to $8d$ than $4d$. This, of course, would have the effect of encouraging bearing failures for those tests dominated by loaded hole stress fields (specimens 9 and 10 in Figure 5-19). The concern lies, however, in the reduced tangential tension stresses (at the top and bottom of the loaded holes) and the (perhaps reduced) interaction with the peak tangential tension stresses from the bypass load (along the sides of the bolt holes). Calculations indicate, however, that the reduction in effective peak tangential stress for the bearing loads was only on the order of 6 or 7 percent (assuming the loaded-hole C-factor from the DLT testing). It is concluded, therefore, that the effect of loading all three rows of fasteners would be minimal.

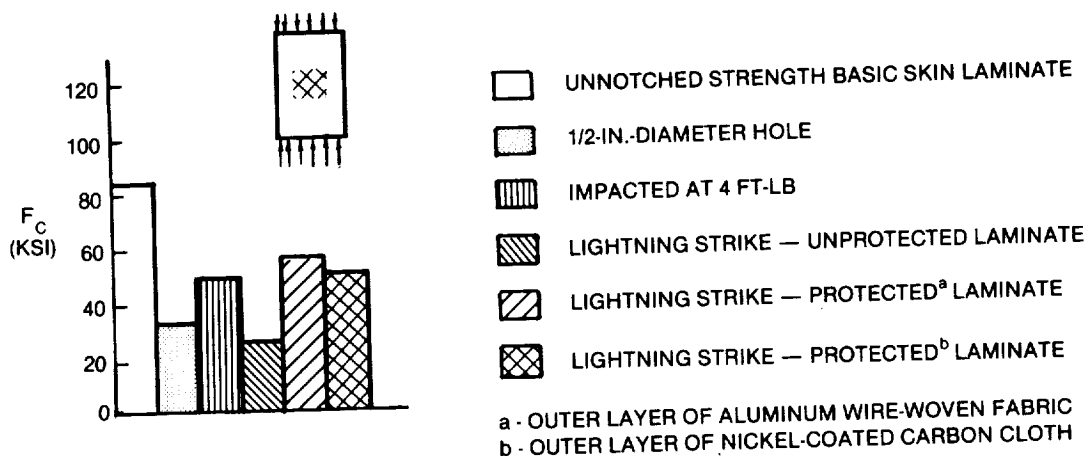
Figure 5-20. CAI Specimen Test Results

The last of the Group A specimens were the compression-after-impact or CAI panels. The results of these tests are summarized in Figure 5-20. The highest strength loss observed was for the unprotected panel subjected to lightning strike, followed by the panel with a 1/2-inch-diameter hole. However, the impacted panel and the protected panels subjected to lightning strike all exhibited strengths greater than 39 ksi (the stress corresponding to the design ultimate strain of $4,500 \mu\text{in./in.}$).

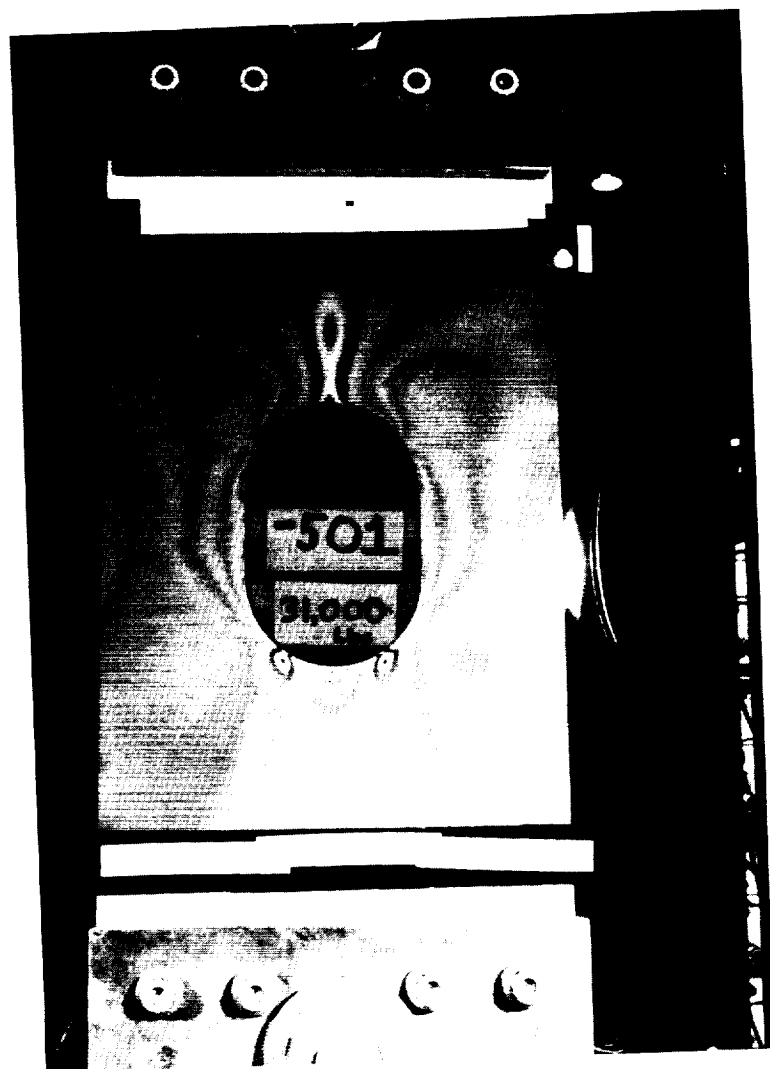
Figure 5-22. Photoelastic Fringe Pattern for -501 Tension Cutout Panel

The baseline panel (-501) was the only one to buckle in opposite directions at the top and the bottom of the cutout. This is illustrated in Figure 5-22 by the asymmetry of the photoelastic fringe pattern at 31 kips. Although difficult to discern, the top of the cutout buckled toward the camera, producing tensile strains on the surface being viewed, which subtract from the membrane compressive strains to produce a black, or zero-principal-strain, region. Likewise, the buckle at the bottom of the cutout is away from the camera, producing bending strains which add to the compressive membrane strains. Typical plots of strain gage and photoelastic data are shown in Figures 5-23 and 5-24.

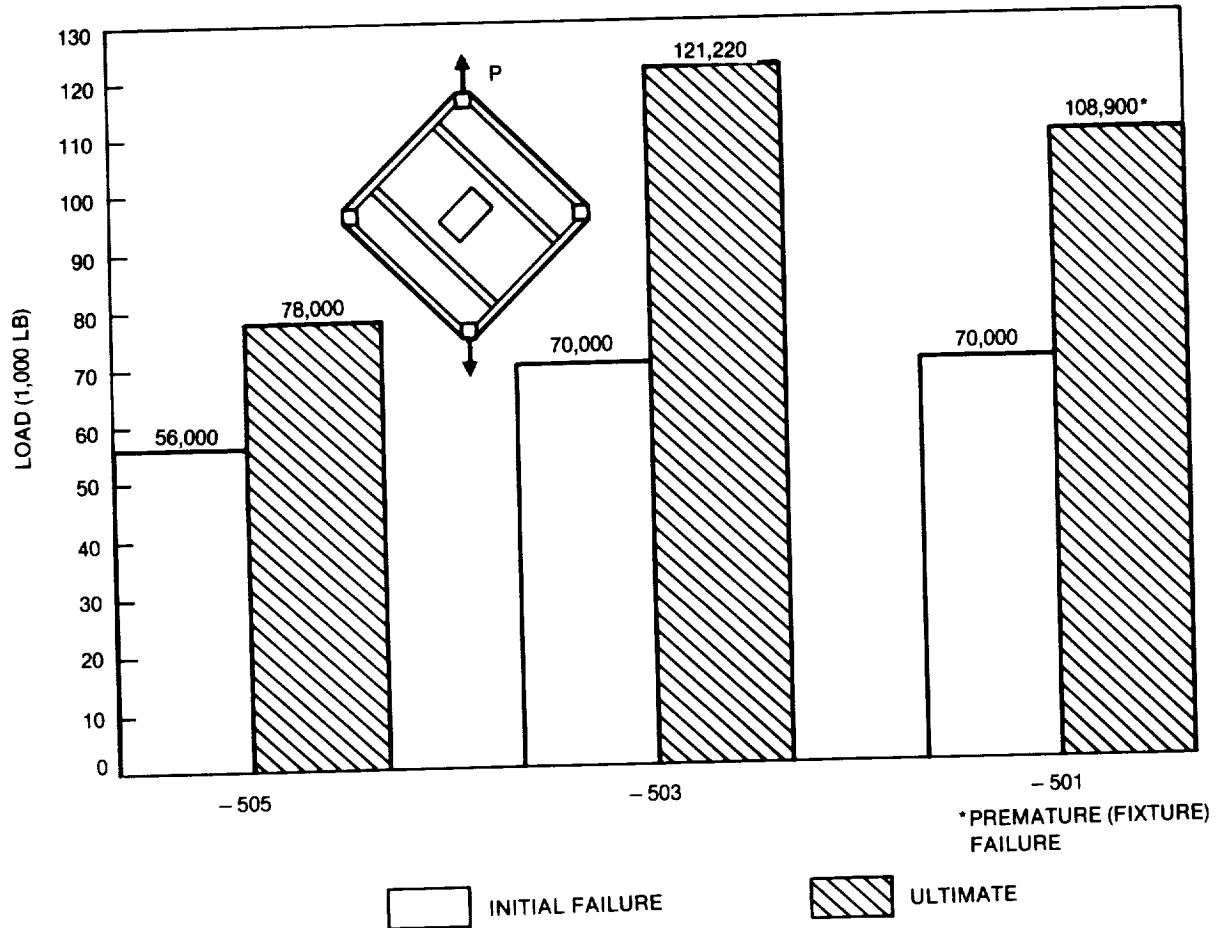
Figure 5-25. Failure Loads for Group B Shear Cutout Panels

A summary of the failure loads for the shear panel tests is given in Figure 5-25. All three panels failed initially at the top and bottom corners of the cutout. These localized failures did not result in the collapse of the panels, however. As indicated, the ultimate failure of the -505 panel was precipitated by a partial failure of the picture frame load introduction fixture. Strain gage data indicated that the panel was close to failure before this occurred.

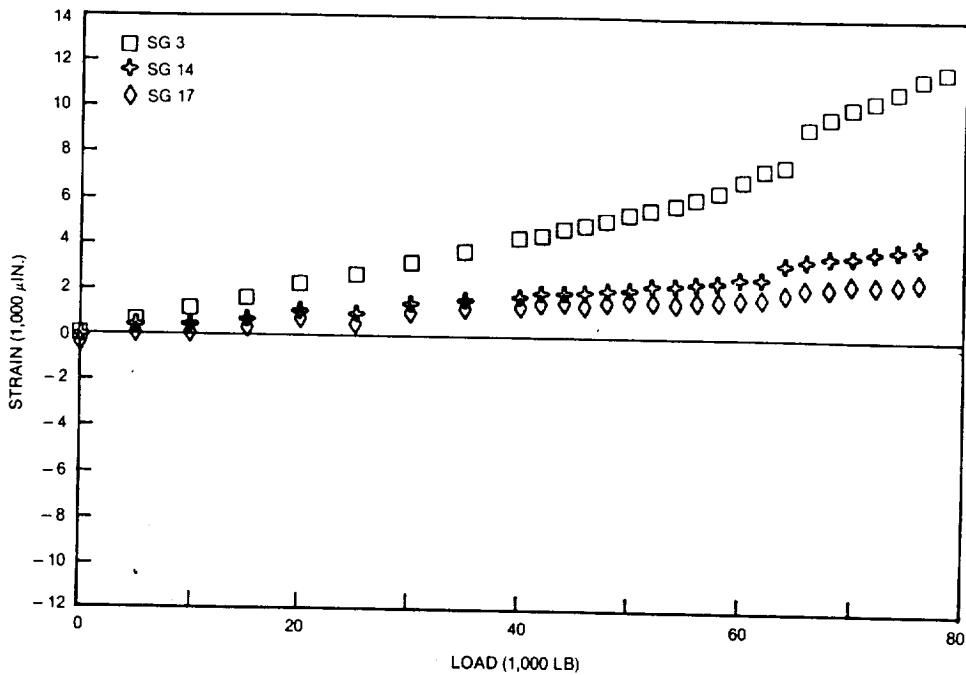
Figure 5-27. Strain Gage Data at Top Corner of Shear Panel Cutout (-501)

A sketch of the failed baseline panel (-501) is included as Figure 5-26. Strain gage data (Figure 5-27) taken at the top corner indicate a moderate change in slope at about 30 kips and a marked nonlinear behavior beginning around 50 kips. While holding the load at 56 kips, a loud noise was heard, and while holding at 58 kips, a drastic drop in measured strain at the top corner ($-9,830$ to $-2,632 \mu\text{in./in.}$) was observed. Inspection of the test article revealed delaminations at the cutout on both compression diagonals (top and bottom corners). As the load was increased, these delaminations were observed to progress toward the intersections of the stiffeners. Panel failure occurred while holding at 78 kips. Ultimate failure appears to have resulted from the stiffeners having disbanded from the panel, thus effectively eliminating the last remaining load path for the diagonal compression load.

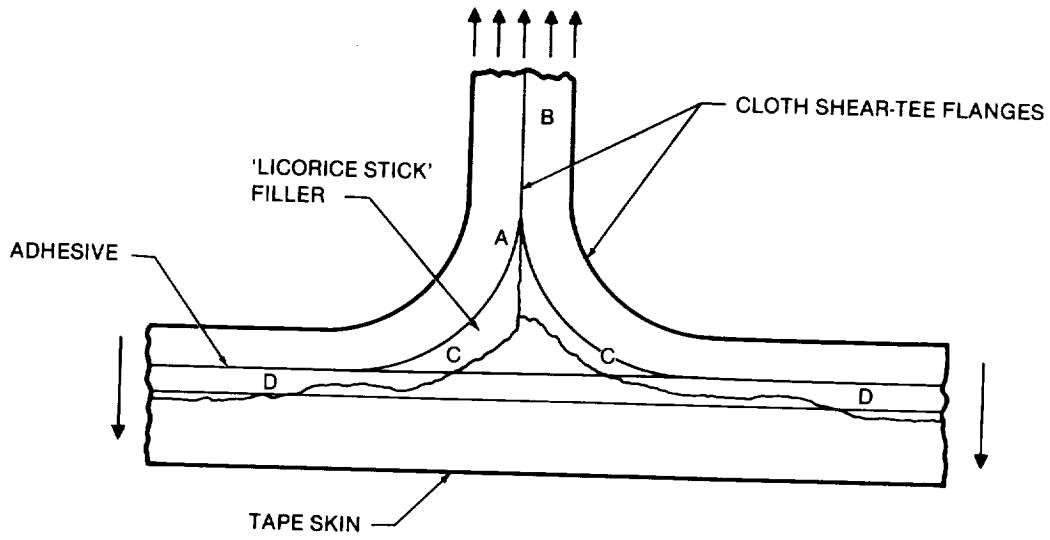
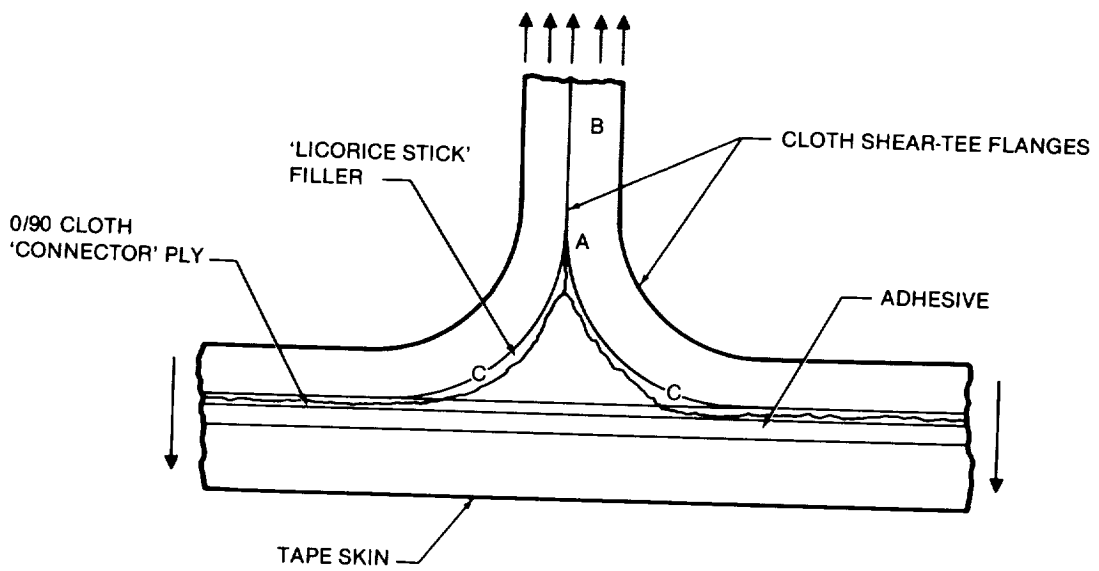
Figure 5-30. Apparent Failure Sequence for Shear-Tee Pull-Off Specimens

Six configurations of the shear-tee/skin intersection were examined. The results of these tests are summarized in Table 5-3. The -503, -509, and -511 configurations all yielded similar results, indicating that neither the alternate adhesive nor the presence of the imbedded hoop plies in the skin had a significant effect on the pull-off strength. The gradual tapering of the shear-tee flange (-505) did, however, result in a noticeable increase in the pull-off load (up to about 425 lb/in.). The worst performers were the -501 and -507 configurations (at about 250 lb/in.), indicating that either adding a ply to connect the tee flanges or thinning/softening the tee as a whole can reduce the pull-off strength dramatically. Figure 5-30 depicts what is thought to be the failure sequence for the shear-tee pull-off specimens. During testing, a loud sound was heard at anywhere from 10 percent to 40 percent of the ultimate failure load (depending on the configuration). As the load continued to increase, a crack was sometimes visible in the region from A to C. These cracks are thought to have originated in the vicinity of A and tended to spread both upward toward B and through the filler material toward either of the C points. Eventually, the cracks would reach a critical length and the specimens would fail suddenly. Examination of the failed specimens revealed adhesive on both the (now separated) tee and skin elements in areas to either side of center. This indicates a cohesive bondline failure in this area (corresponding to the area between points C and D. To either side of this region, there is very little adhesive visible; instead, 0-degree strands are observed on both elements, indicating an interlaminar failure in the first ply of the skin. The -501 specimens, however, showed no sign of any adhesive or 0-degree tape on the failure surface. Instead, there was the very distinct pattern of the 0/90-degree cloth, indicating an interlaminar failure in the tee assembly.

Relating the apparent failure sequence back to the specimens provides some insight into their relative performance. The -503, -509, and -511 specimens all had identical tee elements. Apparently, neither the alternate adhesive, nor the increased stiffness of the skin under the tee, had any significant effect on the peel stress at point C once the crack had propagated to that point. The higher strength of the -505 configuration was likely due to a reduction in this peel stress, effected by the tapered flanges flexing with the

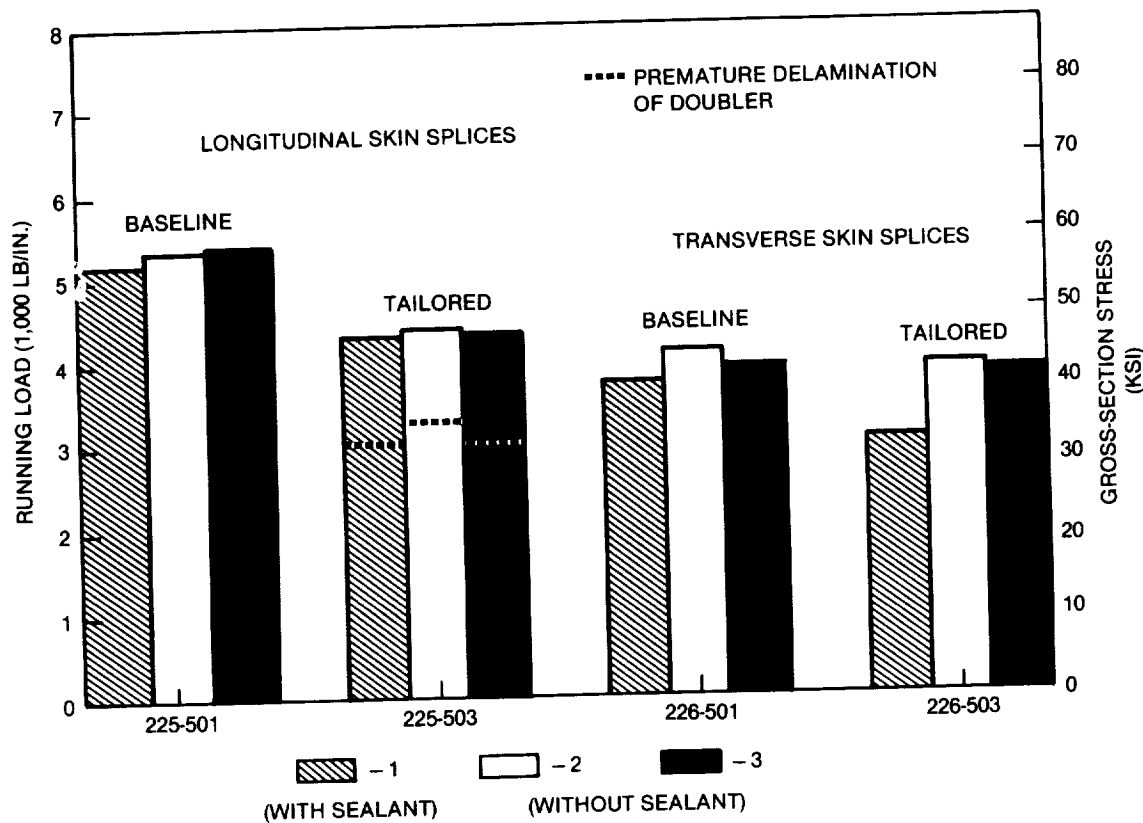
Figure 5-31. Failure Loads for Group C Skin Splice Specimens

The results of the skin splice tests are summarized in Figure 5-31. All of these specimens were fabricated from the basic skin laminate (0.0684 inch nominal thickness) to which four plies of 45 were added at the splice region to yield the reinforced skin laminate (0.0912 inch nominal thickness). Gross-section stresses are based on the built-up thickness. Gross-section strains can be obtained by dividing by measured modulus of elasticity for lay-up No. 2 (7.96 Msi). The first replicate of each of the skin splice configurations was tested with faying surface sealant while the second and third were tested without. The presence of the sealant had little effect on the strength of the longitudinal skin splices. The strengths of the transverse splices were more noticeably affected (reduced) by the presence of the sealant. This reduction is generally attributed to the increased eccentricity of these single-shear joints due to the added thickness of the sealant.

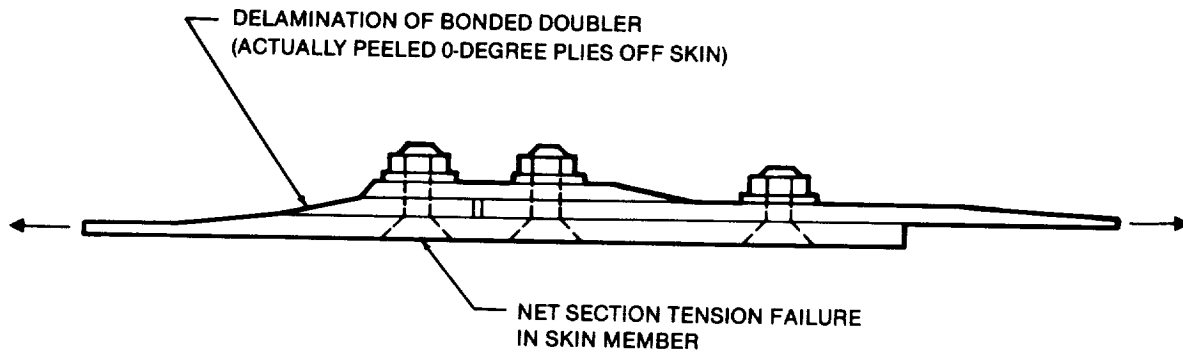
Figure 5-32. Failure Mode of Tailored Longitudinal Splice Specimens

The tailored longitudinal splice specimens experienced premature doubler delaminations prior to failure. Figure 5-32 illustrates the location of the initial delamination as well as that of the ultimate (net-section tension) failure. The taper angle of the small doubler bonded to the left-hand skin was apparently too steep to allow it to conform adequately to the deformed curvature of the skin. The resultant peel force at the end of the doubler thus precipitated the premature delamination. (Note that this was not a bondline failure, but rather was an interlaminar failure in the countersunk skin at the outermost fastener. With the doubler separated from the skin, the ultimate failure occurred in the countersunk skin at the outermost fastener.

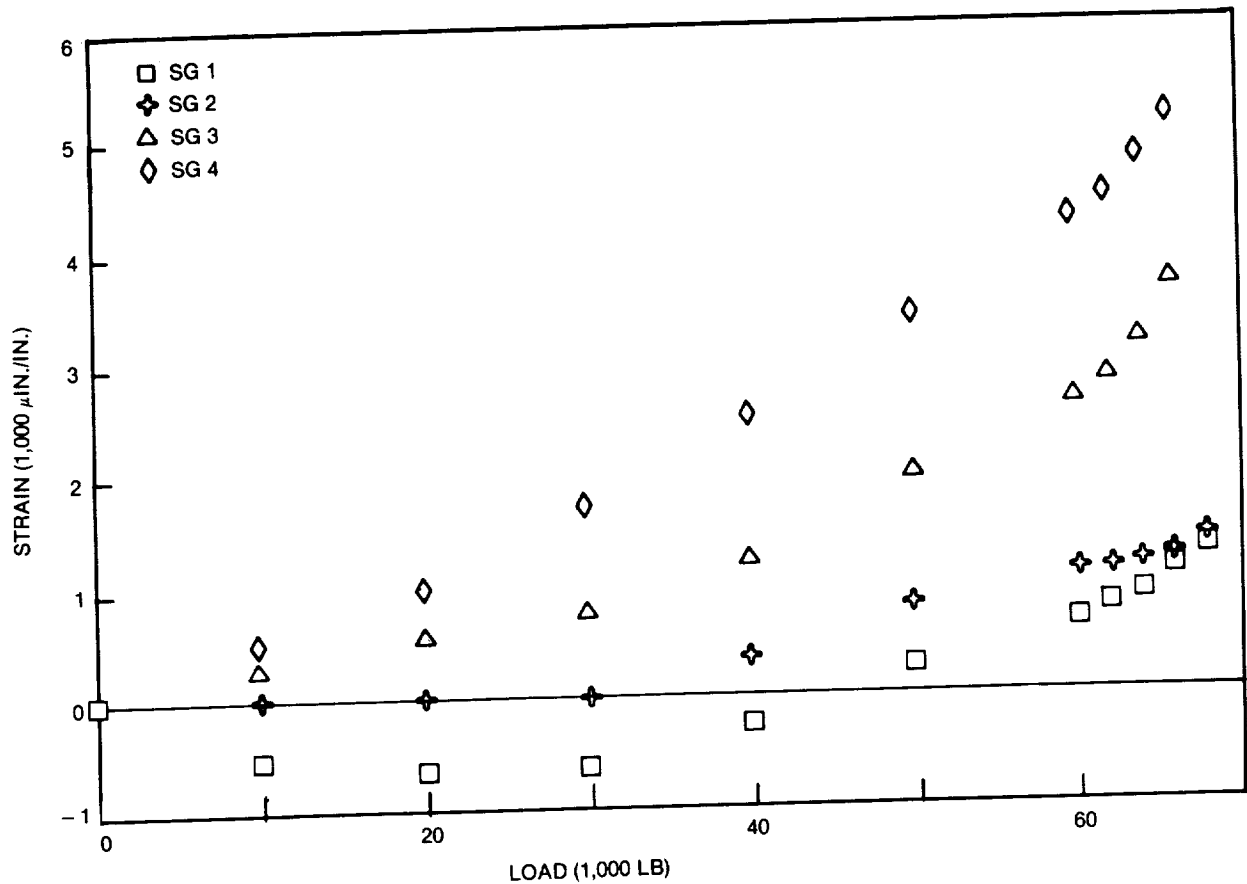
Figure 5-36. Transverse Skin/Longeron Splice Typical Strain Gage Data (Tension)

Strain gage data taken in the vicinity of the splice was noticeably nonlinear. This geometric nonlinear behavior (a result of the eccentricity of the single-shear skin splice) is especially notable in the data from strain gage No. 1 (Figure 5-36). This gage, located in the center of the skin-splice plate, initially read negative even though the applied load was tension. The strain readings leveled off quickly, however, and eventually became positive at about 45 kips. Considerable local bending of the skin and skin-splice members was also visually confirmed during the test. Although not visually detectable, the strain gage data also indicated a degree of eccentricity in the longeron splice, with the strains generally higher in the L-member than in the Z.

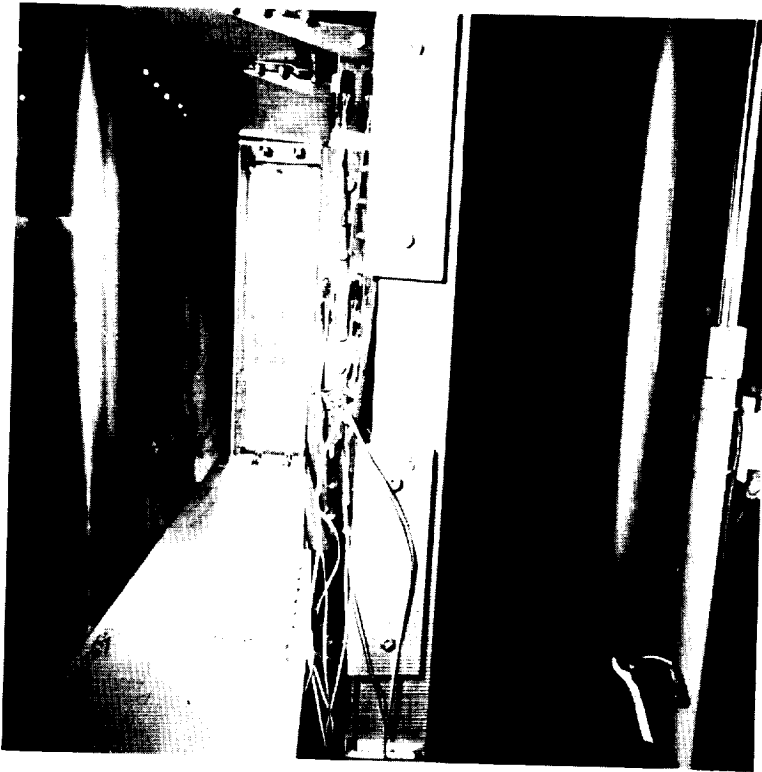
Figures 5-39 through 5-41 show several views of the specimen after failure. The skin failure (best seen in Figure 5-39) did not occur through the skin splice. The damage did, however, go through several of the fasteners which attached the skin/longeron flange combination to the Z and L stiffener flanges. At the panel edges (Figure 5-40), the skin failure was just below the splice plate, and just above the edge support. Failure of the Z and L splice plates (Figure 5-41) likewise did not occur through the longeron splice. The splice plates failed through two fastener holes; however, the load transfer at these fasteners should have been minimal. (These attachments were simply designed to stabilize the Z and L splice members where they bridge the stiffener load across the skin splice.)

Figure 5-40. Failure of Longeron/Skin Splice Panel (Compression Specimen)
