NASA Contractor Report 178246

Test Results for Composite Specimens and Elements Containing Joints and Cutouts

P. T. Sumida, R. C. Madan, and A. V. Hawley

August 1988

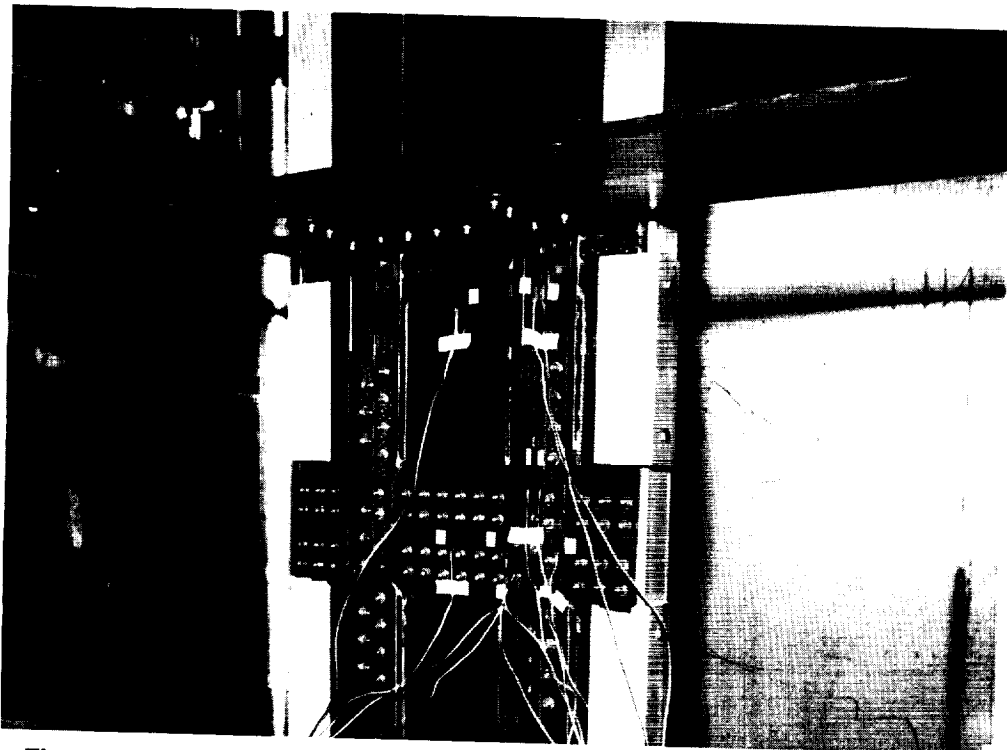
Figures 5-39 through 5-41 show several views of the specimen after failure. The skin failure (best seen in Figure 5-39) did not occur through the skin splice. The damage did, however, go through several of the fasteners which attached the skin/longeron flange combination to the Z and L stiffener flanges. At the panel edges (Figure 5-40), the skin failure was just below the splice plate, and just above the edge support. Failure of the Z and L splice plates (Figure 5-41) likewise did not occur through the longeron splice. The splice plates failed through two fastener holes; however, the load transfer at these fasteners should have been minimal. (These attachments were simply designed to stabilize the Z and L splice members where they bridge the stiffener load across the skin splice.)

Figure 5-41. Failure of Longeron/Skin Splice Panel (Compression Specimen)

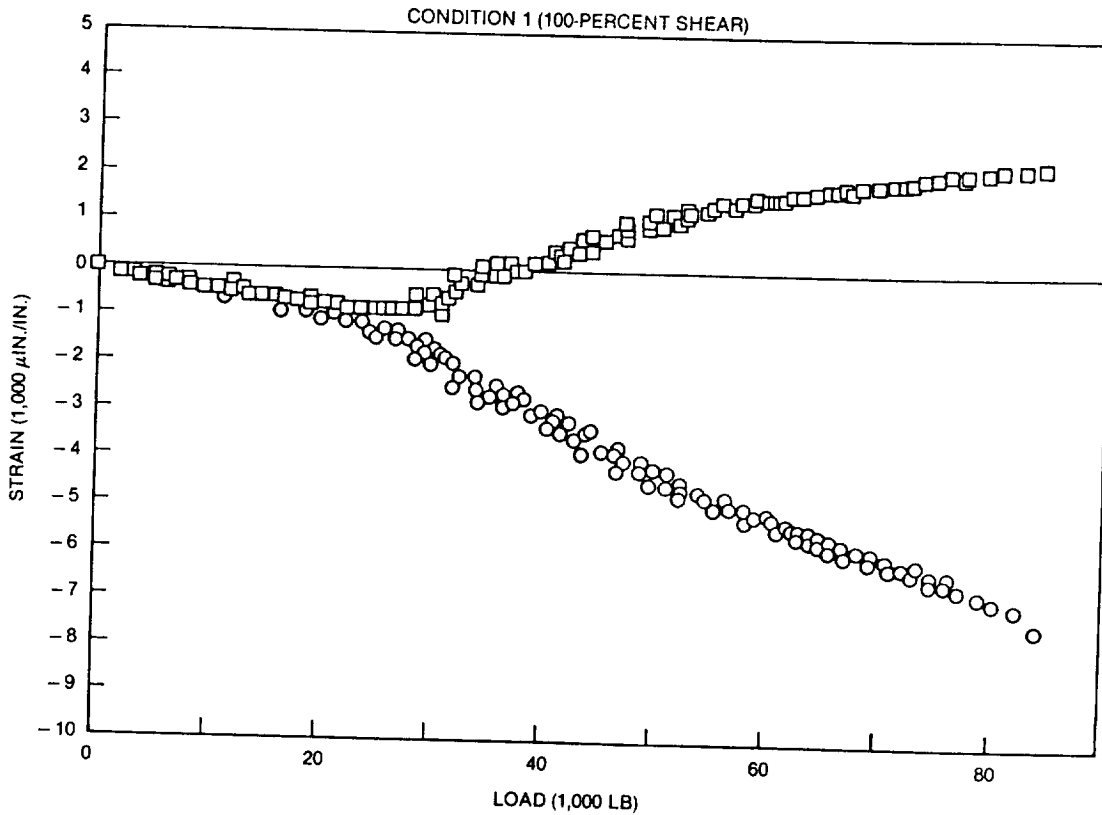
Figure 5-45. Postbuckling Response of Transverse Skin Splice Panel (Shear)

Strain gage data for this specimen (see Figure 5-36) provided information concerning skin buckling and the behavior of the transverse splice. The continuously read data for the shear-only conditions (discussed above) are presented in Figure 5-45. The data and the failure load of 84.1 kips suggest a post-buckling ratio for this panel of between 2.5 and 3.0 (depending on the choice for the initial buckling load). Strain gage data from the small skin bay just above the splice (strain gages No. 5 and 6) indicate a small amount of curvature, which suggests a very shallow buckle present here also. (Skin thickness in this bay was nominally 0.0912 in.). Strain gages at the joint indicated behavior similar to that of the two-stiffener transverse splice panel loaded in compression (i.e., nearly equal strains in the Z and L splice members, and tensile strains on the inside surface of the skin splice plate). The strains at the joint were generally quite low due primarily to the fact that the highest compression load applied was 75 kips, corresponding to a running load of about 1,800 lb/in. (this to be contrasted with the failure load of the two-stiffener panel of 3,336 lb/in.).

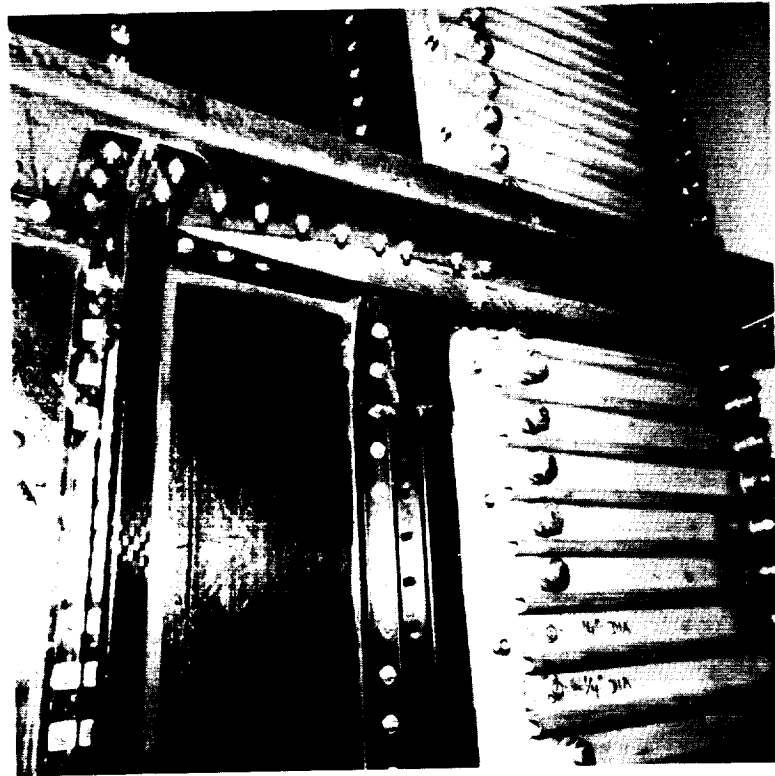
Figure 5-48 is a closeup of the right-hand side of the panel. The collapse of this side of the specimen was more centered about the middle frame. The videotapes indicate that the skin failures (through the cutouts) and the longeron failures preceded the failure of the frame. The frame failure is better seen in Figure 5-49, which is a bottom view of the same area. Local failures also occurred at the upper left and upper right corners of the panel. As these areas were not visible in the videotapes, the relative timing of these failures is unknown. Nondestructive examination of the failed panel revealed skin damage as outlined in Figure 5-50. (The light area around the cutout is the photoelastic film.)

Figure 5-49. Group D Window Belt Panel — Failure of Skin, Longerons, and Frame

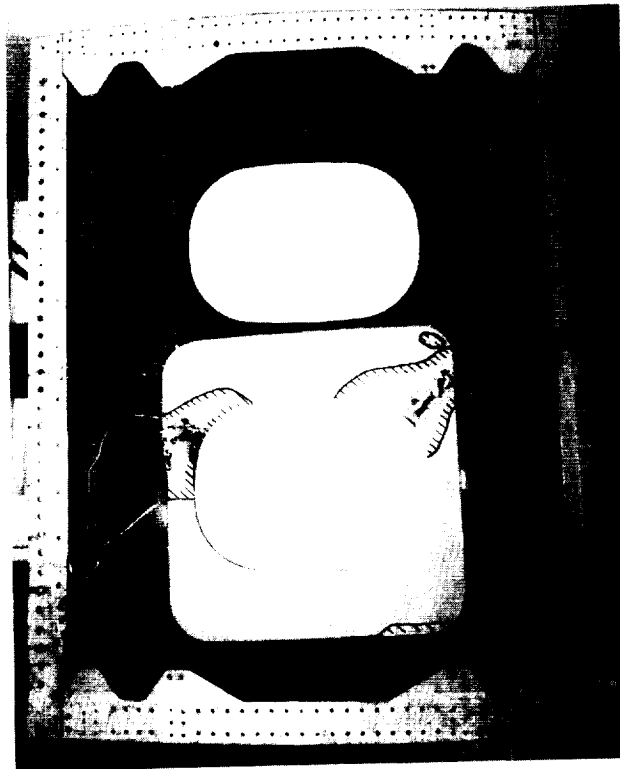
Figure 5-50. Group D Window Belt Panel — Areas of Skin Damage Detected by NDI

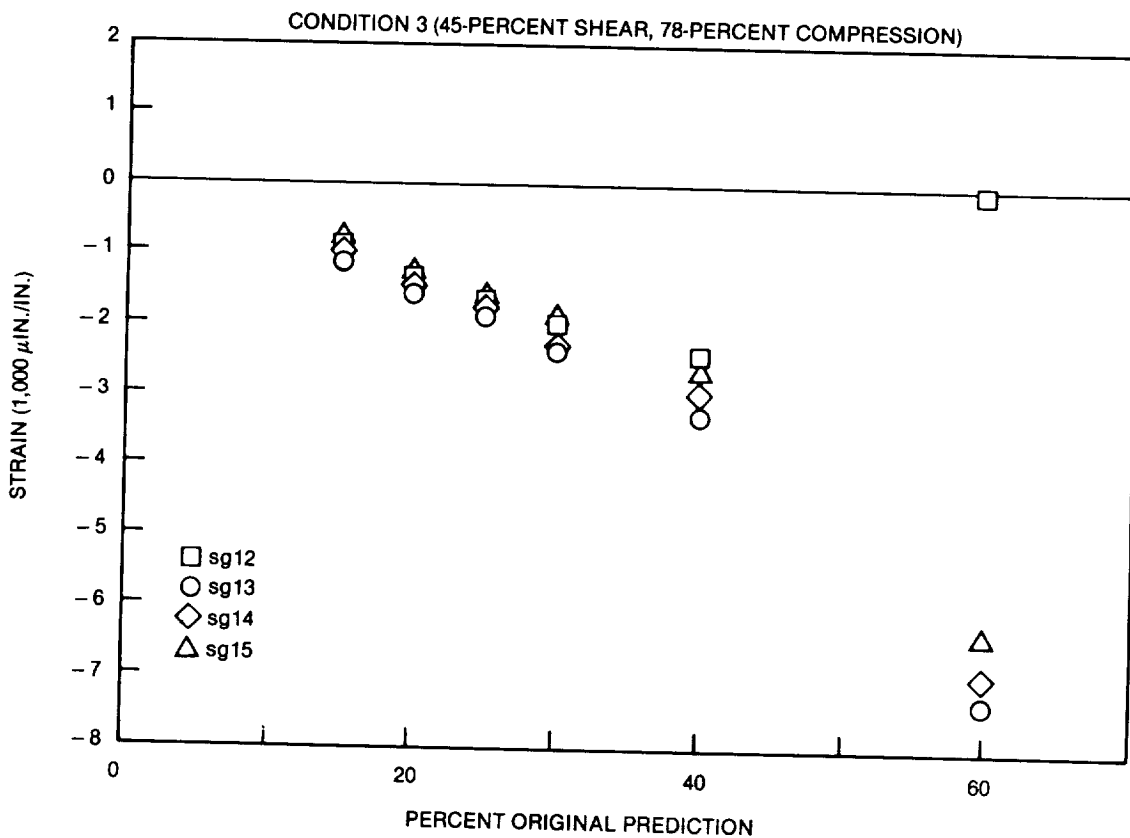
The strains recorded by the gages above and below the cutout remained relatively linear, and were (expectedly) higher for the shear dominated load cases. Those recorded by the gages along the left and right edges were likewise highest for the compression-dominated conditions. There was a noticeable nonlinearity in these data, indicative of either a redistribution of load in the panel, or bending along the cutout. The data from strain gages No. 12 through 15 are the most interesting. The gages located at the lower right-hand corner of the lower cutout (see Figure 5-46) showed the presence of high-compression loads for the shear-dominated conditions. Significant bending was indicated at this location by the difference in the readings from the back-to-back strain gages. These readings were also the most obviously nonlinear. The most dramatic example of this behavior is evidenced in the plot for these gages for Condition 3 (included here as Figure 5-51). It would appear from the severity of the bending indicated at this condition for the 60-percent load series, that a failure at or close to this area had already occurred. However, there was no damage to the skin in this region.

Strain gages at the upper right-hand corner of the lower cutout in Figure 5-46 also displayed a nonlinear characteristic with a moderate amount of bending. These strains were tensile for the shear-dominated conditions and compressive for the compression-dominated conditions. Although a skin failure is indicated at these gages in Figure 5-50 (the upper left corner of the lower cutout), the measured strains were quite low just prior to the collapse of the panel. This adds credence to the observation made from the videotapes that this side of the panel was not involved in the initial failure.

Figure 5-51. Selected Strain Gage Readings for Window Belt Panel
