NASA Technical Memorandum TM 103820

Debris/Ice/TPS Assessment And Photographic Analysis For Shuttle Mission STS-39

April 28, 1991

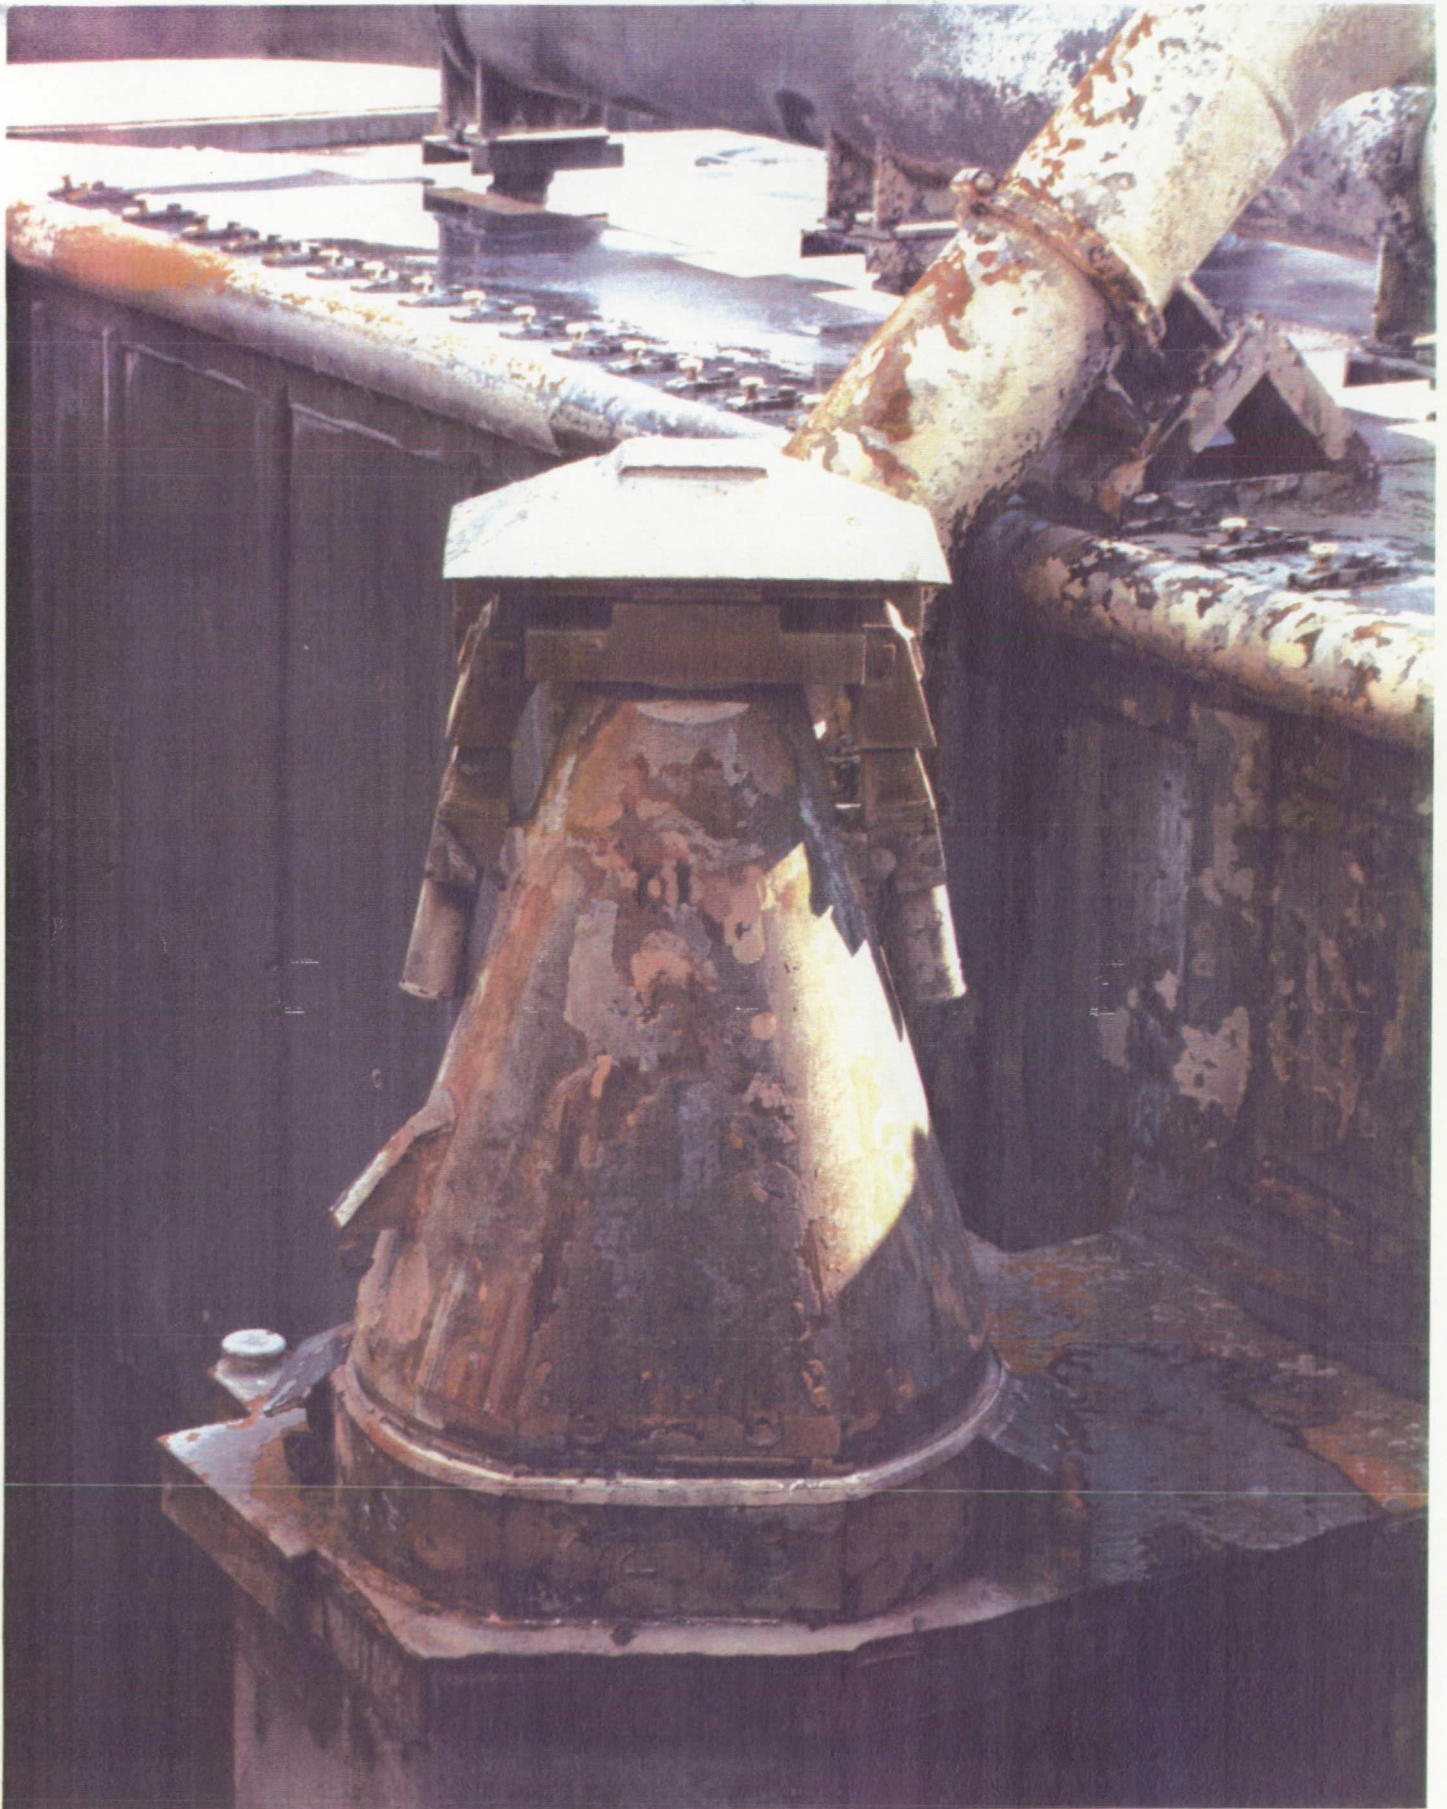
All doghouse blast covers on the north holddown posts had closed properly. Plume erosion appeared to be less than usual.
