NASA Technical Memorandum TM 103815

Debris/Ice/TPS Assessment And Photographic Analysis For Shuttle Mission STS-38

November 15, 1990

Shuttle mission STS-38 was launched at 6:48 p.m. EST 11/15/90

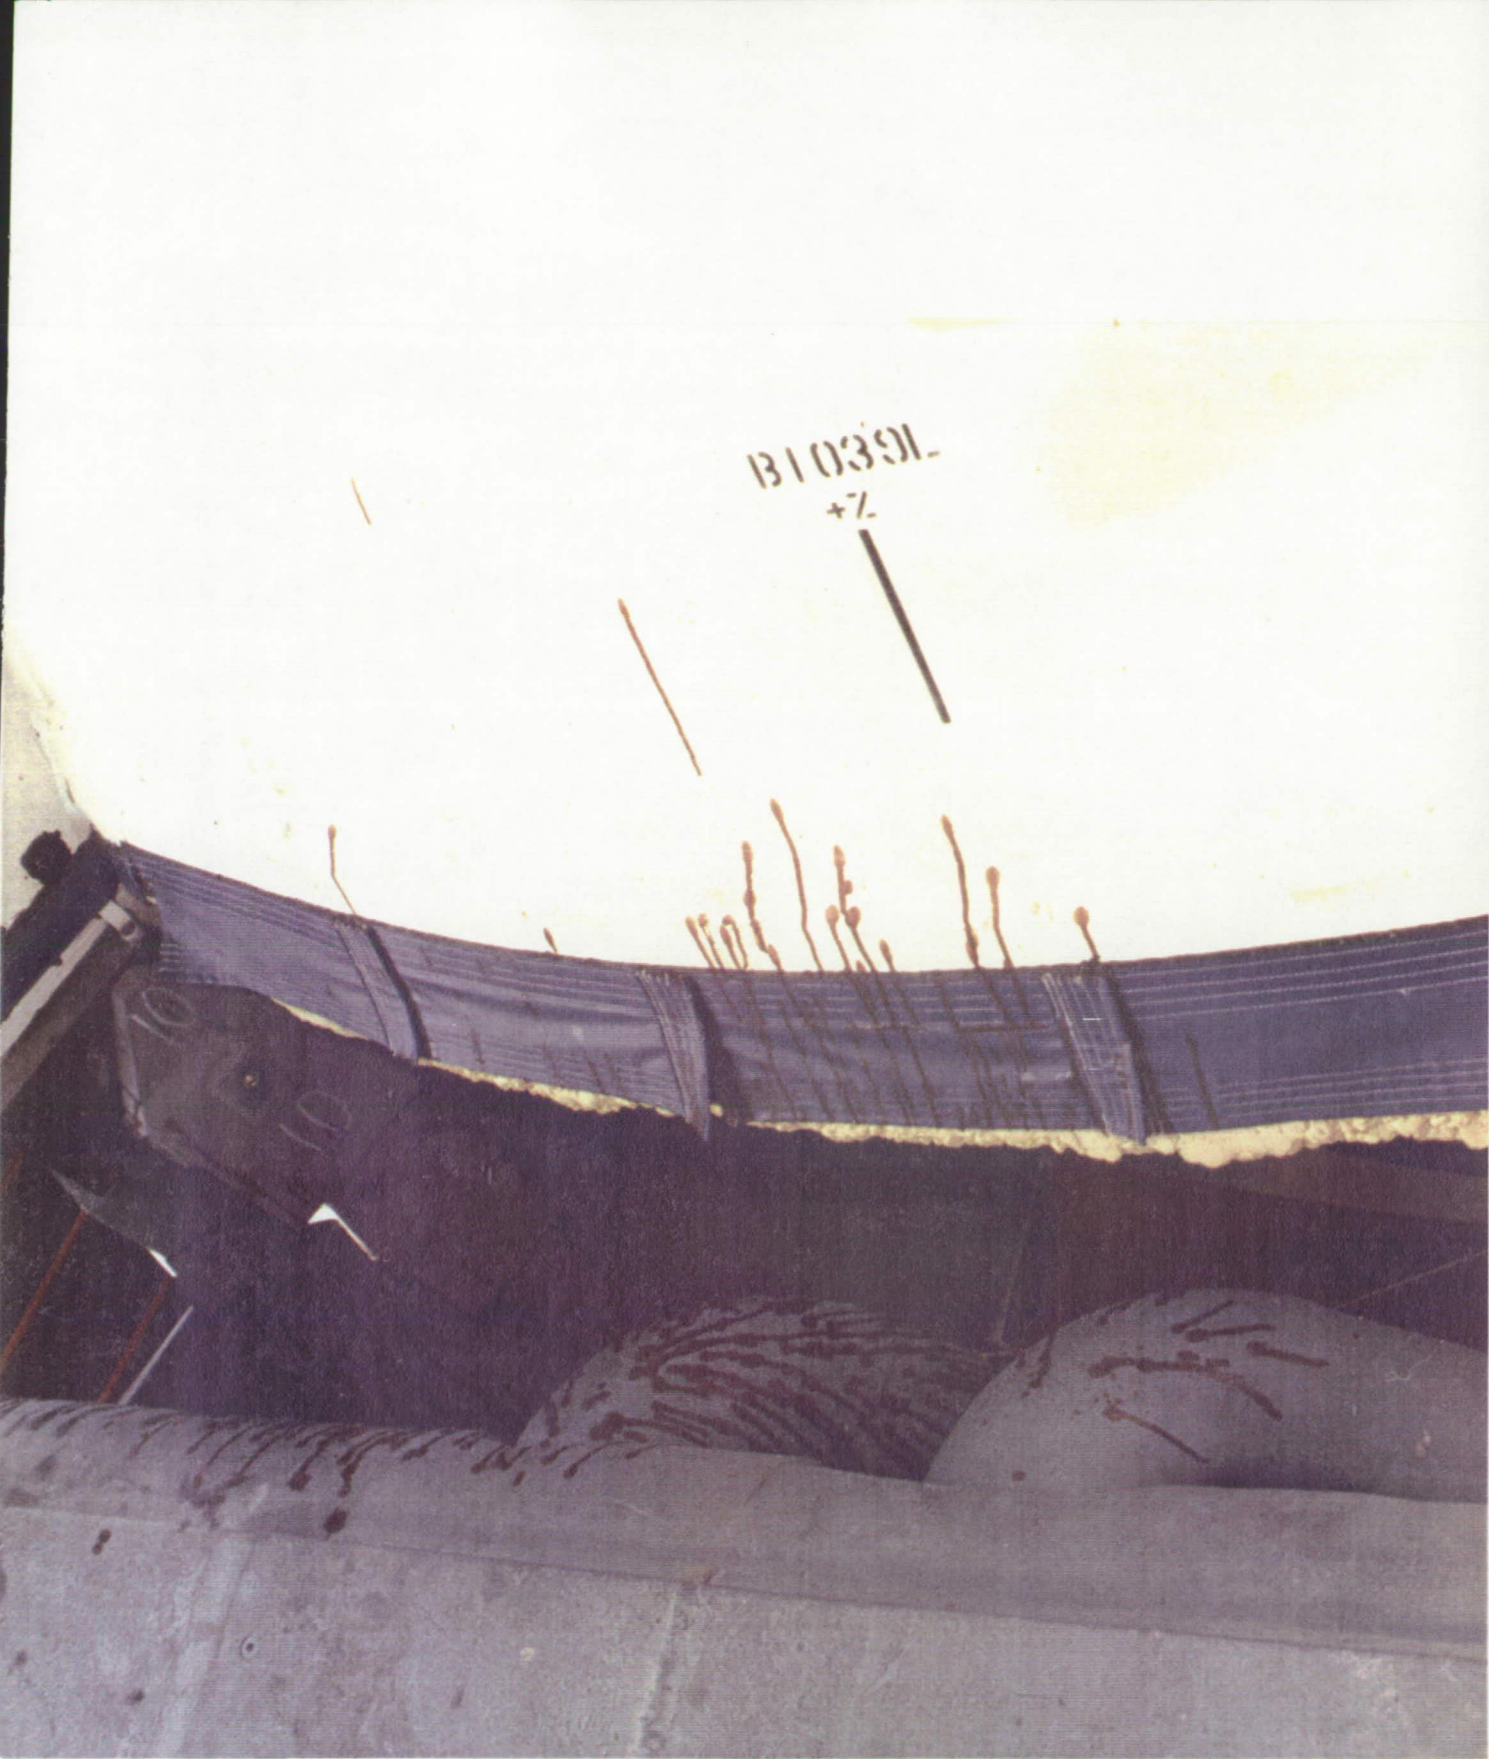
Reddish-brown liquid had dripped onto LH SRB aft skirt from the IEA area during pad closeout operations

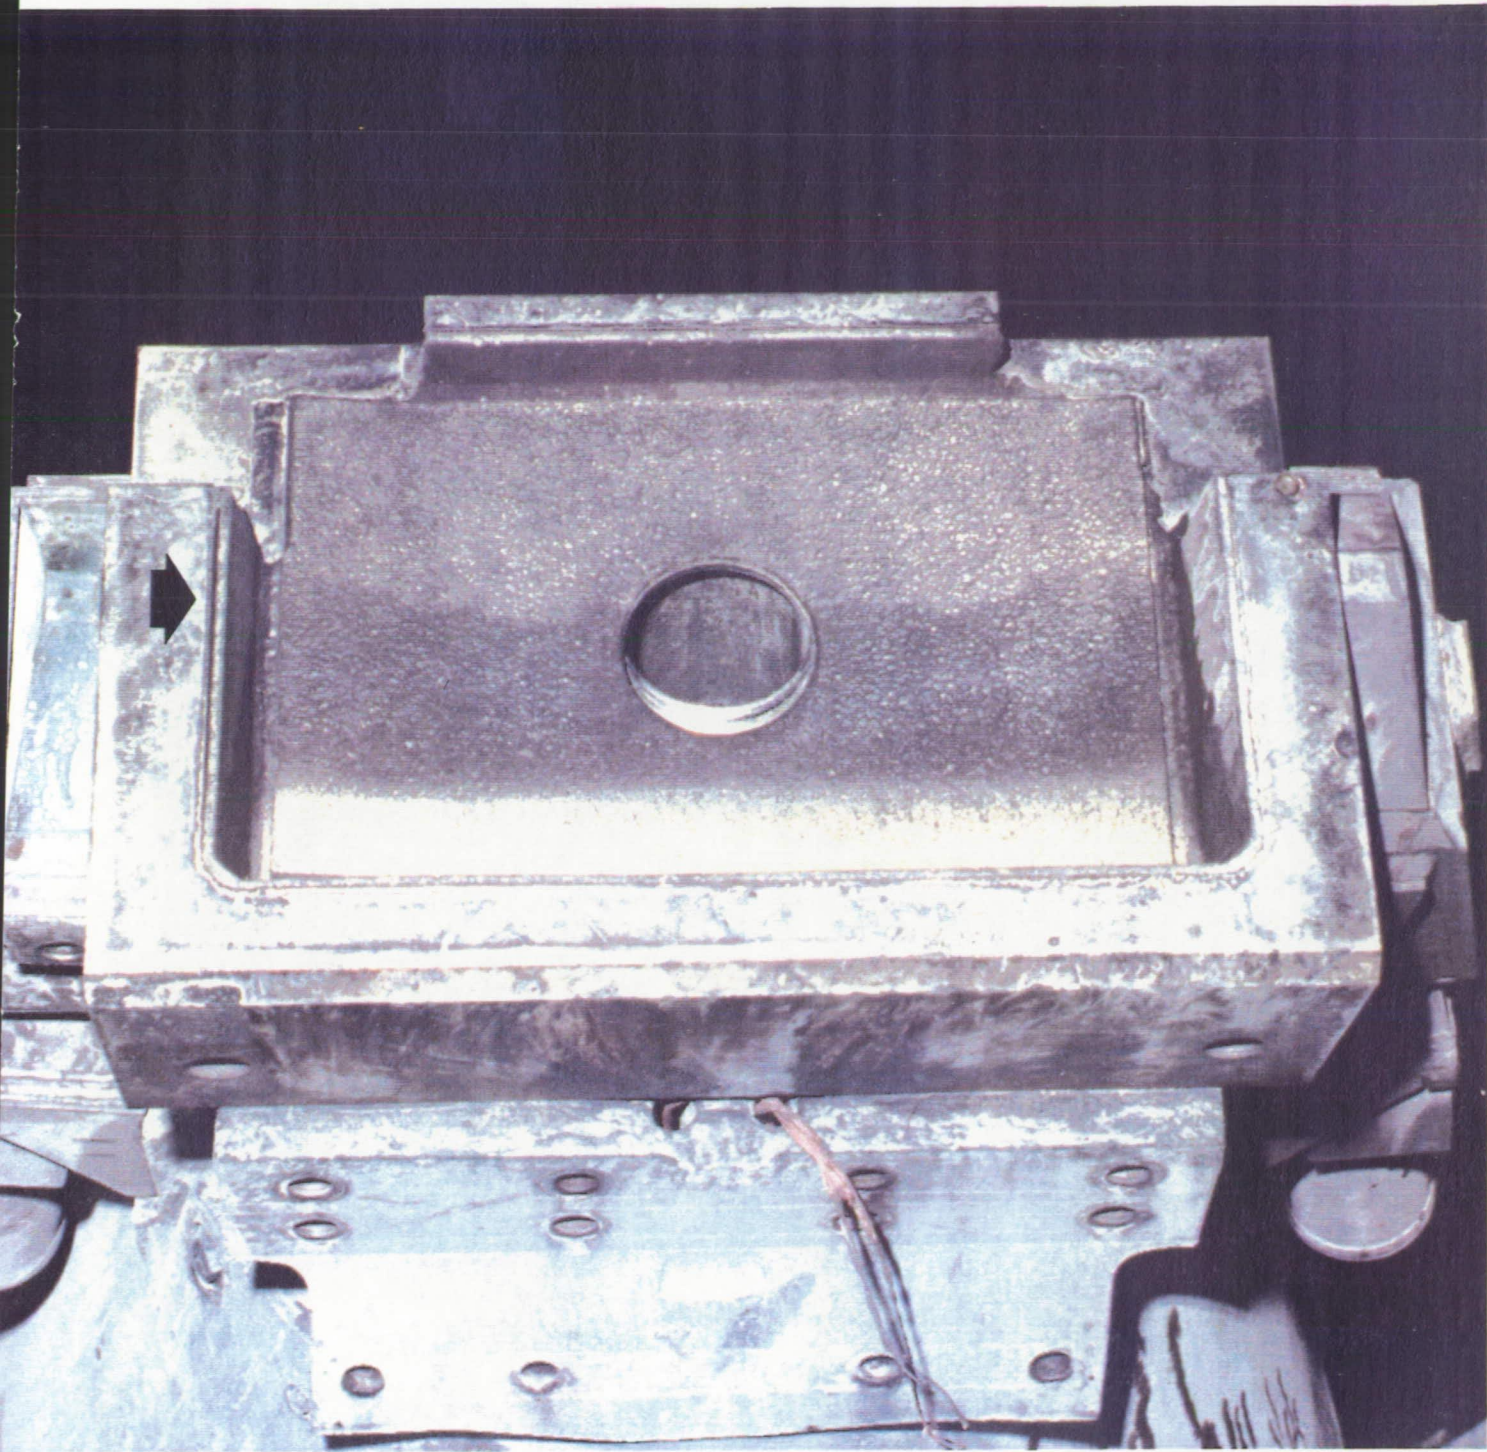
No significant flight hardware or TPS material was found during the post launch debris inspection of Pad 39A. Launch damage to the holddown posts was minimal, though the EPON shim material on all south holddown posts was debonded to some degree. No signs indicative of stud hang-up were visible. No fragments from HDP debris containers were found. The GH2 vent line had latched properly. Overall, the facility sustained minimal damage.

Holddown post shoe sidewall shim material was debonded

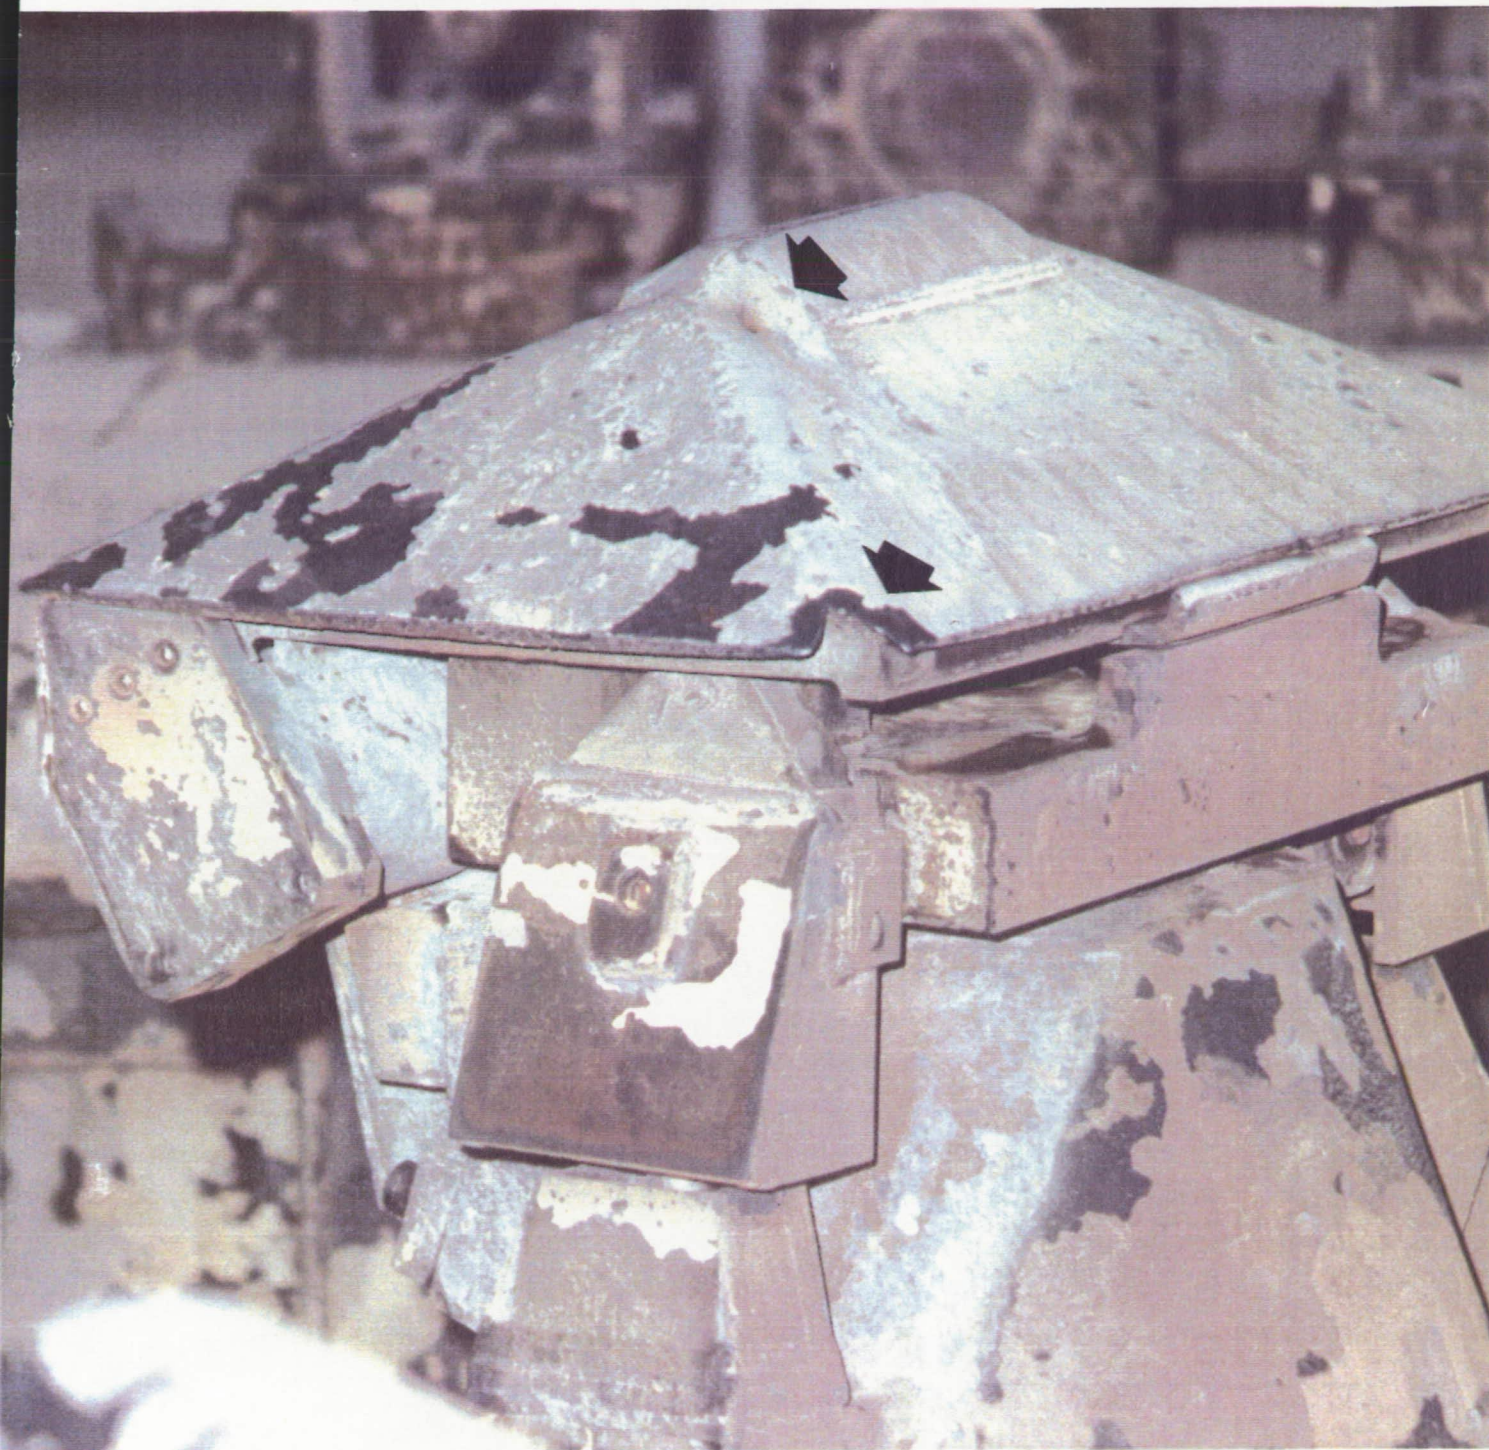
Erosion/heating effects from SRB plume was visible on top and corner of doghouse blast cover

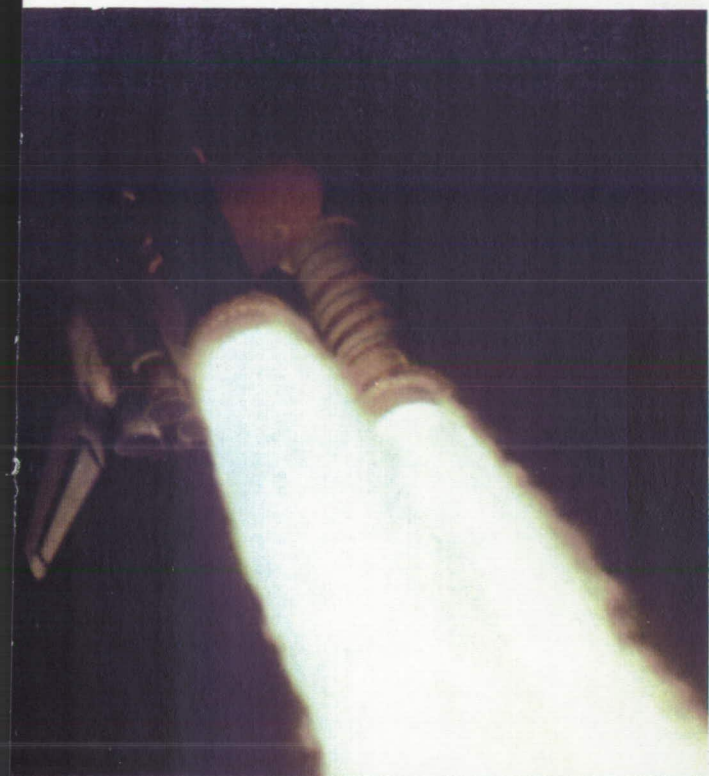
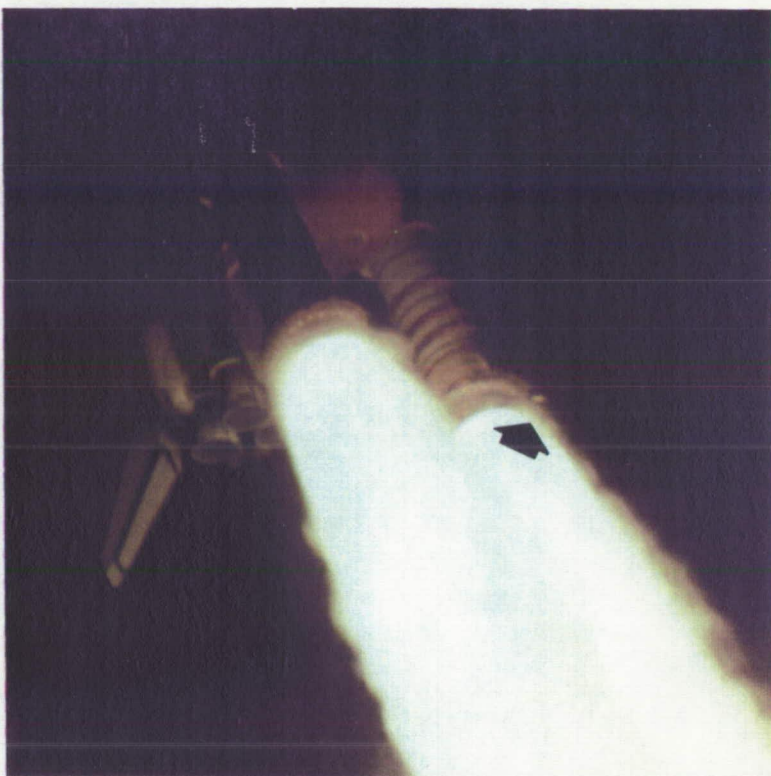
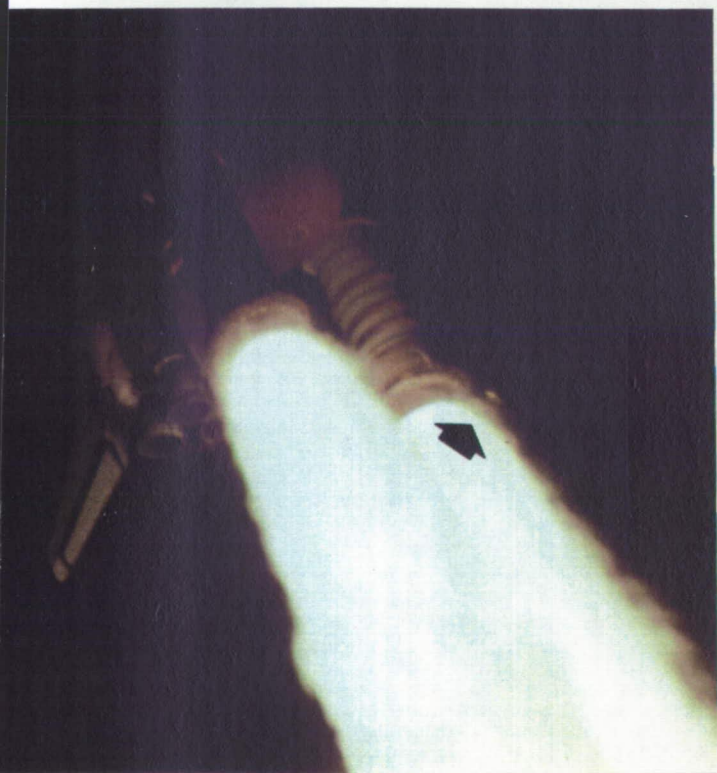
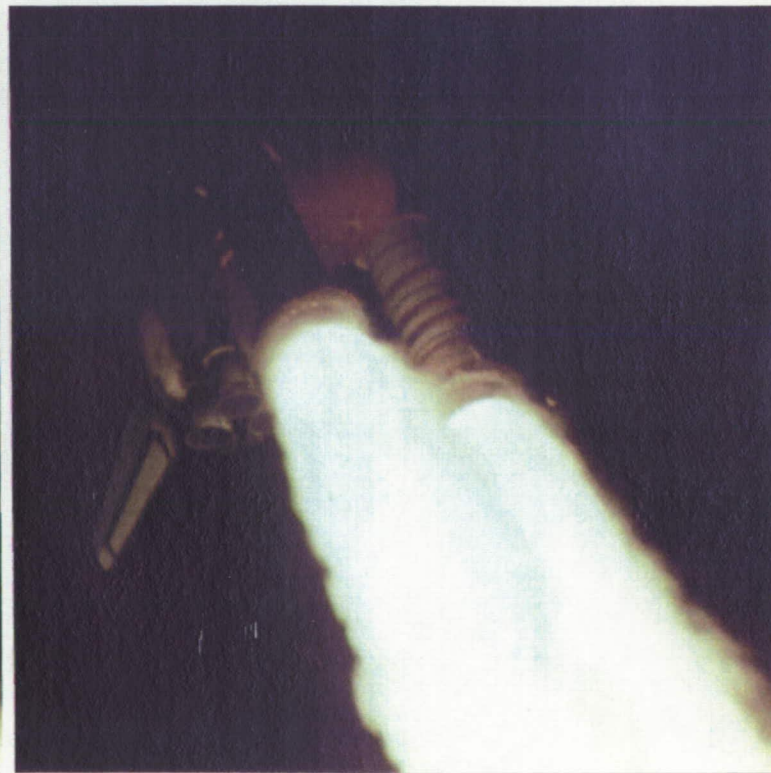
Possible loss of thermal curtain material from the LH SRB aft skirt -Z side at 34 seconds MET. The piece of material was lost against the SRB exhaust plume and could not be tracked further.

Possible loss of second piece of LH SRB aft skirt thermal curtain material at 39 seconds MET. Both objects' apparent size, mass, and behavior tend to preclude the possibility of SRB thermal curtain tape.

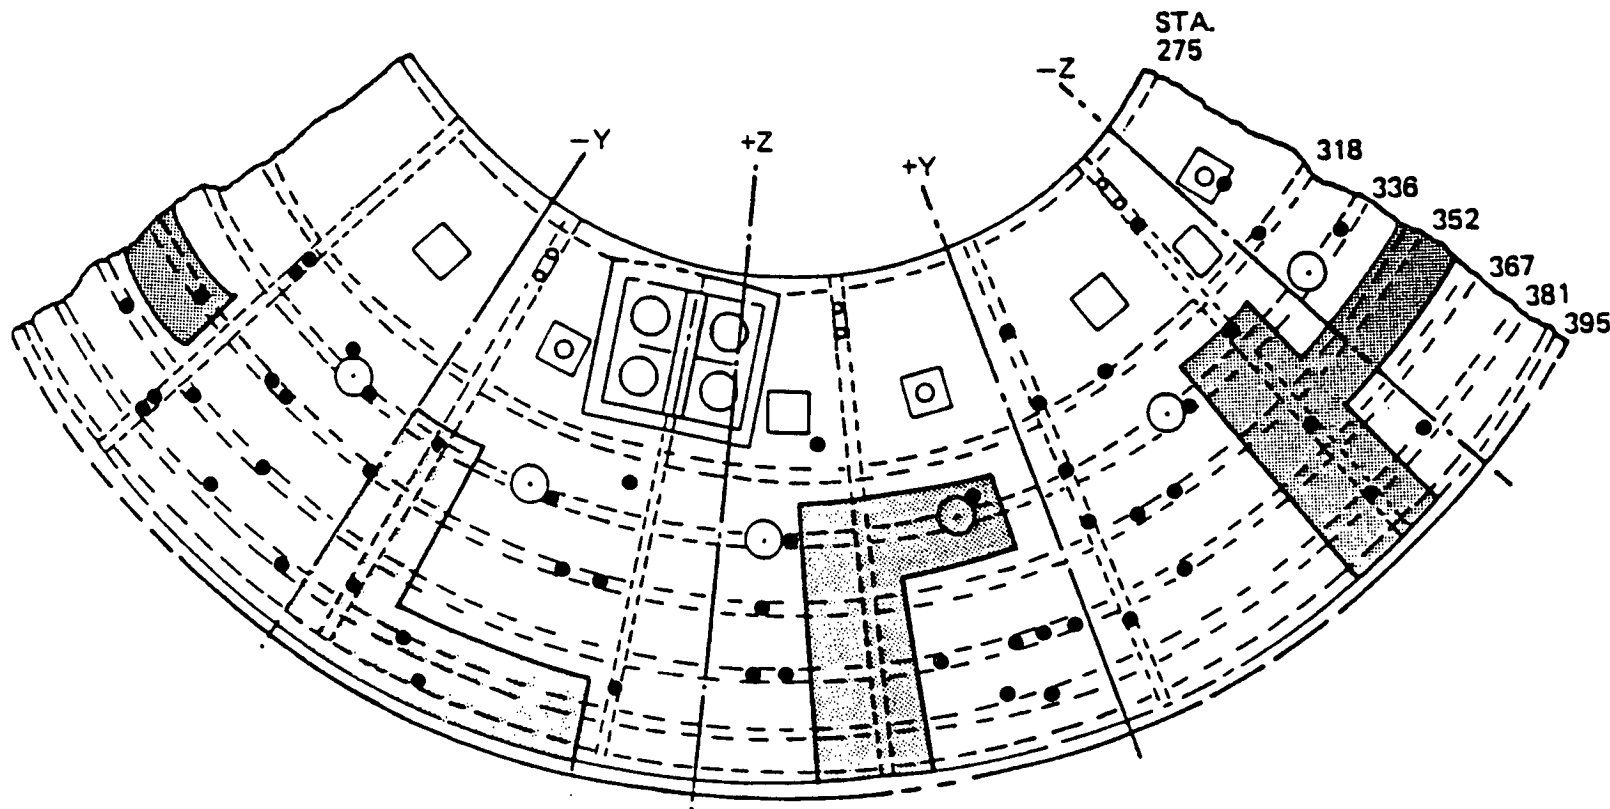
FIGURE 5. RIGHT SRB FRUSTUM

The nose cap was not recovered. The RH frustum had no areas of missing TPS but had 56 debonds over fasteners (Figure 5). The Hypalon paint was blistered slightly in localized areas. All BSM covers were fully opened and locked in the 180 degree position.

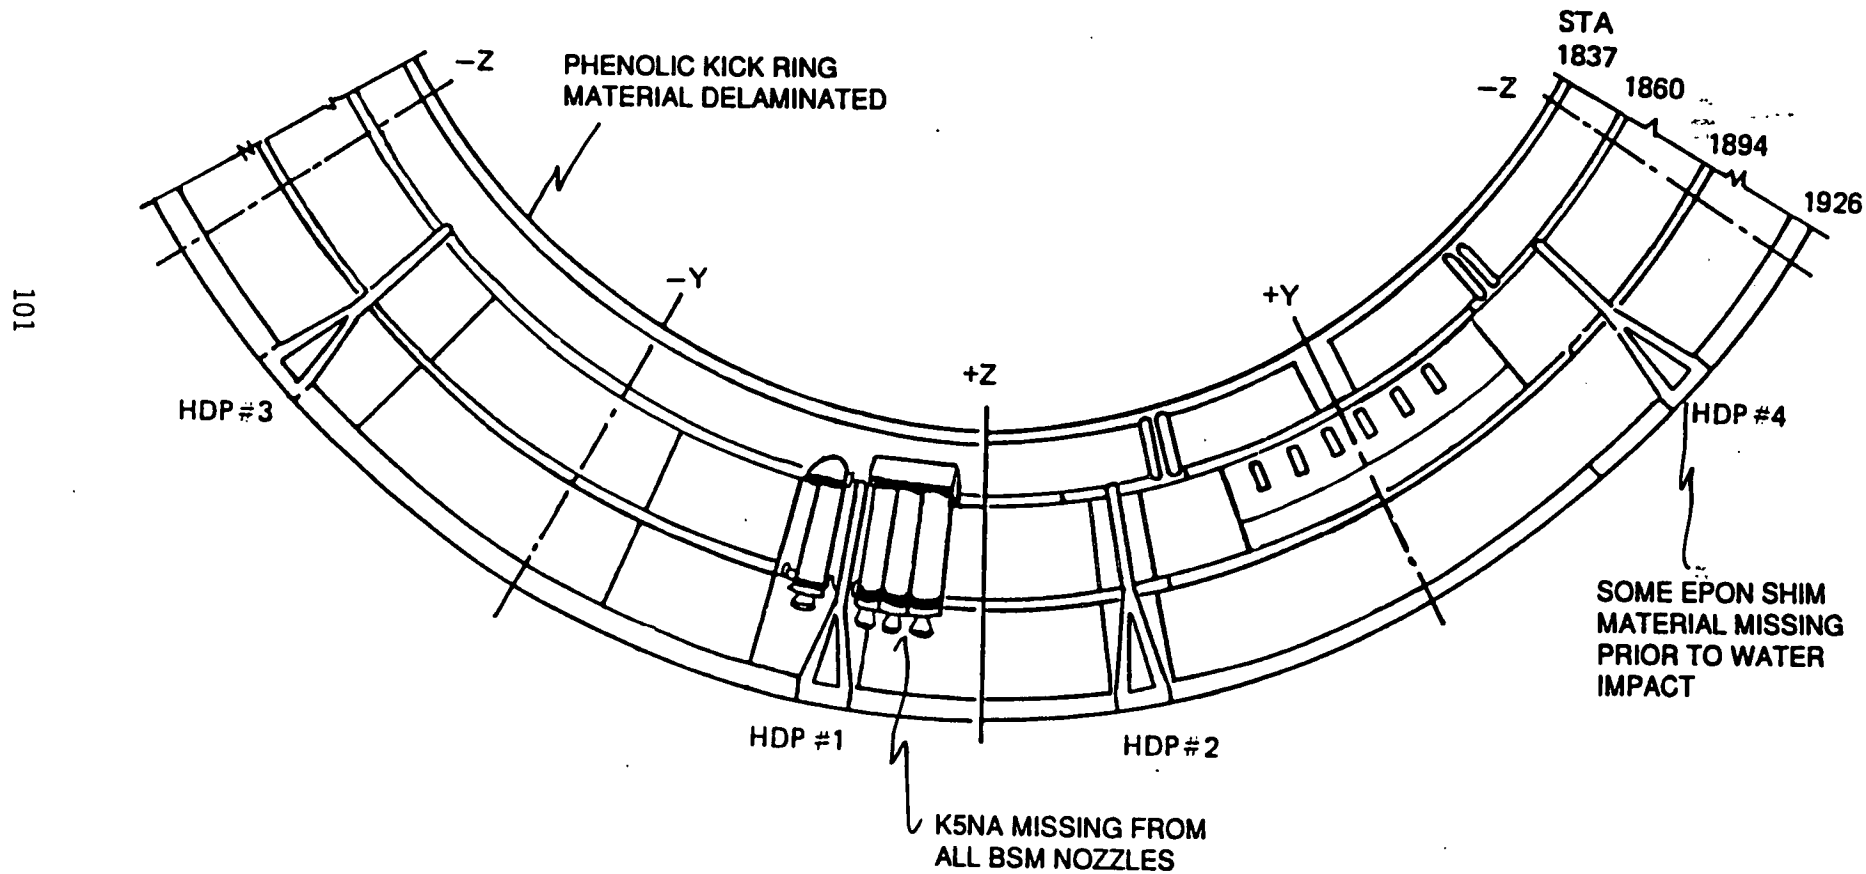
FIGURE 7. RIGHT SRB AFT SKIRT EXTERIOR TPS

The TPS over the aft skirt acreage was generally in good condition with localized blistering of the Hypalon paint (Figure 7). The TVC system appeared to be undamaged. The phenolic material on the kick ring delaminated in several locations. K5NA protective domes were missing prior to water impact at 5 locations. K5NA was missing from all aft BSM nozzles. Instafoam was missing from the aft ring around the aft skirt feet, HPU exhaust horns, and the SRB T-0 umbilical. All four Debris Containment System (DCS) plungers were properly seated. Some Epon shim material was missing from the aft skirt HDP #4 foot and the substrate was sooted. This condition coincides with the piece of EPON shim material that came loose after liftoff (ref Film Item E-7).

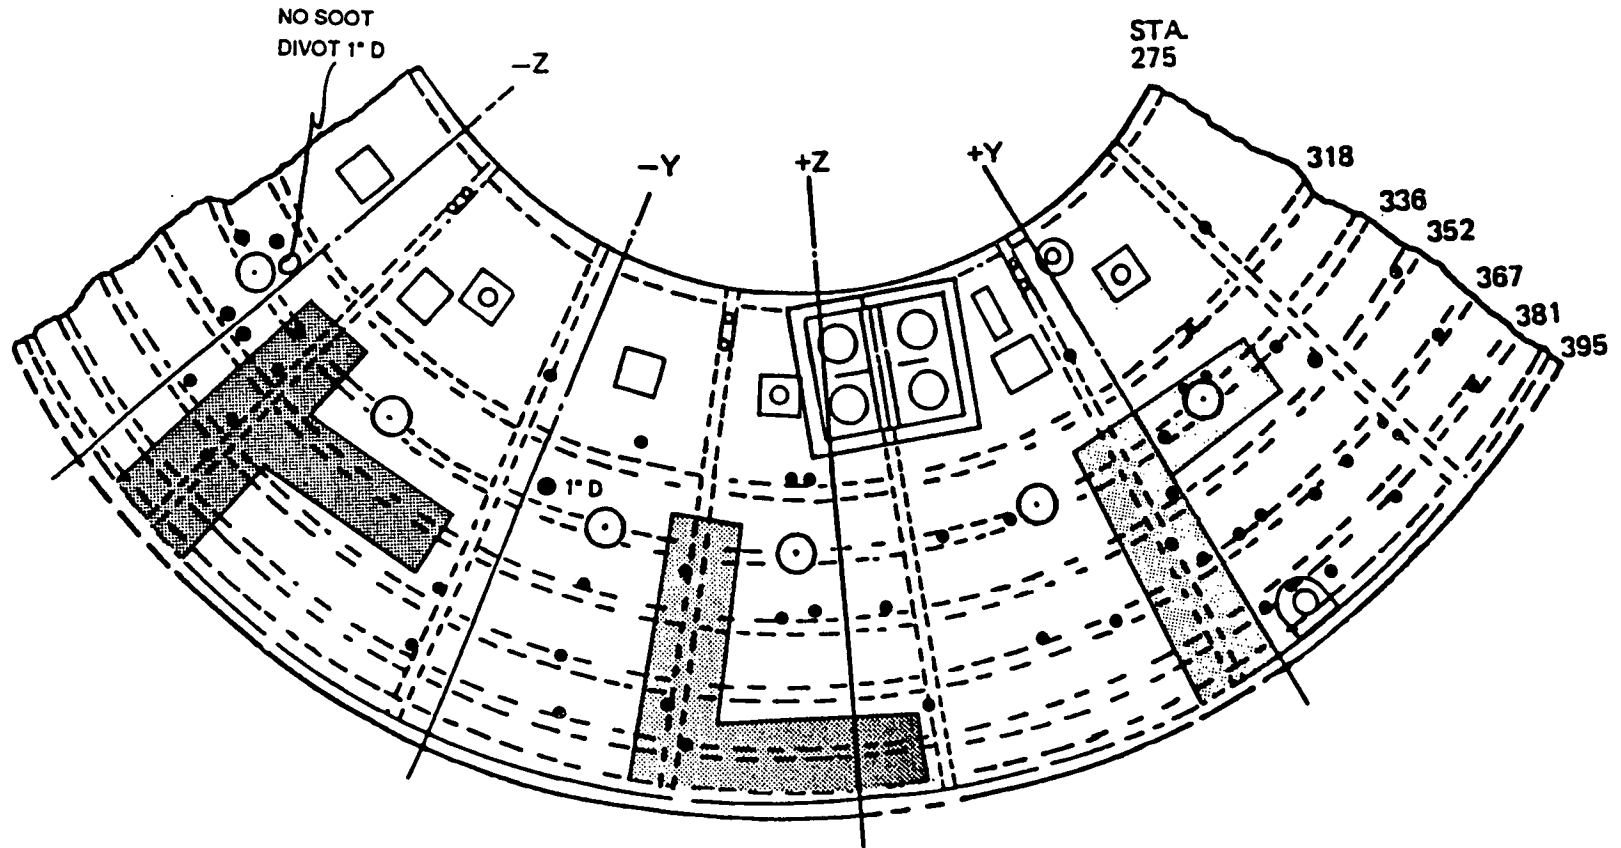
FIGURE 8. LEFT SRB FRUSTUM

The nosecap was not recovered. The LH frustum exhibited no missing TPS but had 54 debonds over fasteners (Figure 8). All of the BSM covers were fully opened and locked in the 180 degree position.

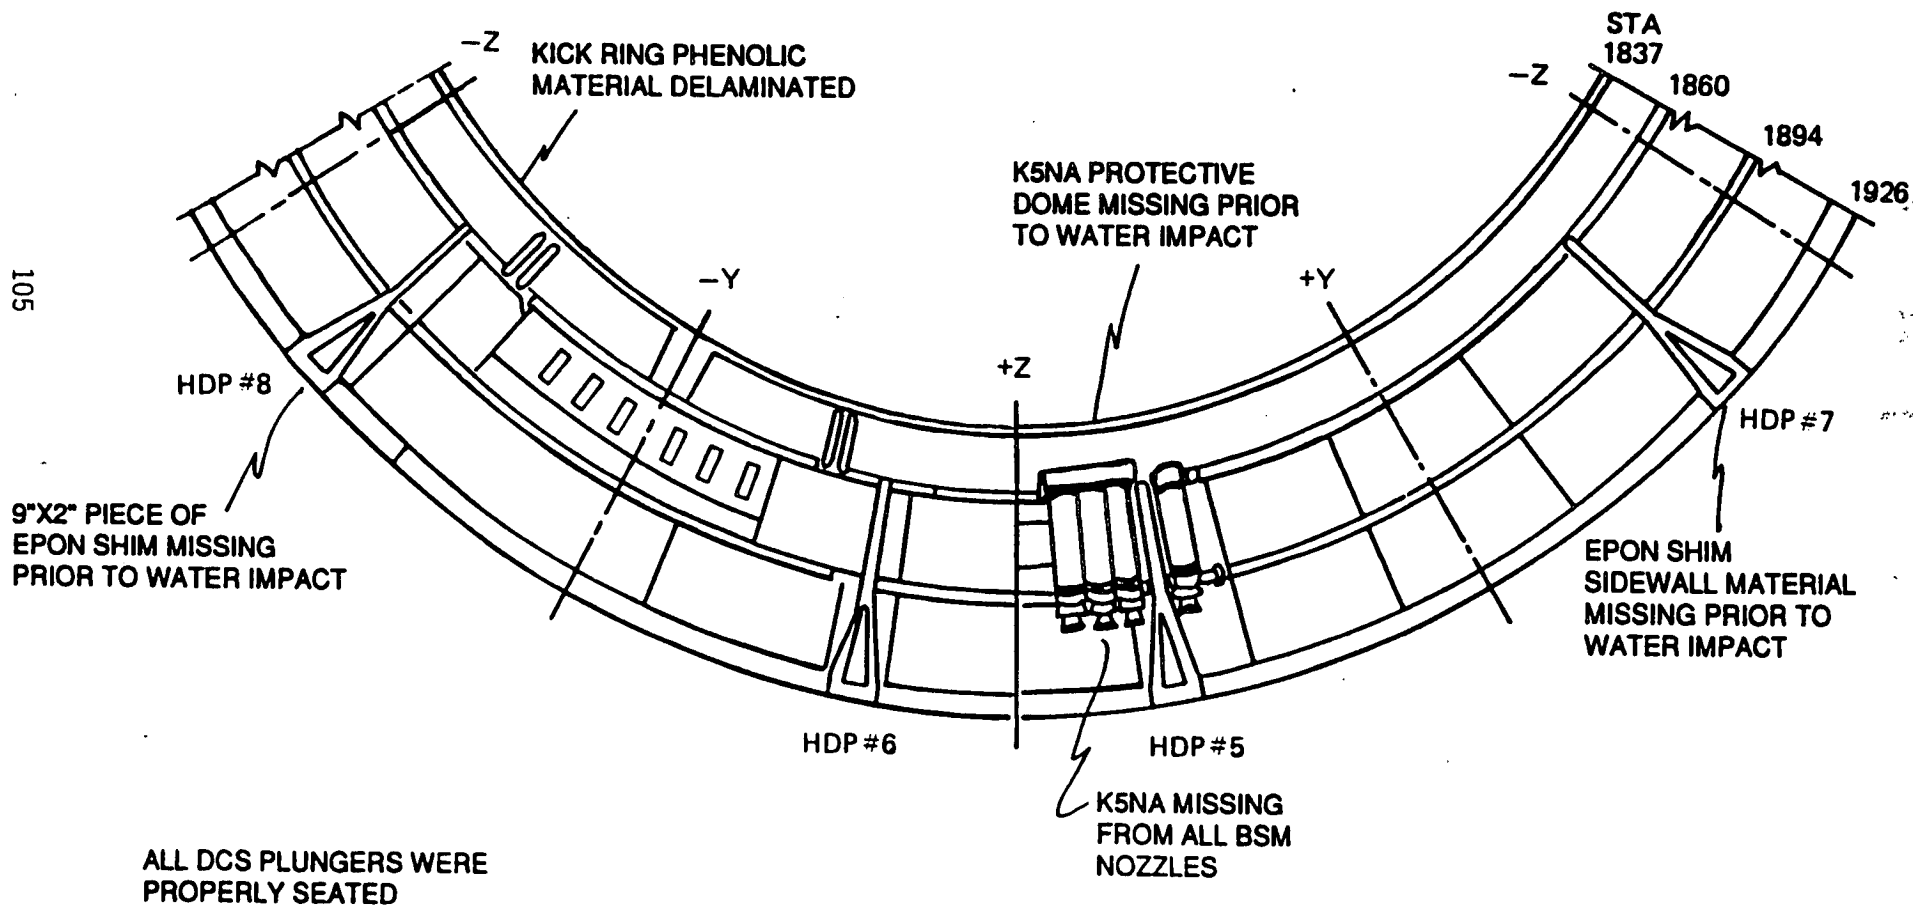
FIGURE 10. LEFT SRB AFT SKIRT EXTERIOR TPS

The TPS over the aft skirt acreage was generally in good condition (Figure 10). The phenolic material on the kick ring delaminated in several locations. K5NA was missing from all aft BSM nozzles. The TVC system appeared undamaged.

All DCS plungers were properly seated. Aft skirt HDP #7 was missing Epon shim from the inboard side of the foot and the substrate was sooted. A 9"x2" piece of HDP #8 aft face shim material was missing prior to water impact. The thermal curtain attach structure and aft skirt aft ring were inspected for damage caused by the suspected loss of a thermal curtain 34 seconds into flight, but no unusual damage was visible. Water impact may have altered any remaining evidence. Instafoam was missing from the aft ring around the aft skirt feet, HPU exhaust horns, and the SRB T-0 umbilical.

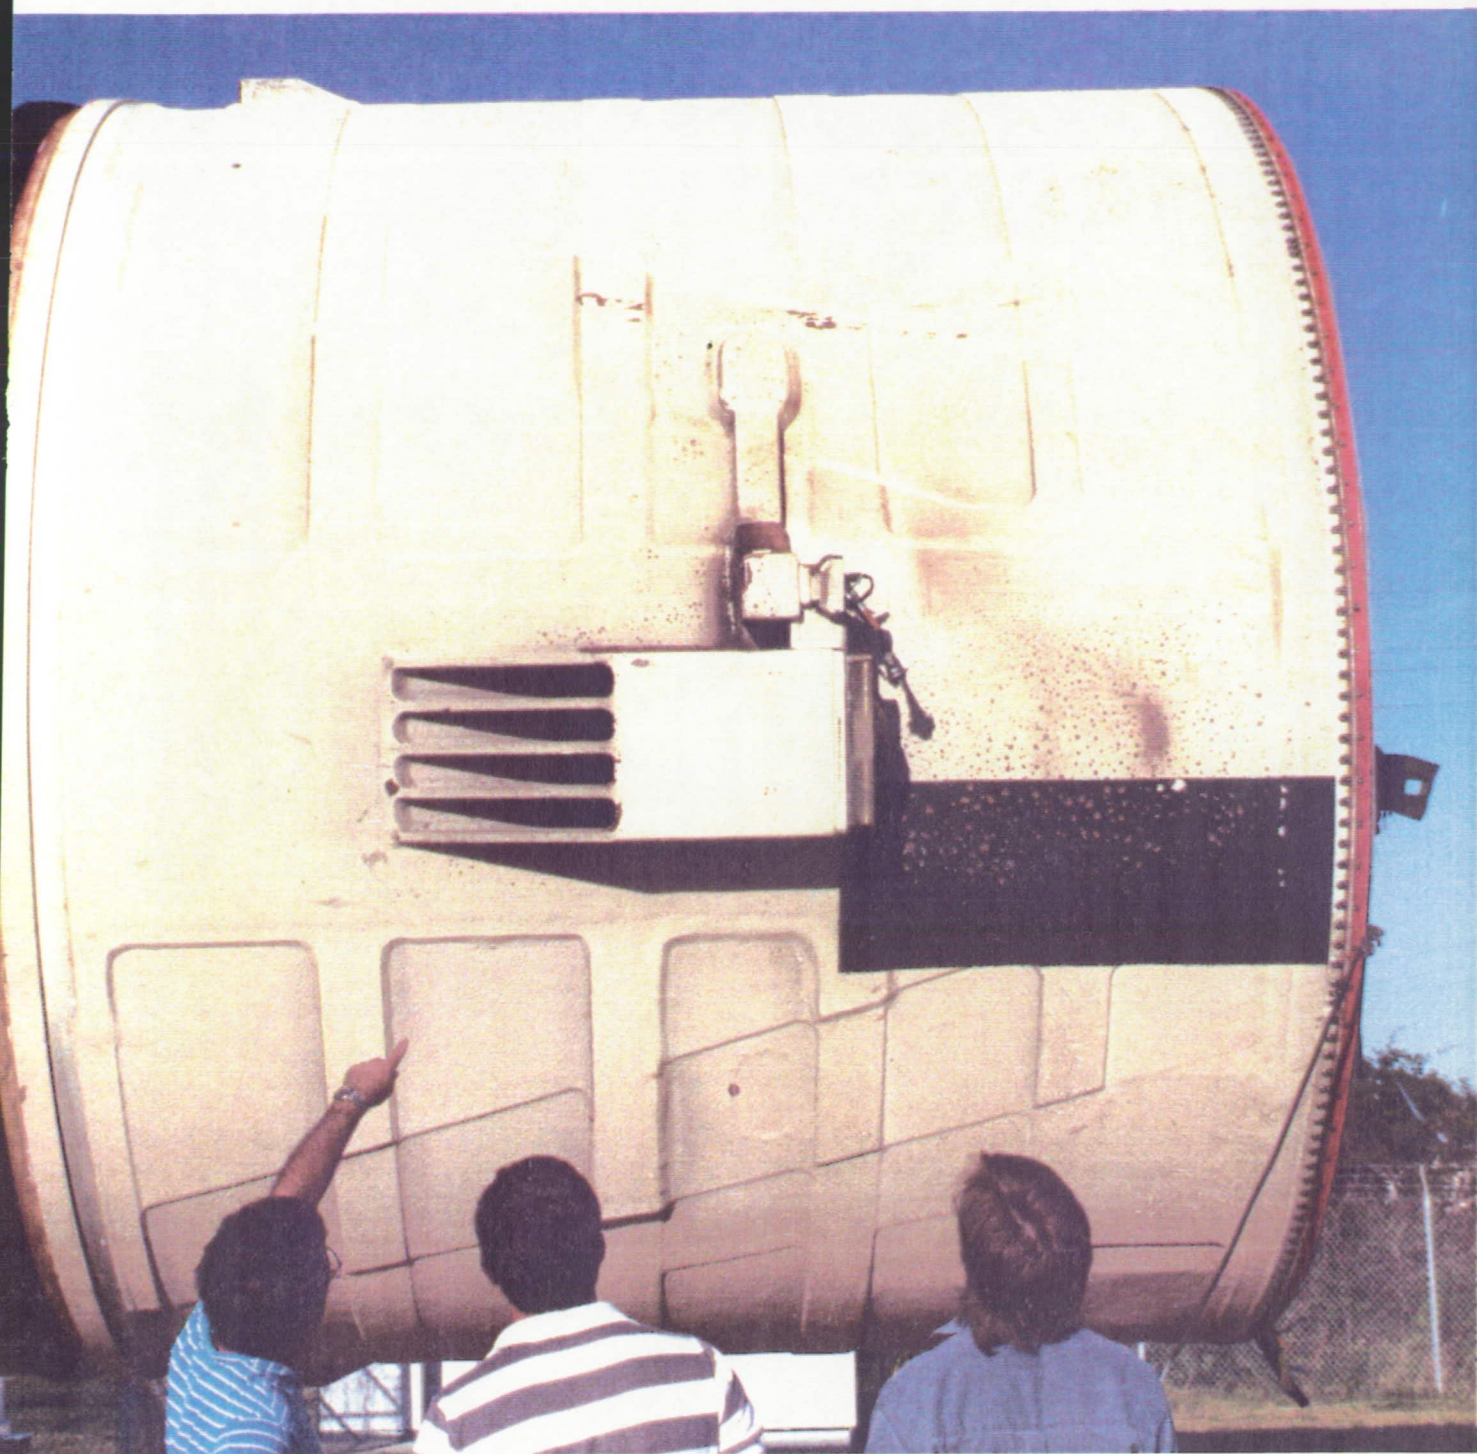
Post flight condition of the RH SRB frustum. There were 56 MSA-2 debonds over fasteners, but no areas of missing TPS

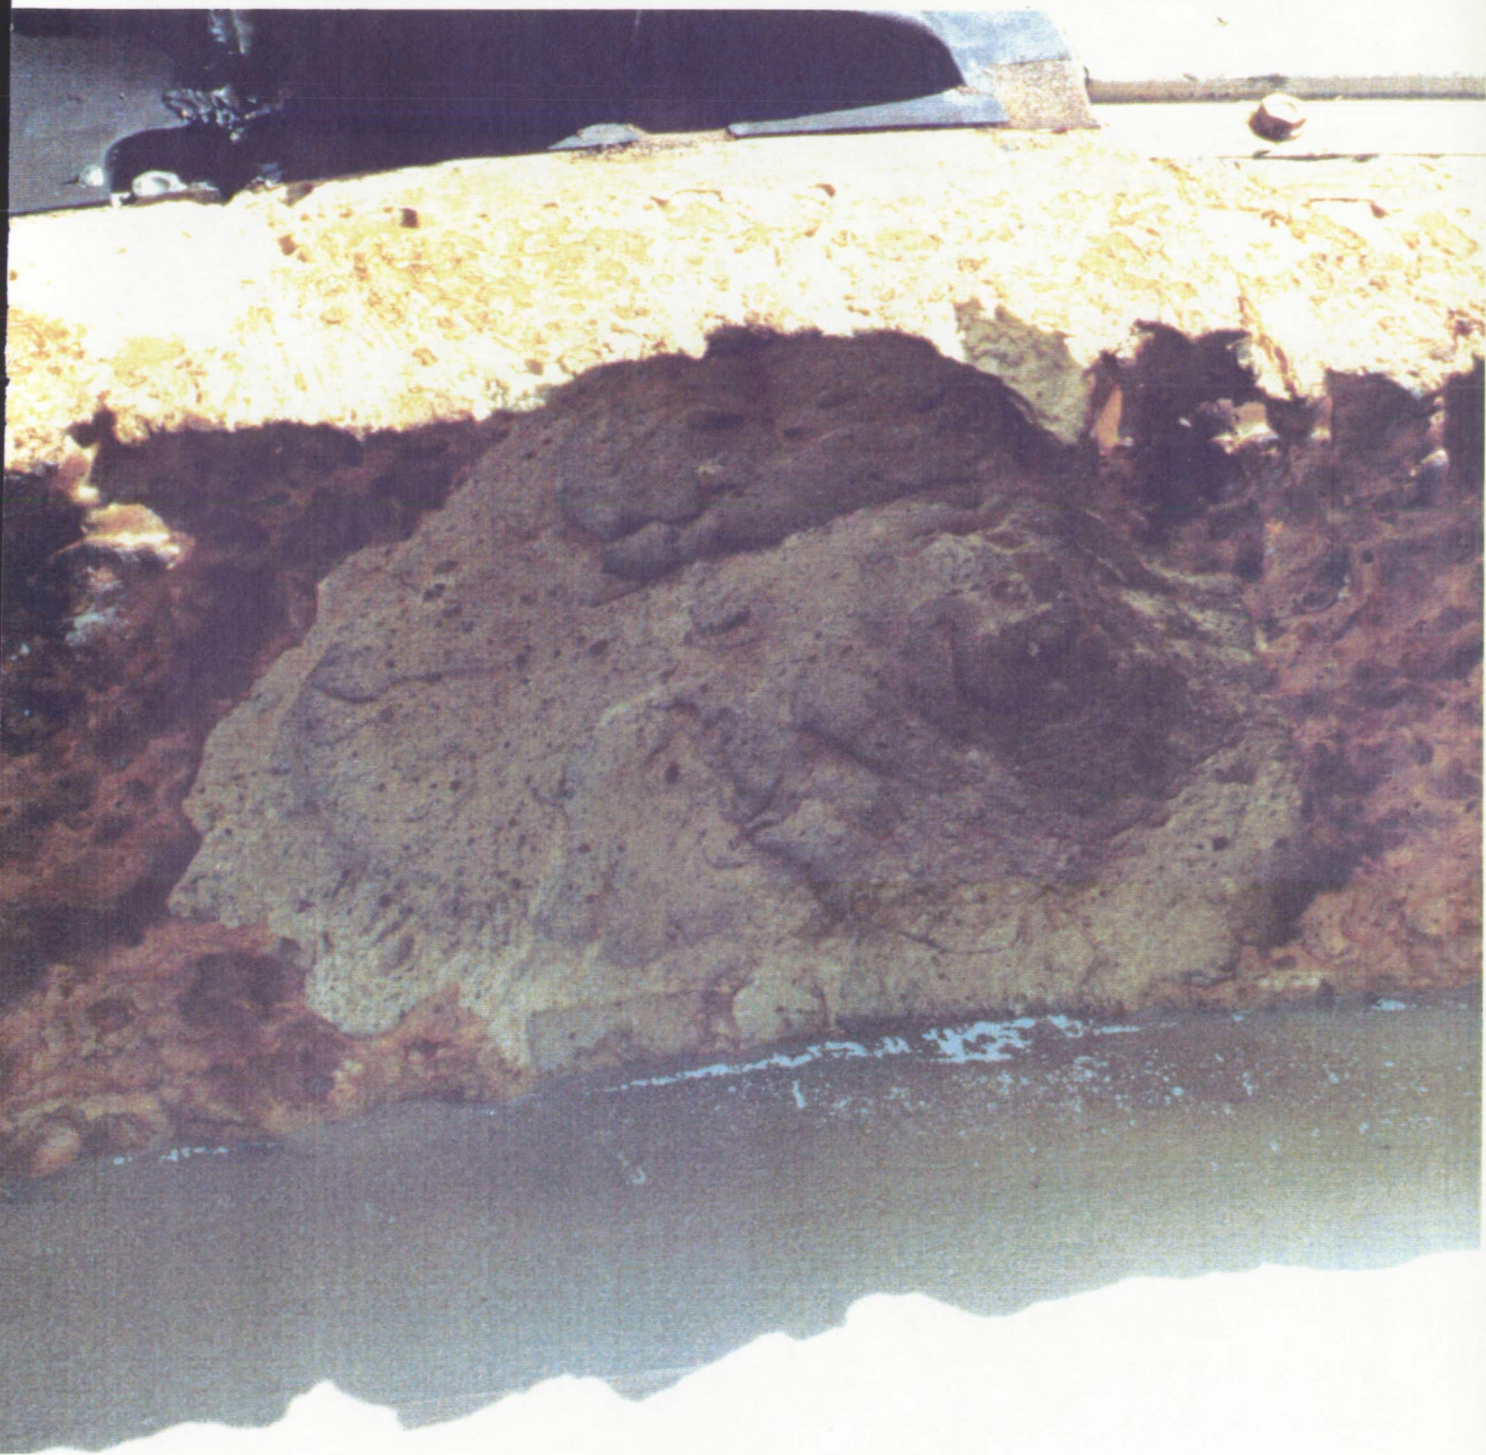
An IFA was taken against a second 8-inch instafoam divot with another 8 inches of delamination on the ETA ring forward side

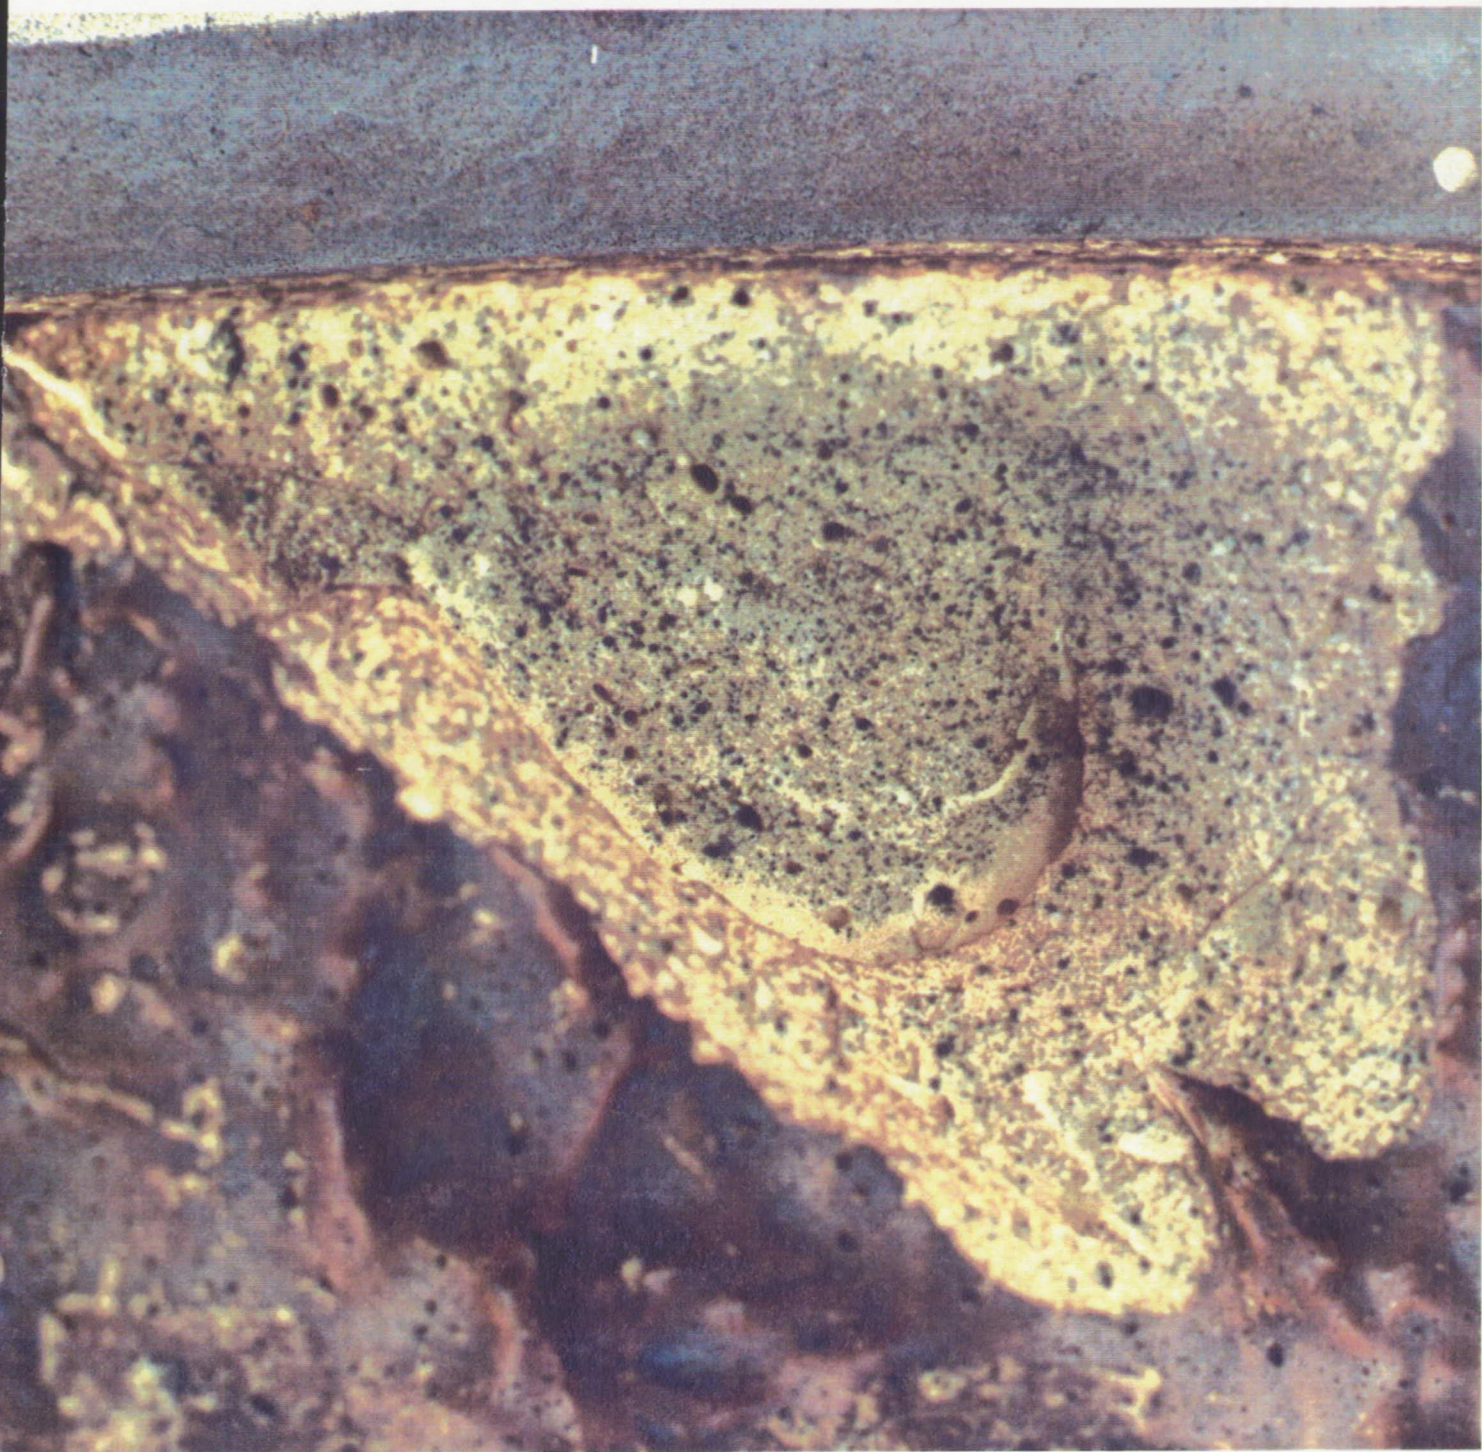
Close-in view of instafoam divot on the ETA ring forward side
