NASA Technical Memorandum TM 103815

Debris/Ice/TPS Assessment And Photographic Analysis For Shuttle Mission STS-38

November 15, 1990

Shuttle mission STS-38 was launched at 6:48 p.m. EST 11/15/90

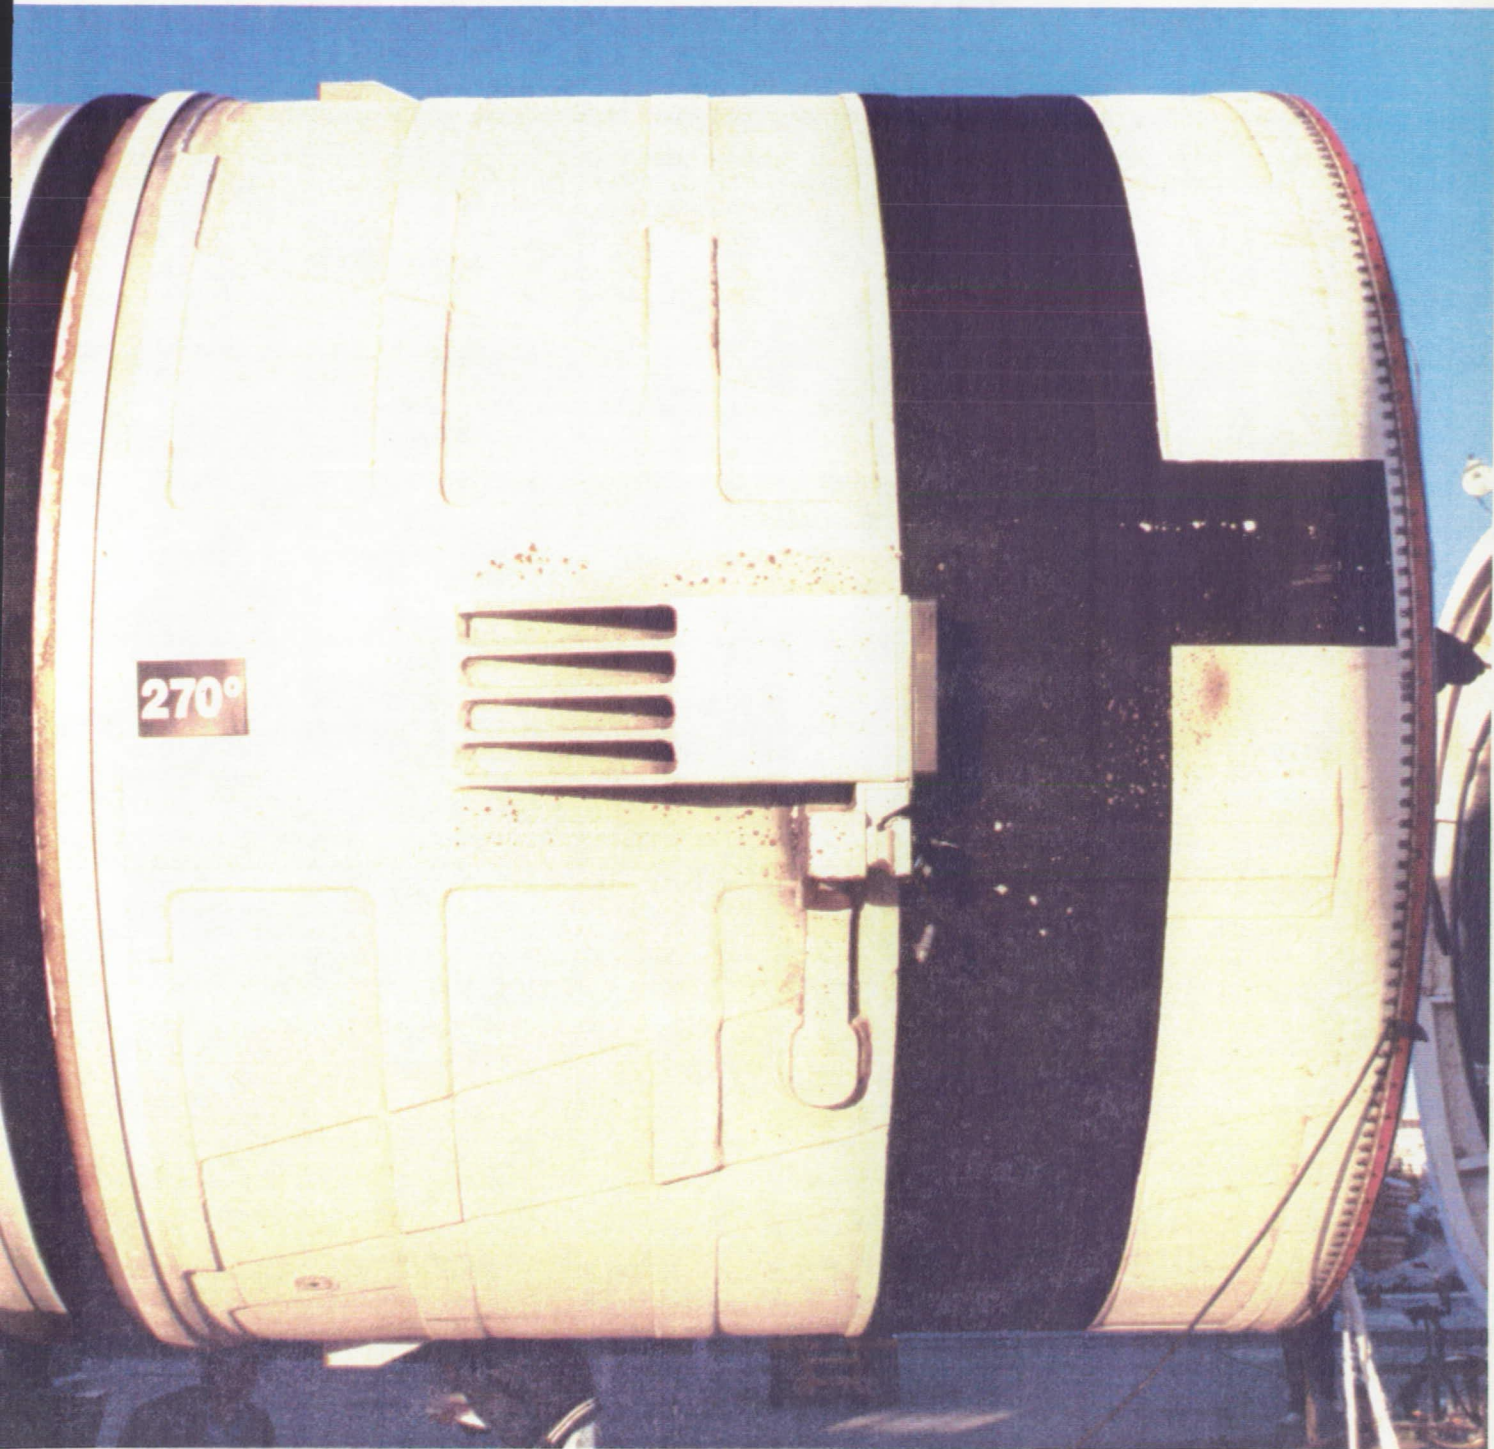
Post flight condition of LH SRB frustum. There were 54 MSA-2 debonds over fasteners, but no areas of missing TPS.

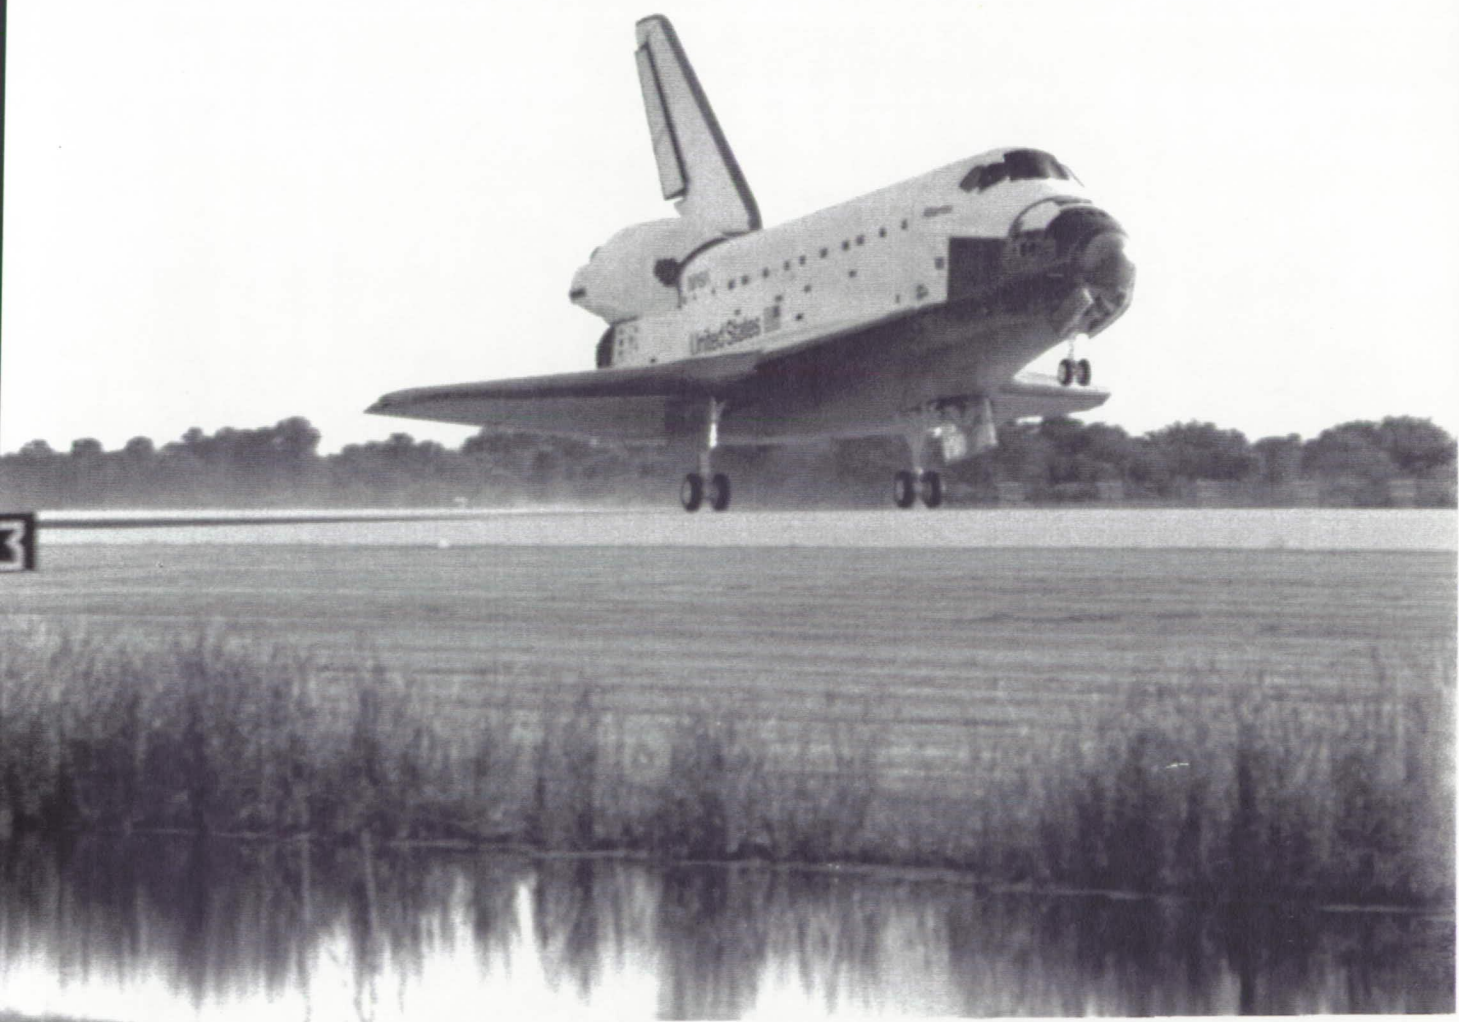
Two pieces of SSME closeout blanket, above the body flap near SSME #2 and outboard of SSME #3, fell aft during final approach

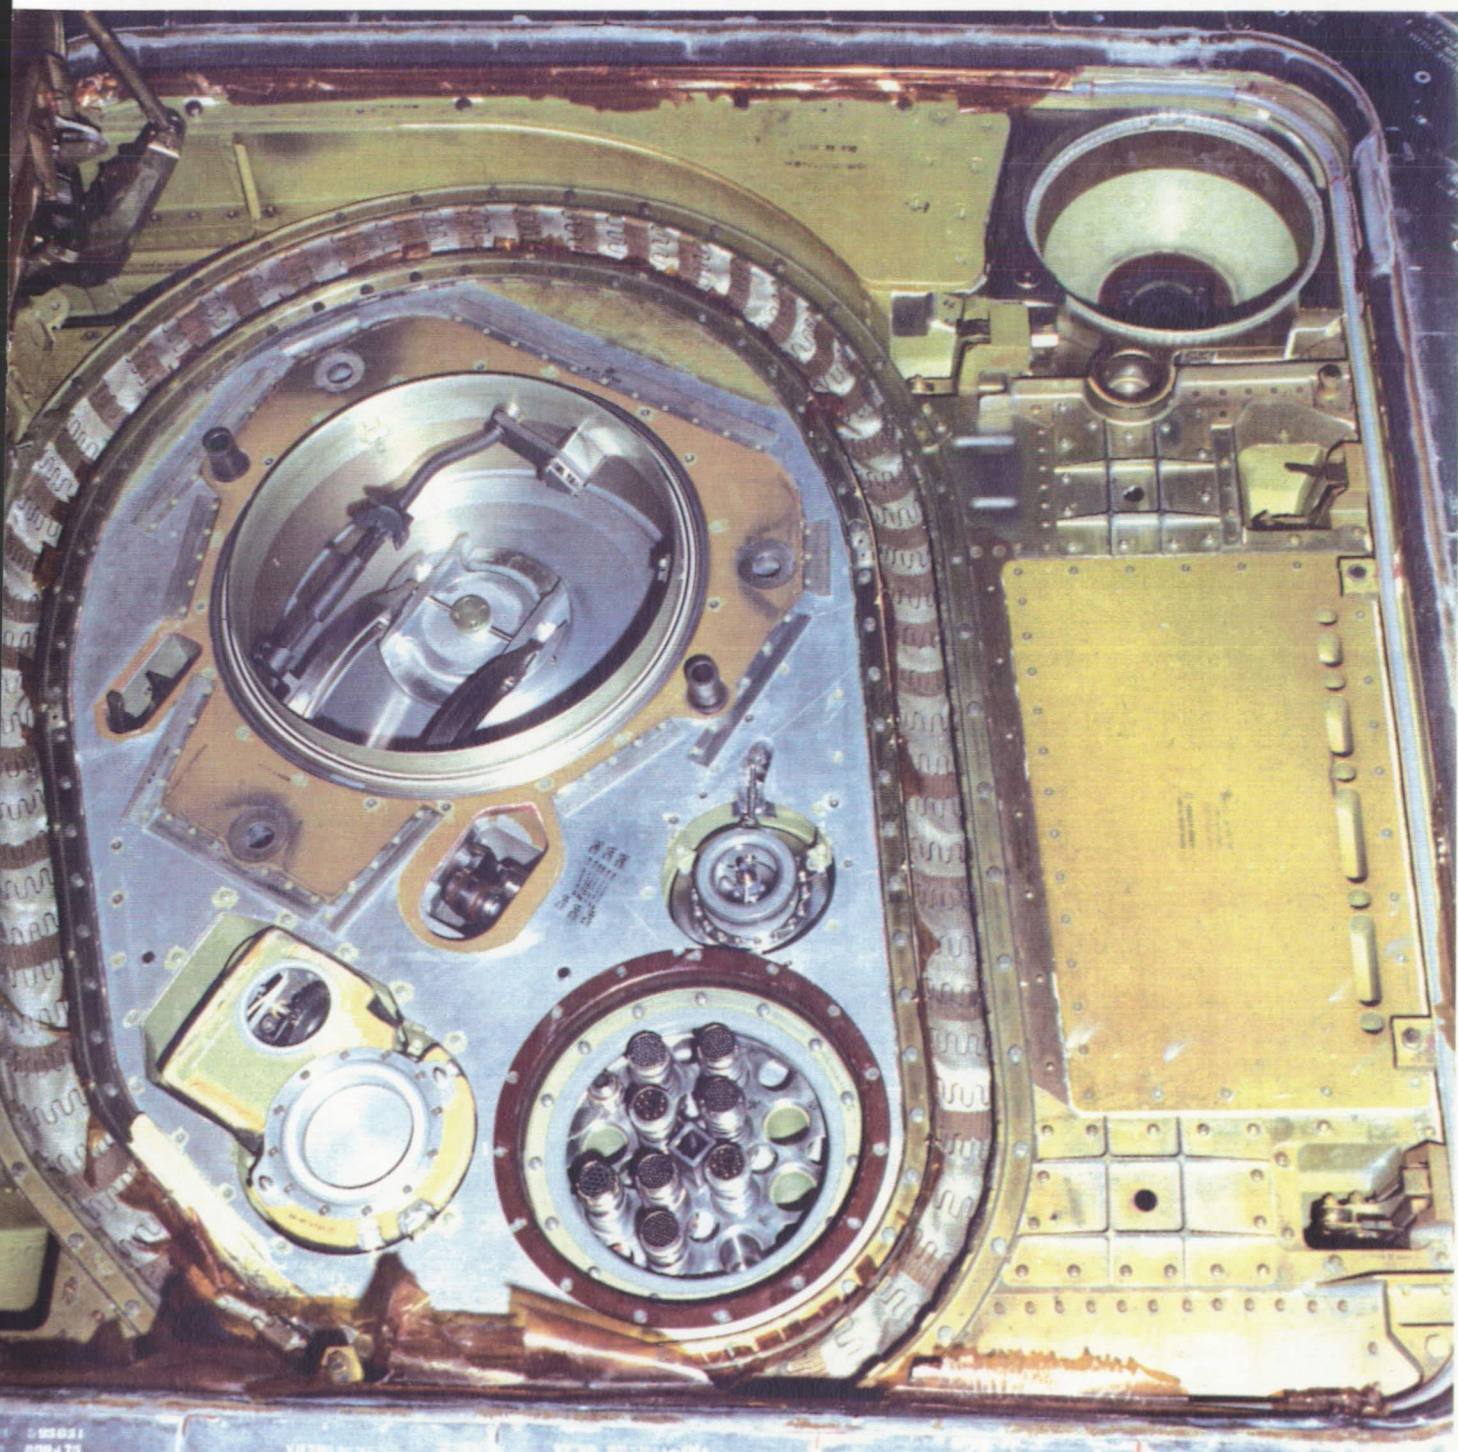
Typical debris impact damage to lower surface tiles

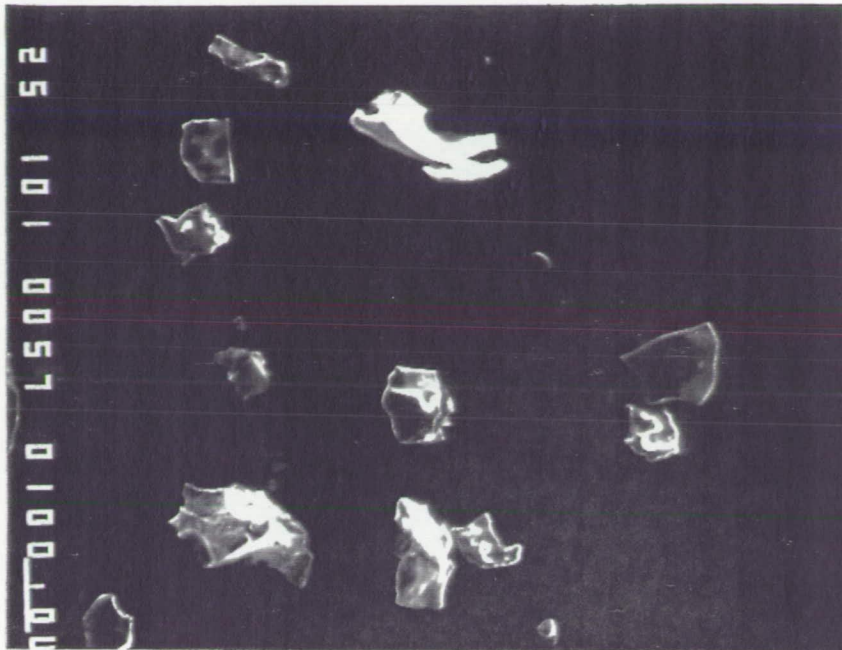
Figure 1. Low magnification SEM photomicrograph of white particles. #3, 100x.

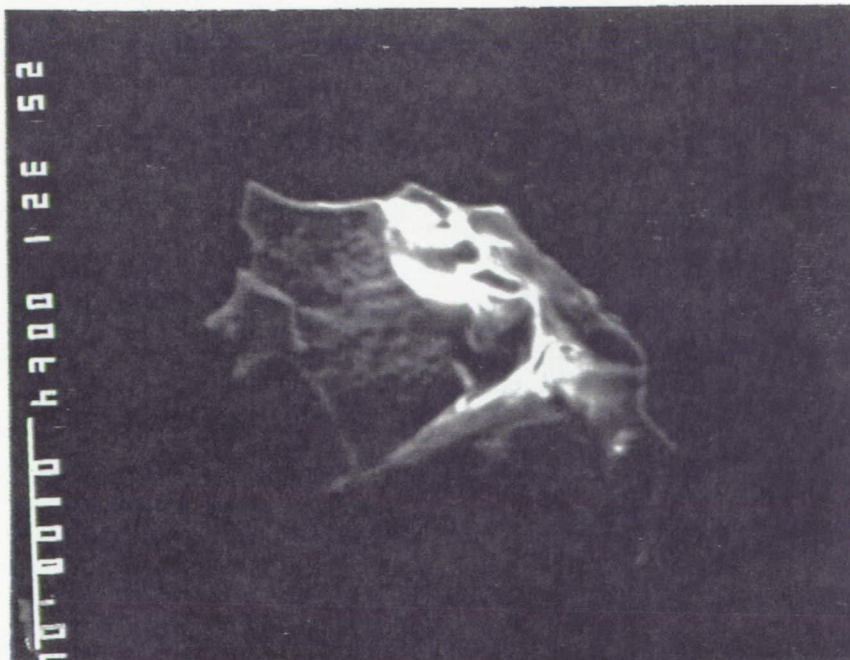
Figure 2. High magnification SEM photomicrograph of white particle from Figure 1. #3. 320x.

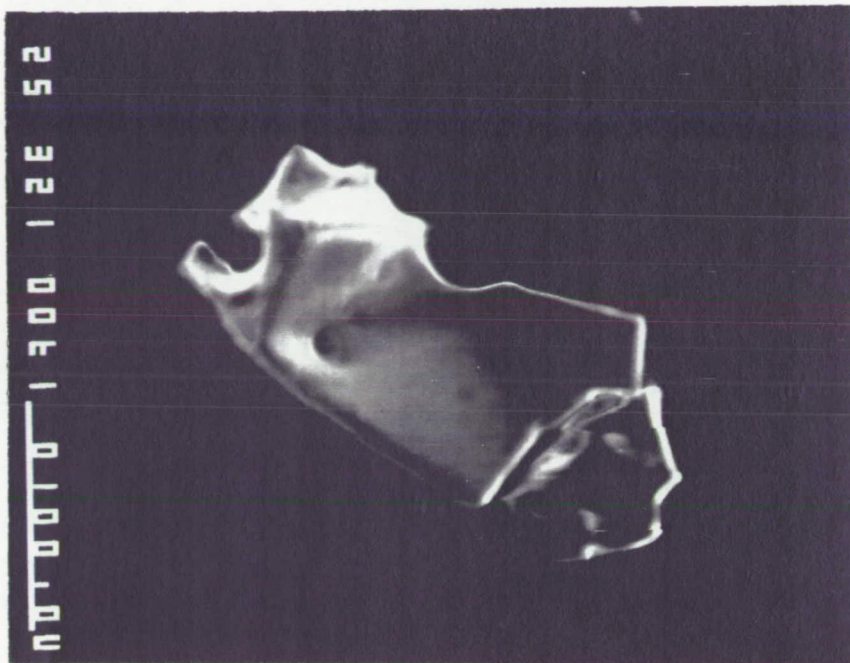
2.2.3 Figures 1, 2, and 3 are low and high magnification SEM photomicrographs of white particles from sample #3 to show the morphological features. Figures 4, 5, and 6 are SEM photomicrographs of white particles from sample #4.

Figure 3. SEM photomicrograph of white particle from Figure 1. #3. 320x. Note the presence of the glossy surface texture.

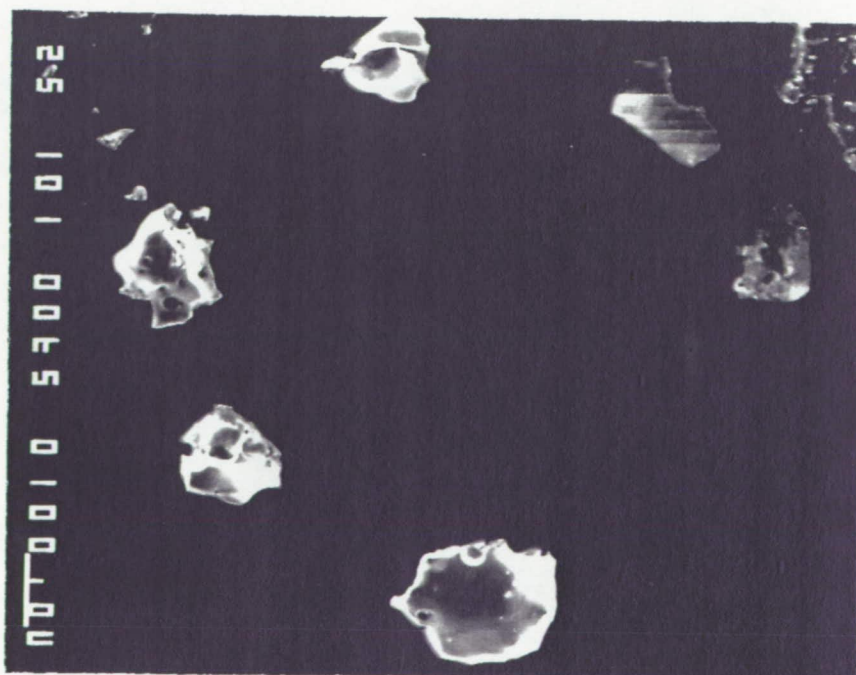
Figure 4. Low magnification SEM photomicrograph of white particles. #4. 100x.

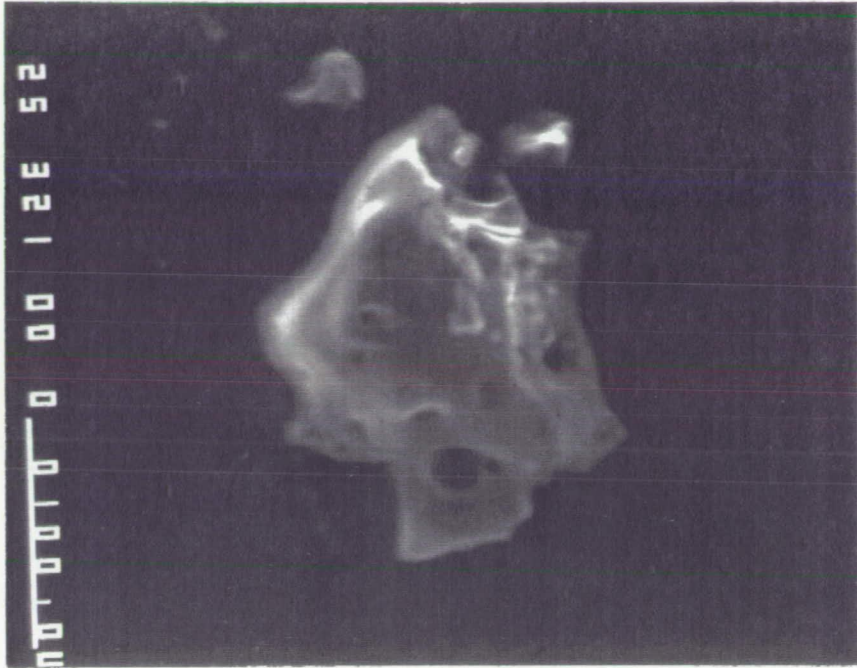
Figure 5. High magnification SEM photomicrograph of white particles to show the morphological characteristics. #4. 320x.

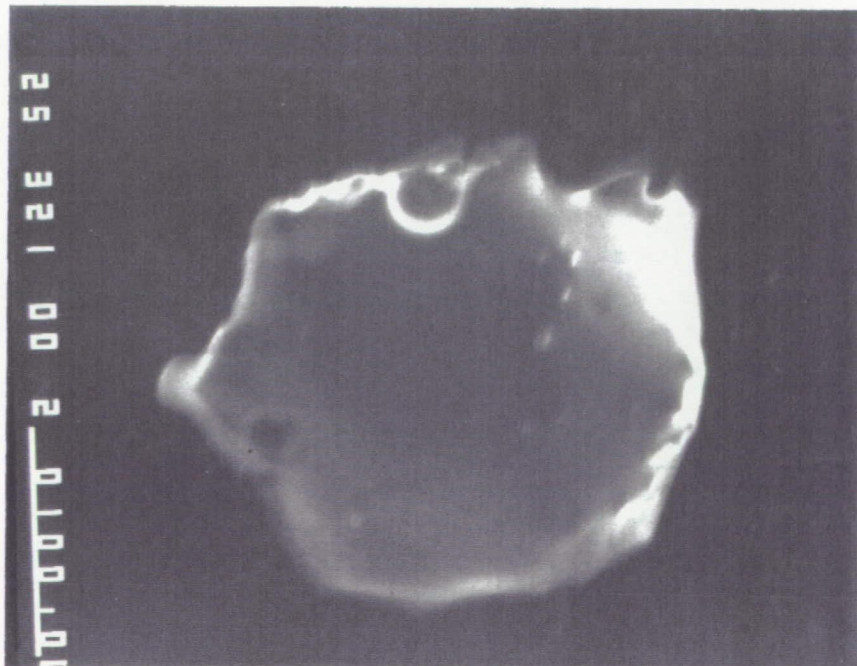
Figure 6. SEM photomicrograph of white particles. #4. 320x.

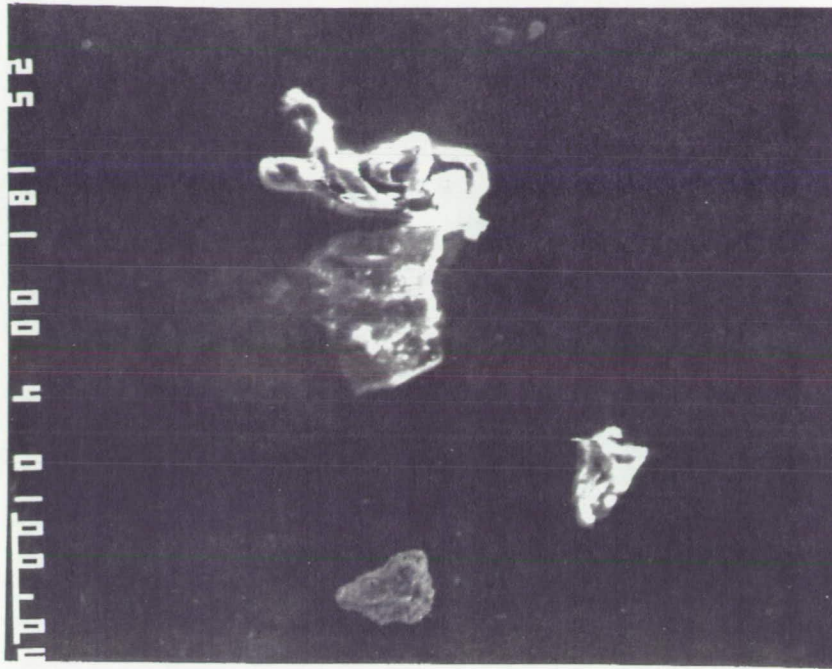
- 2.2.4 Figures 7 and 8 are low and high magnification SEM photomicrographs of Ca-Cl rich particles from sample #5. Figures 9 and 10 are SEM photomicrographs of the Zn-Si rich materials to show the pumaceous surface appearance.

Figure 7. Low magnification SEM photomicrograph of Ca-Cl rich materials. #5. 180x.

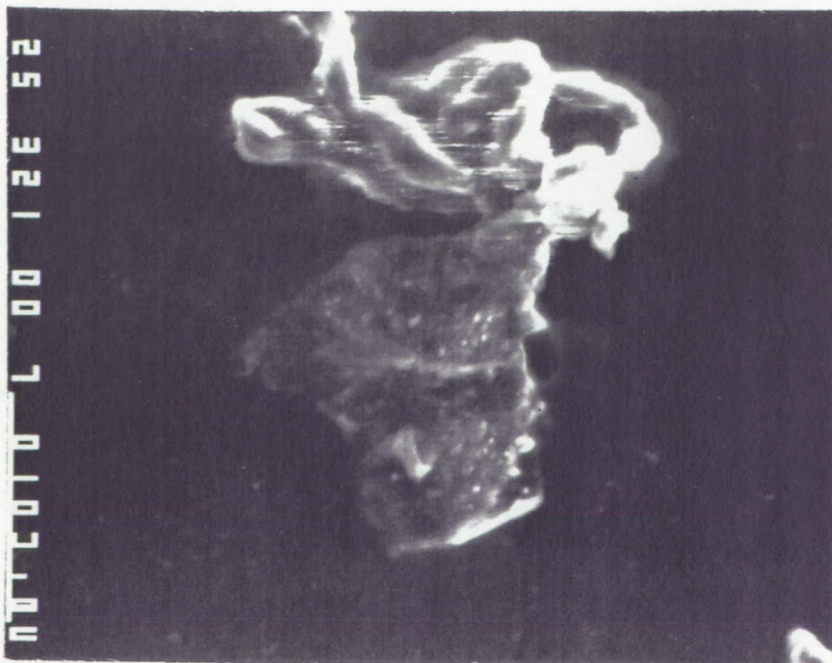
Figure 8. High magnification SEM photomicrograph of the white Ca-Cl rich materials. #5. 360x.

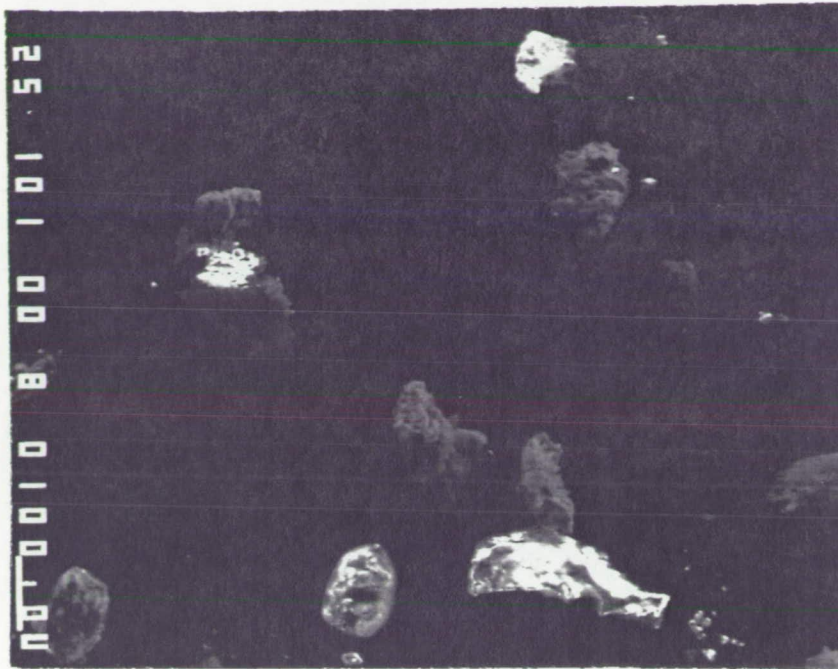
Figure 9. Low magnification SEM photomicrograph of white Zn-Si rich materials. #6. 100x.

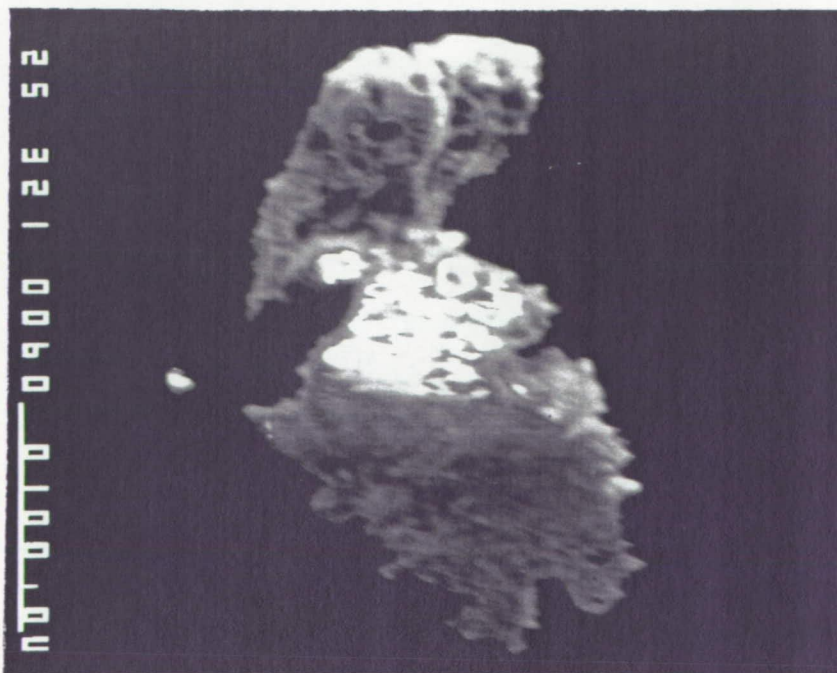
Figure 10. High magnification SEM photomicrograph of the white Zn-Si rich materials. #6. 320x. Note the pumaceous surface appearance.

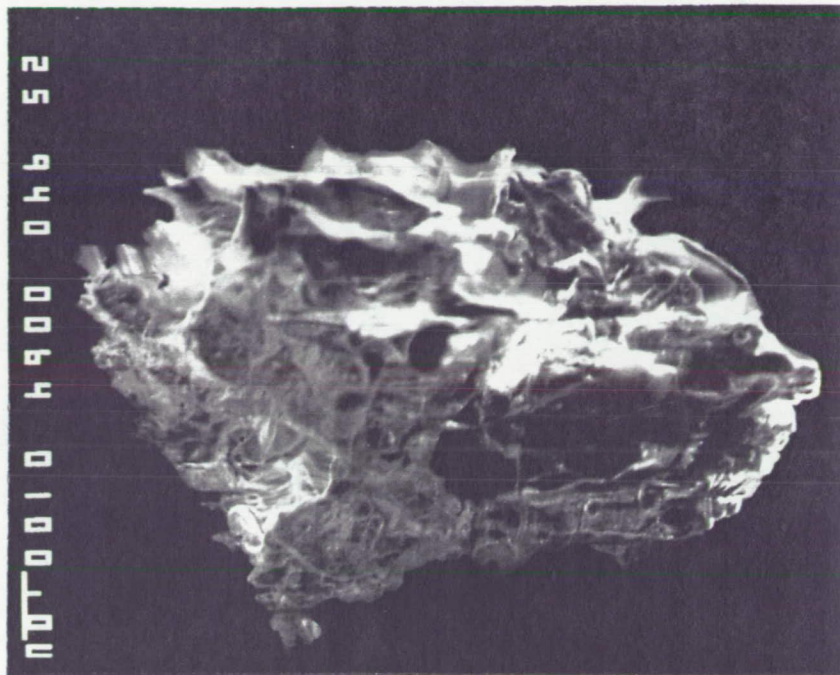
- 3.3 The black pumaceous materials from sample 7 were composed of Si-rich materials. The surface of black pumaceous materials show the melted or fused appearance which might have been at high temperature during reentry (Figures 11 and 12).
- 3.4 The white materials from sample 8 were composed of Si-Al rich TPS. The fused appearance of the particle surface can be seen from Figure 12.
- 3.5 Sample 9, "Elephant hide" ensolite foam, was composed of unknown organics with calcite (CaCO_3), rutile (TiO_2), senarmonite (Sb_2O_3) and possibly SiC.
- 3.6 The EDS data suggested that the white streaks could be originated from the hypalon paints.

Figure 11. Low magnification SEM photomicrograph of the black pumaceous Si rich materials. #7. 94x.

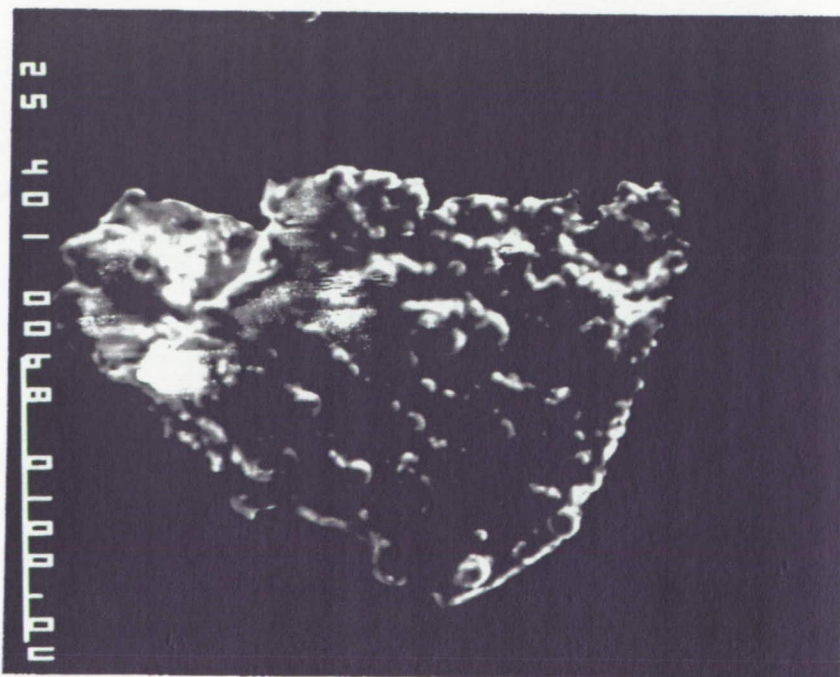
Figure 12. High magnification SEM photomicrograph of white particles. #8. 400x. Note the fused surface appearance.
