TWR-17591, Volume IV

QM-8 FINAL PERFORMANCE EVALUATION REPORT - SEALS

June 1989

***Thiokol* CORPORATION**
SPACE OPERATIONS

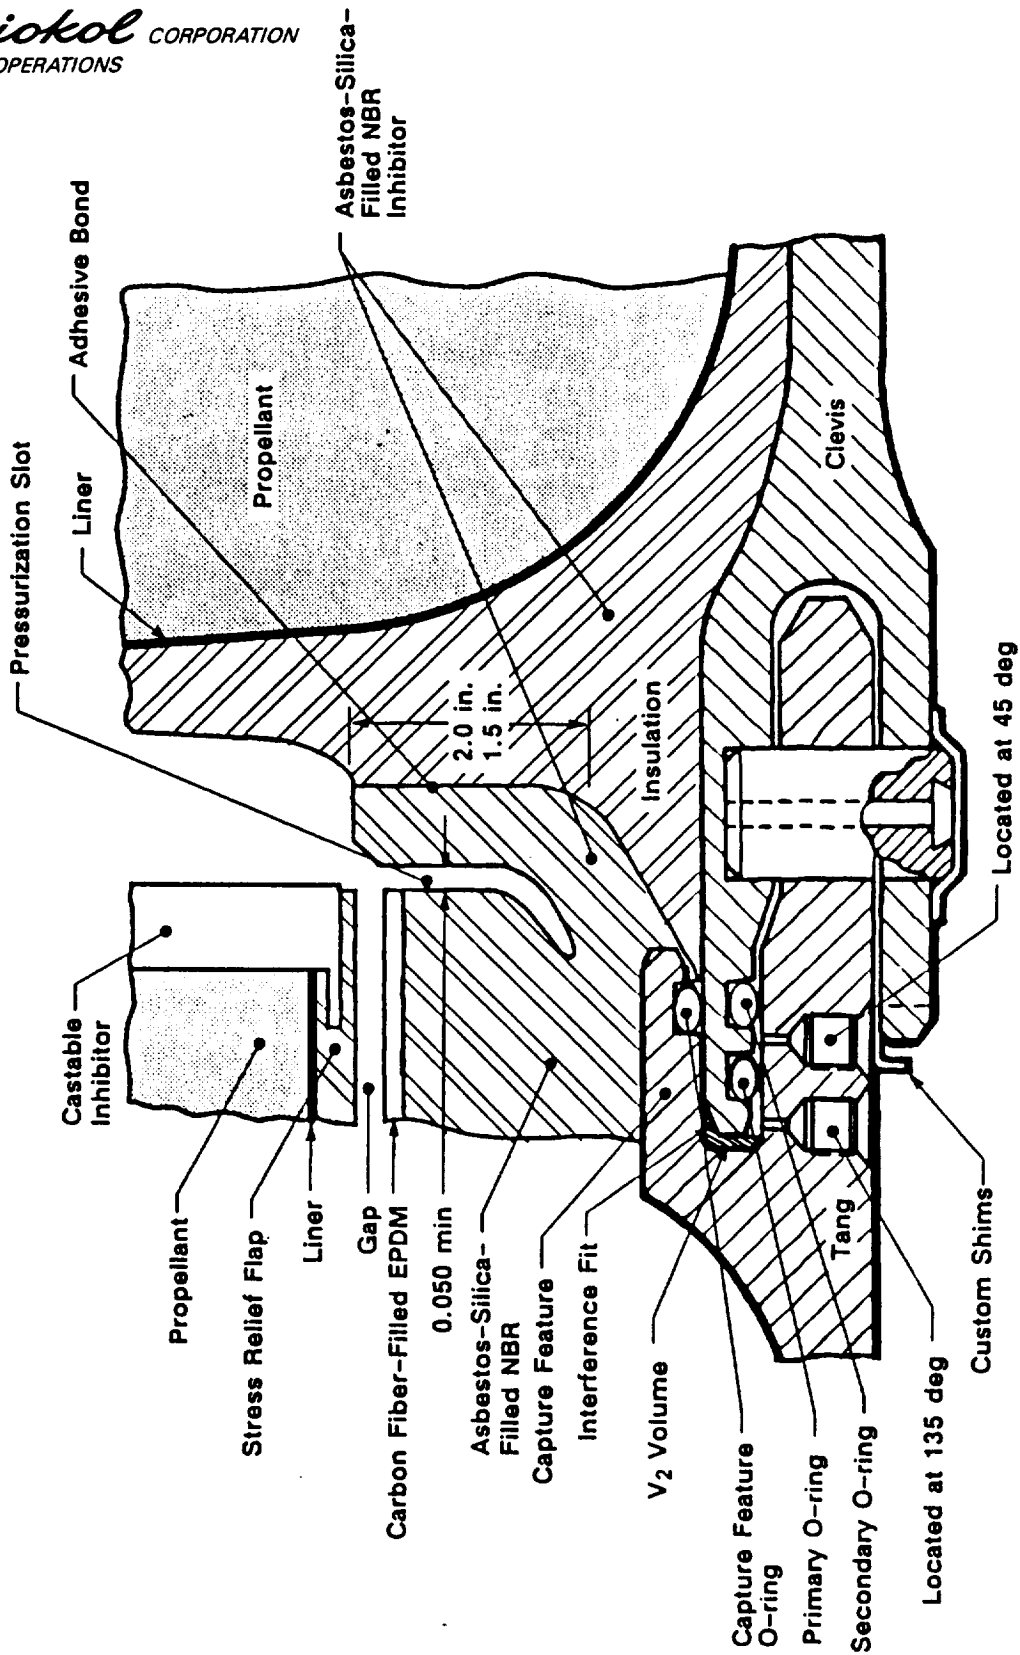
Figure 2 QM-8 Assembled Field Joint

The QM-8 field joint configuration is shown in Figure 2. Joint conditions were as expected; there was no field joint O-ring damage found by inspection at the time of disassembly. The V2 filler did not obstruct the

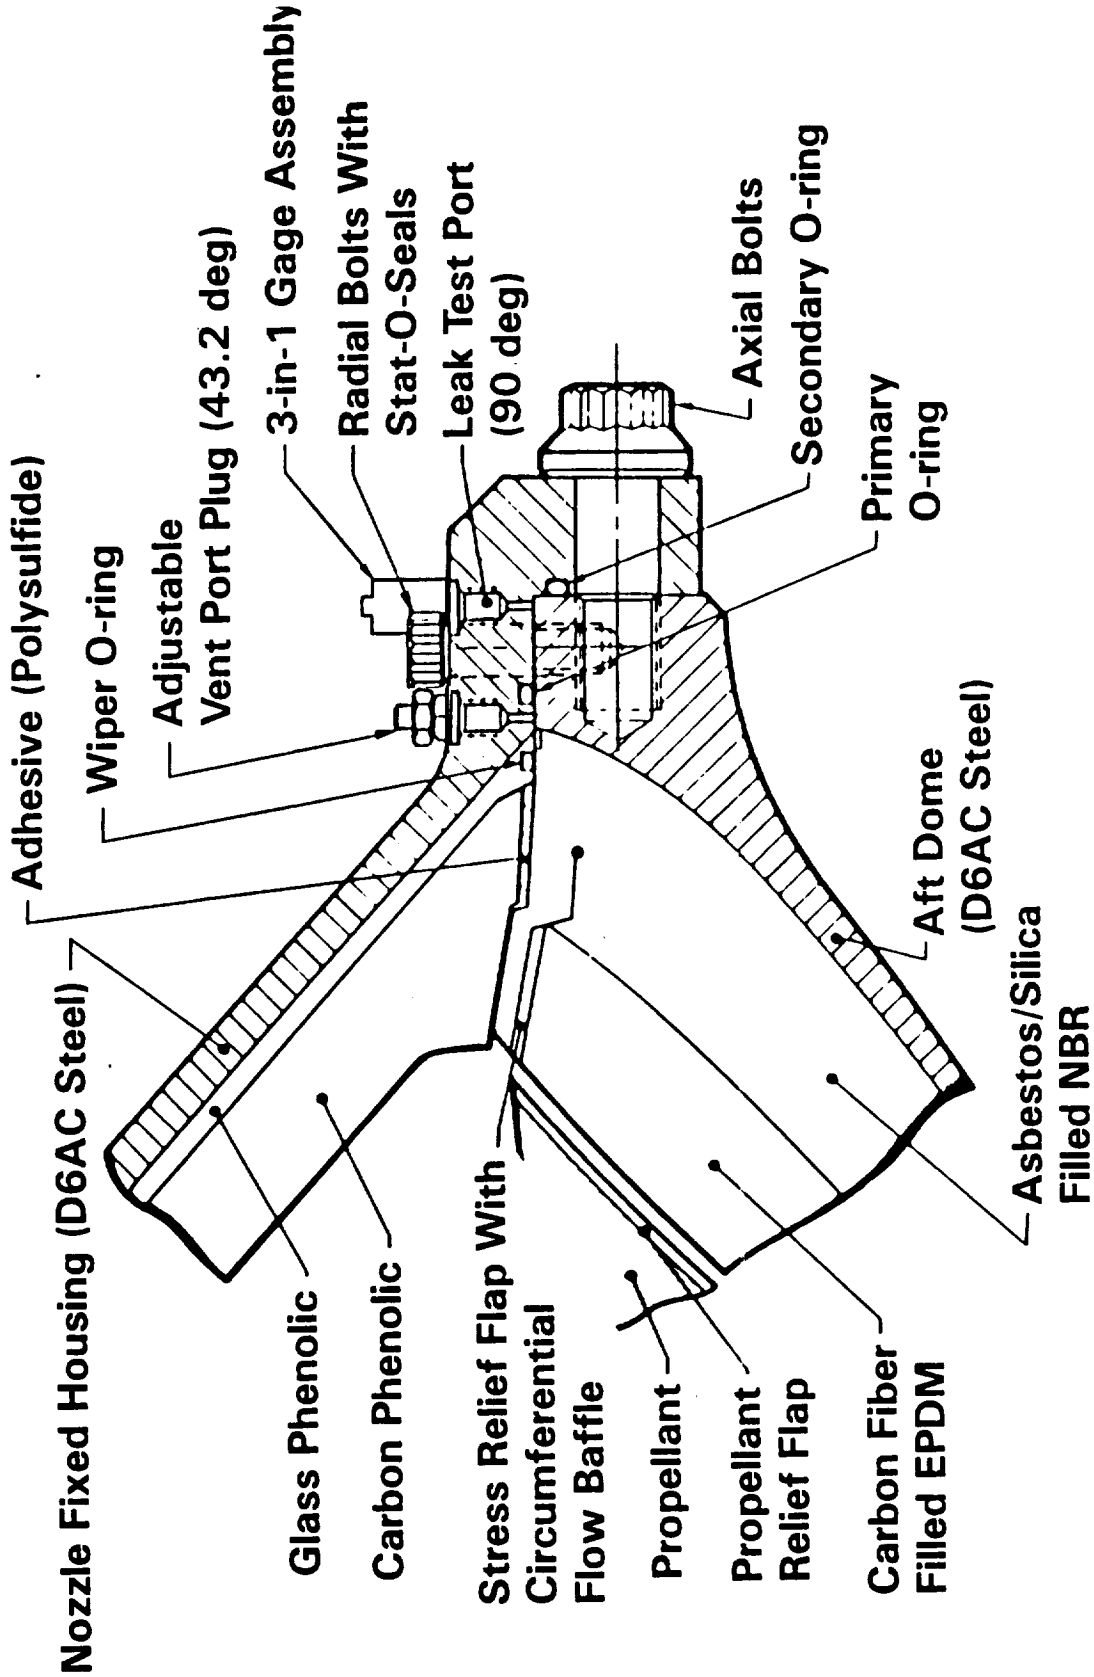
Figure 3 QM-8 Assembled Nozzle-to-Case Joint

The QM-8 nozzle-to-case joint (see Figure 3) was disassembled on 13 February 1989 (see pages A-18 through A-22, Appendix A). The overall condition of the joint was excellent. No hot gas or soot was observed past the polysulfide. There was no corrosion or metal damage found.

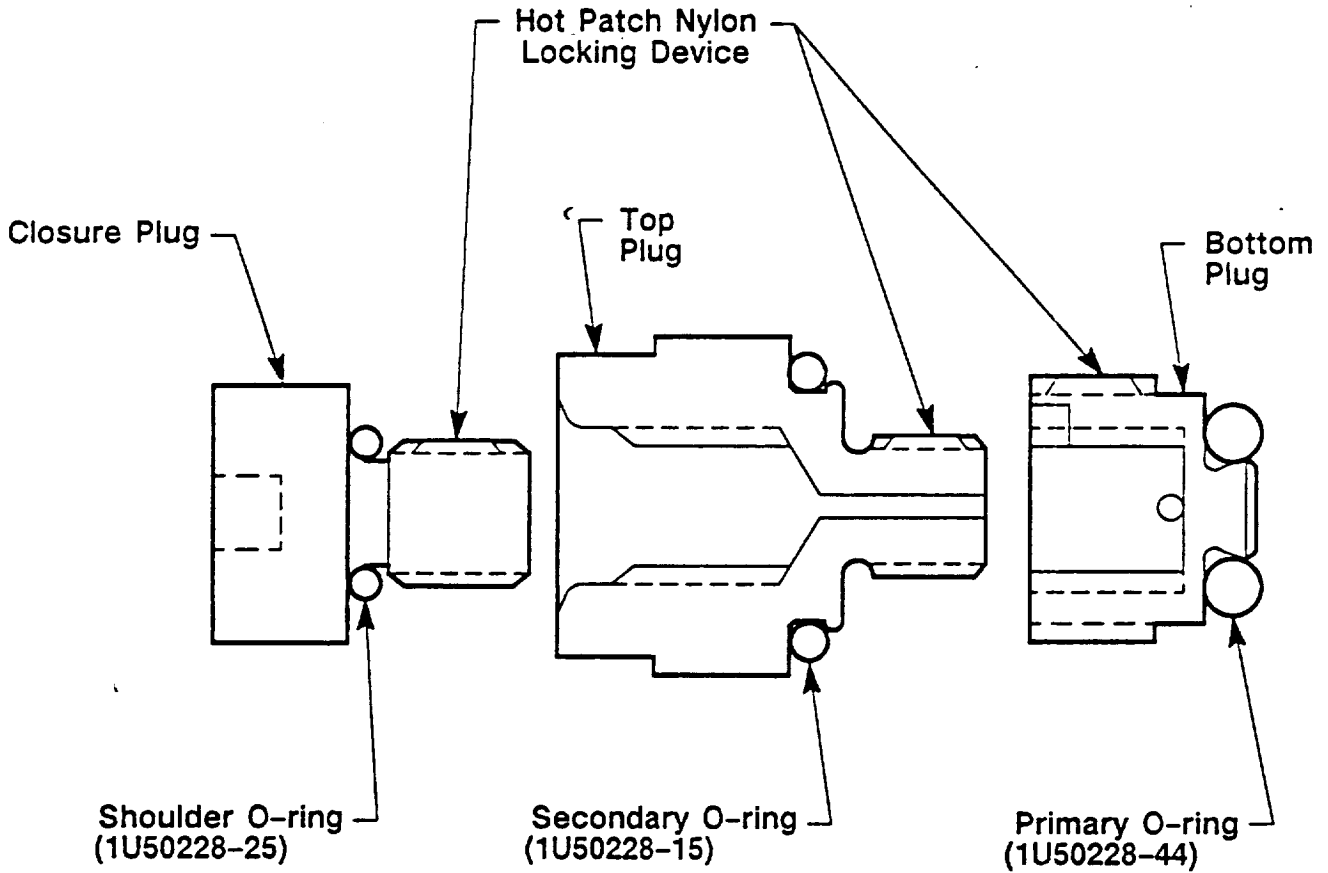
Figure 7 Adjustable Vent Port Plug

The adjustable vent port plug (AVPP), illustrated in Figure 7, was tested in QM-8. Four AVPPs were successfully installed in the case field joints and the nozzle-to-case joint vent ports at 135 and 43.2 degrees, respectively. A 2U132133 (8U76549) installation tool, shown in Figure 8, was used to install the bottom portion of the AVPPs in the vent ports. Each AVPP was installed per STW7-3499 (see Reference 8) and leak checked per STW7-3661 (see Reference 9).

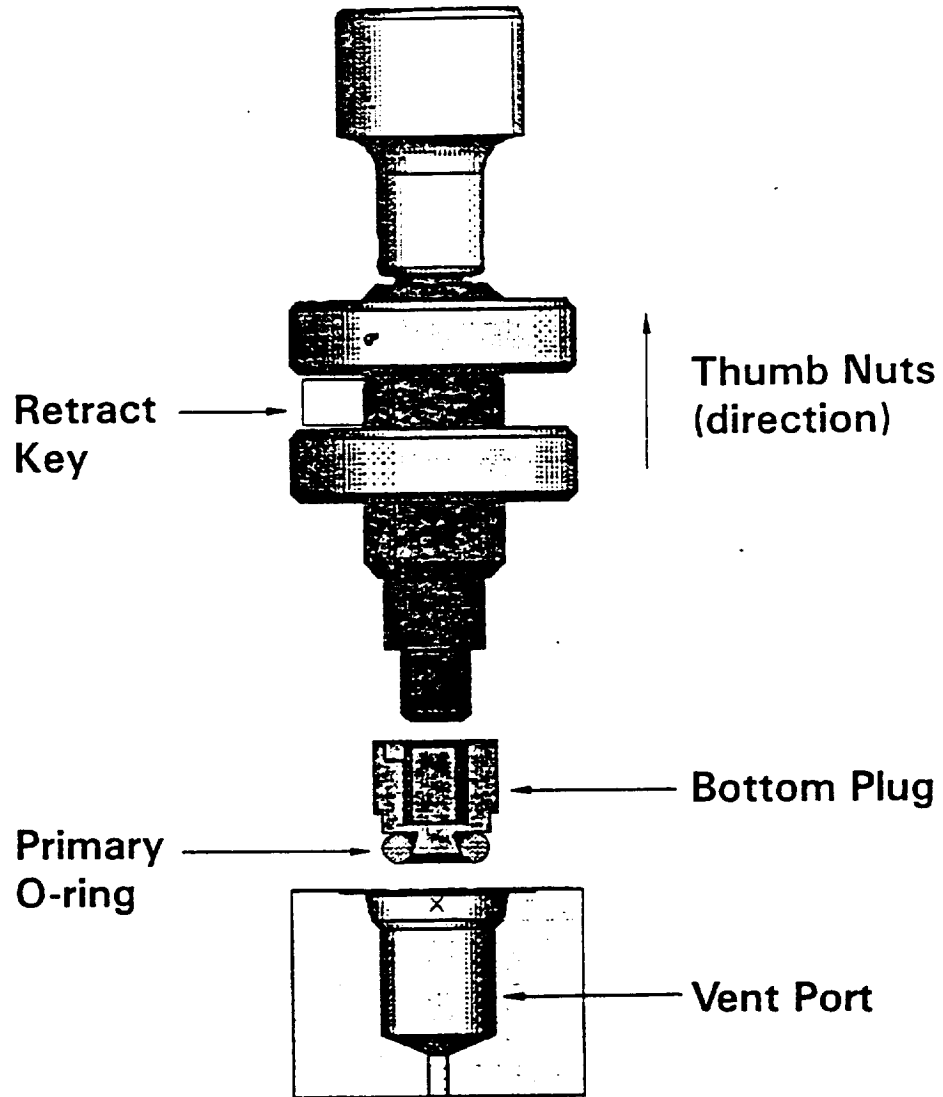
Figure 8 Bottom Plug Installation Setup

All bottom sections of the plugs were installed correctly with the installation tool. However, three bottom sections had to be replaced when the tool slipped causing raised metal on the bottom section. This problem was a result of inadequate training in the use of the tool, not the tool design (see Section 3.5). Objective CQ was met.

The tool size and weight are acceptable (see Figure 8).

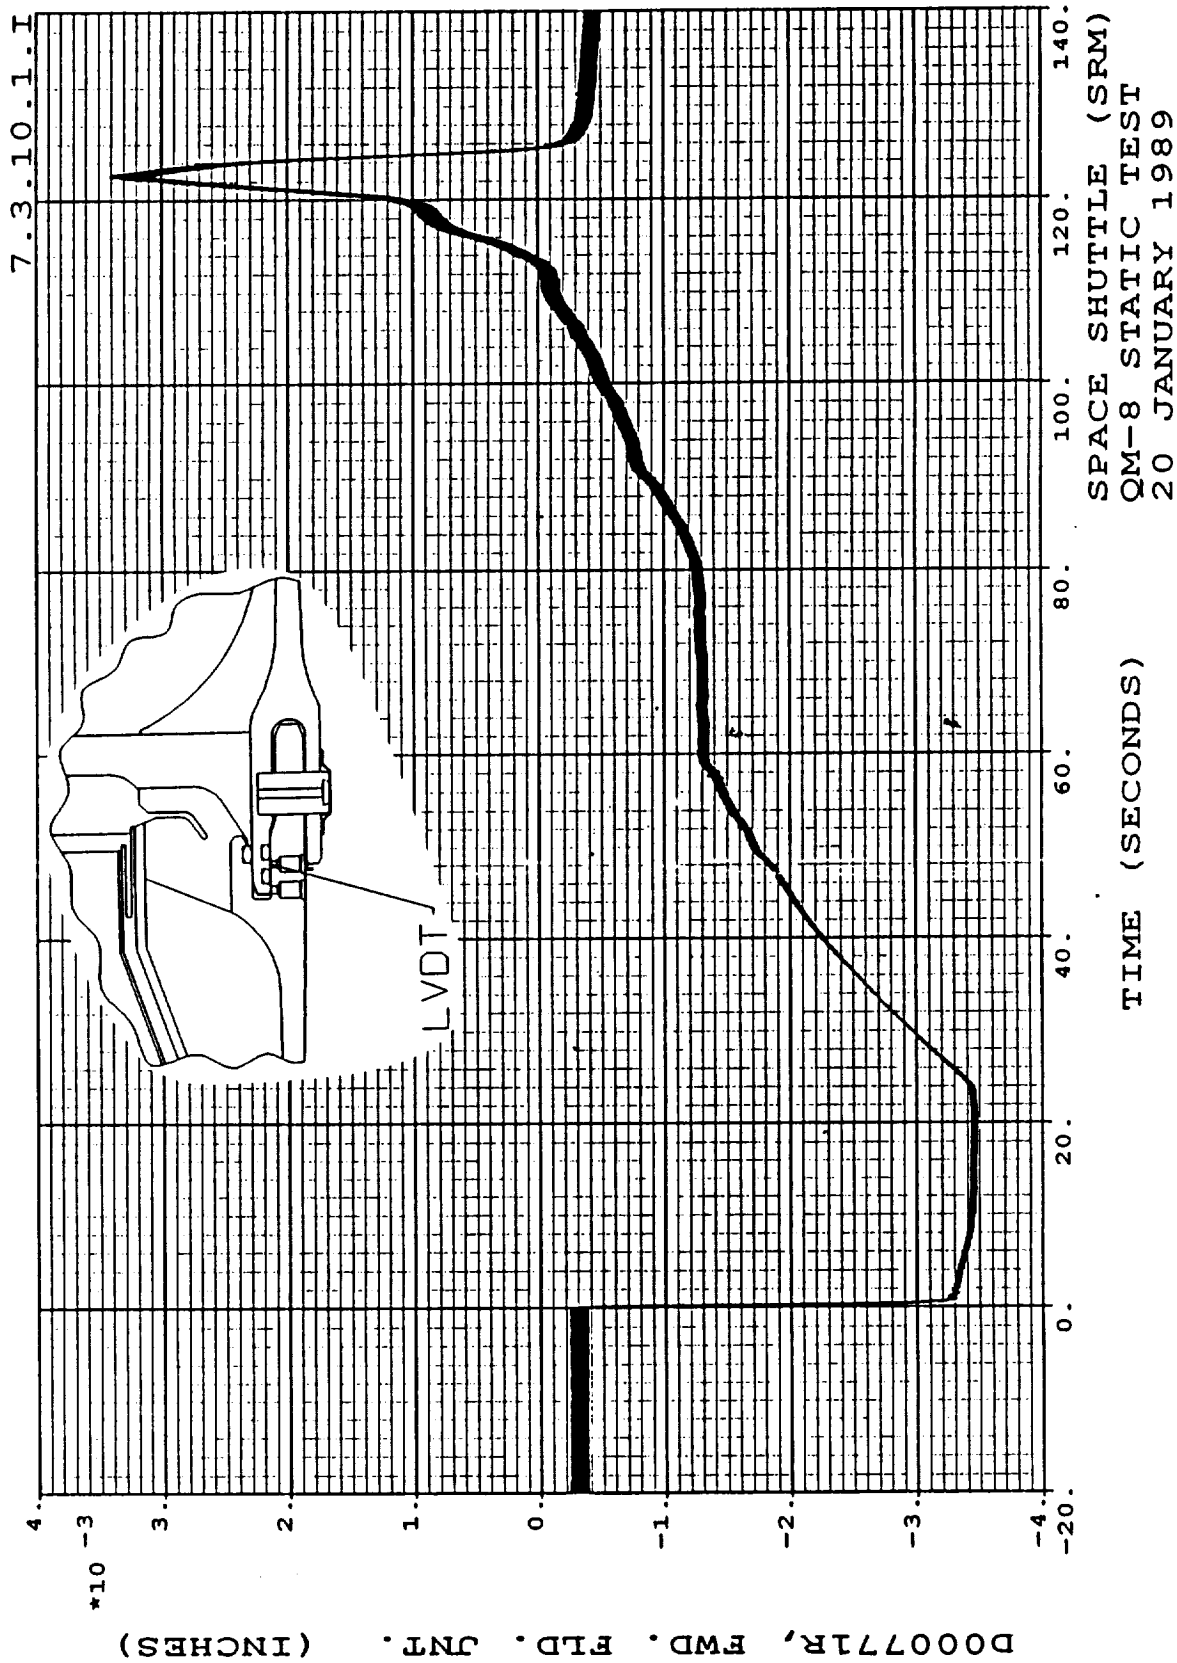
Figure 12 Forward Field Joint LVDT Measurement (Gap Opening)

The O-ring gap opening for QM-8 was measured directly for the forward, center and aft field joints via the 45 degree leak check ports. The LVDTs were lockwired, torque painted, and fitted tight into their respective ports. These measurements were also taken on the JES and TPTA tests. Figure 12 shows the actual test data for the forward field joint LVDT. The center, and aft field joint LVDT gages produced no data. Note that a negative value on the plot corresponds to gap opening and positive value to gap closing. Table 12 lists the maximum measured O-ring gap openings; the flaw, if any, to the joint; and the test pressure for QM-8, QM-7, QM-6, TPTA-1.1, JES-3A, and JES-3B. For QM-8, the maximum field joint gage pressure was estimated to be 833 psig, which occurred at the forward field joint between 9 to 11 seconds.

Therefore the value measured on QM-8 falls within the TPTA and JES data base which demonstrates that the O-rings would of remained sealed if motor pressure reached the primary O-ring. Also resiliency testing, which is an on-going study at this time, has shown that fluorocarbon will track 0.018 inch gap opening (see TWR-17991, Reference 14), given the following conditions:

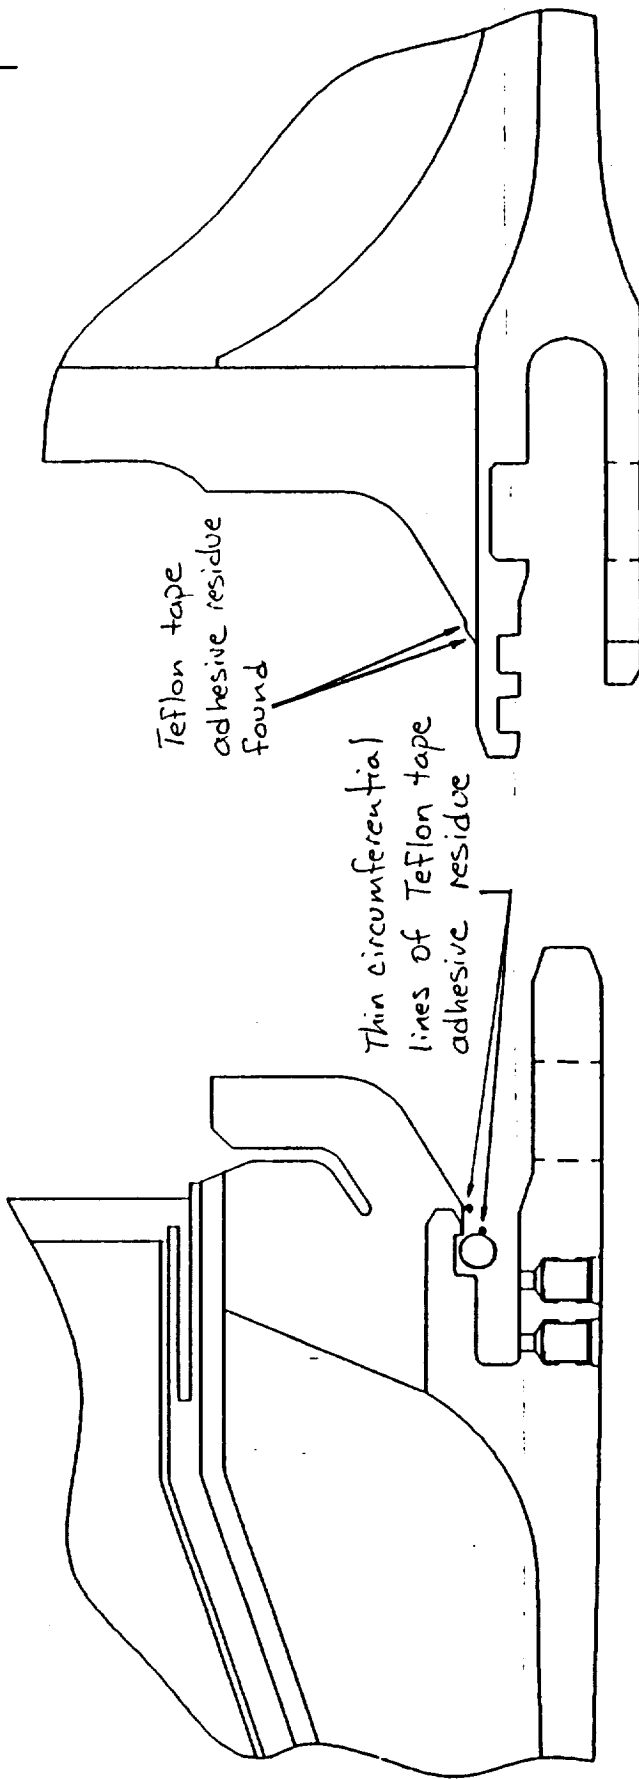
QM-8 FORWARD FIELD JOINT

Small thin lines of the white colored material were found on the capture feature metal to J-leg interface (aft of the capture feature groove on the tang J-leg) at 153, 178, 180, 227, 228, and from 230 to 233 degrees. All of the thin lines of the white colored material ran circumferentially on the joint except for the lines of white colored material at 178 degrees. On the clevis, the white colored material was found on the top of the J-leg (near the inner clevis leg metal) at 138, 150, 152, 178, 180, and from 162 to 165, 167 to 170, 230 to 234, and 252 to 254 degrees. As on the tang, all of the thin lines of the white colored material ran circumferentially on the joint except for the lines of white colored material at 178 degrees.

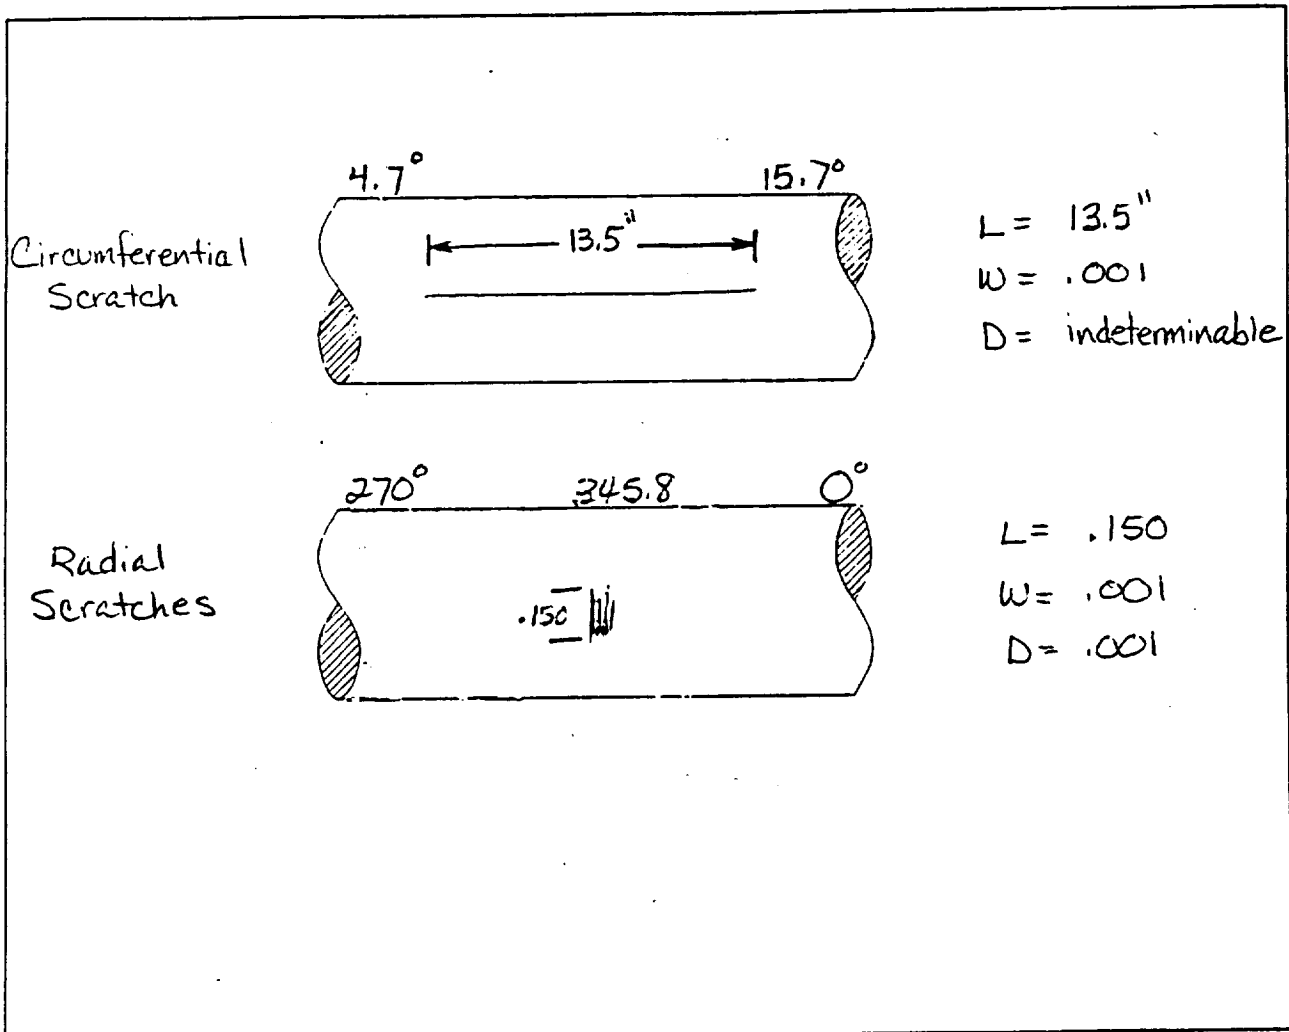
Date: 2-9-89 Inspector(s): Rocky Ash, Scott Eden, Wayne Spruy, D. GARY NELSON
Motor No.: QM-8
 Left (A) Right (R) Joint: CTR FIELD JOINT
O-ring Location: Primary Secondary Capture Feature Wiper
Part Number: 1075150-11
Serial Number: 0000051
Depth: _____
Description: See Below

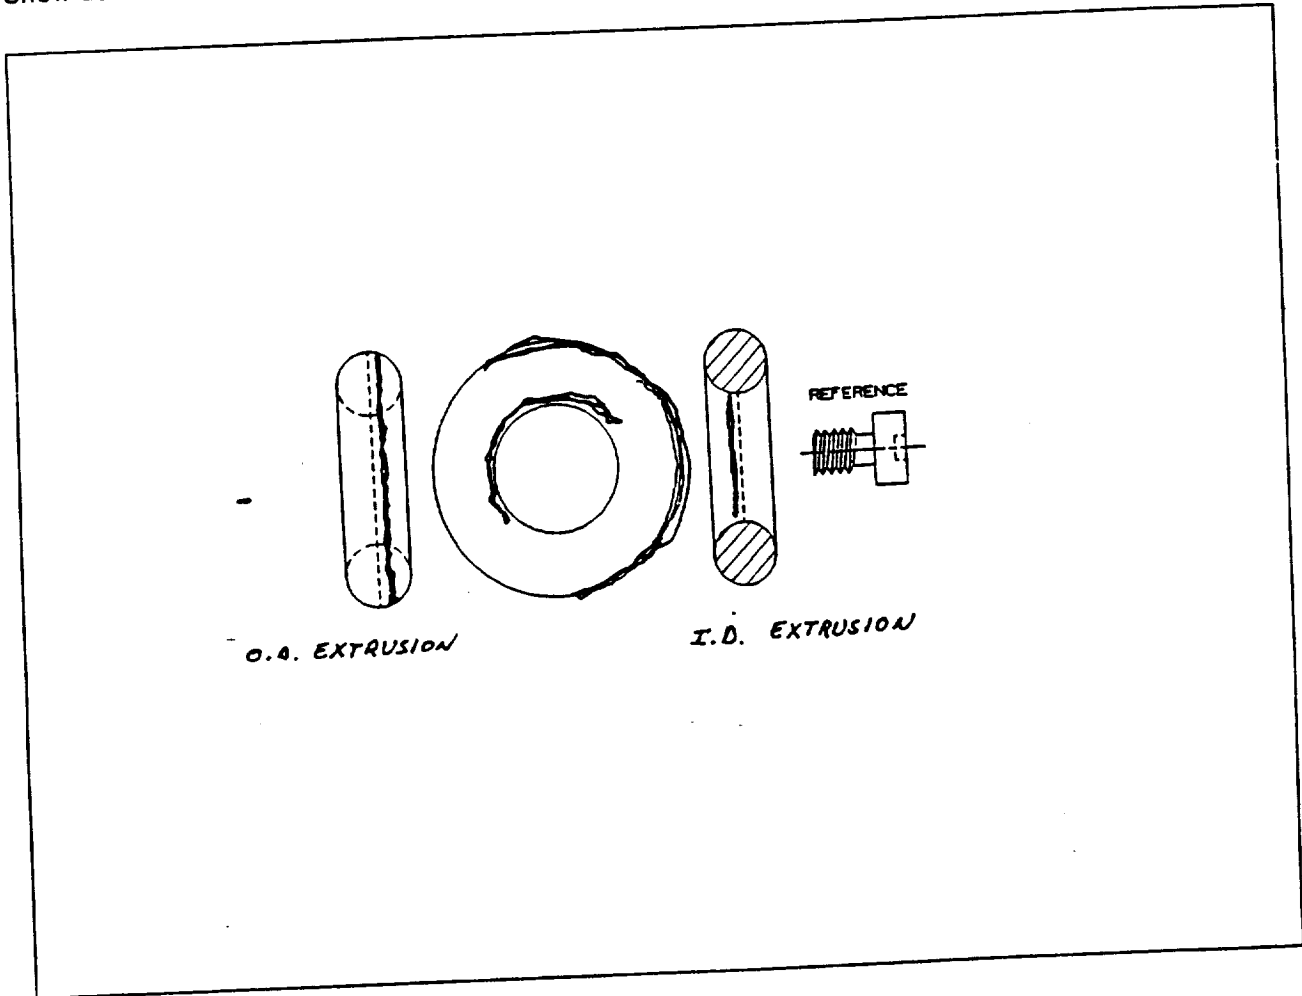
Note: very, light coat of grease.
wrong size o-ring was installed
(too large "W" diameter) o-ring
positioned on thread side

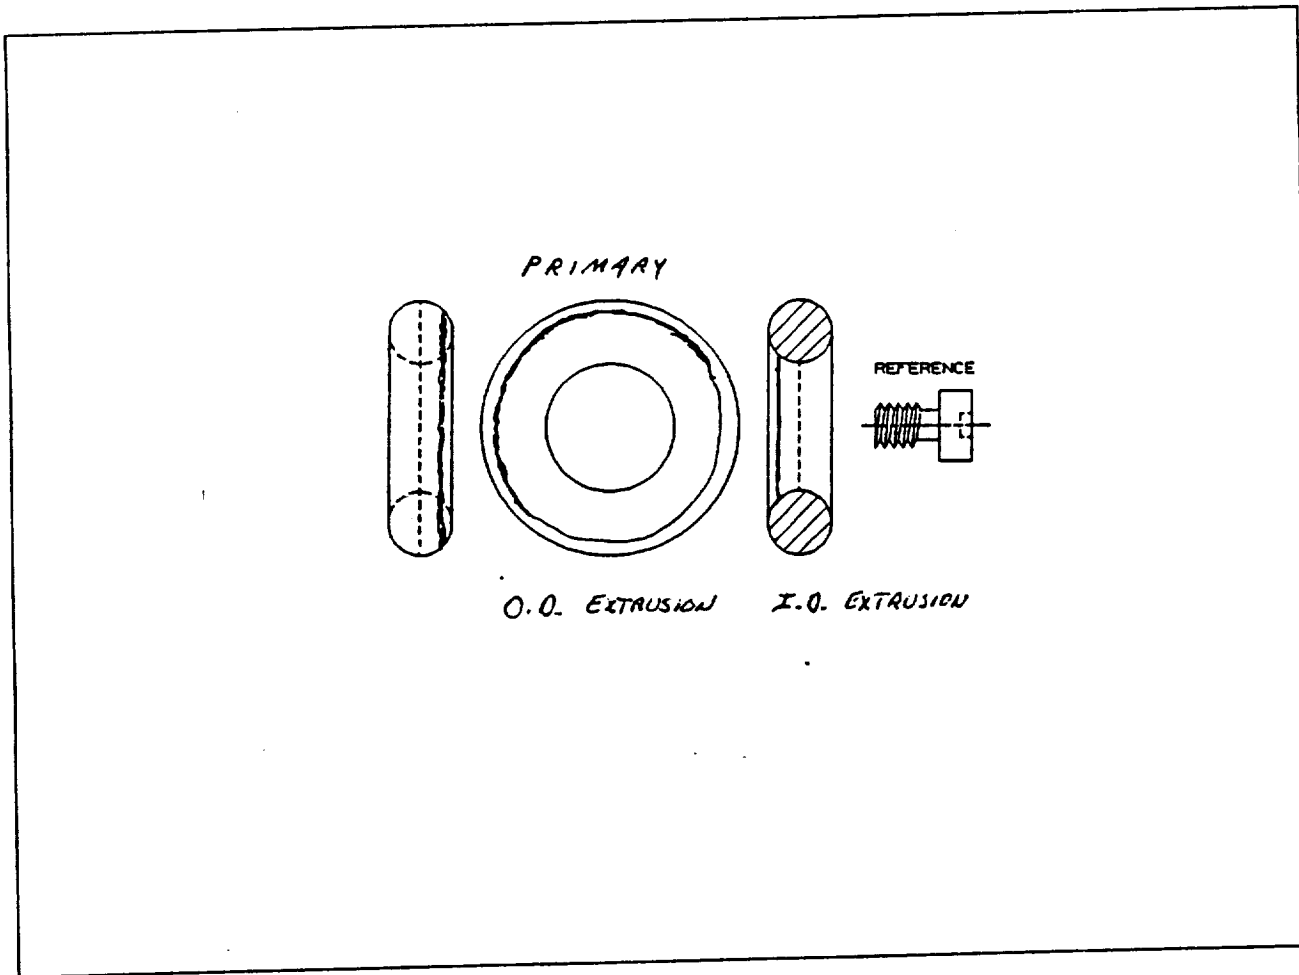
Description: Typical O.D. & I.D. Extrusion Damage (Acceptable)

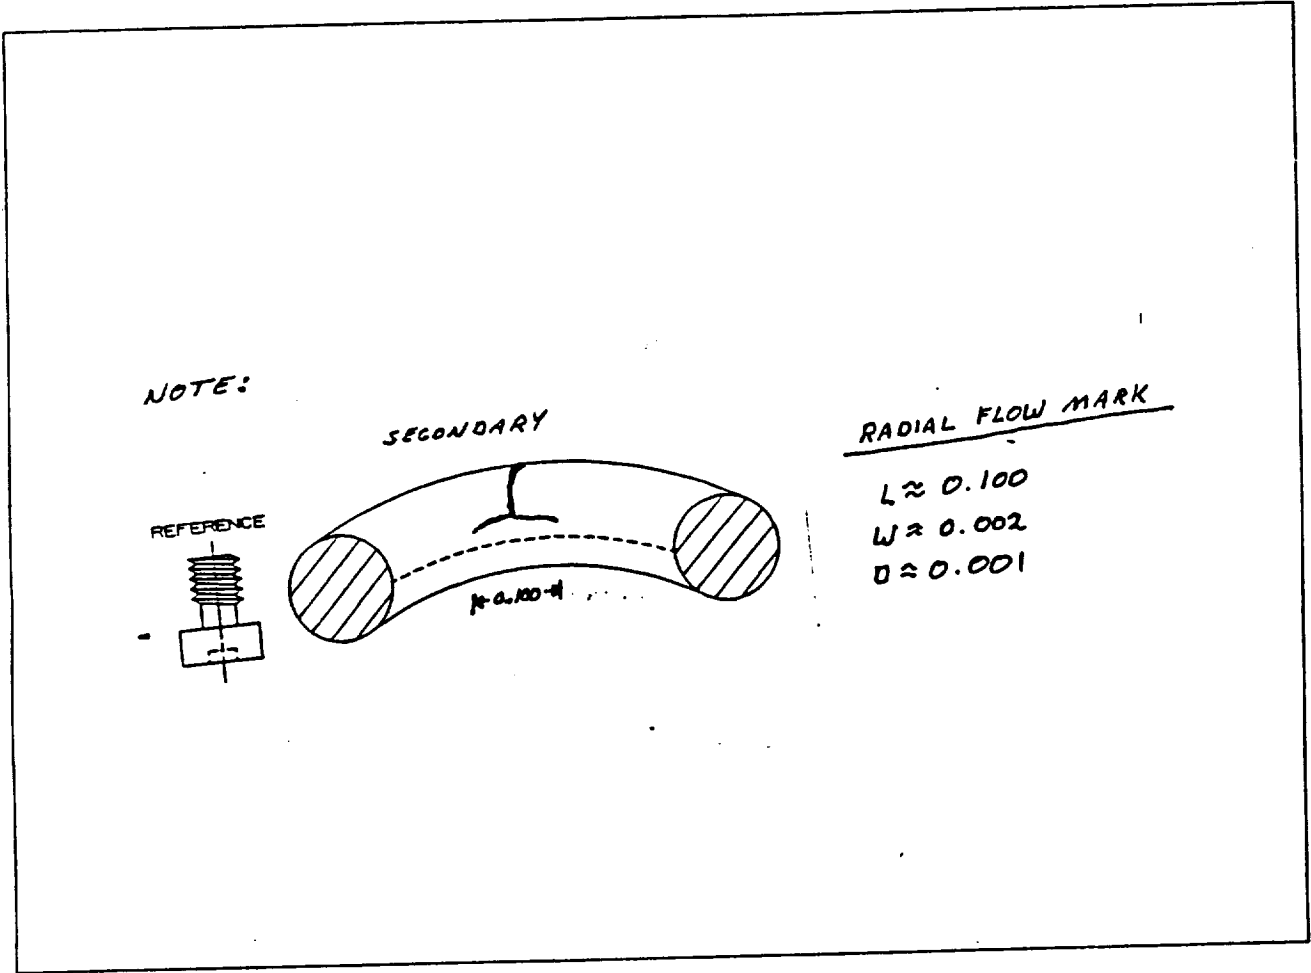
Figure B-3

_____ RADIAL FLOW MARK ON SECONDARY O-RING,
_____ ANT VENT PORT PLUG

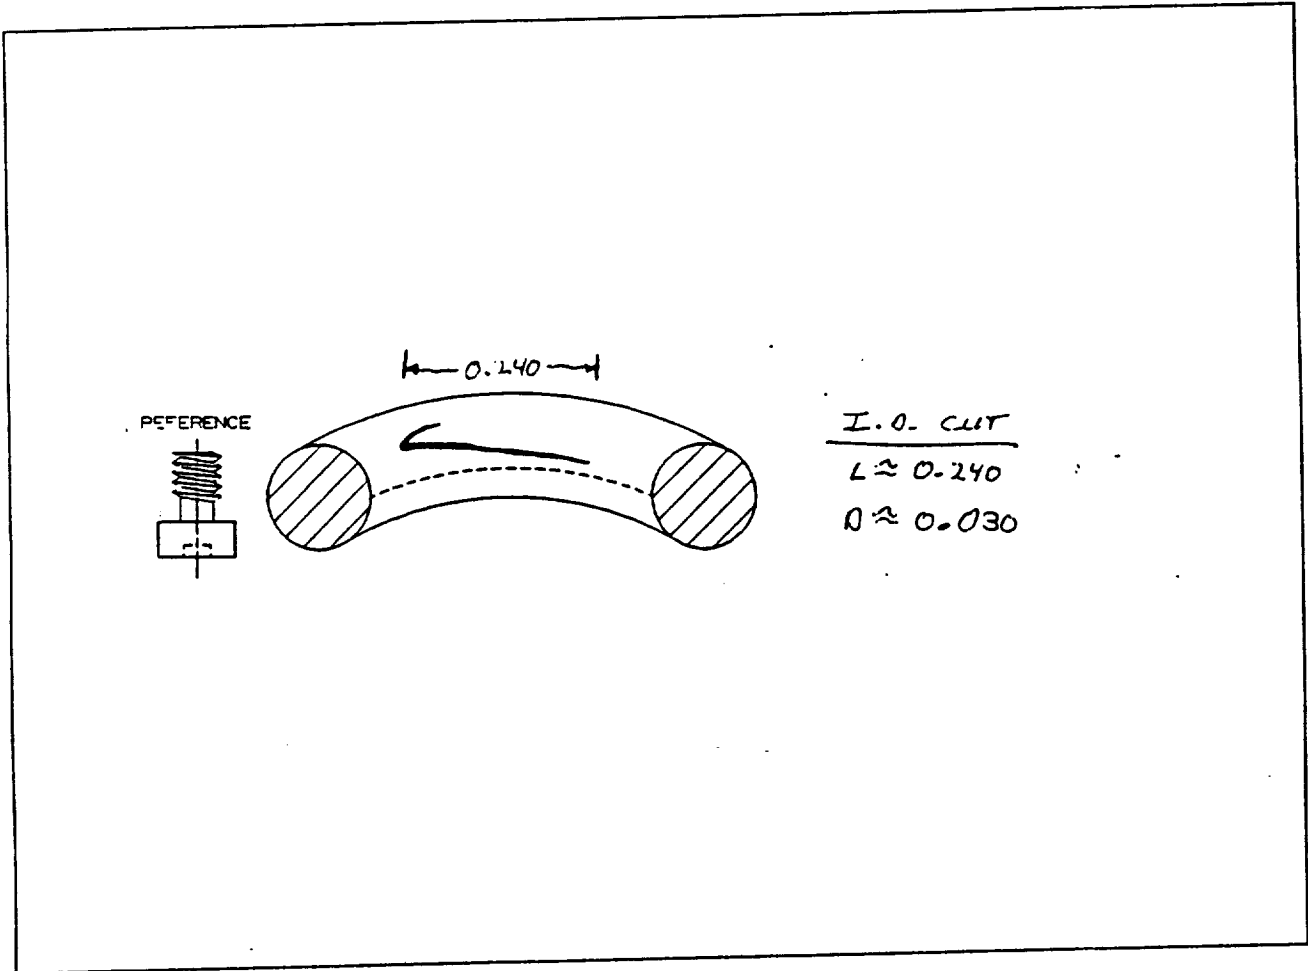
NOTE: O-RING WAS POSITIONED ON THE THREAD SIDE
OF THE PLUG GROOVE. LAST THREAD OF PLUG
WAS SHARP.

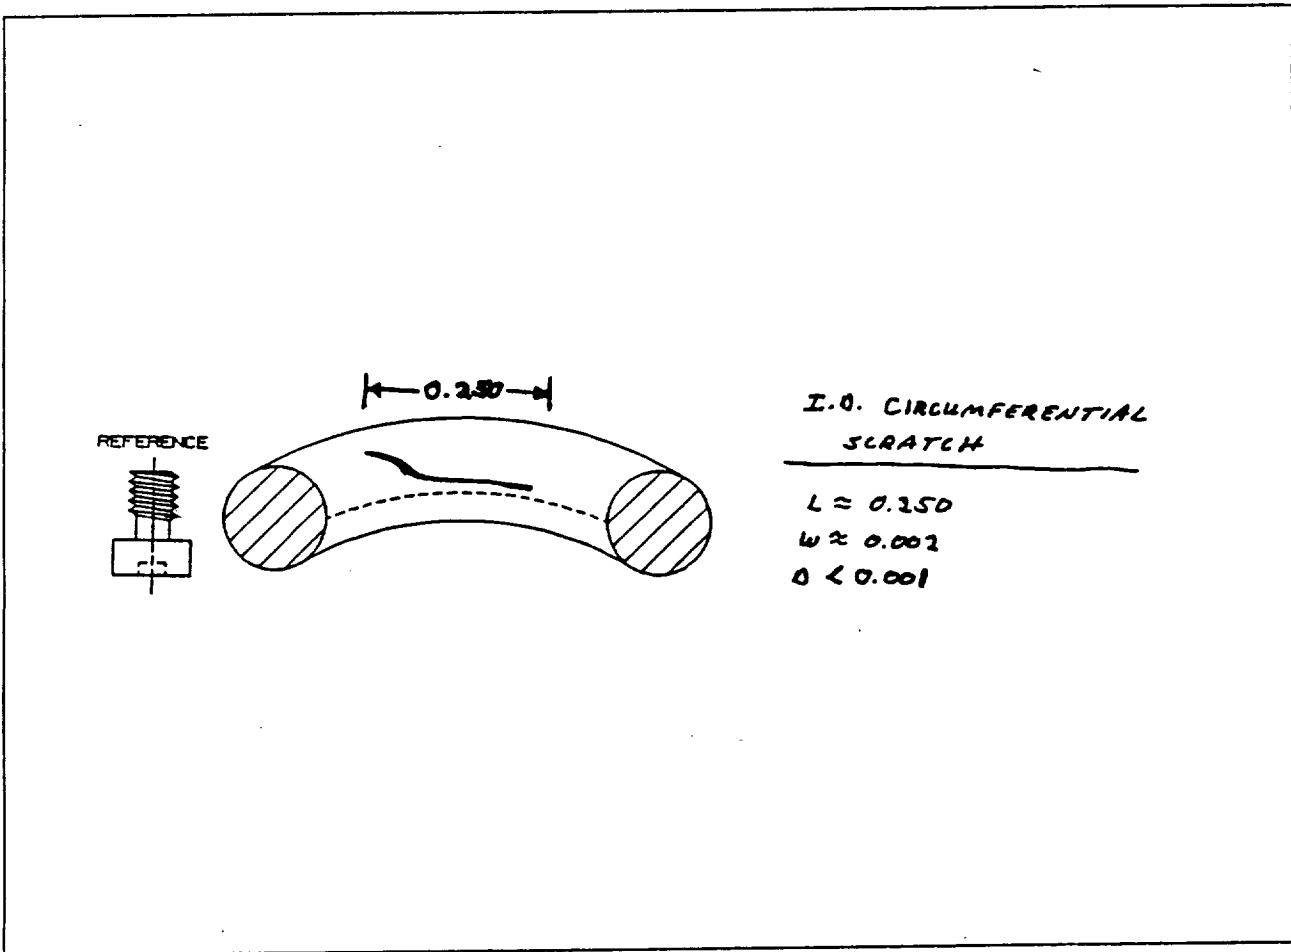
I.D. CIRCUMFERENTIAL SCRATCH (SEE BELOW)
NOTE: O-RING WAS POSITIONED ON THREAD SIDE OF
PLUG GROOVE.

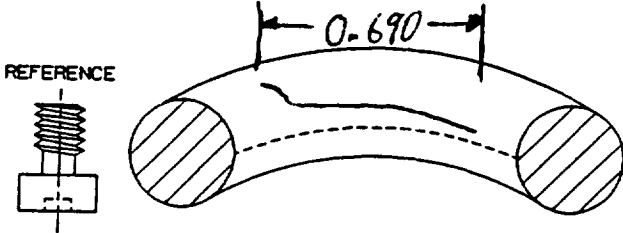
1) I.O. circumferential cut			
L \approx 0.690			
D \approx 0.030			
NOTE: O-ring positioned on thread side Chisel gouge on plug head O.D. Sharp last thread			
REFERENCE

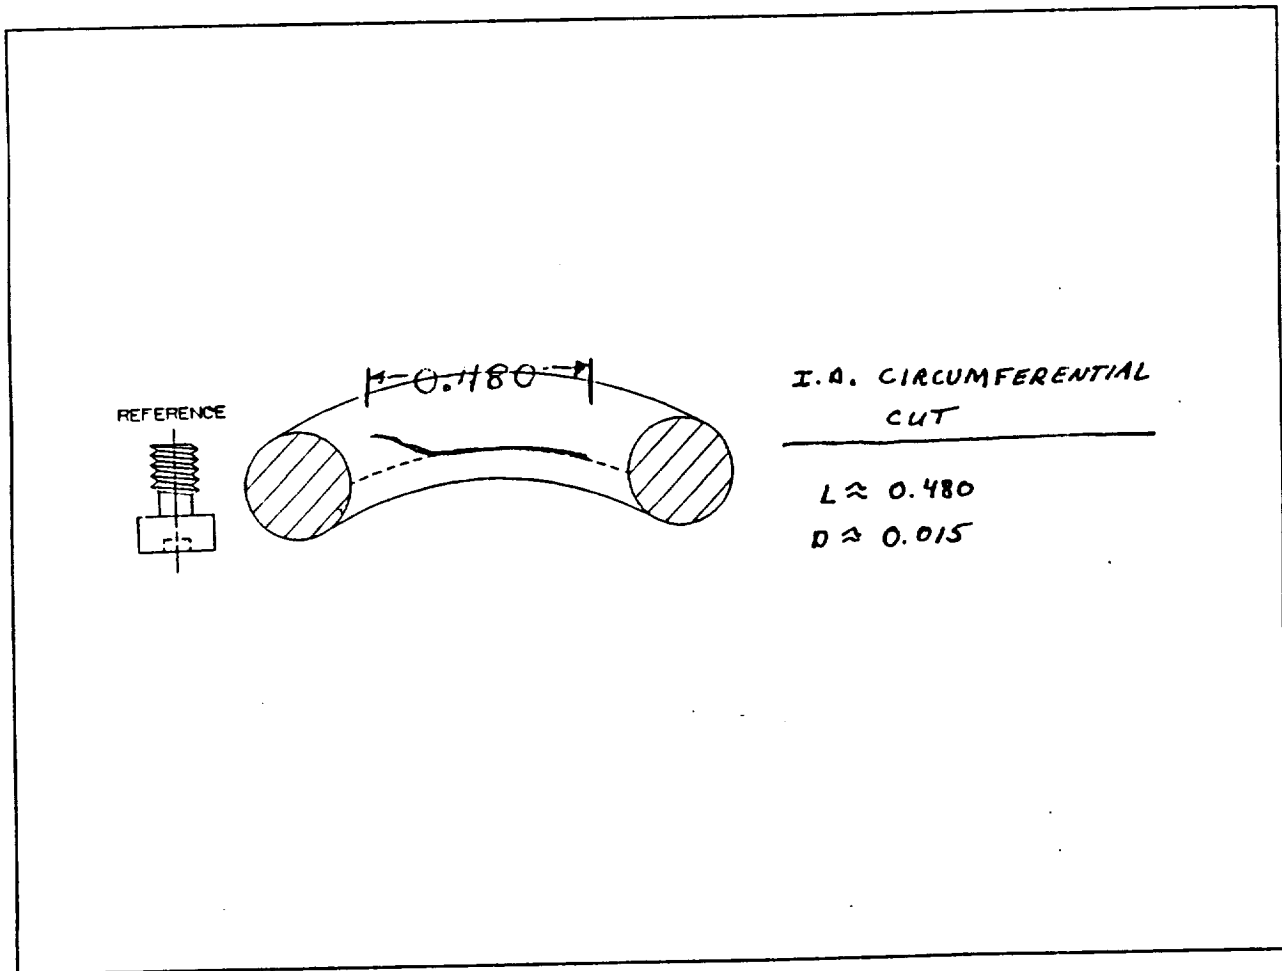
NOTE: o-ring positioned on thread side.
Chisel gauge on plug O.D.

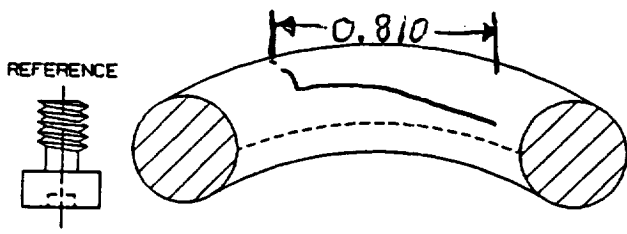
SECONDARY O-RING (or Shoulder) N/A: _____
 Part No.: 1U50228-15 Lot No.: ECL0037 Comment Number _____
 A. Erosion (SORE)? _____ Yes No _____
 B. Heat Affect (HASOR)? _____ Yes No _____
 C. Cuts, Assembly/Disassembly Damage (SCUT, SDMG, SDIS)? Yes _____ No 1
 If any of the above conditions exist, record below:
 1) I.O. circumferential cut
L ≈ 0.810
D ≈ 0.030
 NOTE: Sharp last thread
Ding in last thread
O-ring positioned on last thread
Chisel gauge on O.O. of plug head

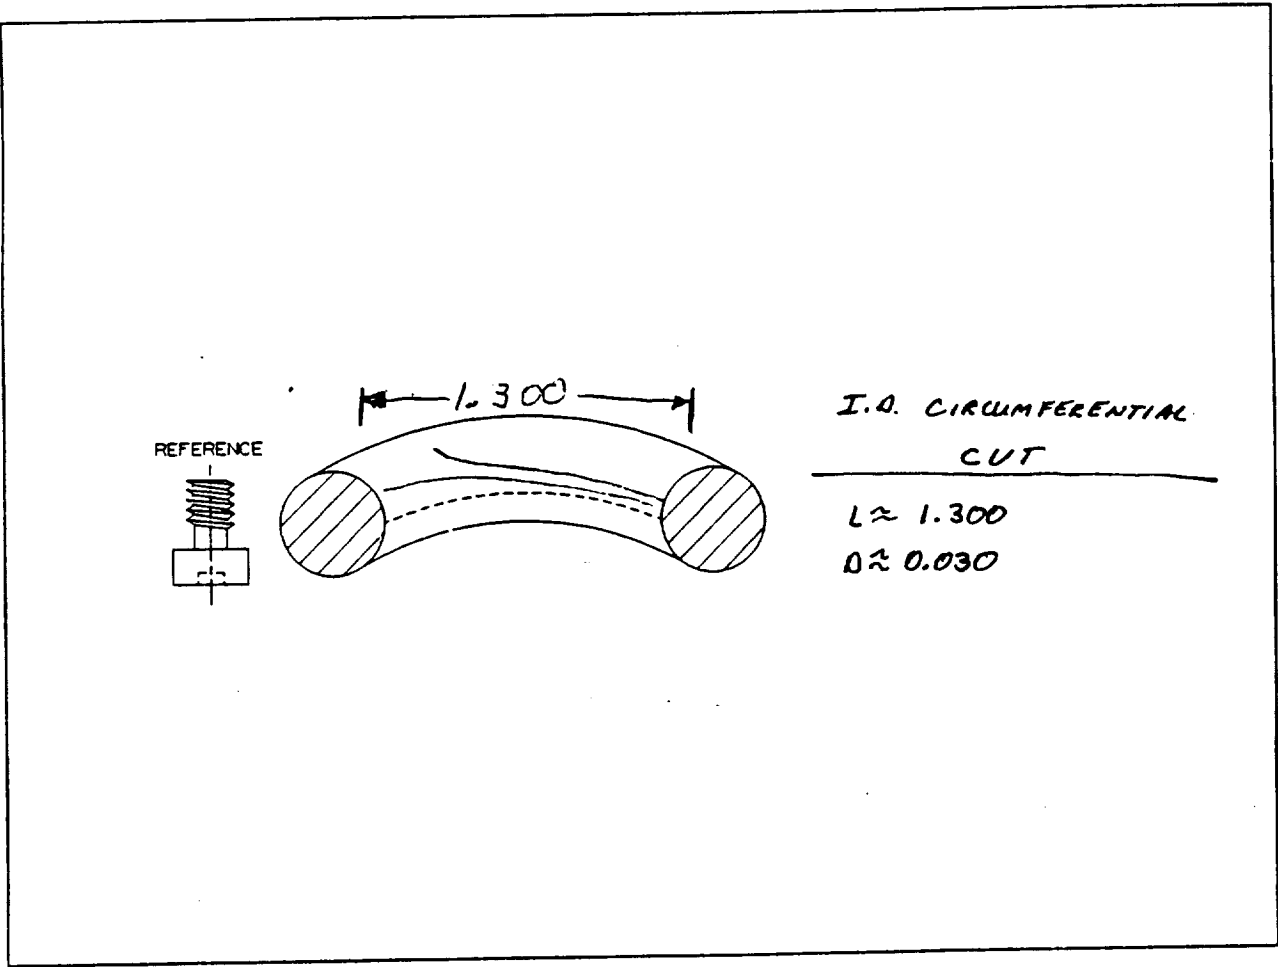
Note: O-ring positioned on last thread, cut is opened on last thread. Plug and o-ring had little to no grease. Chisel gouge on top O.D. of plug.
