**NASA Technical Memorandum 102681
USAAVSCOM Technical Report 90-B-003**

Behavior of Composite/Metal Aircraft Structural Elements and Components Under Crash Type Loads--What Are They Telling Us?

Huey D. Carden, Richard L. Boitnott, and
Edwin L. Fasanella

May 1990

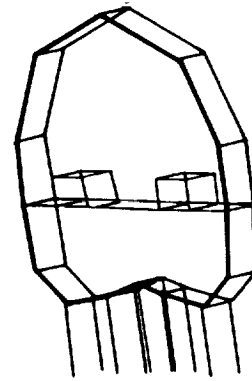
(d) Deformed model.

A comparison of the two frame analytical predictions and the full section experimental responses are shown in figure 10. The correlation of the vertical displacement, wall/floor, and dummy pelvis accelerations are considered good. As may be noted in figure 10(d), the overall impression from the analytical model deformation pattern is quite similar to the visual behavior seen in the experiment shown in figure 8. Thus, the full section behavior was basically contained in the two frame model.

Figure 10. - Comparison of experimental and analytical fuselage crushing and accelerations of metal transport section.

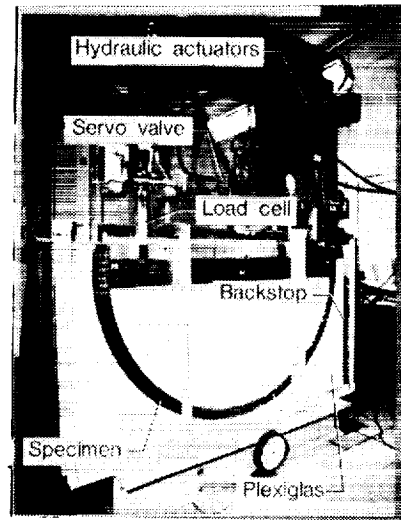
(a) Static test apparatus.

Static tests.- Results from the static test of a semi-circular frame with a Z cross-section²⁷ are presented in Figure 11. A photograph of the static test apparatus in figure 11(a) shows that the splice plate was at the load point. Consequently, the frame failed just outside the doubler splice plate area by a complete fracture across the Z-section. Load-deflection data and the location of failures of the frame are shown in figure 11(b). The load-deflection data show a saw-toothed behavior of loading and unloading. The load increased linearly until initial failure, then falls off to under 600 pounds force. Subsequent loading of the frame after initial failure was at a new, reduced stiffness. Second and third fractures occurred up the side again at about 54 and 58 degrees under continued loading as may be noted in the sketch at the right of figure 11(b). Photographic data in figure 10(c) shows that the initial failure was induced by a local buckling of the frame which occurred at about 18 degrees from the bottom loading point outside the splice plate area.

Figure 11. - Static results from tests of single composite Z-frame.

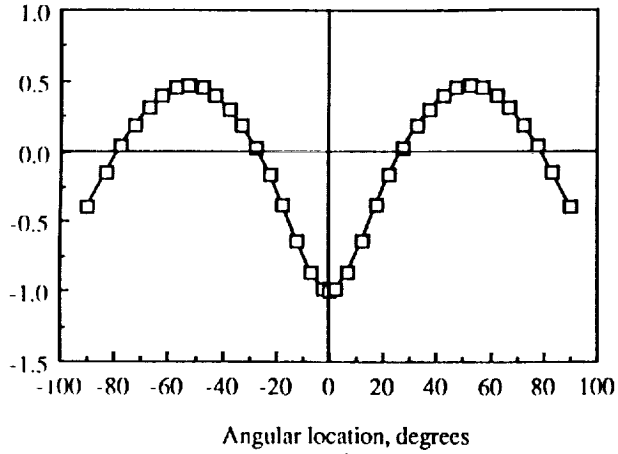
(b) Case I---Normalized moment (Prior to failure).

- (4) Noted failures were located in the same regions as the maximums in the moment distribution on the structures.

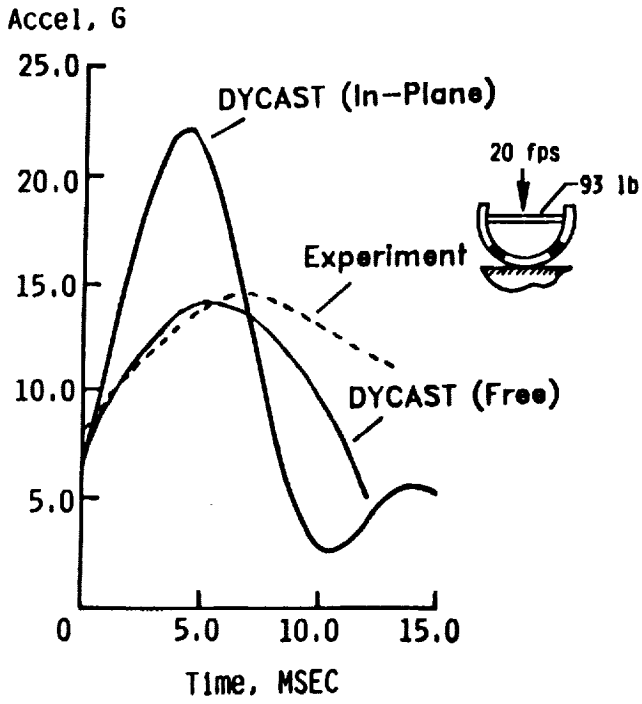
(c) Experimental and analytical accelerations.

Figure 13. - Concluded.
