NASA Technical Memorandum 102679

Unique Failure Behavior of Metal/Composite Aircraft Structural Components Under Crash Type Loads

Huey D. Carden

May 1990

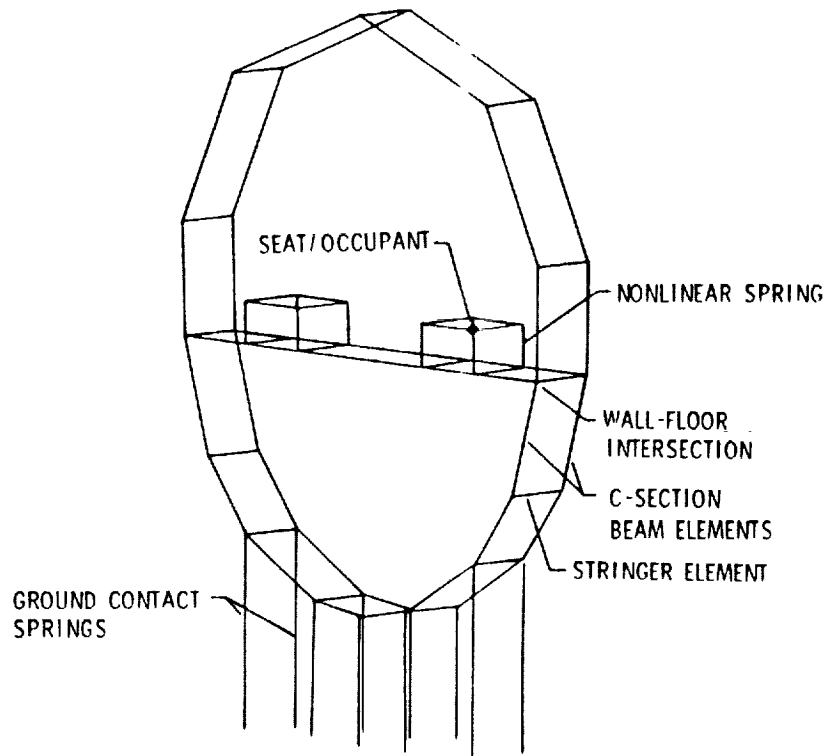
Figure 9. - Finite element two-frame model of metal transport section.

Analytical studies.- A DYCAST model of the section (from forward of the wing location) was constructed with sufficient detail the model the floor, two seats with lumped mass occupants, and the fuselage structure to determine if such a model could predict the response of the complete section with fidelity. The finite element model is shown in figure 9. Stiff ground springs simulated the concrete impact

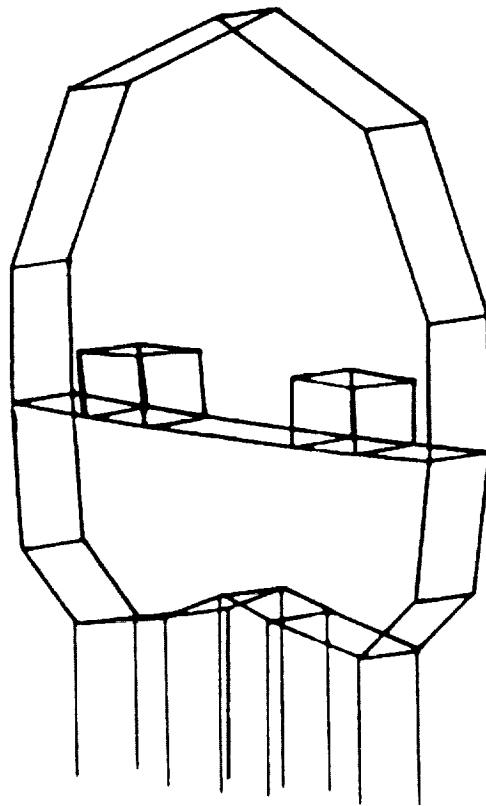
Figure 10.-Computer graphics showing analytical failure of metal transport section.

The predicted deformation pattern of the two frame model is shown in figure 10. As may be noted, the overall impression from the analytical model deformation pattern is quite similar to the visual behavior seen in the experiment shown in figure 8. The full section behavior was basically contained in the two frame model.

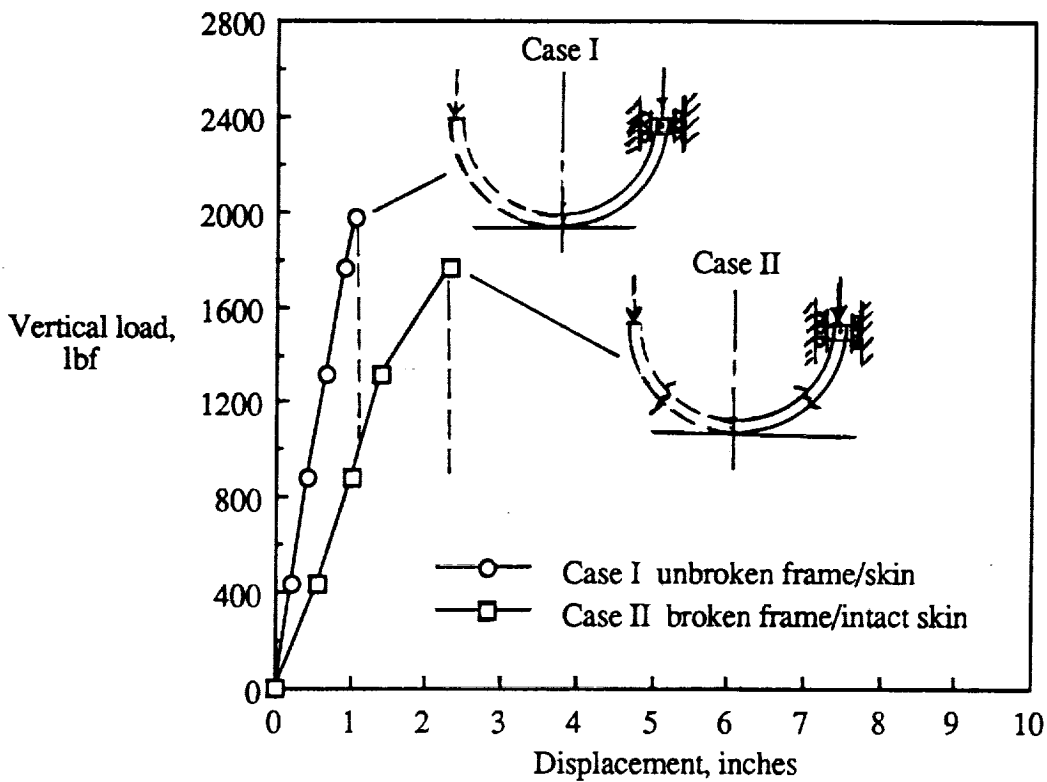
(a) Load-displacement.

Furthermore, a comparison of the analytical cases (figure 12(a)) with the actual static load-deflection of the Z-section (figure 11(b)) indicates very similar load-

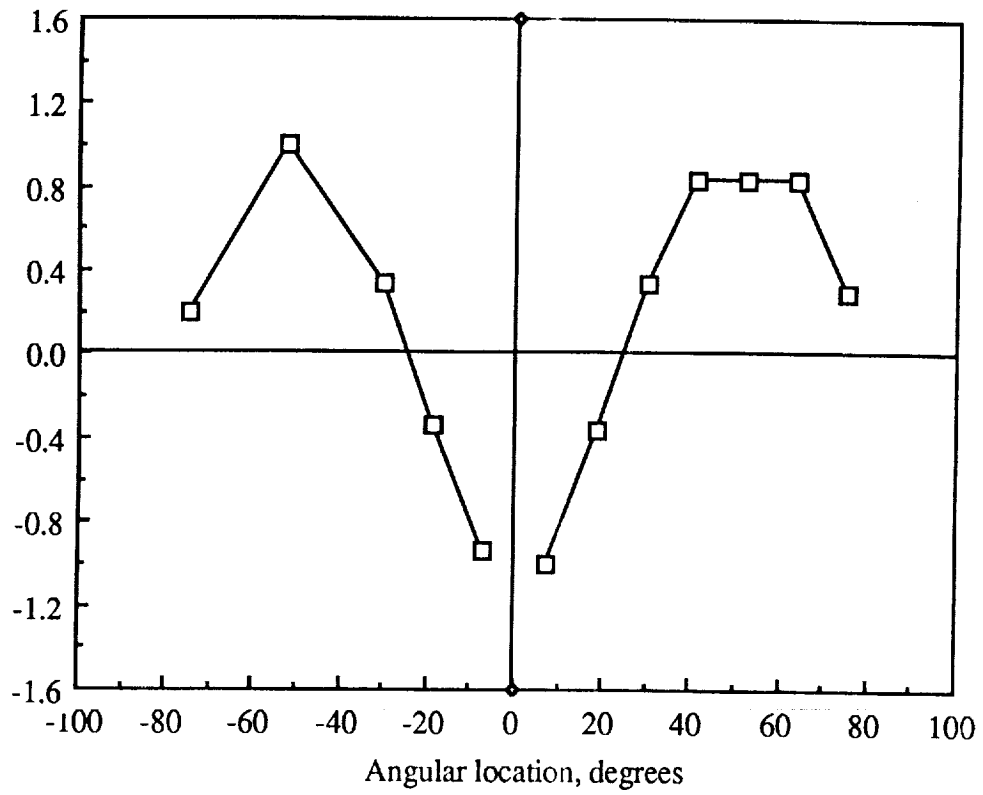
(c) Normalized strain distribution.

Figure 15. - Behavior of skeleton composite subfloor under dynamic loading tests.

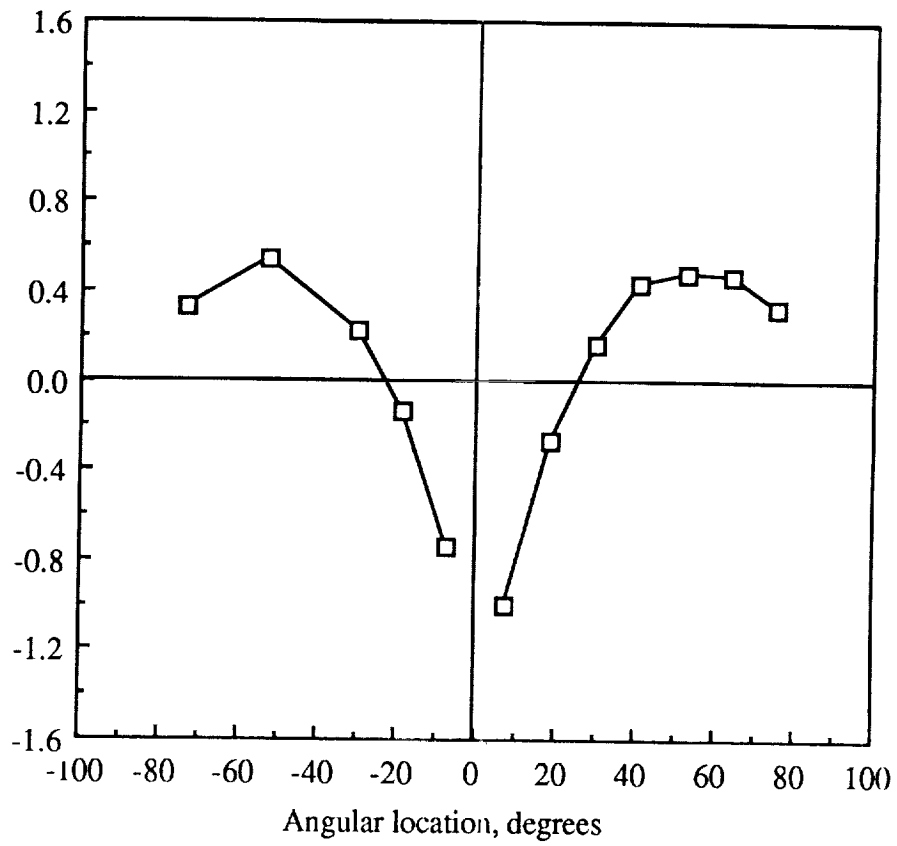
(c) Normalized strain distribution.

Figure 16. - Behavior of skinned composite subfloor under dynamic loading tests.
