JPL Publication 89-35

Galileo Report 1625-429

# Magellan/Galileo Solder Joint Failure Analysis and Recommendations

September 15, 1989

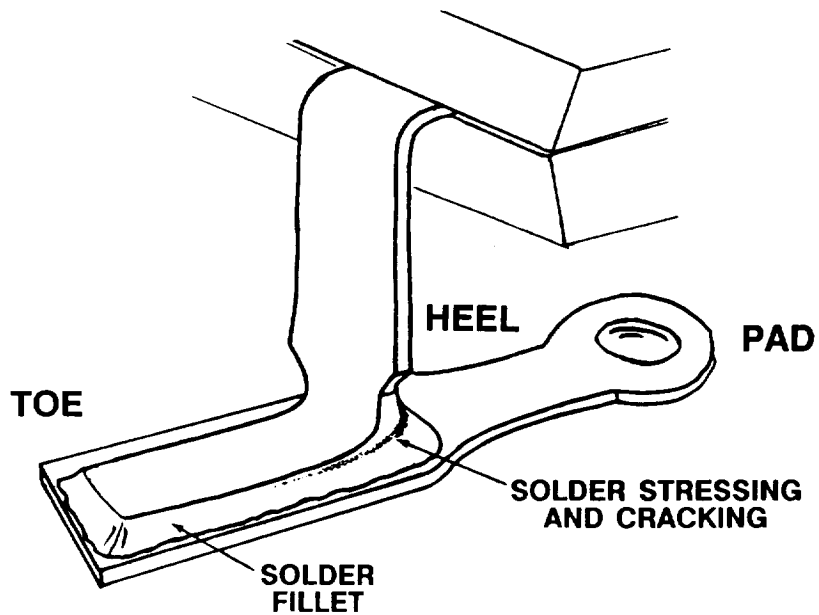
The observed cracks and stressing, schematically illustrated in Fig. 7, invariably initiated at the heel of the solder joints, and gradually progressed toward the toes. There was a general trend for all, or most of the leads on one side of the DIP, to be significantly worse off than those on the other side, and no particular trend for end leads to be worse than middle leads, or vice versa. It is hypothesized that one weakest lead fails first thus transferring mechanical loads it was carrying to its nearest neighbors, and thereby cascading into an unzipping action for all the leads on a single side. Once the leads on one side (eg. pins 1 through 8) yield, the leads on the other side (pins 9 through 16) will be relieved of their load and will remain in good condition.

Fig. 7. Solder joint nomenclature

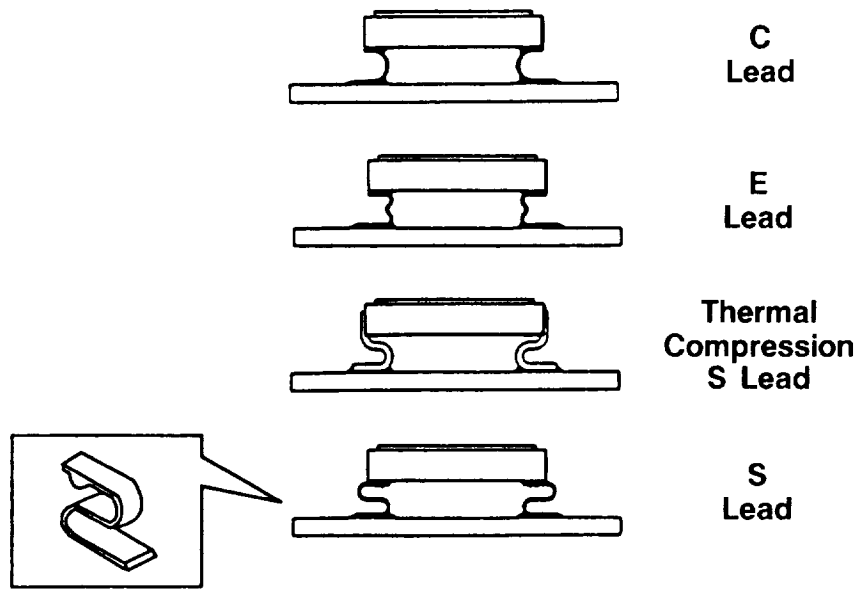
Fig. 16. Candidate strain relief modifications for DIP packages

Although workable fixes were developed and successfully implemented as part of the Tiger-team activity, **there is a clear need for improved DIP mounting techniques in the future.**

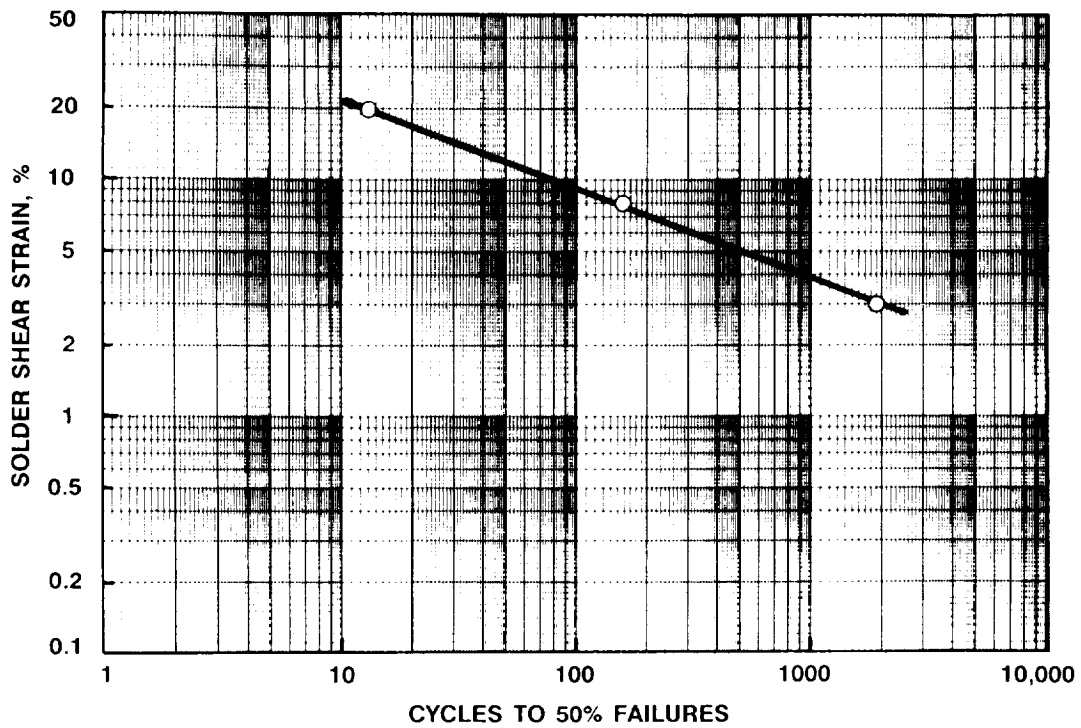
Figure 18 presents representative fatigue-life data for 63-37 SnPb solder joints taken from IBM test results [8]. The plot illustrates the typical dependency between cycles-to-failure and the level of mechanical strain introduced into the solder joint. Such a mechanism is called an accrued damage mechanism because failure occurs after a number of strain cycles have been accumulated. Note that the level of damage (number of cycles to failure) is an extremely strong function of the strain level. Doubling the strain (for example doubling the Solithane thickness) can reduce the fatigue life by nearly an order of magnitude.

Fig. 18. Solder-joint fatigue life versus cyclic strain level at 25°C (IBM data using 15 minutes per strain cycle [8])

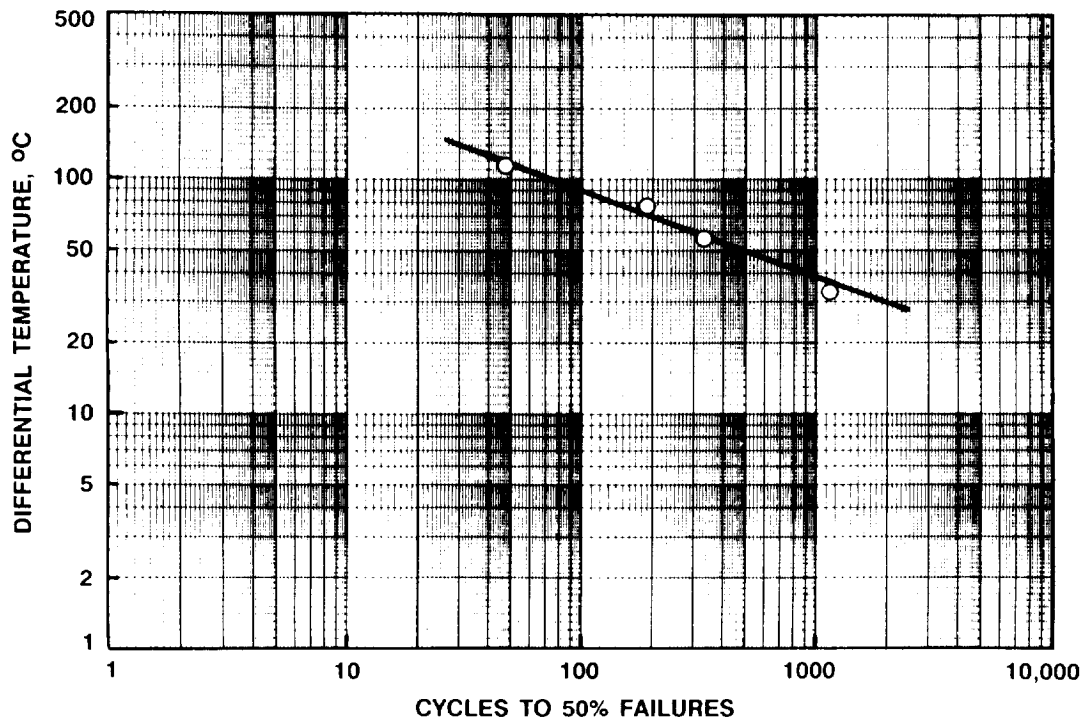
Fig. 19. Example solder-joint fatigue life versus temperature cycle depth (TRW data for Solithane encapsulated parts [9])

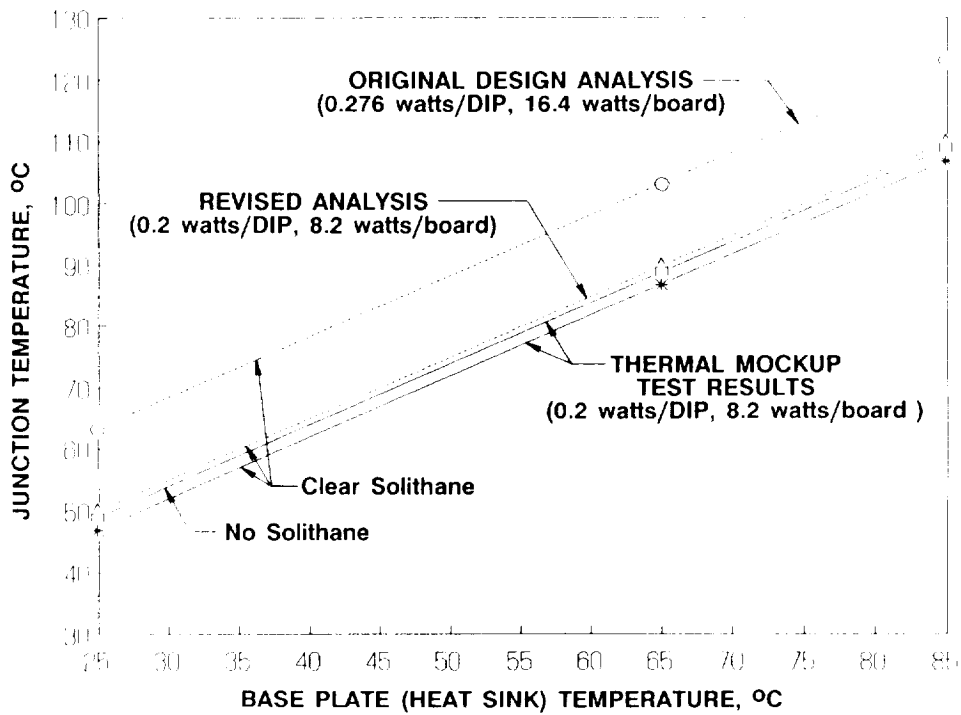
Examination of Fig. 24 reveals that the rework design with no Solithane under the parts has excellent margin; the predicted junction temperature is only 55°C for the expected flight baseplate temperature of 30 to 35°C, and is below 70°C at the maximum allowable flight baseplate temperature of 45°C.

Fig. 24. Comparison of analysis and test data on DIP junction temperature in vacuum as a function of circuit board heat-sink temperature

The test data also demonstrate that the presence of clear Solithane beneath these parts only lowers the part temperature by 2°C (3°C for alumina-filled Solithane). This temperature reduction would increase proportionately for parts with higher power dissipations, or for parts such as flat-packs, which have much greater thermal resistance in their leads.

The largest difference between the original flight design analysis and the Tiger-team analysis is more accurate power dissipation estimates for both the part, and the total module (the module is the two back-to-back boards combined). The test and analysis data in Fig. 24 are based on a measured power dissipation for the module of 8.2 watts, compared to a previously assumed value of 16.4 watts, and a measured worst case part power dissipation of 0.2 watts for the optical isolator DIP (compared to 0.276 watts). Even the present 0.2 watt estimate is very conservative; it assumes a manufacturer's maximum 25 mA LED drive current and 100% duty cycle (fraction of time in the on state), as opposed to the flight application, which uses a 15 mA drive current, and a duty cycle closer to 50%.

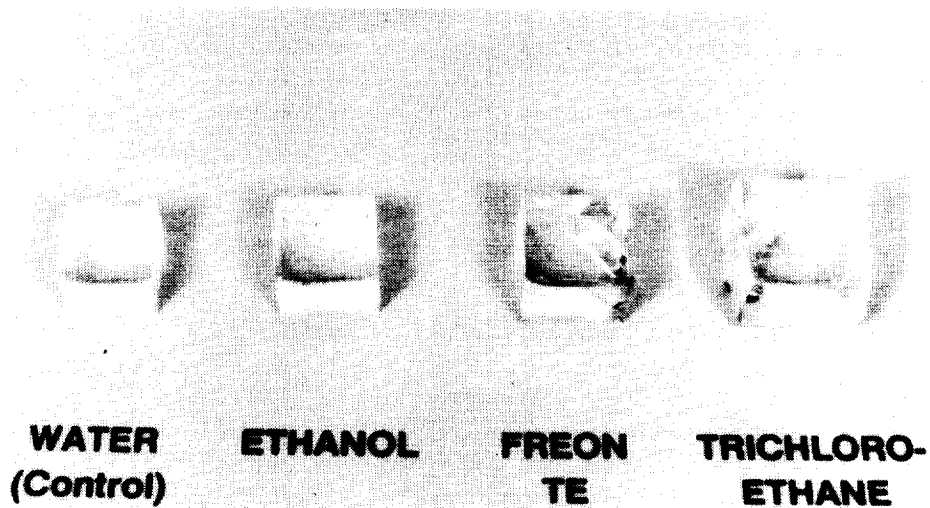
**It is clear from these experiments that Trichloroethane is extremely reactive with the Solithanes, and causes enormous swelling; under no circumstances should it be used in the presence of the Solithanes. Freon TE and Ethanol are much less reactive. Considering the fact that Freon**

Fig. 25. Visual appearance of 5/8" clear Solithane cubes after immersion in solvents. Before solvent exposure, all cubes were identical in size to the cube labeled "control"--water immersion had no swelling action. After withdrawal from the solvent, the cubes return to their original size

evaporates much faster than Ethanol, its use should shorten the exposure period. Although brief (less than 5 minutes) exposure of Solithane to Freon TE and Alcohol is relatively benign, prolonged exposures to even these solvents can cause significant damage to parts with trapped Solithane, such as under DIPs and flat packs.

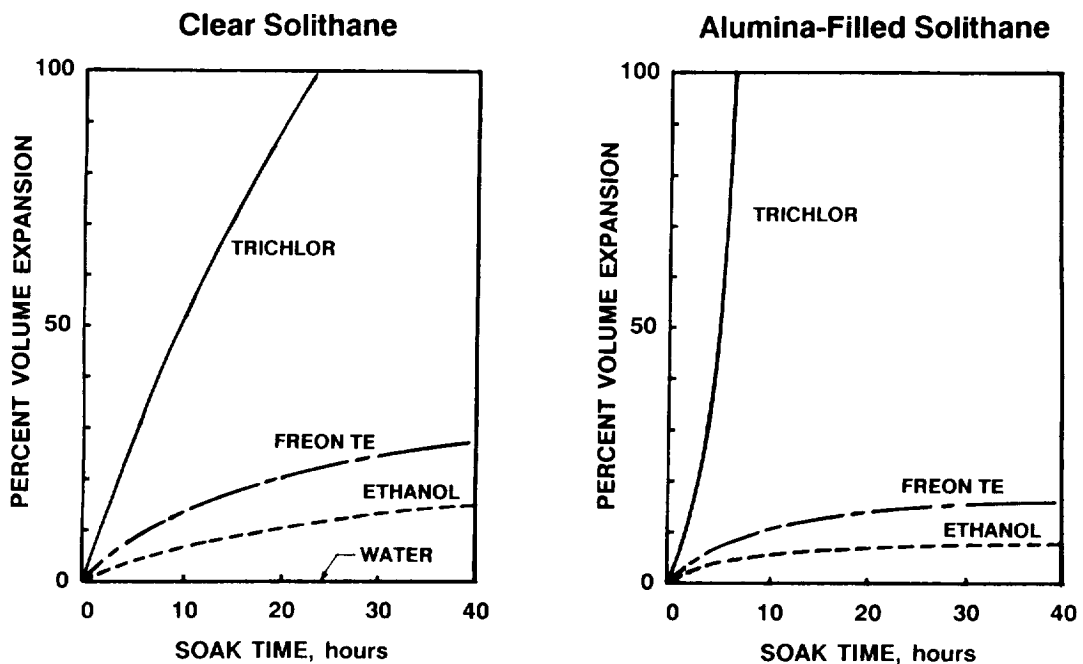
Normally, cleaning solvents such as Trichloroethane, Freon and Alcohol are applied only prior to conformal coating. This precludes negative interactions between the solvents and the polymeric materials. Unfortunately, in the rework setting, cleaning solvents are often required to be used after the conformal coat or heat-sink compound is applied and cured in place. During rework cleaning, the solvent will be adsorbed by any contacted polymeric material and cause the polymer to swell. The amount of swelling is very dependent on which solvent is used, and the length of solvent exposure. Fig. 25 illustrates the dramatic swelling of 5/8" cubes of clear Solithane after reaching equilibrium during room temperature immersion in the noted solvents: water, Ethyl alcohol, Freon TE and 1,1,1-Trichloroethane; Figure 26 presents quantitative data for the same cubes. Note that the alumina-filled Solithane exhibits a much faster time constant than the clear Solithane (probably because of its foamy porosity), but reaches a lower equilibrium level of swelling due to the presence of the alumina filler.

As might be expected in light of their much shorter time constant for diffusion, thin sections of Solithane are found to expand much more rapidly than these bulk samples. For example, 0.030" thick samples of clear Solithane reached 30% volume expansion in Trichloroethane in 5 minutes, and 10% volume expansion in boiling Freon TE (43°C vapor degreaser) in 4 minutes [4].

Fig. 26. Volume percent expansion of clear and alumina-filled Solithane (5/8" cubes) during immersion in solvents
