NASA Technical Memorandum TM 102153

Debris/Ice/TPS Assessment And Photographic Analysis For Shuttle Mission STS-34

November 1989

October 18, 1989

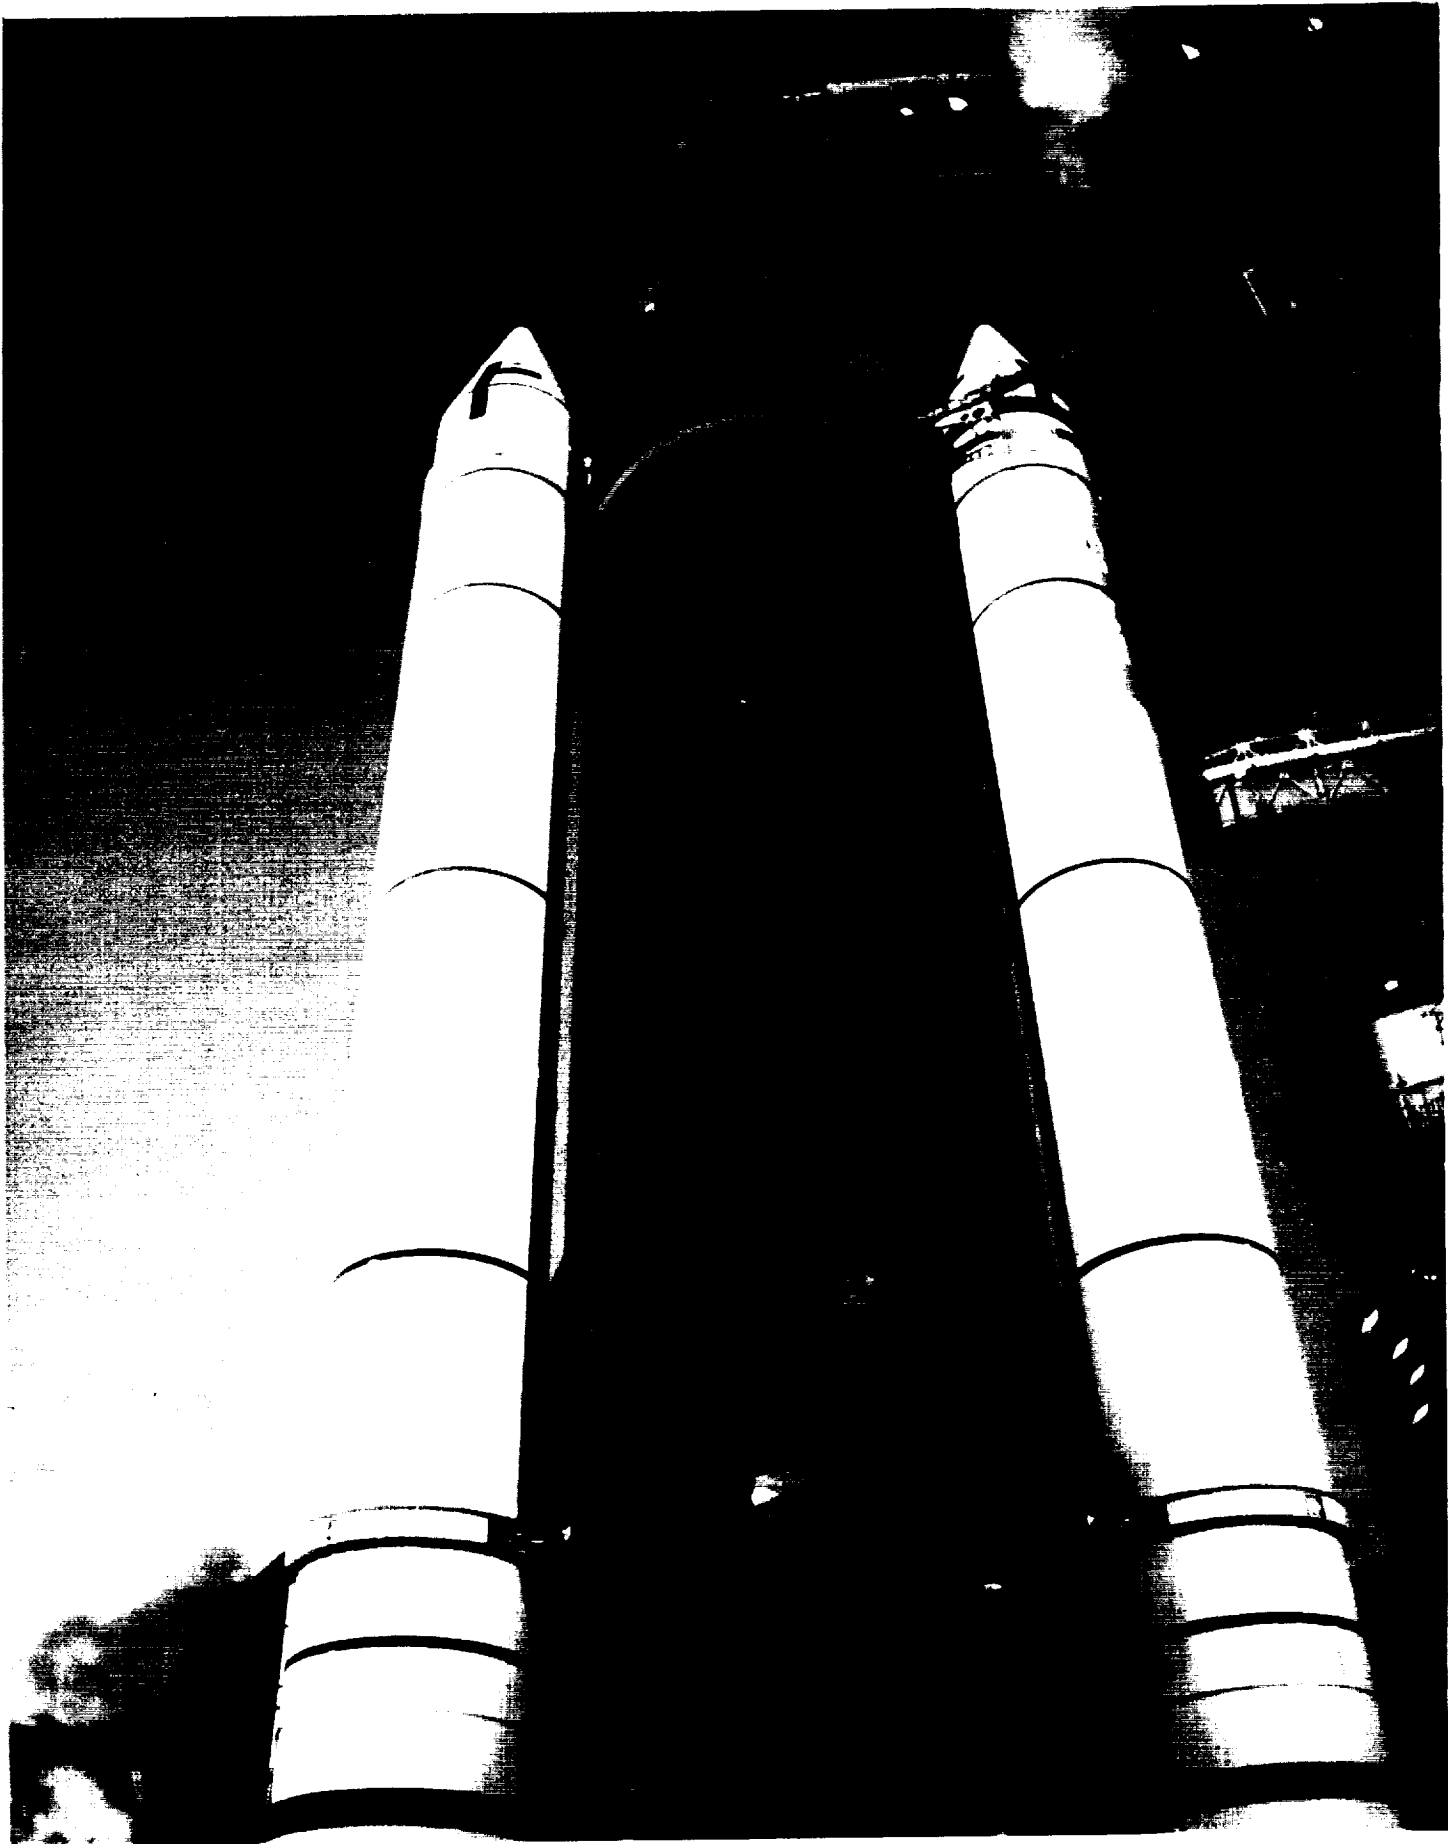
Overall view of the Solid Rocket Boosters/External Tank -Z side
Note reflection of condensate on aft hardpoint TPS closeout

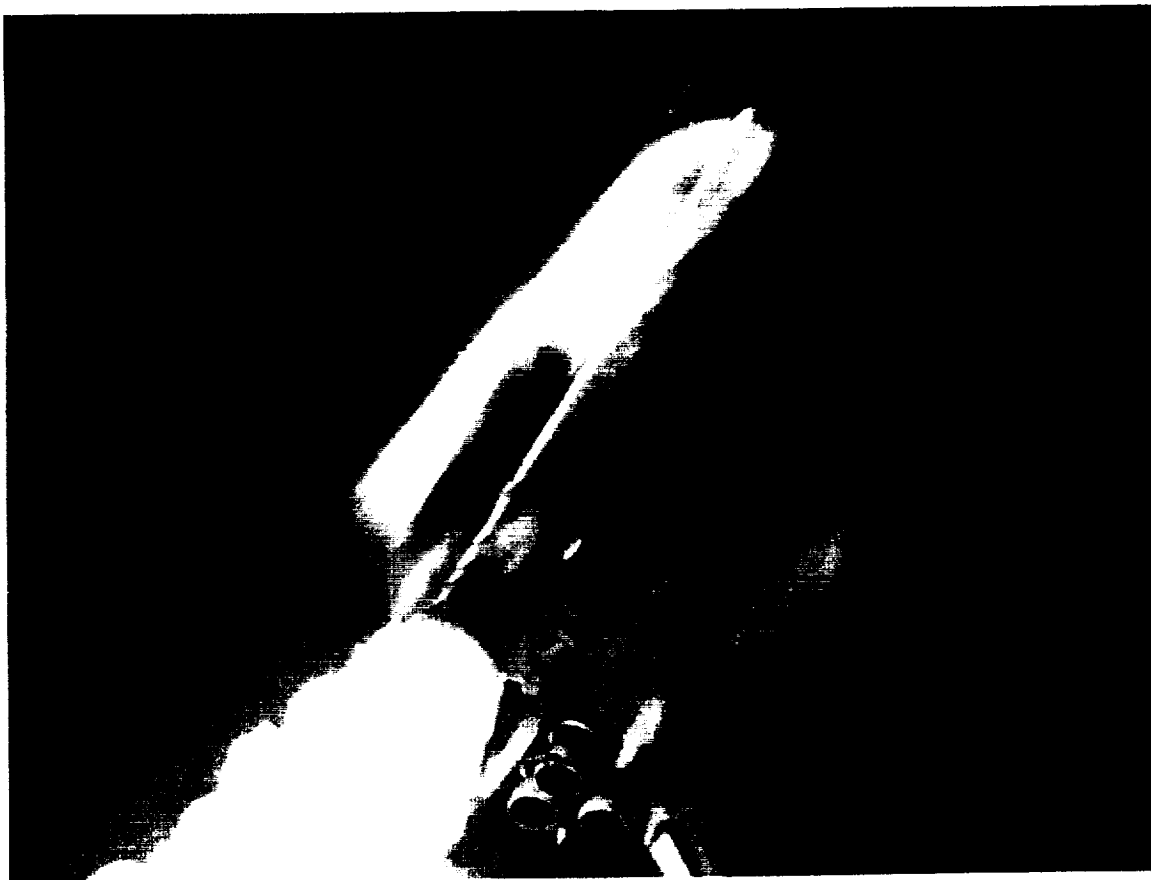
Local supersonic flow condensation forms on Orbiter, ET/SRB forward attach points, and SRB ETA ring in the Max Q region at GMT 16:54:28 (film item E-207)
