NASA CR-179645

**VOLUME II  
MATERIALS FOR ADVANCED TURBINE ENGINES  
(MATE) - PROJECT 4  
EROSION RESISTANT COMPRESSOR AIRFOIL COATINGS  
FINAL REPORT**

**UNITED TECHNOLOGIES CORPORATION  
Pratt & Whitney  
Engineering Division**

**Prepared for  
National Aeronautics and Space Administration  
Lewis Research Center  
Contract NAS3-20072 - Project 4**

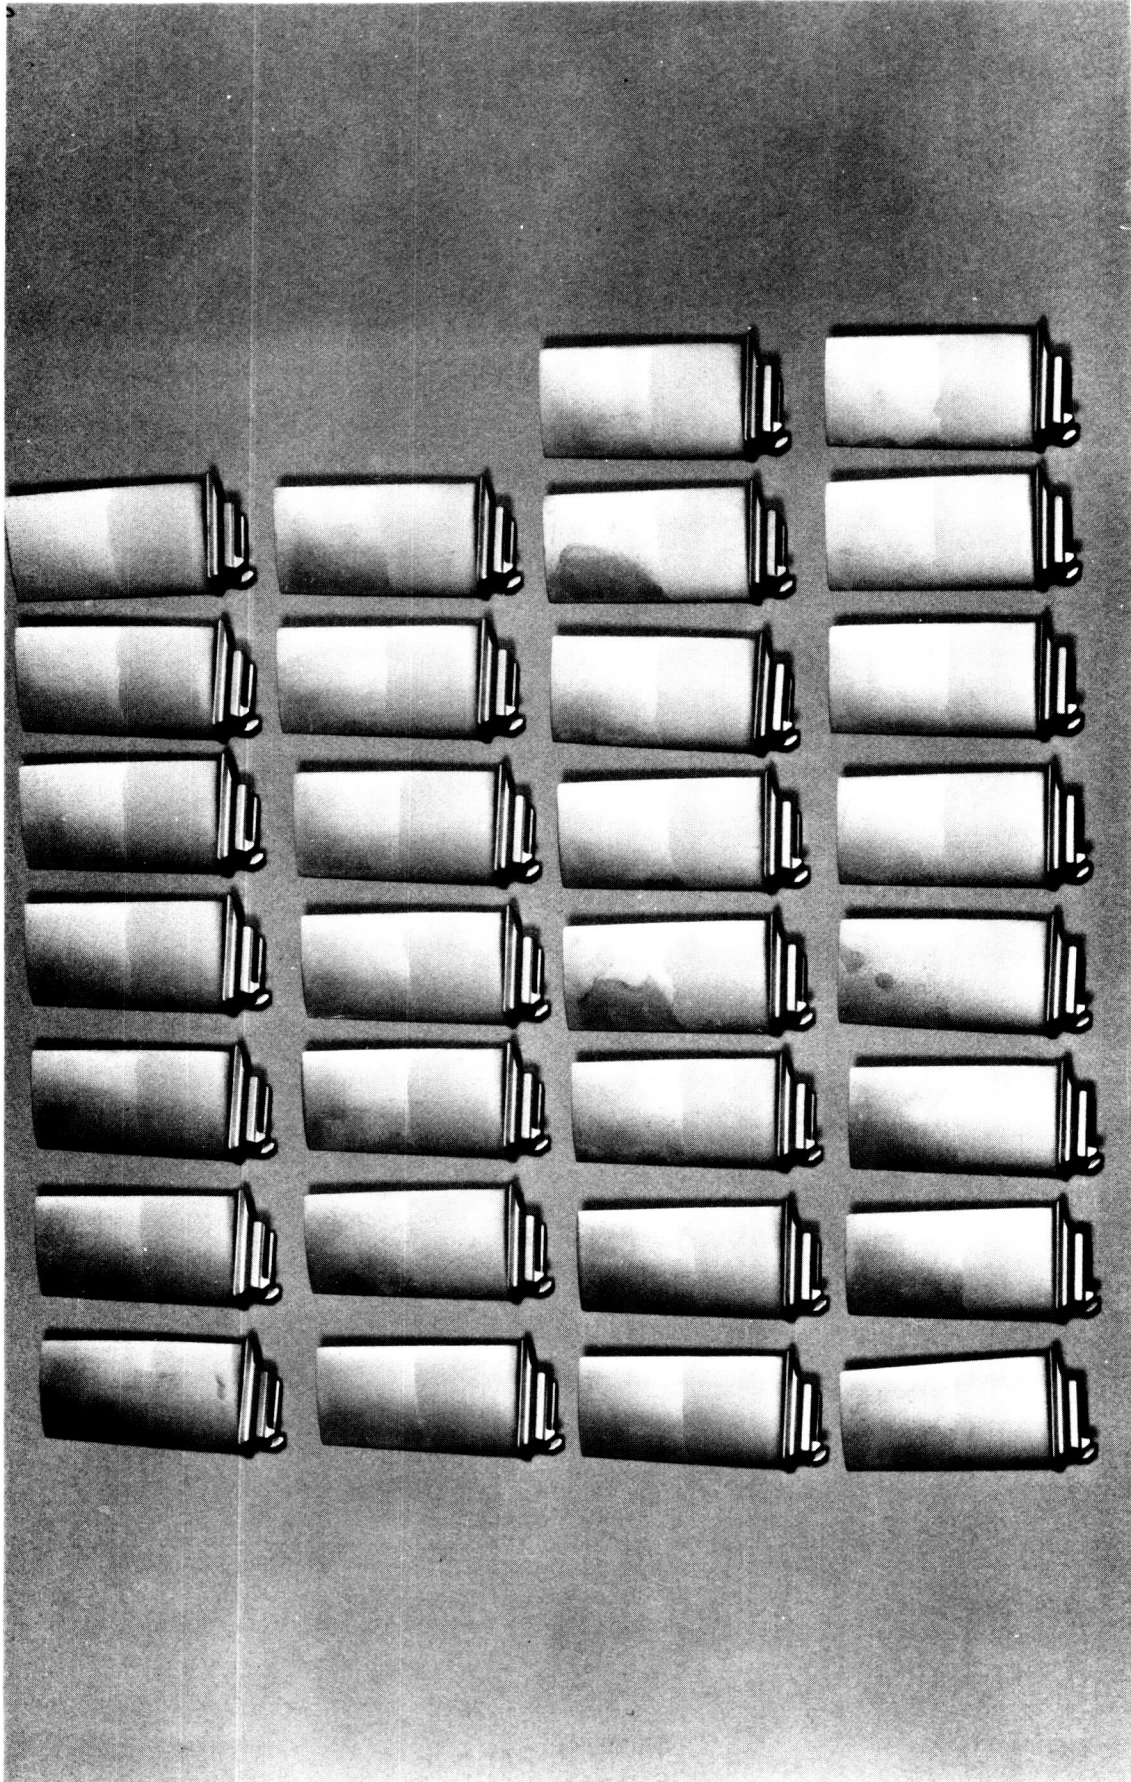
Figure 1 JT8D AMS 4928 8th Stage Compressor Airfoils Gator-Gard Plasma Spray  
Coated with 88WC-12Co and Media Finished

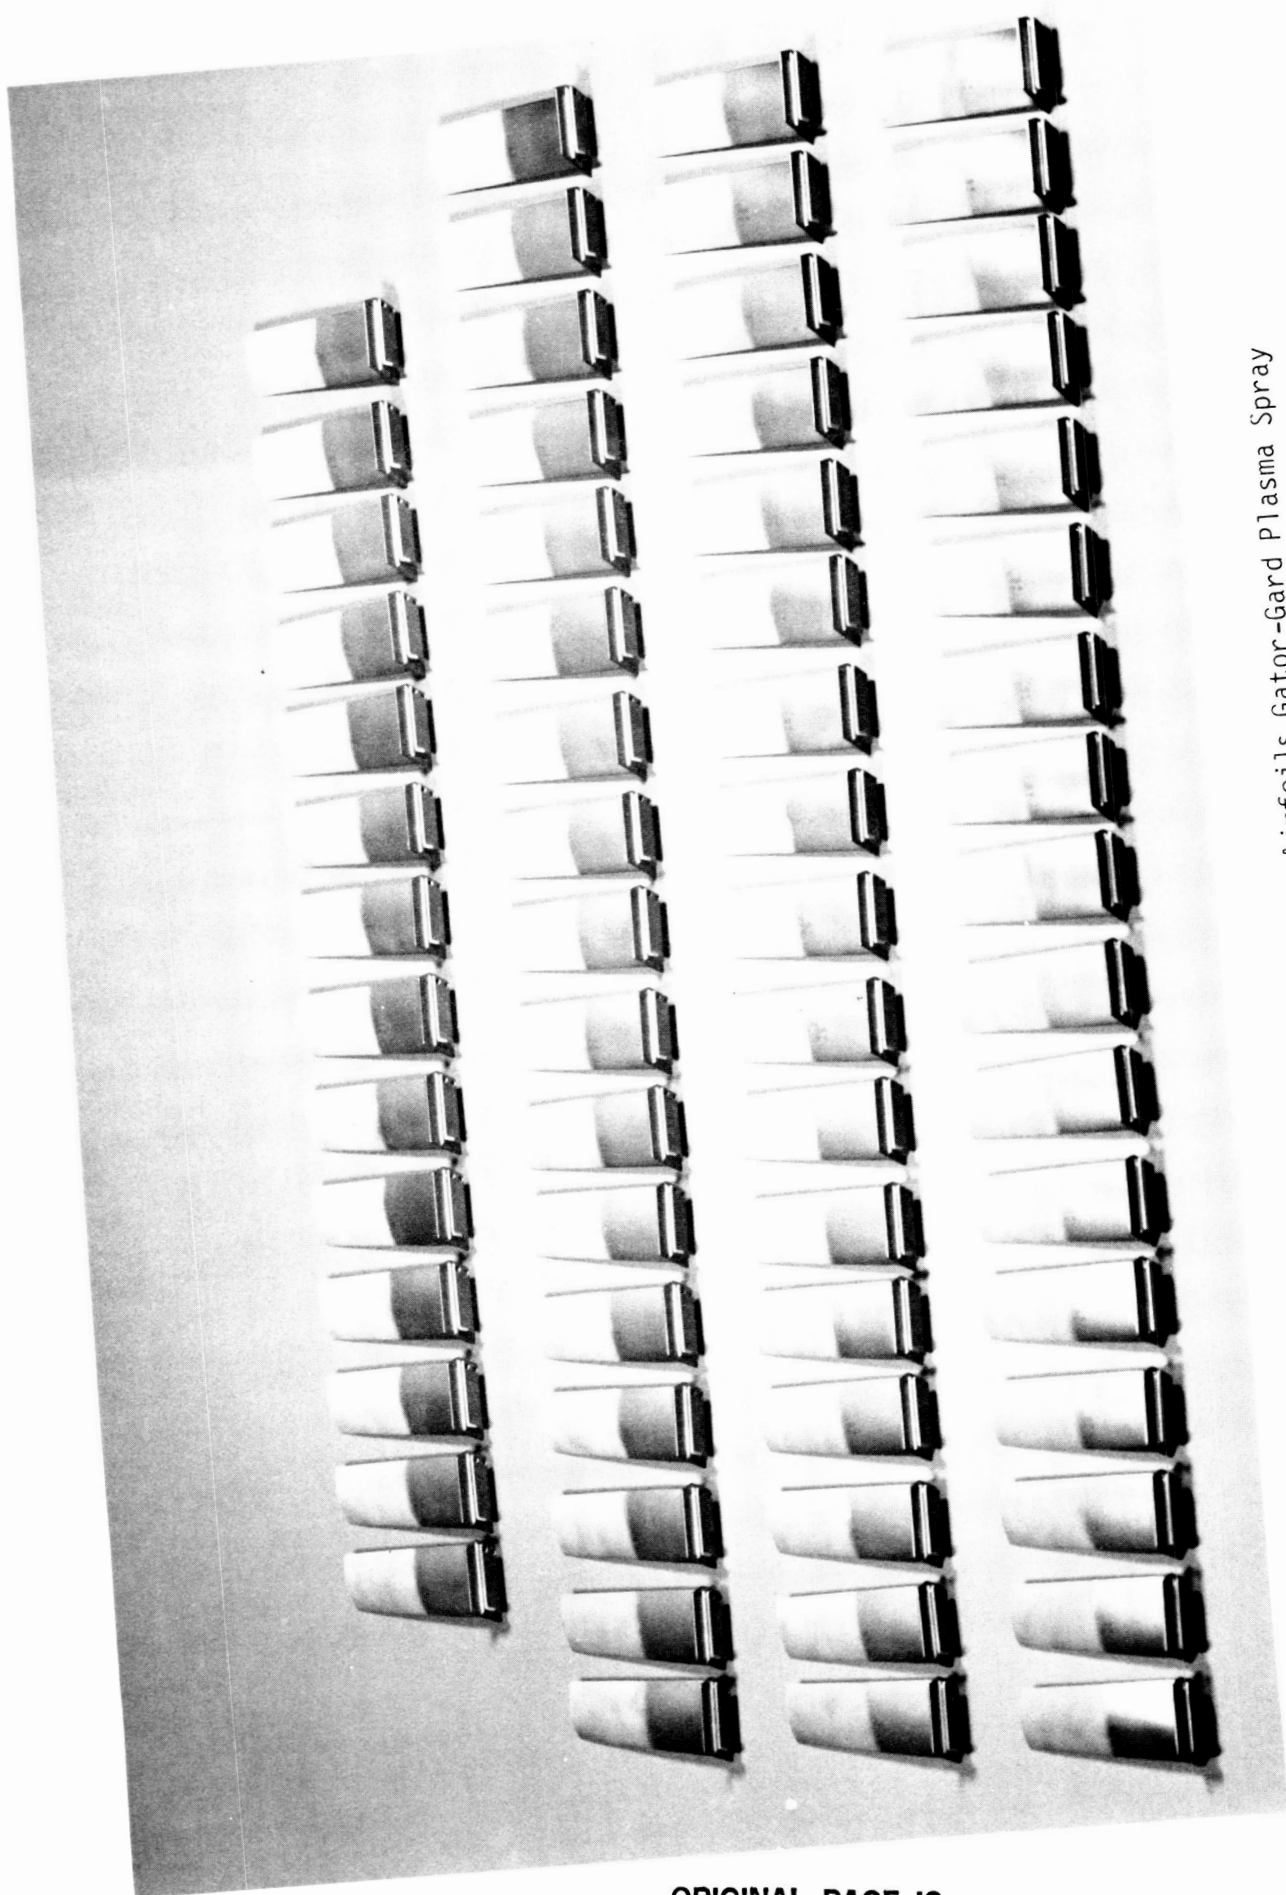
Figure 2 JT9D AMS 4928 7th Stage Compressor Airfoils Gator-Gard Plasma Spray  
Coated with 88WC-12Co

One Gator-Gard plasma spray coated 88WC-12Co seventh stage AMS 4928 compressor blade fractured through the airfoil approximately 2 5/8" above the root platform (Figure 10).

Binocular and scanning electron fractographic examination of the JT9D seventh stage airfoil fracture surface revealed high cycle fatigue (HCF) which had progressed for approximately 7/8" from an origin at the trailing edge surface, and for approximately 5/32" from an origin in vicinity of the leading edge (Figures 11 and 12); rubbed leading edge fracture surface precluded identification of the exact origin location. Fracture terminated in tensile overload between the extremities of the two HCF progressions.

Metallographic examination of plasma coated sections through the leading and trailing edges revealed transgranular HCF fracture paths; there were no apparent material or processing defects at the fatigue origins (Figure 13). Examination of a transverse section through the airfoil, inboard of the fracture, revealed that the coating conformed to the thickness requirement of 25 to 63 microns (1 to 2.5 mils). Coating microstructure was similar to the coating tested in Task VI.

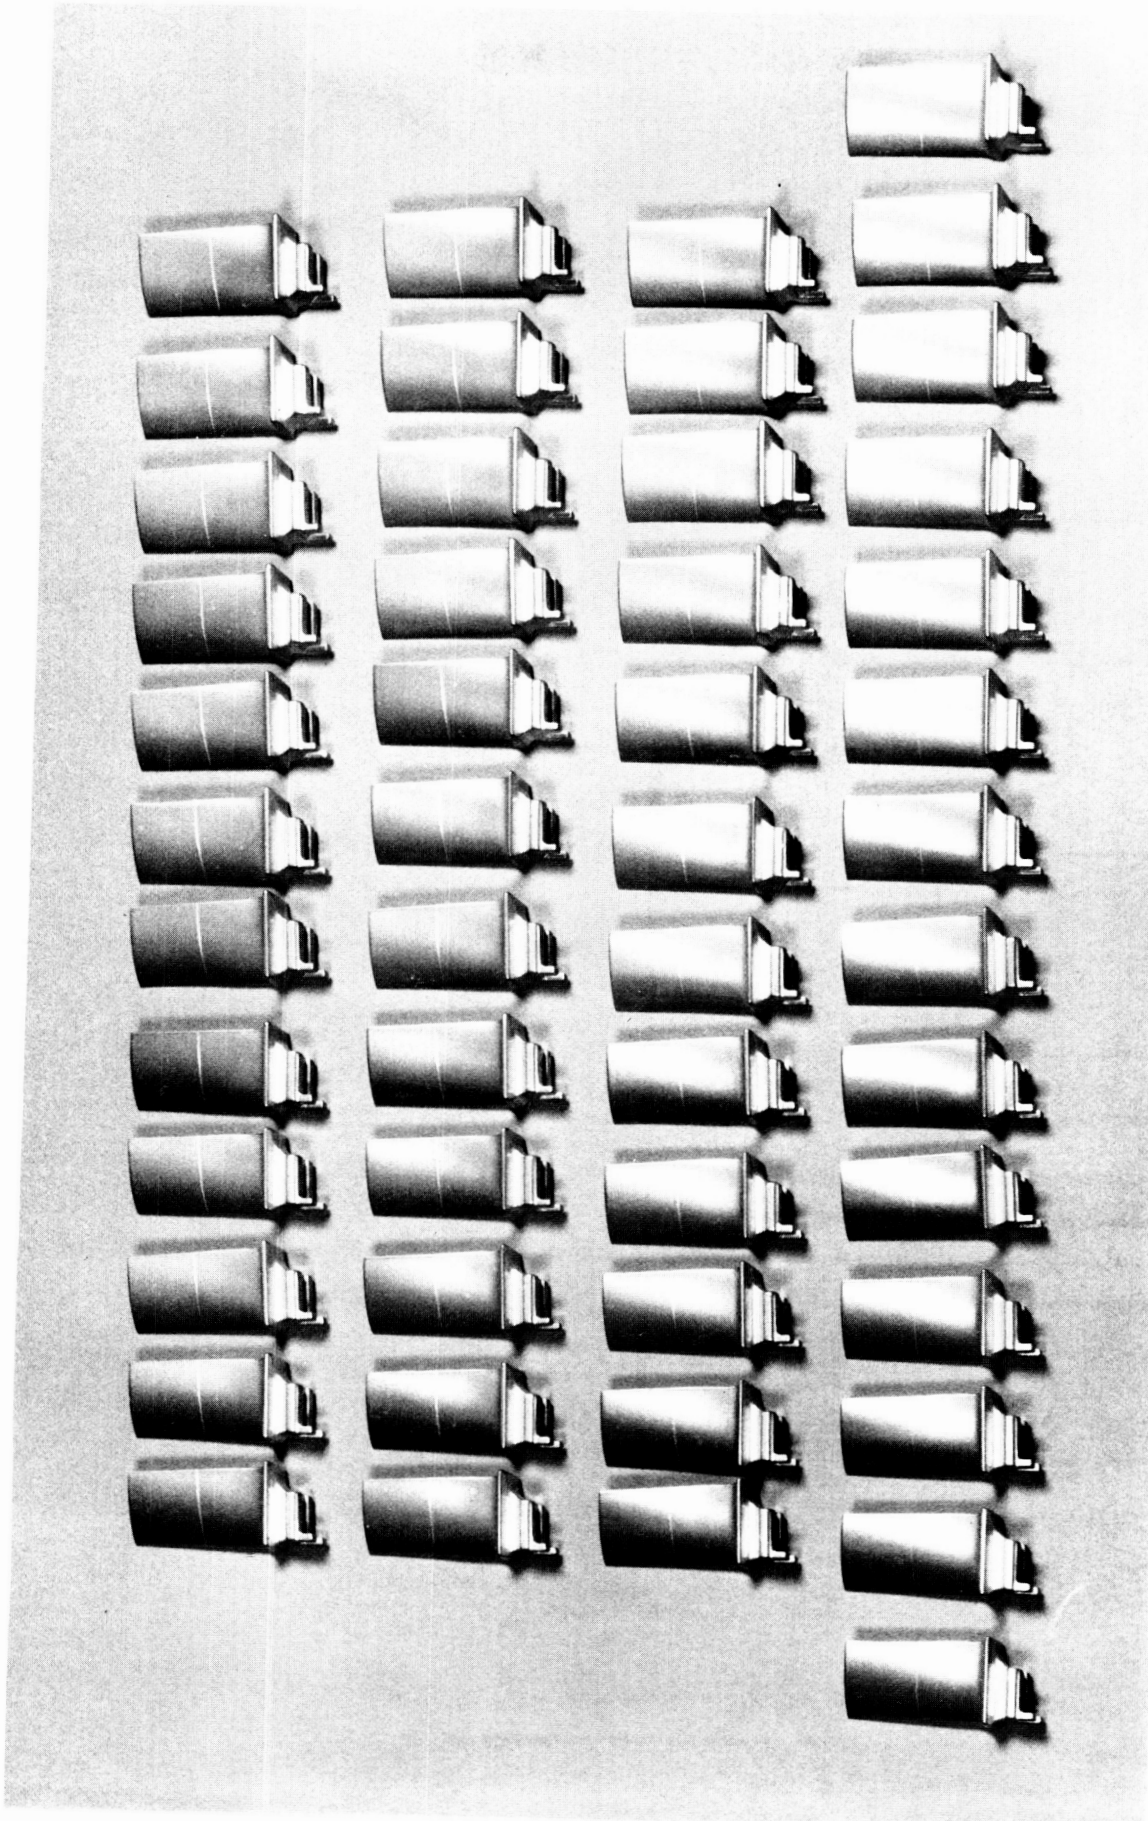
Figure 3 JT8D AMS 5616 12th Stage Compressor Airfoils 60 Kw Plasma Spray  
Coated with 88WC-12Co and Overcoated with SermeTel 5380

Post test inspection of the twelfth stage AMS 5616 airfoils, plasma spray coated with 83WC-17Co, using the 60 KW process, indicated no evidence of cracks. All of these airfoils were still acceptable for engine operation.

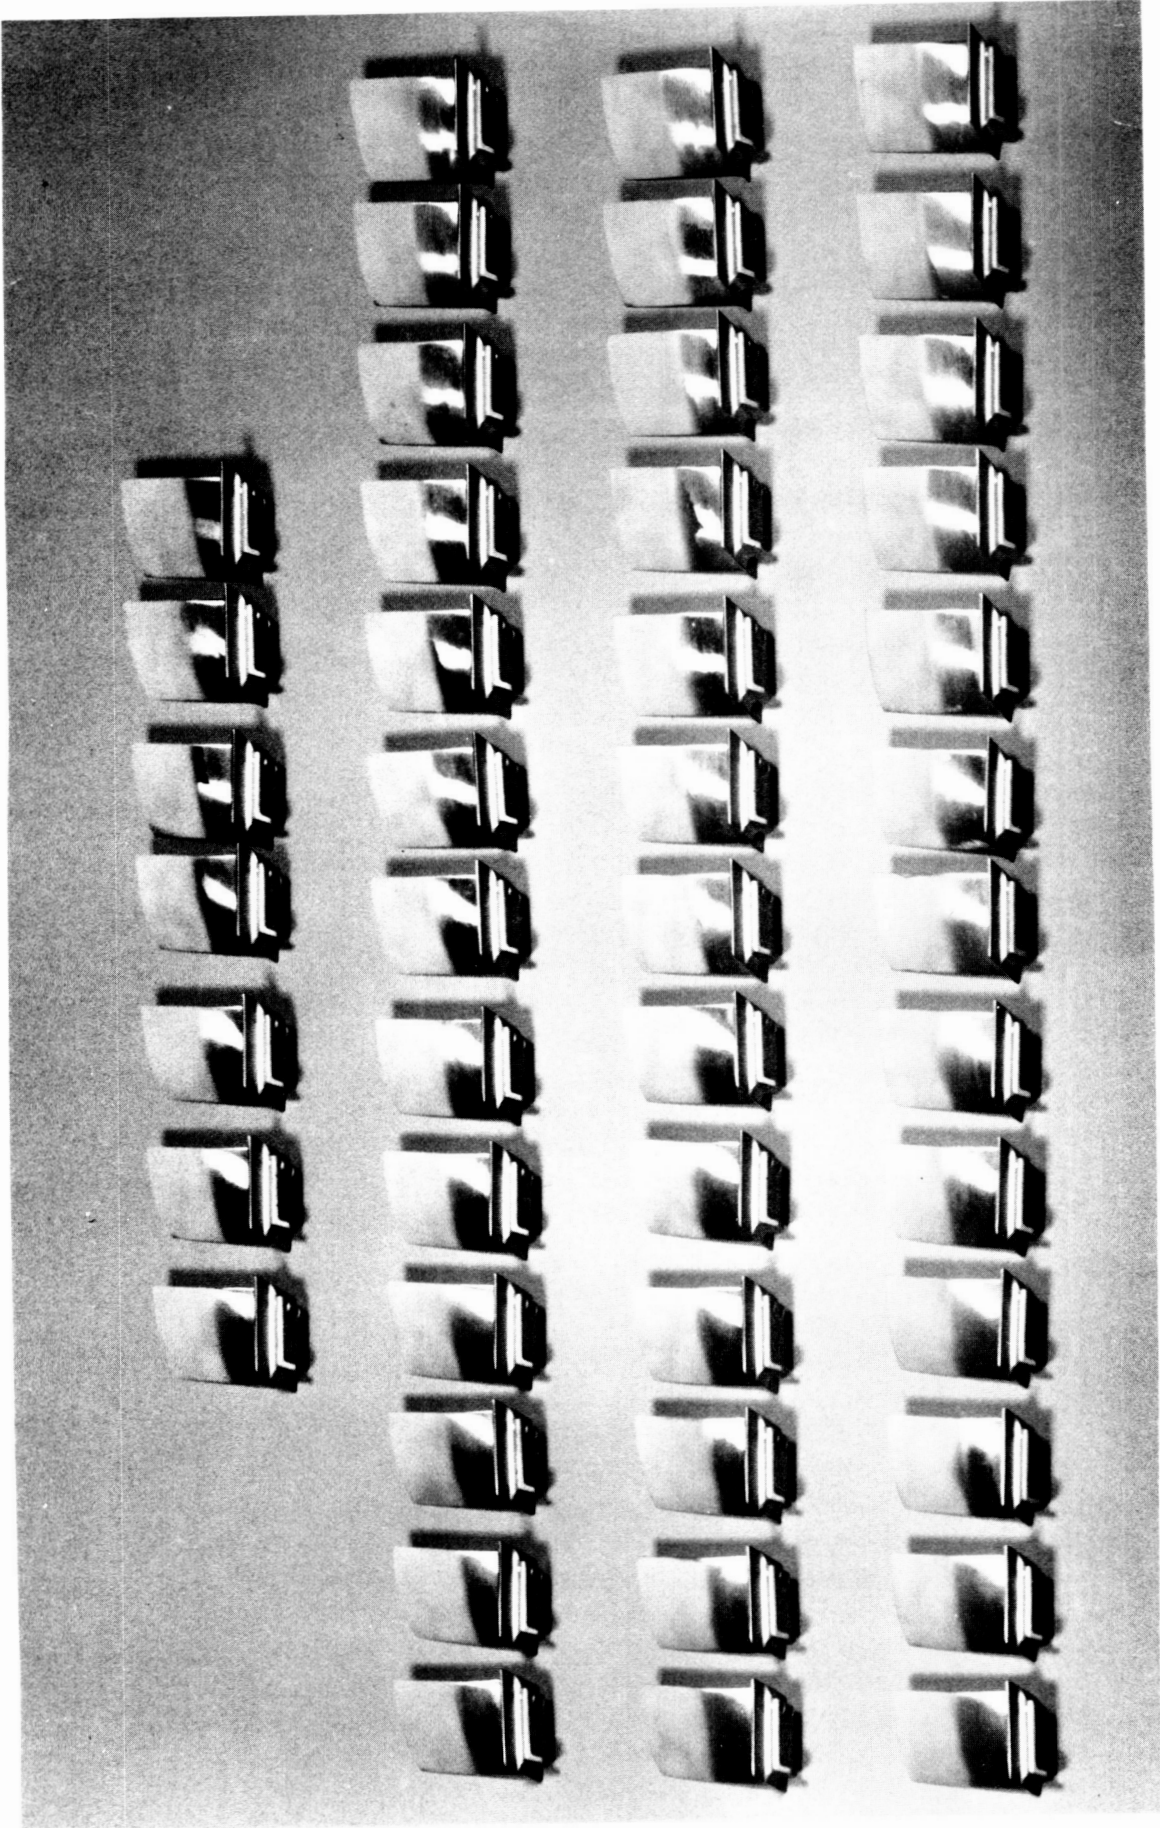
Figure 4 JT9D Incoloy 901 14th Stage Compressor Airfoils Gator-Gard Plasma Coated with 88WC-12Co

Incoloy 901 fourteenth stage airfoils coated with either Gator-Gard plasma spray 88WC-12Co on pack diffusion applied Cr+B did not exhibit any detrimental conditions which would have precluded additional engine testing.

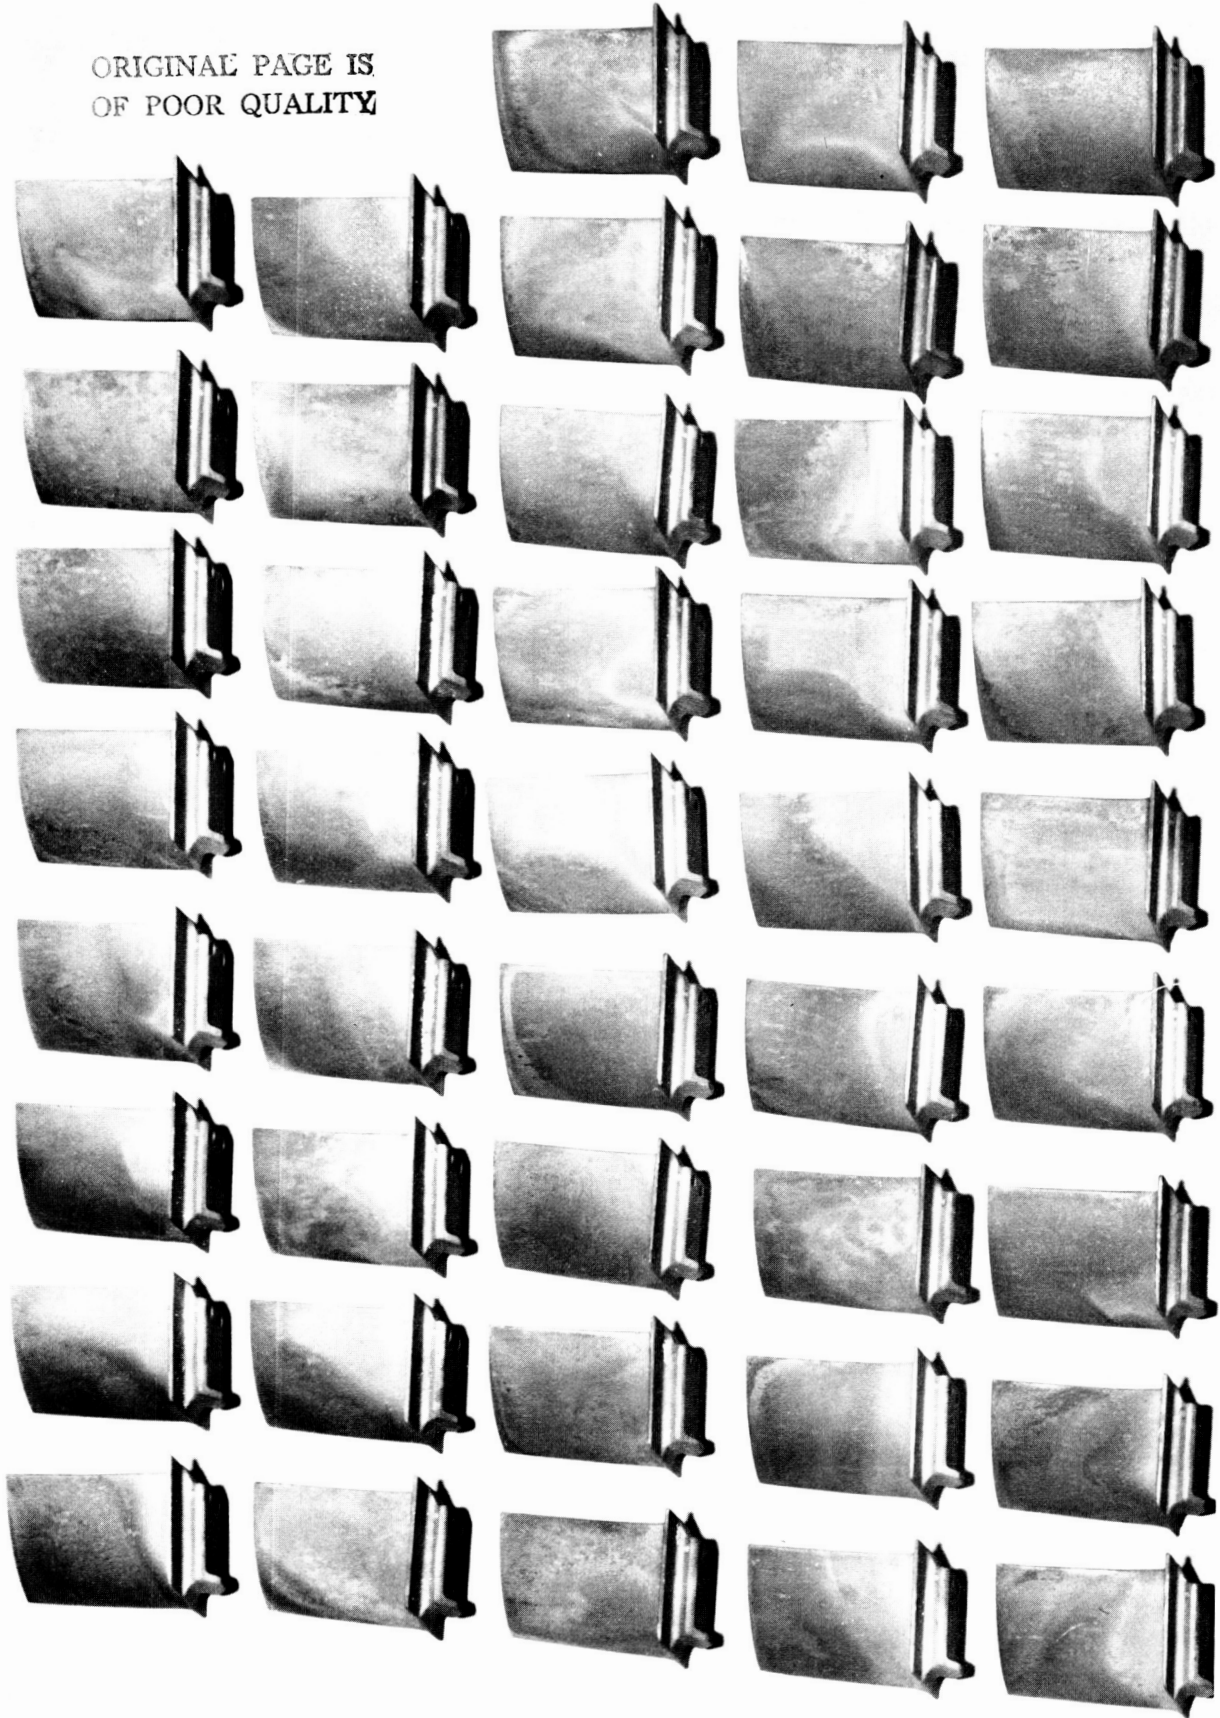
Figure 5 JT9D Incoloy 901 14th Stage Compressor Airfoils Pack Diffusion Coated With Cr+B
