## INSTABILITY OF MULTISTAGE COMPRESSOR K1501

Zhou Ren-mu  
Hangzhou Steam Turbine Works  
Hangzhou Zhejiang, People's Republic of China

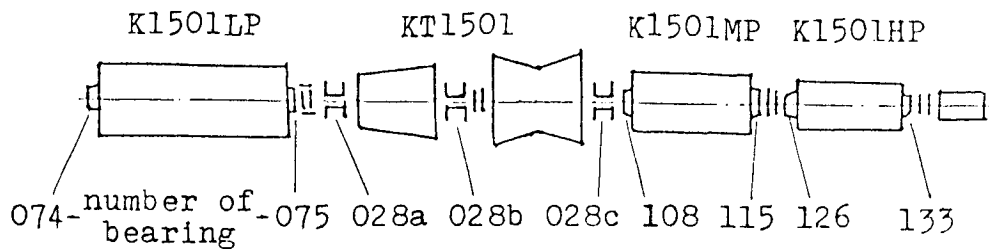
- (1) Six teeth in the middle of the diaphragm labyrinth were removed.
- (2) The ratio of bearing width to diameter was decreased from 0.40 to 0.39 mm.
- (3) Additional displacement transducers were installed on bearings 074 and 075 (fig. 1) to improve vibration monitoring.

Figure 1. - Steam turbine compressor set of KT150-K1501.

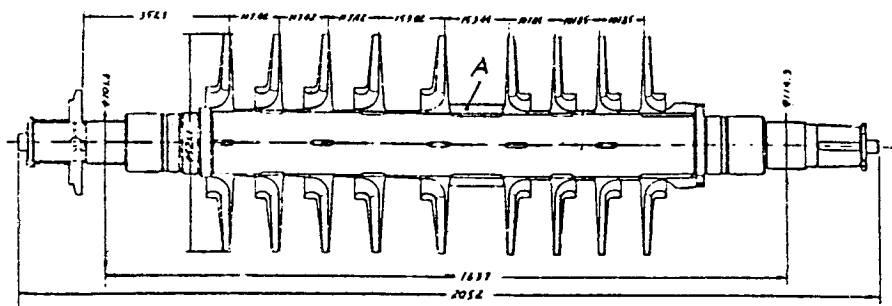
Intensive vibration originated from the low-pressure compressor, K1501LP. Figure 2 shows the longitudinal section of its rotor. Table I shows the parameters of the tilting pad of both bearings. Figure 3 shows the gas labyrinth construction of the middle diaphragm. Figure 4 provides a critical speed map and mode shapes for the rotor.

Figure 2. - Rotor of K1501LP.

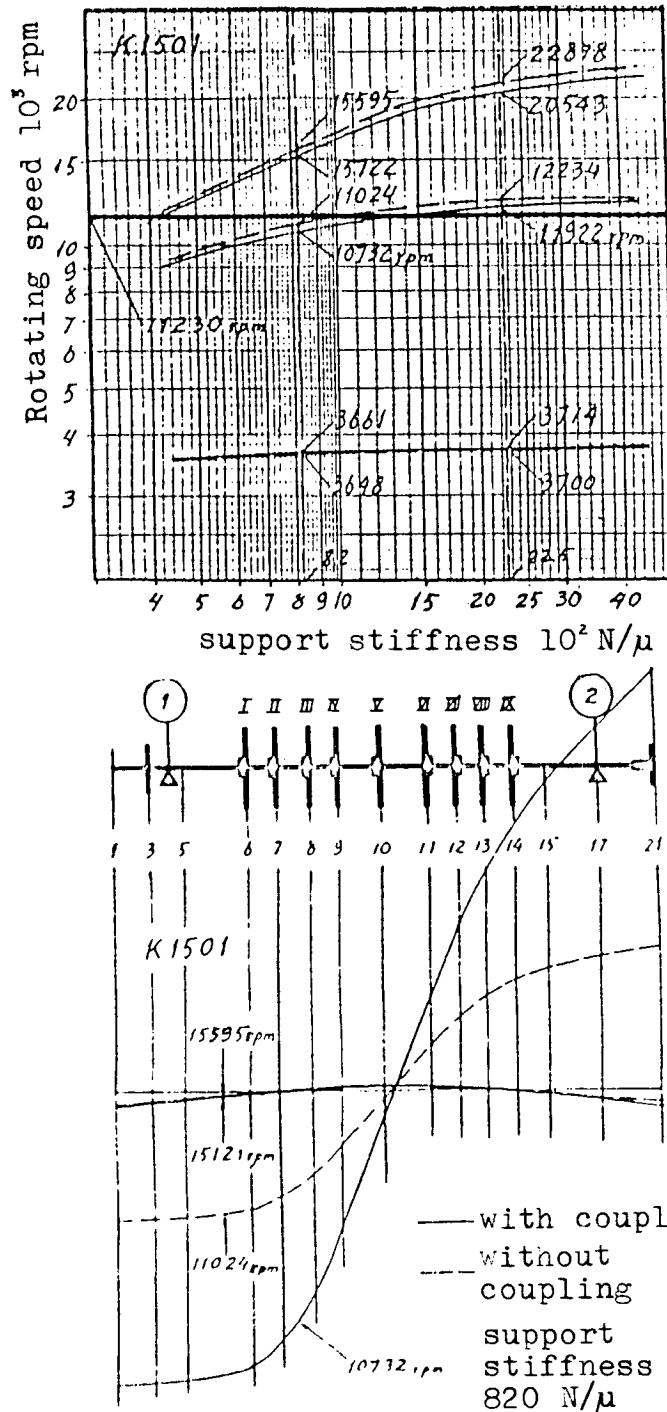
Figure 4. - Critical speed and mode shape of rotor K1501LP.

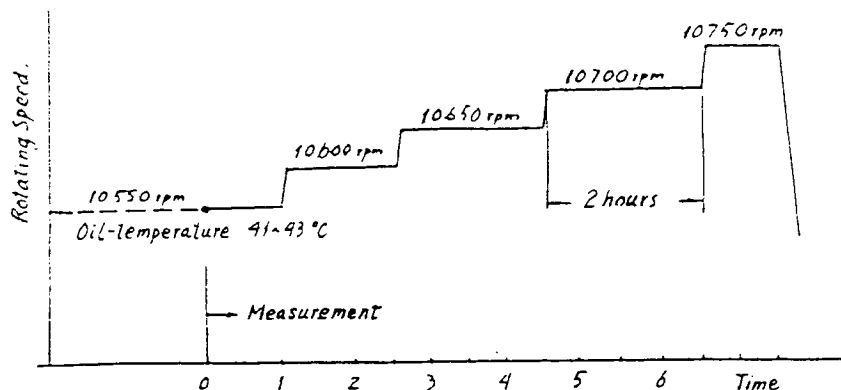
To eliminate the vibration failure rapidly, we cooperated with Mitsubishi in completing a series of tests on November 5-8, 1983. The test speeds were to 10 222 rpm on the first day, and to 10 550 rpm on the third day. All the tests were within specifications. The test procedure for the fourth day is shown in figure 11. After reaching 10 750 rpm and running for an hour, the shaft vibrated intensely.

Figure 11. - Test procedure for November 8, 1983.
