NASA Technical Memorandum 88974

# Fatigue Failure of Regenerator Screens in a High Frequency Stirling Engine

David R. Hull, Donald L. Alger,  
Thomas J. Moore, and Coulson M. Scheuermann  
*Lewis Research Center*  
*Cleveland, Ohio*

March 1987

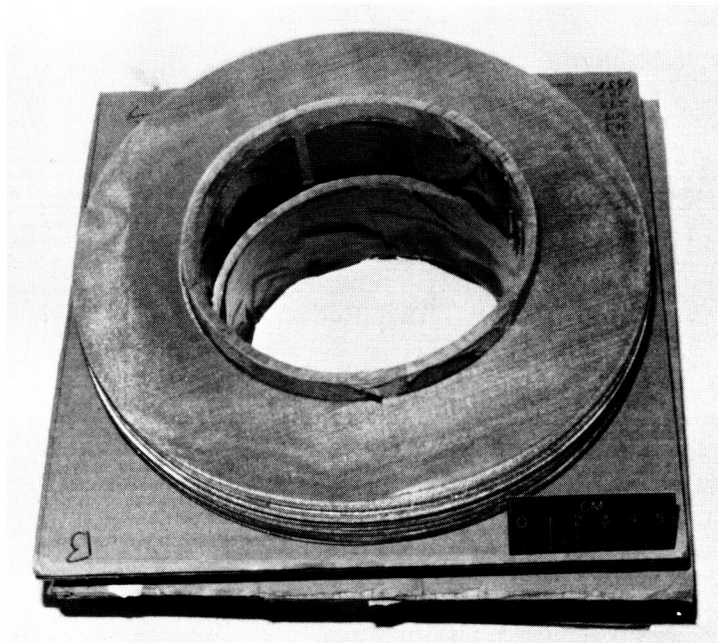
The regenerator matrix for each of the opposed engines of the SPDE is made up of a stack of 350 annular shaped, 200 mesh, woven screens with a wire thickness of 41  $\mu\text{m}$ . A stack of new regenerator screens is shown in figure 3. The screens are pressed into the annular space at the base of the heater shown in figure 4, between the displacer cylinder and heater housing. The screens fill a regenerator length of about 2.54 cm.

FIGURE 3. - STACK OF 350 TYPE 304 STAINLESS STEEL REGENERATOR SCREENS.

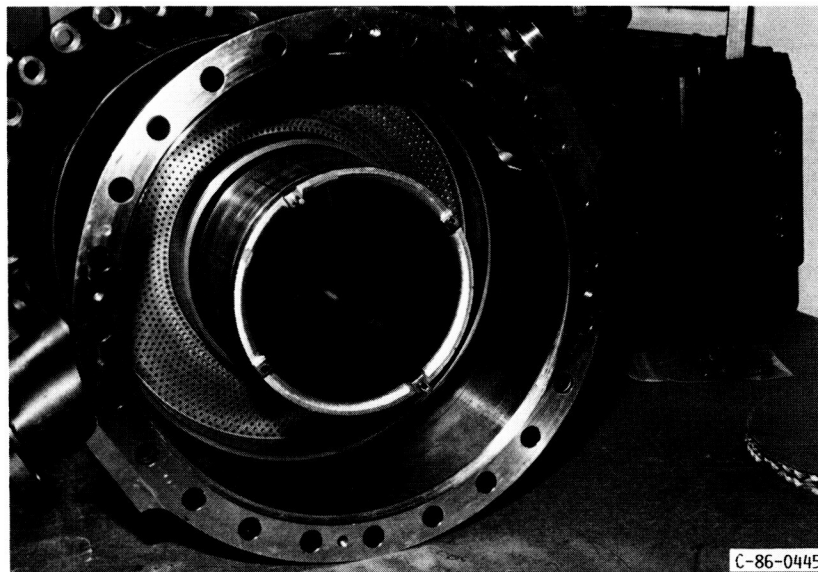
FIGURE 4. - DISASSEMBLED ENGINE SHOWING ANNULAR SPACE AT THE BASE OF THE HEATER WHERE REGENERATOR SCREENS ARE LOCATED.

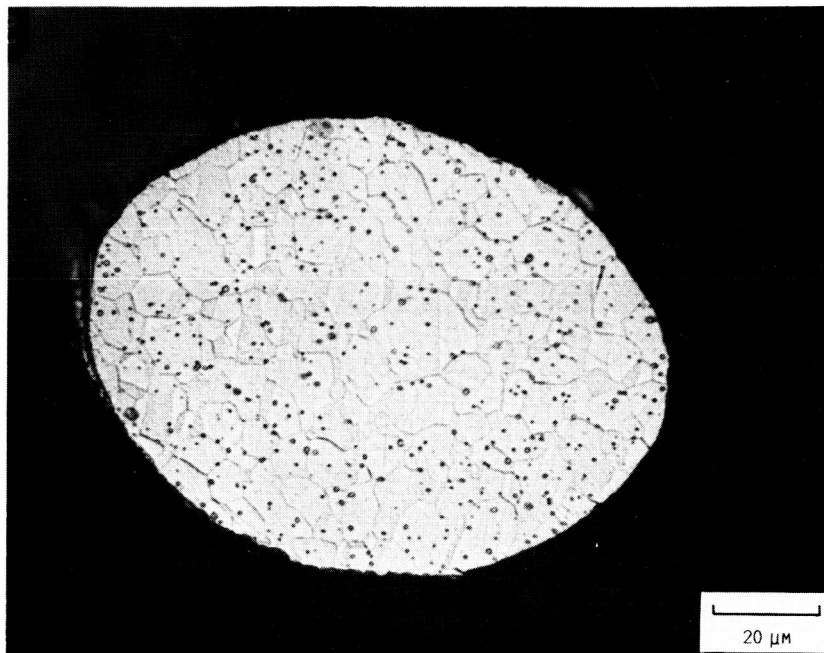
(B) TRANSVERSE SECTION OF UNDEFORMED WIRE.

Microstructures of the as-received and run-in-engine screens were examined by performing standard metallographic techniques. Optical micrographs show the wire crossovers to contain a highly worked microstructure, while away from the crossovers the microstructure consisted of equiaxed grains (fig. 10). Transverse sections of the wires showed the worked microstructure to exist across the full thickness of the wires at crossovers (fig. 10(c)). No variation in microstructure was observed between the as-received and run-in-engine screens.

FIGURE 10. - OPTICAL METALLOGRAPHY OF SCREEN WIRES SHOW A HIGHLY WORKED STRUCTURE AT CROSSOVERS. ETCHED ELECTROLYTICALLY USING 8 VOLTS/1 AMPERE IN A SOLUTION OF 10 PERCENT CHROMIC ACID IN WATER.
