# **NASA Contractor Report 3715**

## **DC-10 Composite Vertical Stabilizer Ground Test Program**

**J. M. Palmer, Jr., C. O. Stephens,  
and J. O. Sutton**

**CONTRACT NAS1-14869  
AUGUST 1983**

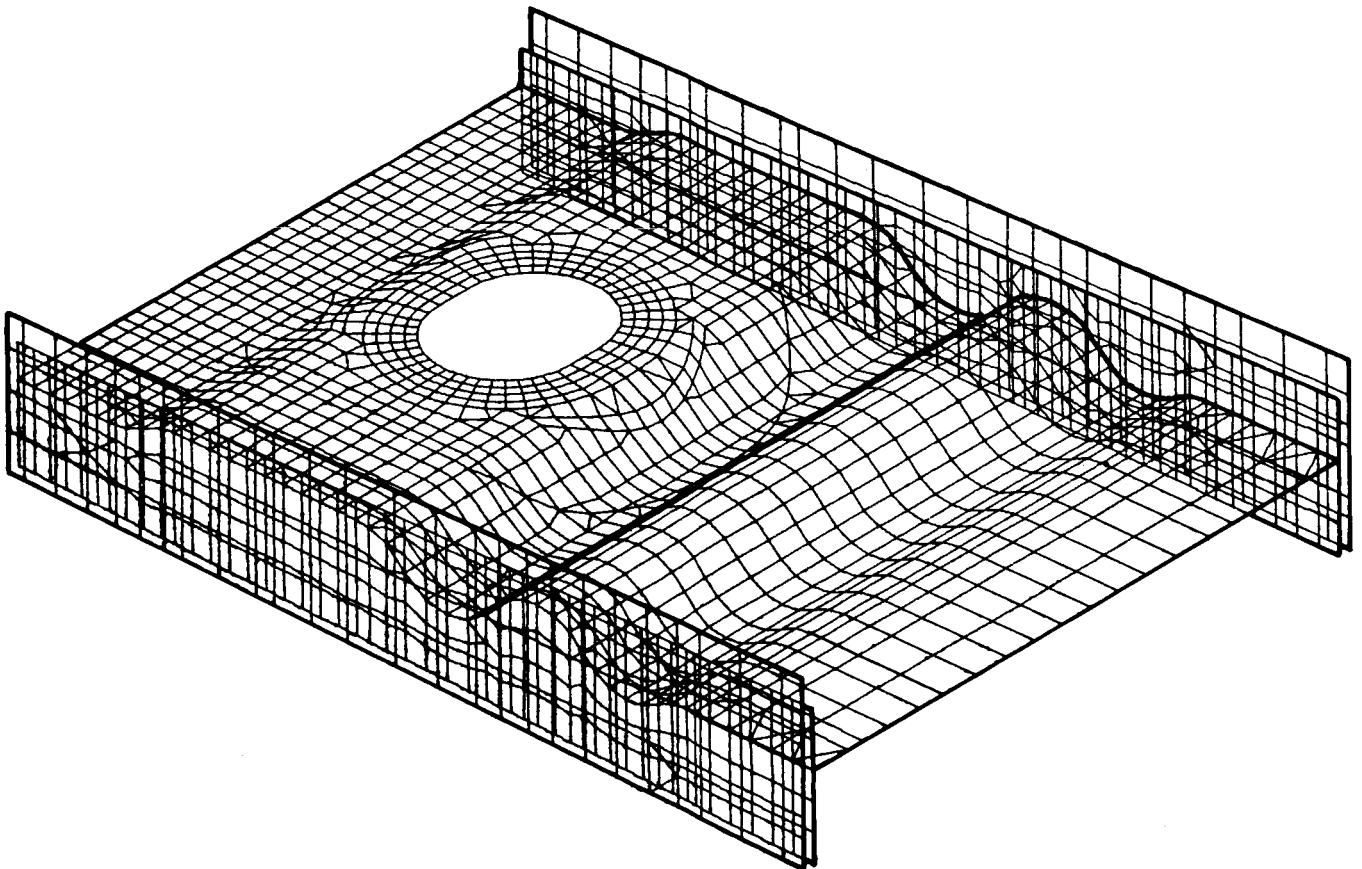
**FIGURE 24. NASTRAN MODEL OF REAR SPAR WEB**

The second area of investigation was the covered cutouts in the rear spar web and the center bay of the Z<sub>FR</sub> Station 314 rib. A simple planar analysis indicated that the strains at the perimeter of the cutouts were not critical even with the door missing. However, it was recognized that the sine wave web produces significant out of plane forces at the hole which would modify those results. Accordingly, a detailed three dimensional NASTRAN model of the critical rear spar web was developed (Figure 24). Web shear, spar cap and bolted joint interface loads were applied to the model while the attachment of the door module to the web module was analytically varied from full shear effectivity to zero shear effectivity. A reference case with no door installed was also run. The results are shown in Figure 25, where the laminate mid-plane strains at the perimeter of the access opening are plotted for each quality of fastener fit. Clearly, if sufficient slippage between the door and web is available, the presence of the fasteners provides almost no relief from the maximum strains, while fully effective fasteners (i.e., a fully effective door) provides considerable support at the edge of the cutouts.

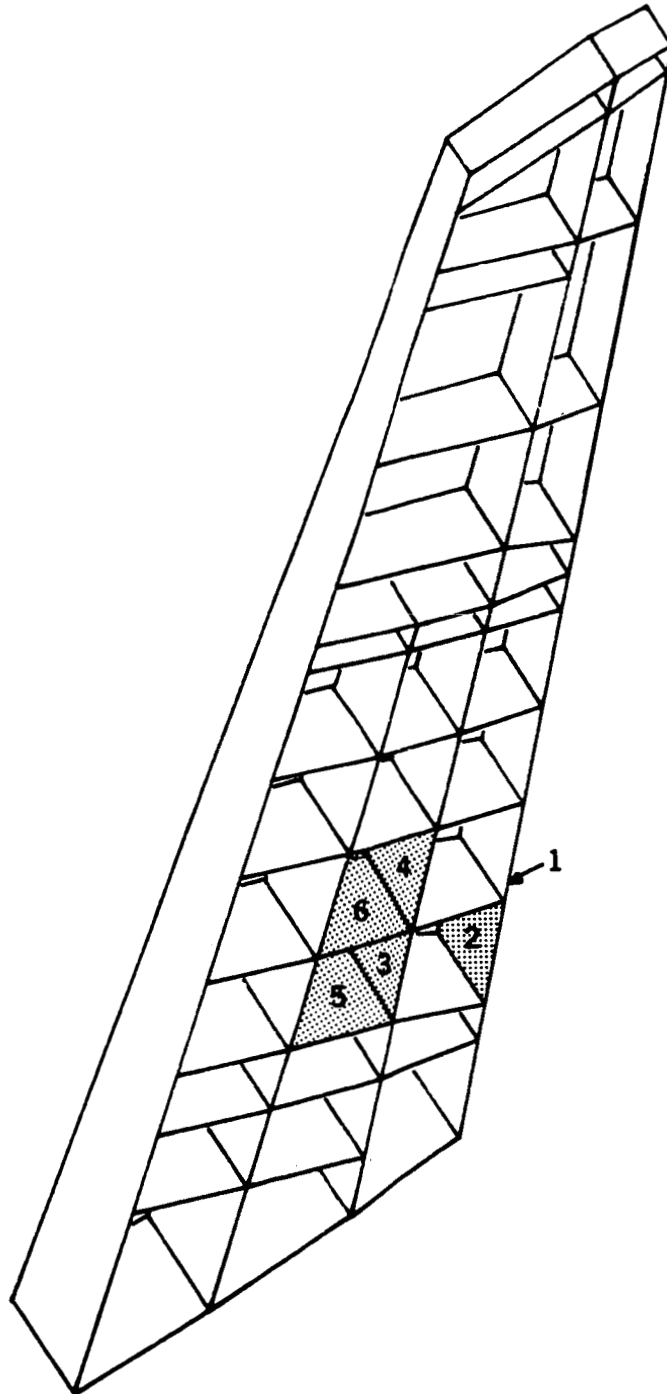
**FIGURE 26. FAILURE INITIATION INVESTIGATION POINTS**

The NASTRAN internal loads model for the complete stabilizer was next modified to reflect assumed failures in areas which were failed in both the stub box and GTU in order to establish the probable failure initiation point. The locations are shown in Figure 26. Loads equal to the test loads at failure were applied to the model. Only the assumed failure in the rear spar web between Z<sub>FR</sub> Stations 326 and 350 resulted in negative margins of safety for the remaining structure.

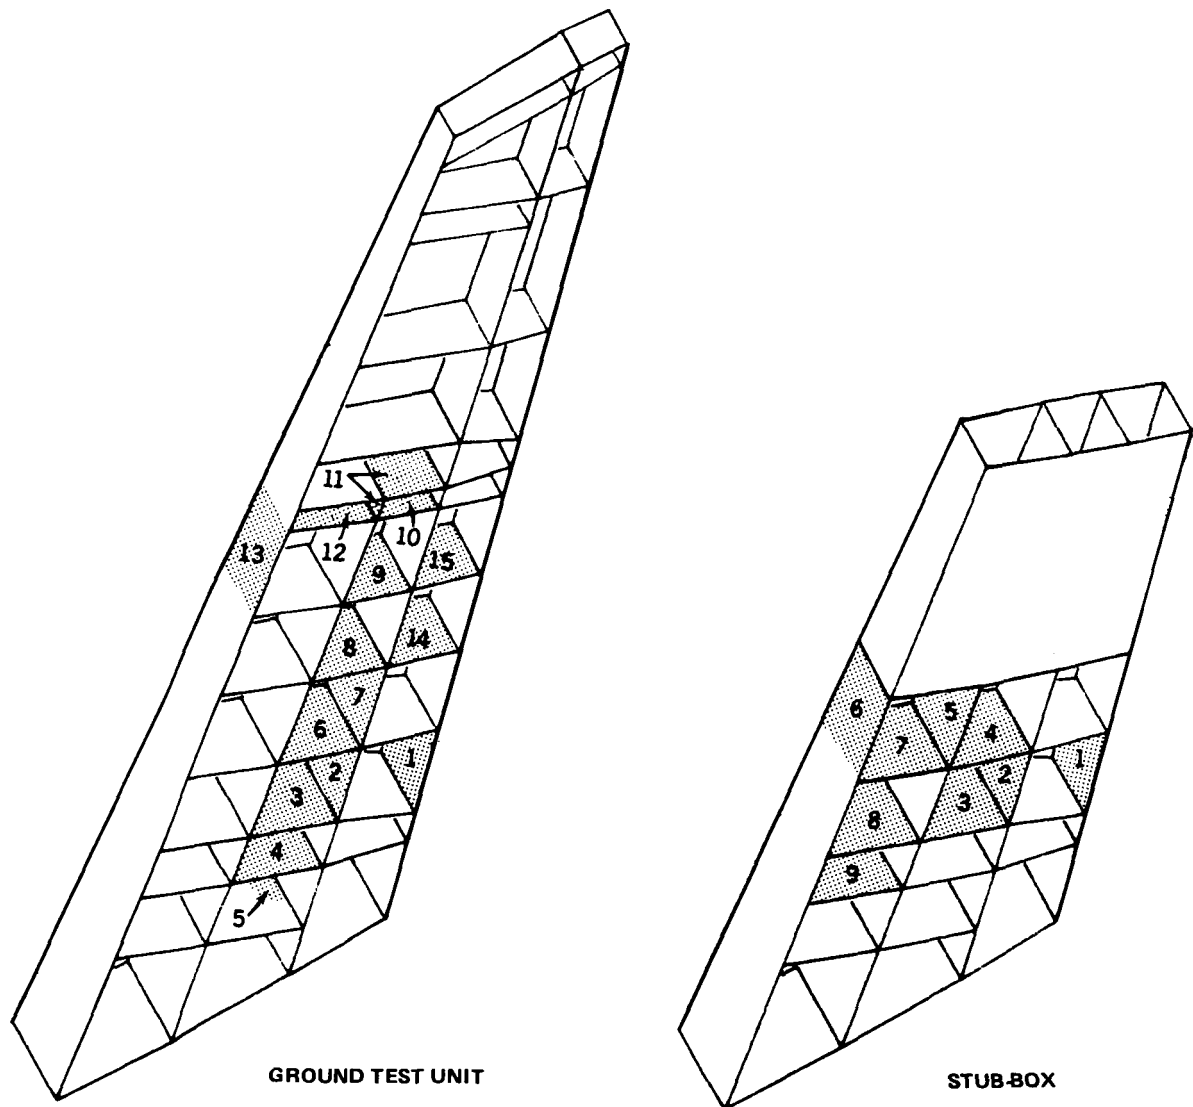
**FIGURE 27. ANALYTICAL FAILURE SEQUENCE**

The NASTRAN model for the stabilizer was modified to reflect an assumed failure in the rear spar web at Z<sub>FR</sub> Station 342 and was subjected to the appropriate load condition (maximum bending case). This analysis indicated a progression of failure to the aft center spar web between Z<sub>FR</sub> Stations 329 and 350. This failure progression was pursued analytically with the finite element model to determine the probable sequence of failure. Each structural element that subsequently indicated a negative margin was deleted from the model and the loads reapplied. A search was then made for negative margins in the remaining structure. In this fashion, a probable failure sequence was established for both test articles as shown in Figure 27. Each distinctive structural failure observed in the substructure of both test articles was predicted by this analysis.

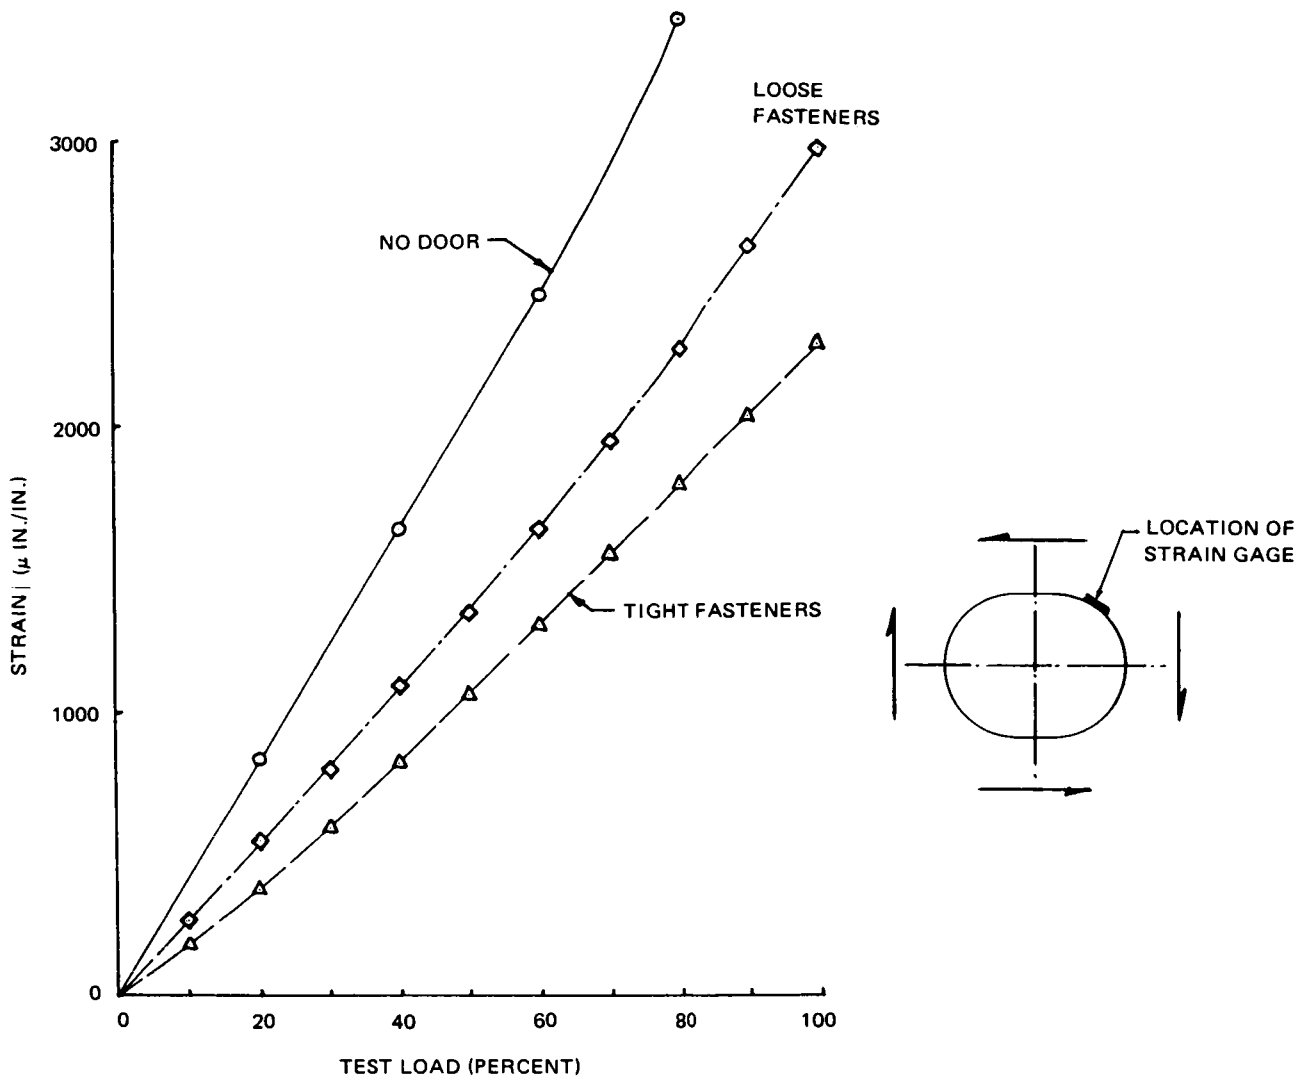
FIGURE 29. STRAIN AT PERIMETER OF CUTOUT IN AMC7855-5 RIB COMPONENT

The results of these tests are shown in Figure 29, where the maximum strains measured at the perimeter of the access opening are plotted versus load. Without a door attached, the hole perimeter strains were extremely high. With the tight fit holes, the perimeter strains were considerably reduced. When the door holes were drilled out, the strains increased, as was expected. When the web holes were drilled out (not shown) no additional effect was observed. This is consistent with the failure theory, in that once the fasteners lose contact with the holes, additional clearance can do no additional harm. Only after sufficient distortion had occurred to bring the intermediate fit configuration fasteners into contact with their holes would any difference become apparent. This load level was not reached during the test due to the risk of prematurely damaging the specimen.

The analyses using the NASTRAN models of the stabilizer and the critical rear spar web together with the results of the tests on the rib component all confirmed the validity of the failure theory. The failures in both test articles was the result of high stress concentrations at the edge of the lower rear spar access opening. These high stress concentrations were the result of the clearance between the holes and fasteners attaching the load-carrying access covers to the spar webs. The discrepancy in load level at failure between the two test articles was the result of differences in fit of the fasteners.

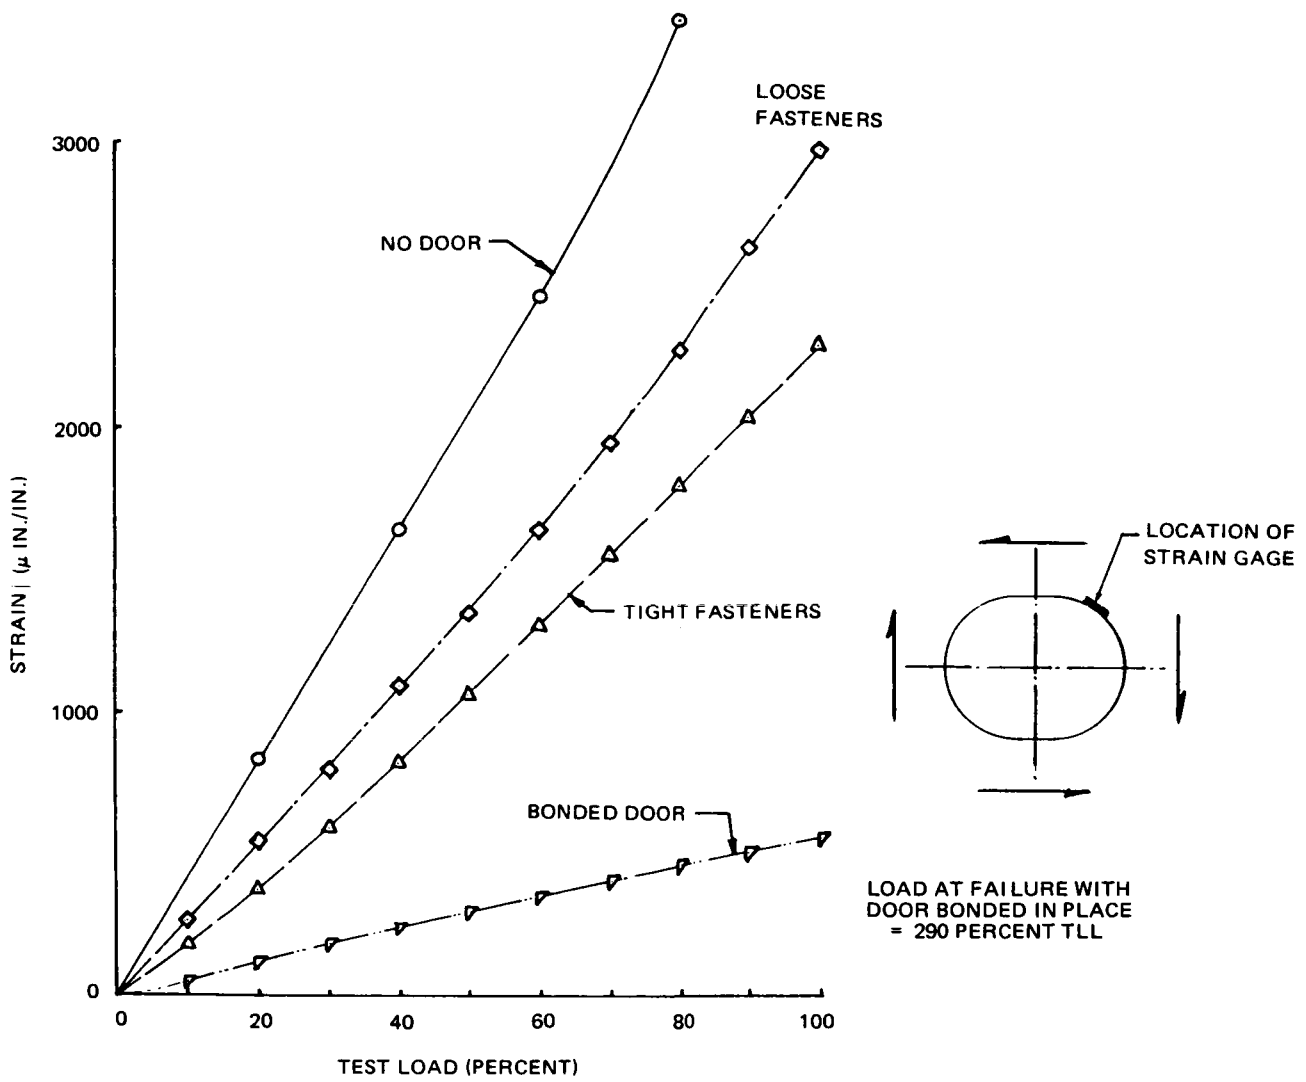
FIGURE 33. STRAIN AT PERIMETER OF CUTOUT IN AMC7855-5 RIB COMPONENT

To test the validity of the concept, a flanged plate was made and installed on the AMC7855-5 rib test specimen (Figure 31). The panel was tested to failure, with failure occurring in the basic sine-wave web, well away from the opening (Figure 32). The strains measured at the perimeter of the hole with the bonded cover in place are shown in Figure 33.
