**FLIGHT SERVICE EVALUATION  
OF COMPOSITE COMPONENTS ON THE  
BELL HELICOPTER MODEL 206L**

**SECOND ANNUAL FLIGHT SERVICE REPORT  
AUGUST 1983 THROUGH DECEMBER 1985**

**H. E. WILSON, II**

**BELL HELICOPTER TEXTRON, INC.  
FORT WORTH, TEXAS 76101**

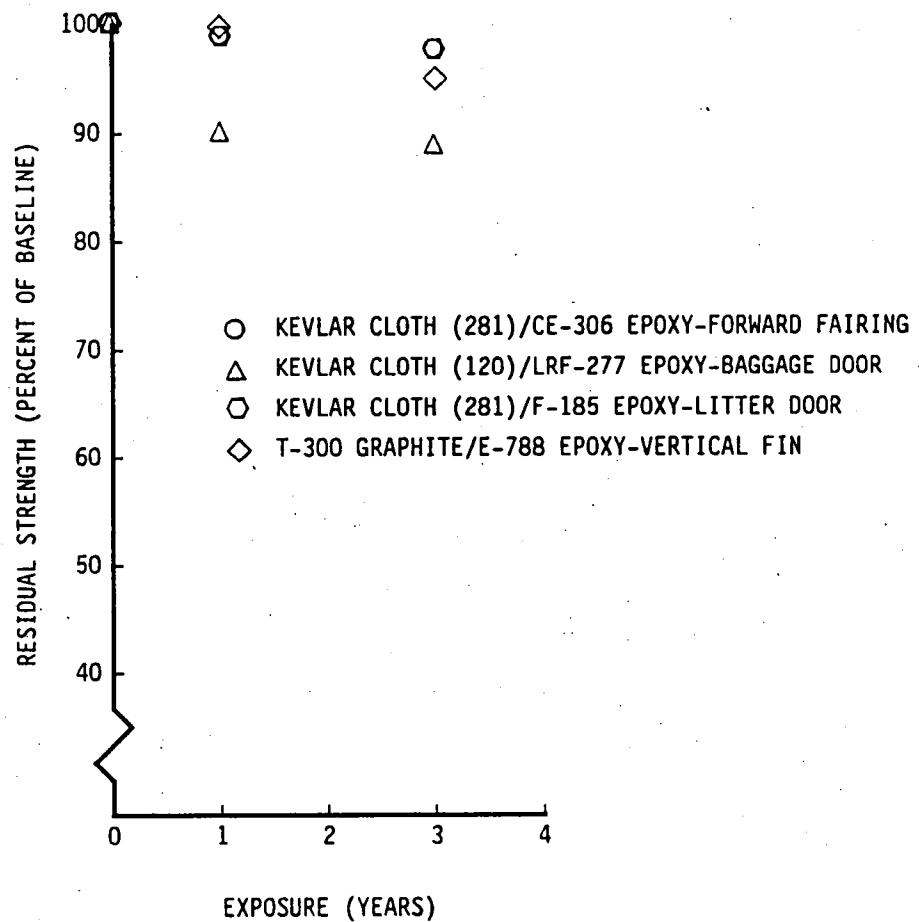
Figure 3-4. Average residual compression strength for painted specimens after three years of exposure.

The average residual compression strengths for painted specimens after three years of exposure are shown in Figure 3-4. Data from all five geographic locations are averaged and presented as a percentage of the baseline strength. All the material systems exhibit fairly good strength retention in compression. The Kevlar-49/LRF-277 (baggage door) had the greatest strength degradation. Its strength retention was 88% of the baseline after three years of exposure. The effects of environment on the residual compression strength for each material are shown in Figures 3-5 through 3-8. The data represent a comparison of the average compression strength after exposure as compared to the average baseline strength for each laminate.

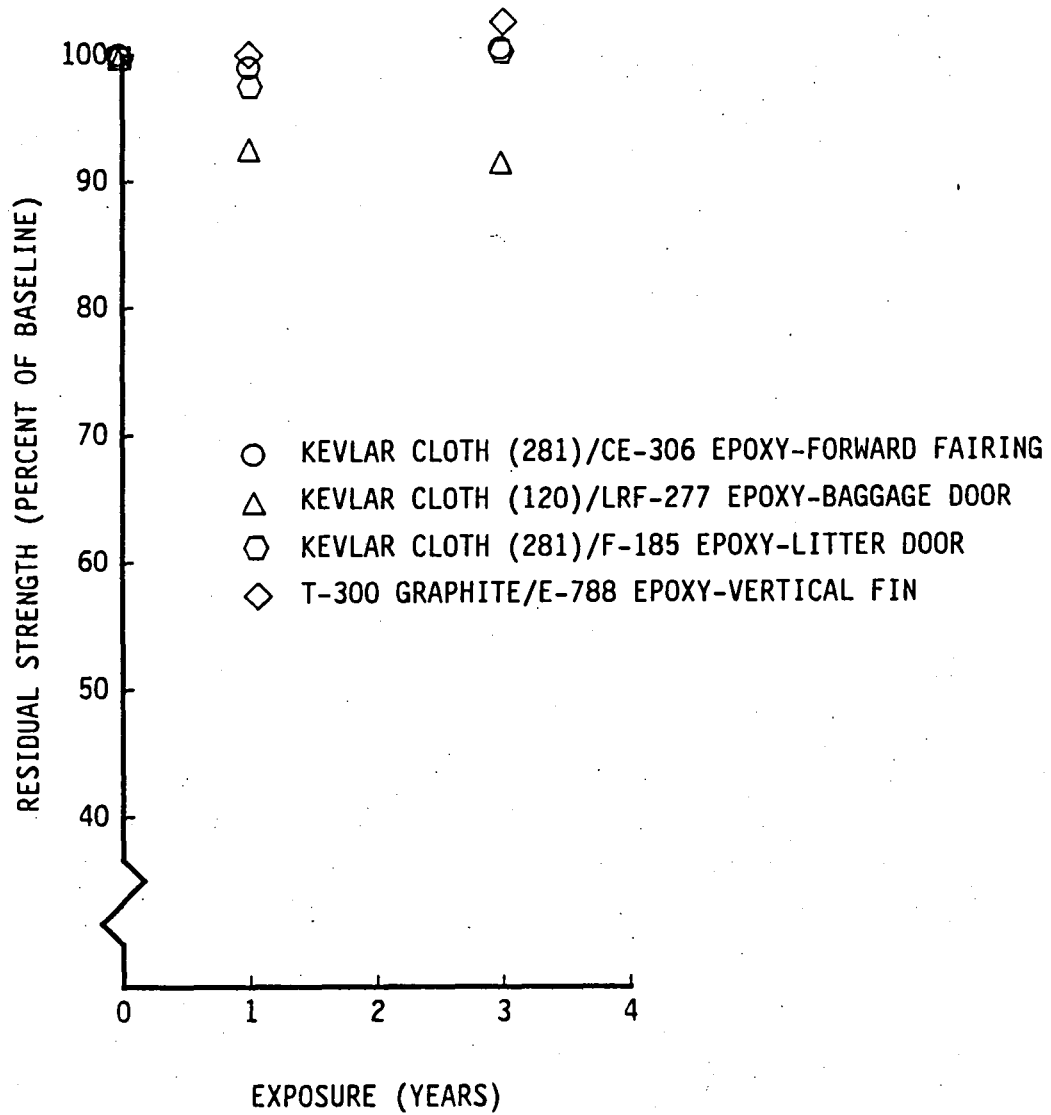
Figure 3-9. Average residual short beam shear strength data.

The average residual short beam shear strength data for the painted specimens with three years of exposure are shown in Figure 3-9. The Kevlar-49/LRF-277 (baggage door) had the lowest short beam shear strength retention. It was

91% after three years of exposure. The other laminates have a residual strength greater than 95% of baseline. The effects of the environments are given in Figures 3-10 through 3-13.

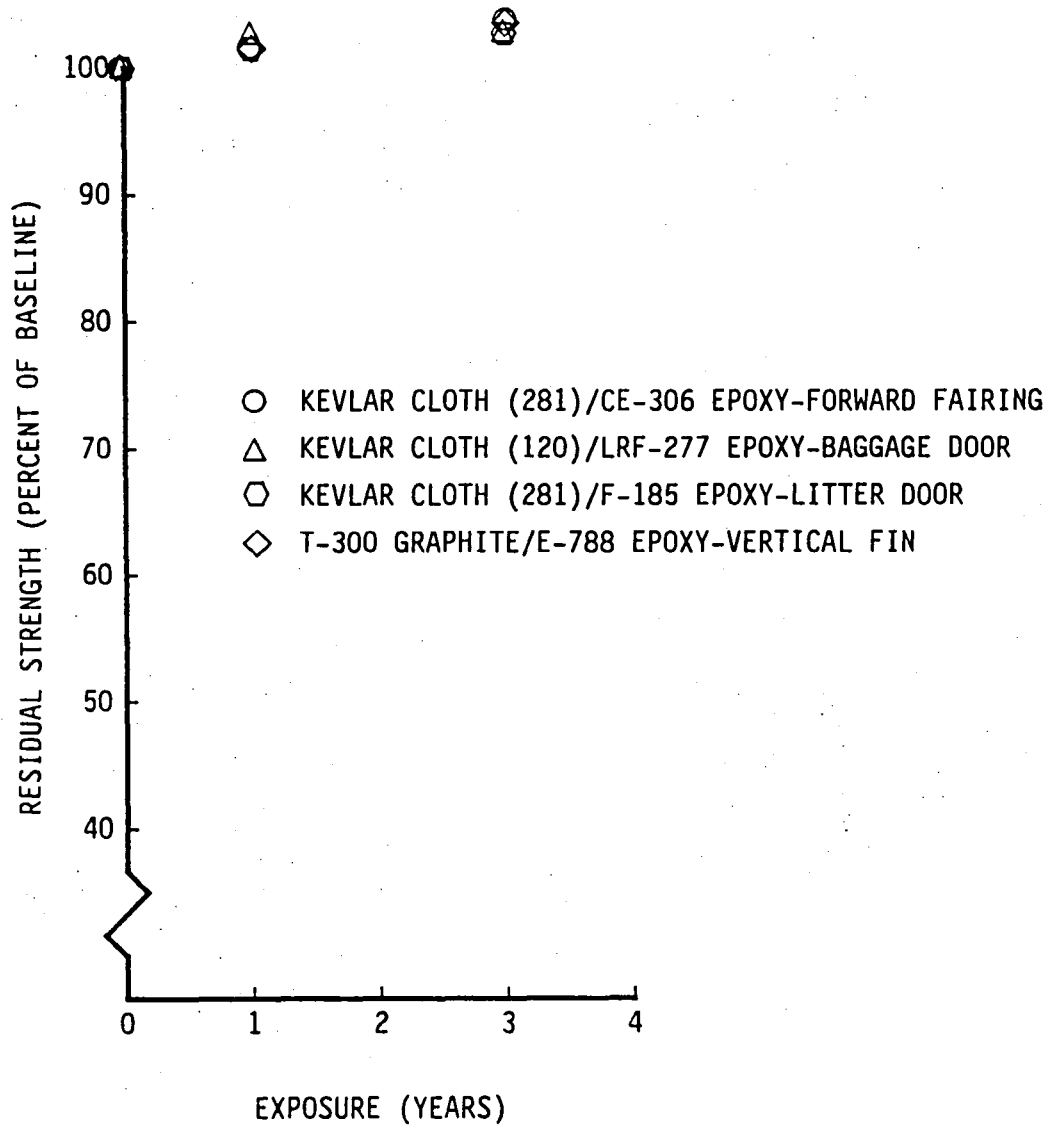
Figure 3-14. Average residual strength for tension coupons.

The tension specimen did not show any significant reduction in strength from three years of exposure. Figure 3-14 shows the average residual strength for the tension coupons. The effects of the environments are given in Figures 3-15 through 3-18.

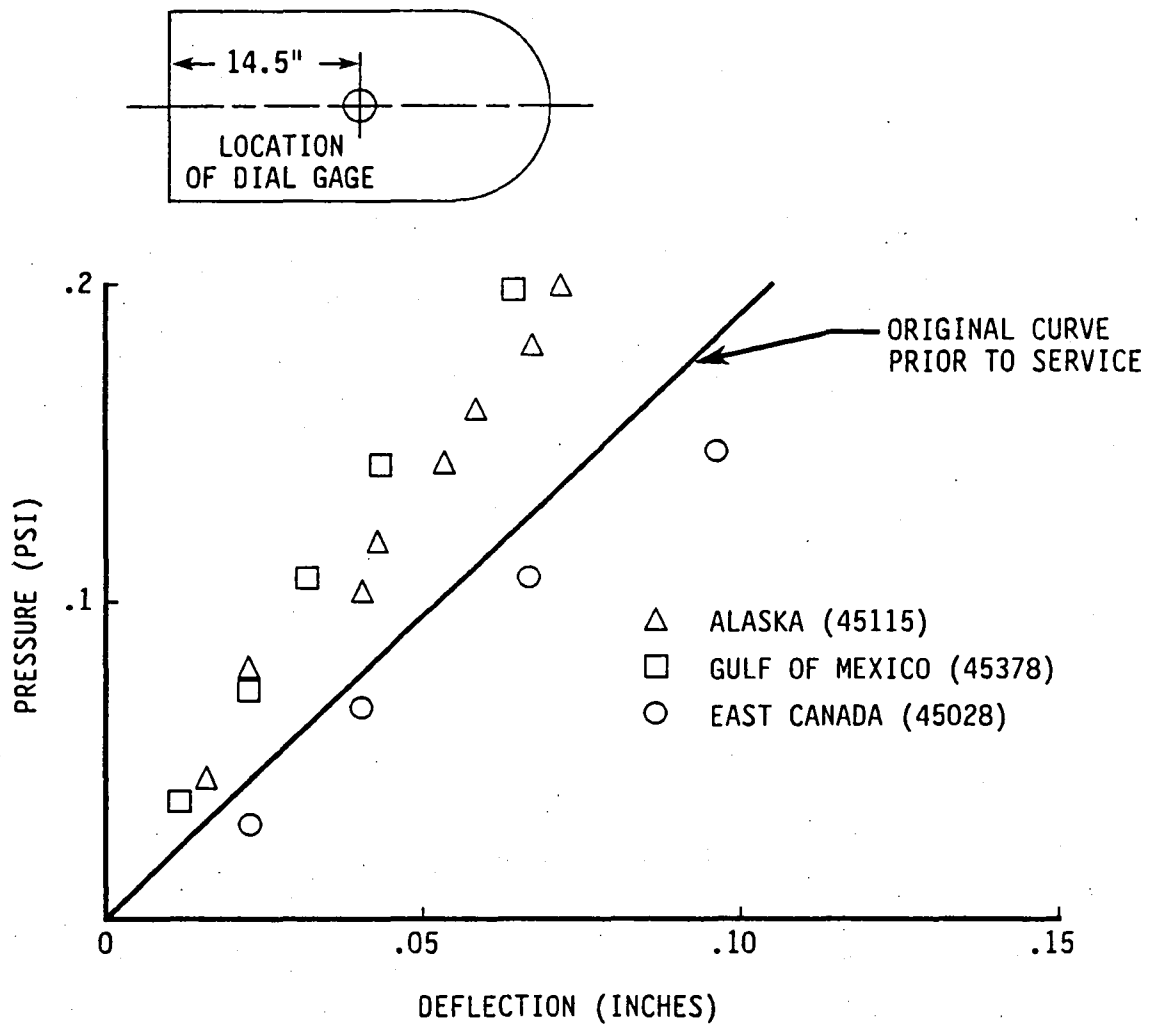
Figure 4-1. Load deflection curve of forward fairing after three years of service.

The deflection for the forward fairing was measured in the center of the fairing, 14.5 inches forward of the back of the fairing. The load deflection data is given in Figure 4-1. The solid curve was developed at the time of certification, prior to service. The current results are given as the symbolized points.

The test was conducted by sealing the fairing in an aluminum box and drawing a vacuum. It was very hard maintaining dimensional stability of the deflection gage during the test. This is the reason for the test of the East Canada fairing being softer than the other parts. Failure occurred when a crack began at the aft latch locations then propagated forward parallel to the edge of the fairing. This failure mode was consistent in all tests.

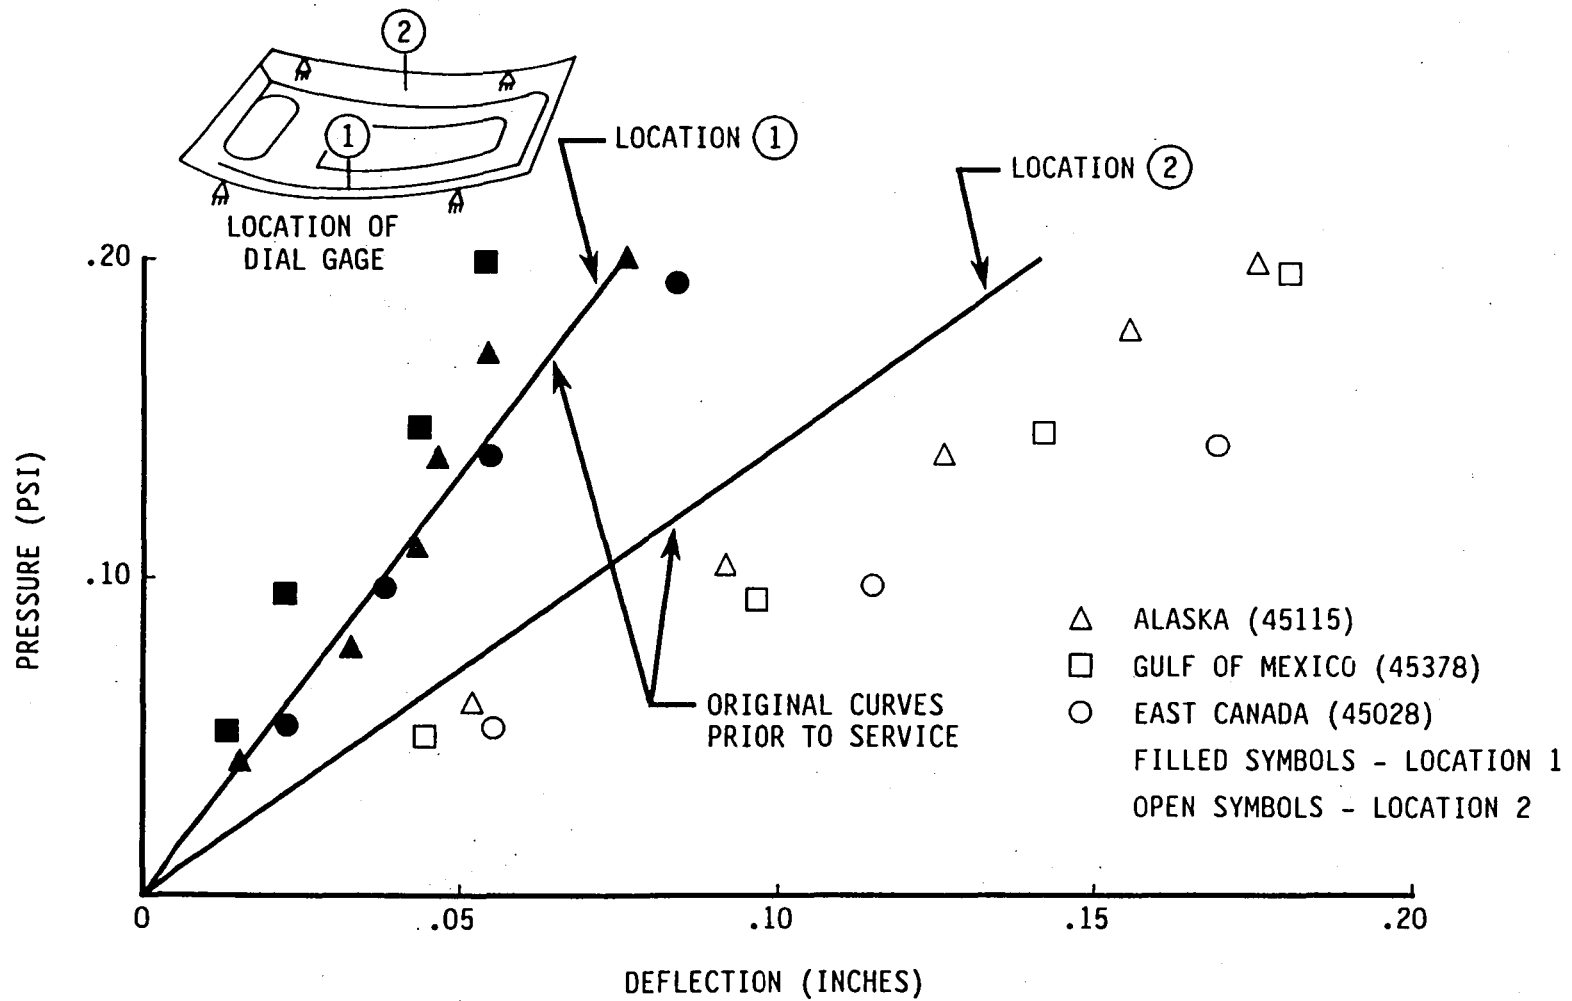
Figure 4-2. Load deflection curve of litter door after three years of service.

Deflections were taken at two locations for the litter door. The locations are shown in Figure 4-2. Location one data tracks the original curve while location two (the larger post) shows a softening of the door. The load deflection curves are given in Figure 4-2. The litter door failure was initiated on the major door post failing as a simply supported beam. After the post breaks, the entire door folds in the middle. This failure was characteristic in all tests.

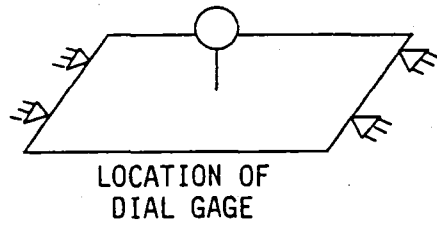
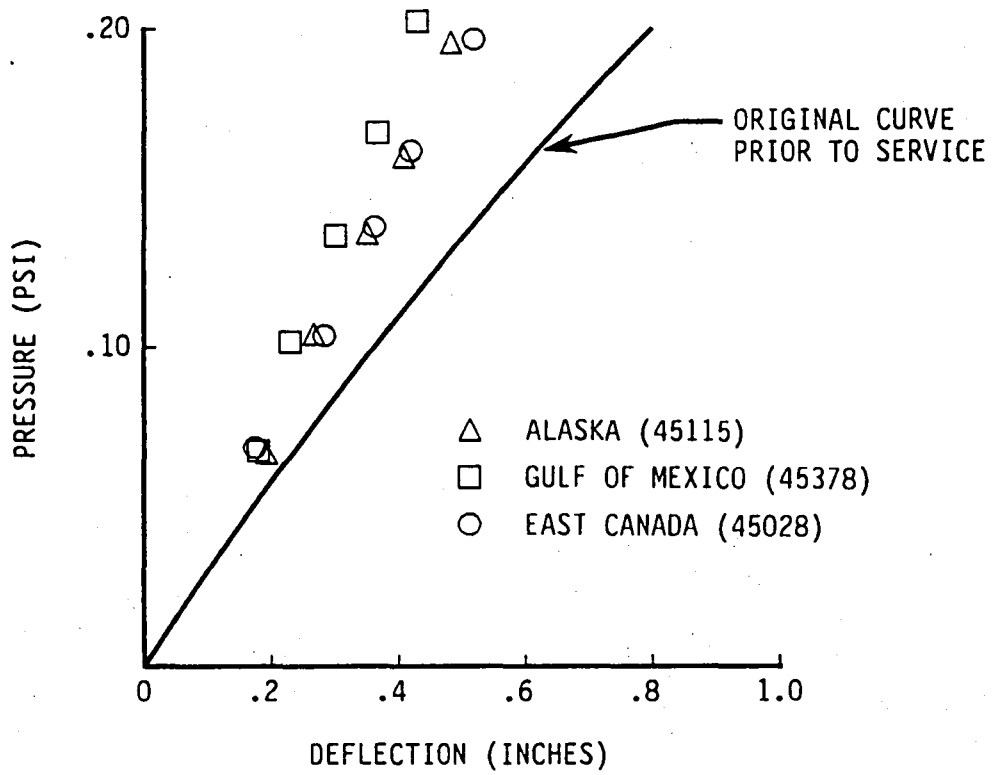
Figure 4-3. Load deflection curve of baggage door after three years of service.

All tests of the baggage door failed as a simply supported beam, folding in the middle, where the moment is the highest. The deflection data for the baggage door was measured in the geometric center of the door. All three geographic areas plot within a tight scatter. They show a stiffening of the door. Examination of the material of the door shows an "evaporation" of the resin thus yielding a stiffening of the door. The load deflection curve of the baggage door is given in Figure 4-3.

The increased strength of the composite baggage door follows the trend of the deflection test where its stiffness increased 60%. The resin had dried out resulting in a much more brittle laminate. It should be noted that while the strength and stiffness of the baggage door has increased, its service behavior was the worst, primarily due to the large void areas and brittleness of the laminate.

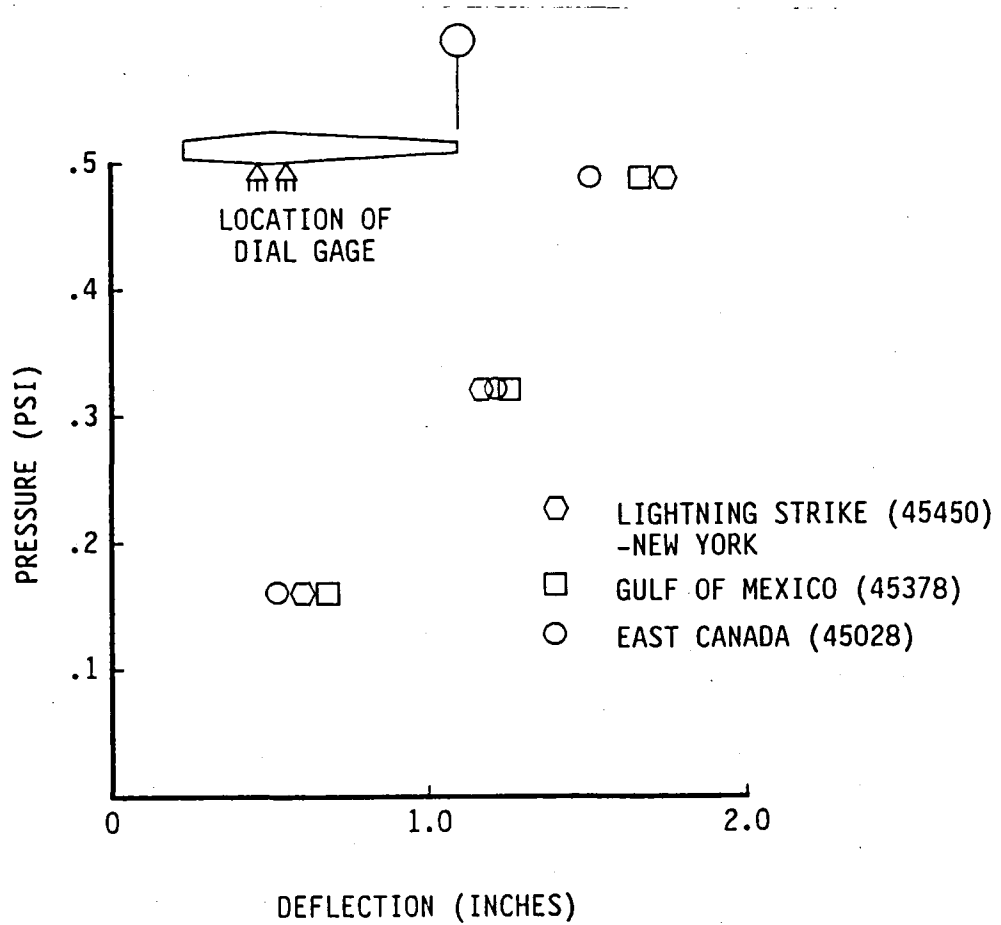
Figure 4-4. Load deflection curve of vertical fin after three years of service.

There was no deflection data developed at the time of certification of the vertical fin. Therefore, the data given has no basis to compare. Since there was no fin from the Alaskan ship set, the lightning strike fin was substituted in the set. The results of the lightning strike will be discussed in Section 5. The load deflection curve for the vertical fin is given in Figure 4-4. All fins failed on the upper part near the root of the fin. It was a classic cantilever beam failure, breaking at the maximum moment section.

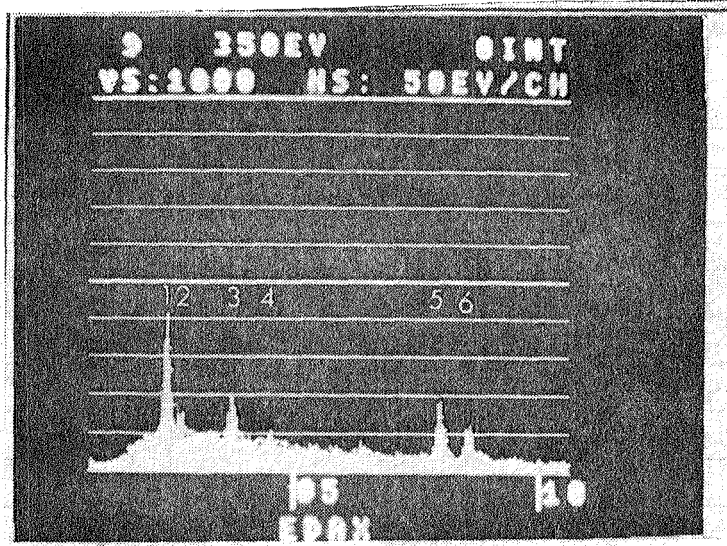
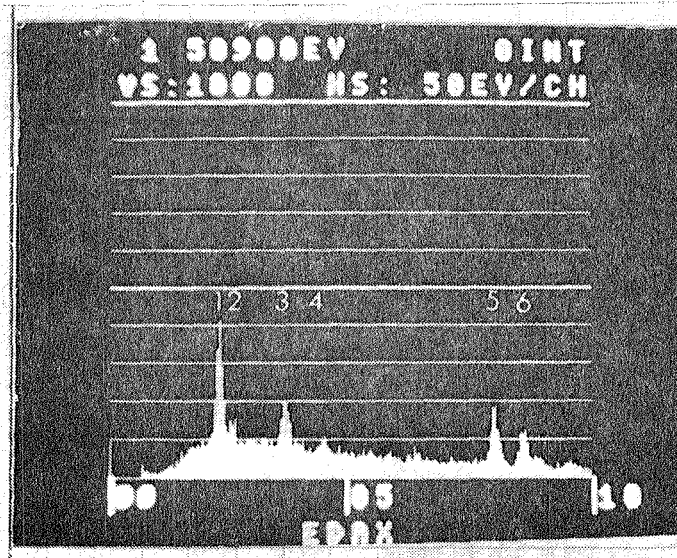
Figure 5-5. Results of EdaX scan on the damaged and undamaged specimen.

The effects of the lightning strike on the graphite was studied using an energy dispersive x-ray analyser (EdaX). Figure 5-5 shows the results of the EdaX scan on the damaged and undamaged specimen. Based on the EdaX results in Table 5-2, there is no basic difference in material.
