HYDRAULIC INDUCED INSTABILITY ON A VERTICAL SERVICE

WATER PUMP: CASE HISTORY

R.F. Bosmans
Bently Rotor Dynamics Research Corporation
Minden, Nevada 89423

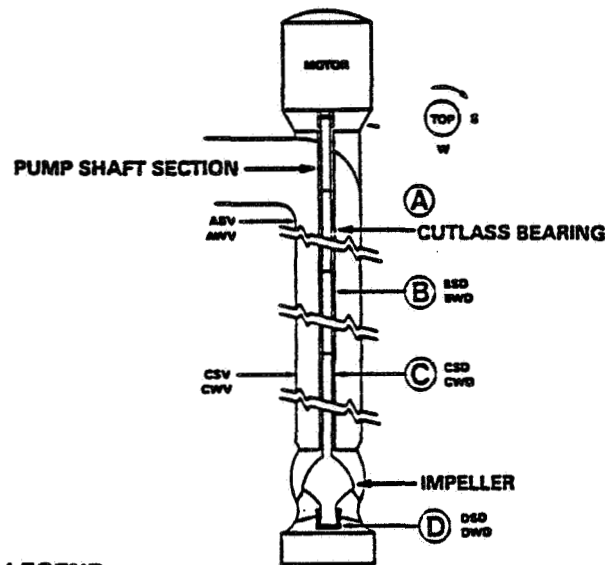
Figure 1. - Vertical low-pressure service water pump.

An outline drawing of this pump and motor is shown in figure 1. A number of shafts on this specific pump had failed in recent years for unknown reasons. The lower bearing consists of a grease-lubricated bronze bushing supported by the pump end bell. Intermediate "bearings," supported by the pump vertical column, are water lubricated and lined with scalloped rubber. This type of bearing is sometimes referred to as a "cutlass" bearing or bumper. The couplings between the shaft sections are rigid and transmit torque through two keys spaced 180° apart. For example, the transducer identified as DWD in figure 1 is located at the bottom bearing and is the west proximity probe. The rated pump performance is

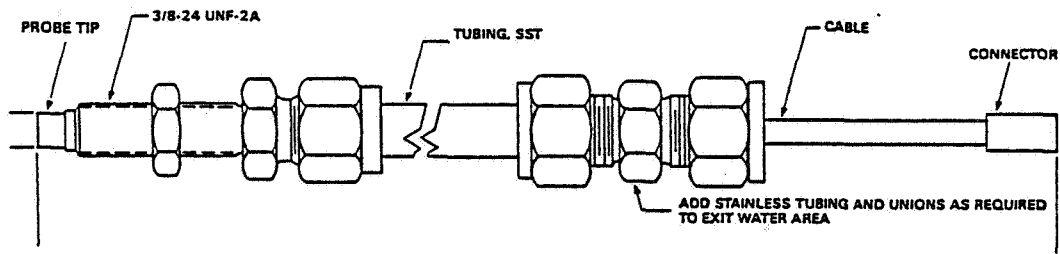
Figure 2. - Waterproof proximity probe transducer.

Since very little information is available on the rotordynamic characteristics of this type of pump, proximity and velocity transducers were installed at each bearing and at the motor coupling. Locations are shown on the pump outline drawing. The transducers are identified by a three-letter code shown in the legend in figure 1. Transducers at locations C and D were below the river level and had to be water-proof. The transducer also had to be designed to provide mechanical protection and to survive the abrasive action of sand in the flowing water. Figure 2 is an outline drawing of the probe design used.

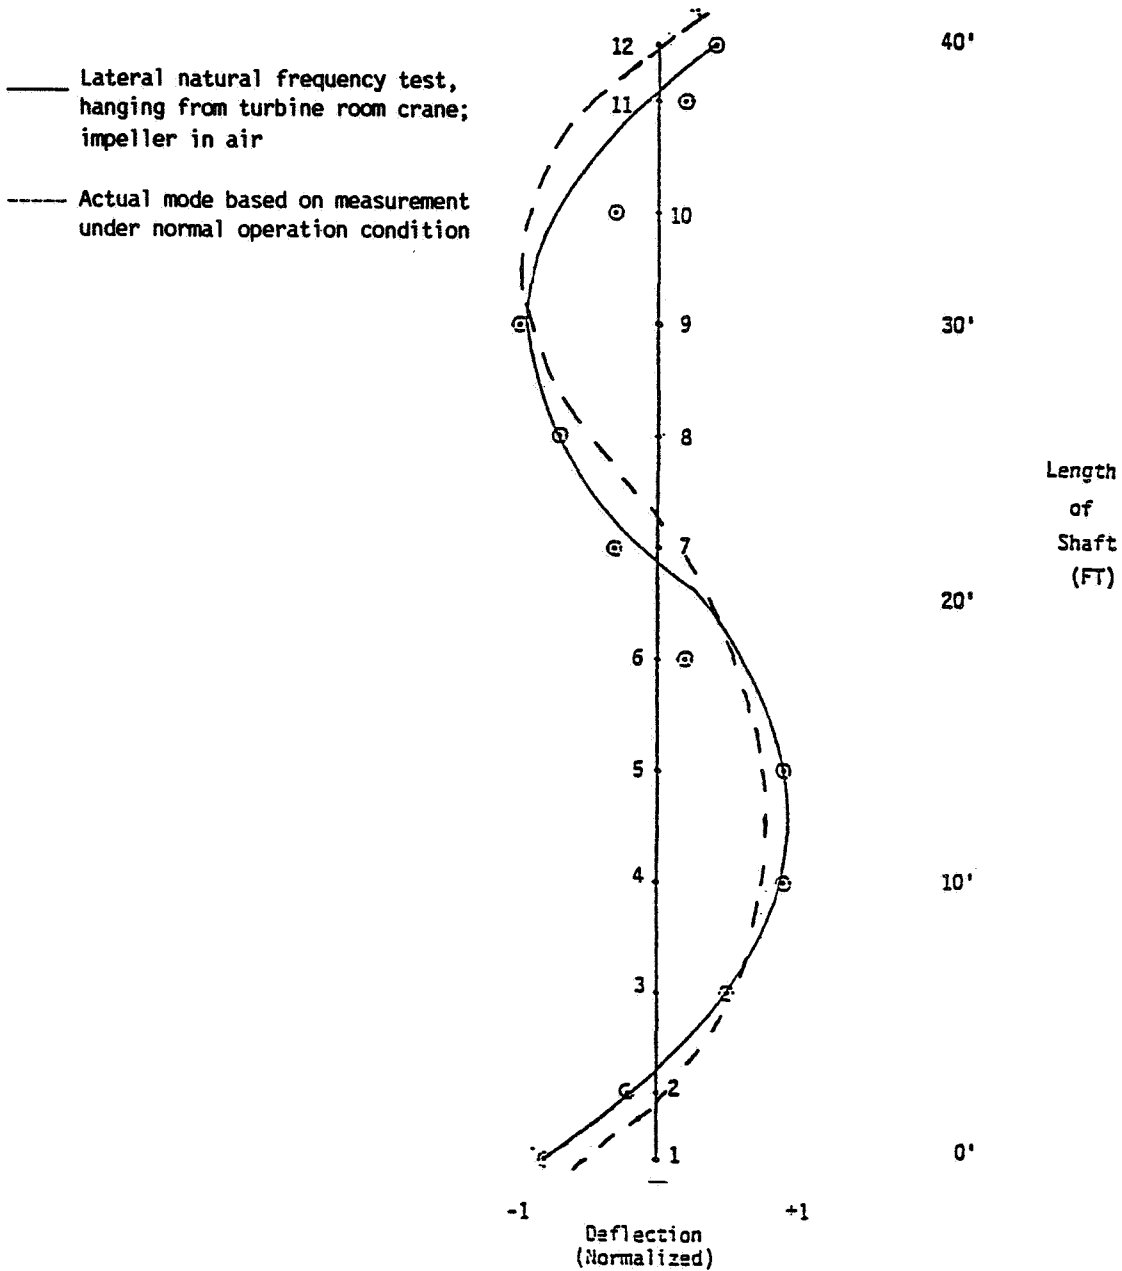
Figure 3. - Mode #2 at 525 cpm.

The rotor system was tested experimentally for both lateral and torsional resonances. Testing was performed by suspending the instrument pump shaft, motor rotor, and pump impeller vertically and perturbing the assembly by striking it with an instrumented force hammer. The results of these tests, summarized in table 1 and figure 3, were correlated with data obtained in later field testing. The pump speed of 720 rpm dictated that the system would run above the second and below the third lateral balance resonance.
