ROTOR-TO-STATOR RUB VIBRATION IN CENTRIFUGAL COMPRESSOR

**Gao Jin Ji and Qi Qi Min
Liaoyang Petrochemical Fiber Company
Liaoning, The People's Republic of China**

This paper discusses one example of excessive vibration encountered during loading of a centrifugal compressor train (H type compressor with HP casing).

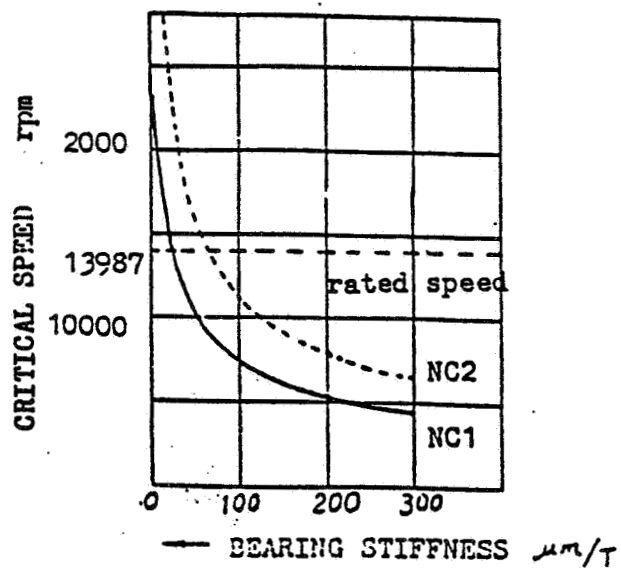
Figure 5.- Radial load versus machine power.

The results of calculation and analysis show that the high speed rotor and the #3, #4 bearings in the LP casing belong in the variable stiffness bearing system. It is different from most compressors. With an increase in dynamic load during opening the guide vane, both machine power and load of the #3, #4 bearings are increased. Fig. 5 shows radial load of the #3 bearing and direction angle vs. power of the machine. Because the bearing stiffness directly affects the critical speed of the rotor-bearing system (Fig. 6), at the moment when the dynamic load reaches a certain value, the critical speed can coincide with the operation speed, and the resonance will occur. This value of dynamic load is called "threshold load." In normal cases the machine runs smoothly as soon as it passes through the threshold load (Ref. 2).
