5105-146
Solar Thermal Power Systems Project
Parabolic Dish Systems Development

Bearing Development Program for a 25-kWe Solar-Powered Organic Rankine-Cycle Engine

September 15, 1985

JPL Publication 85-81

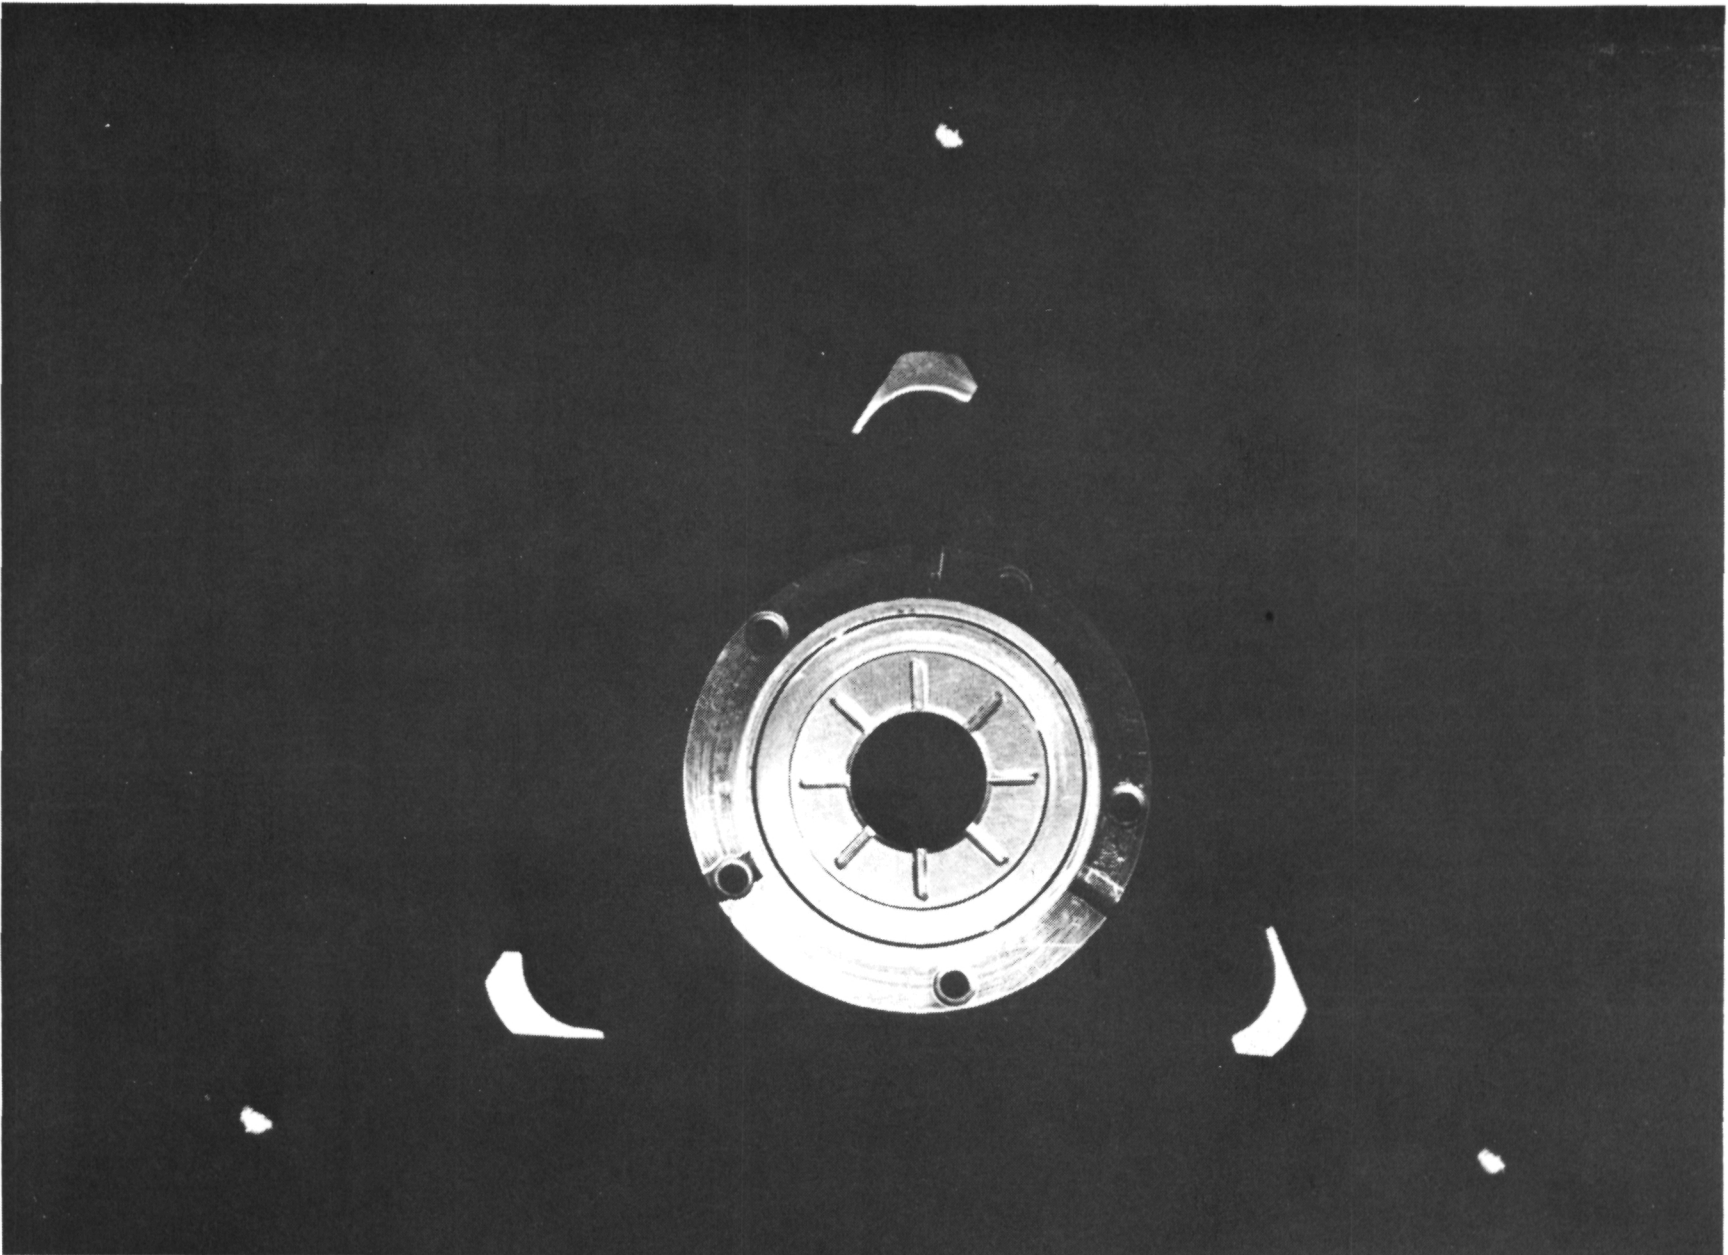
Figure 3-2. Reduced-Mass Tilting Pads with 10-deg Leading Edge Chamfer

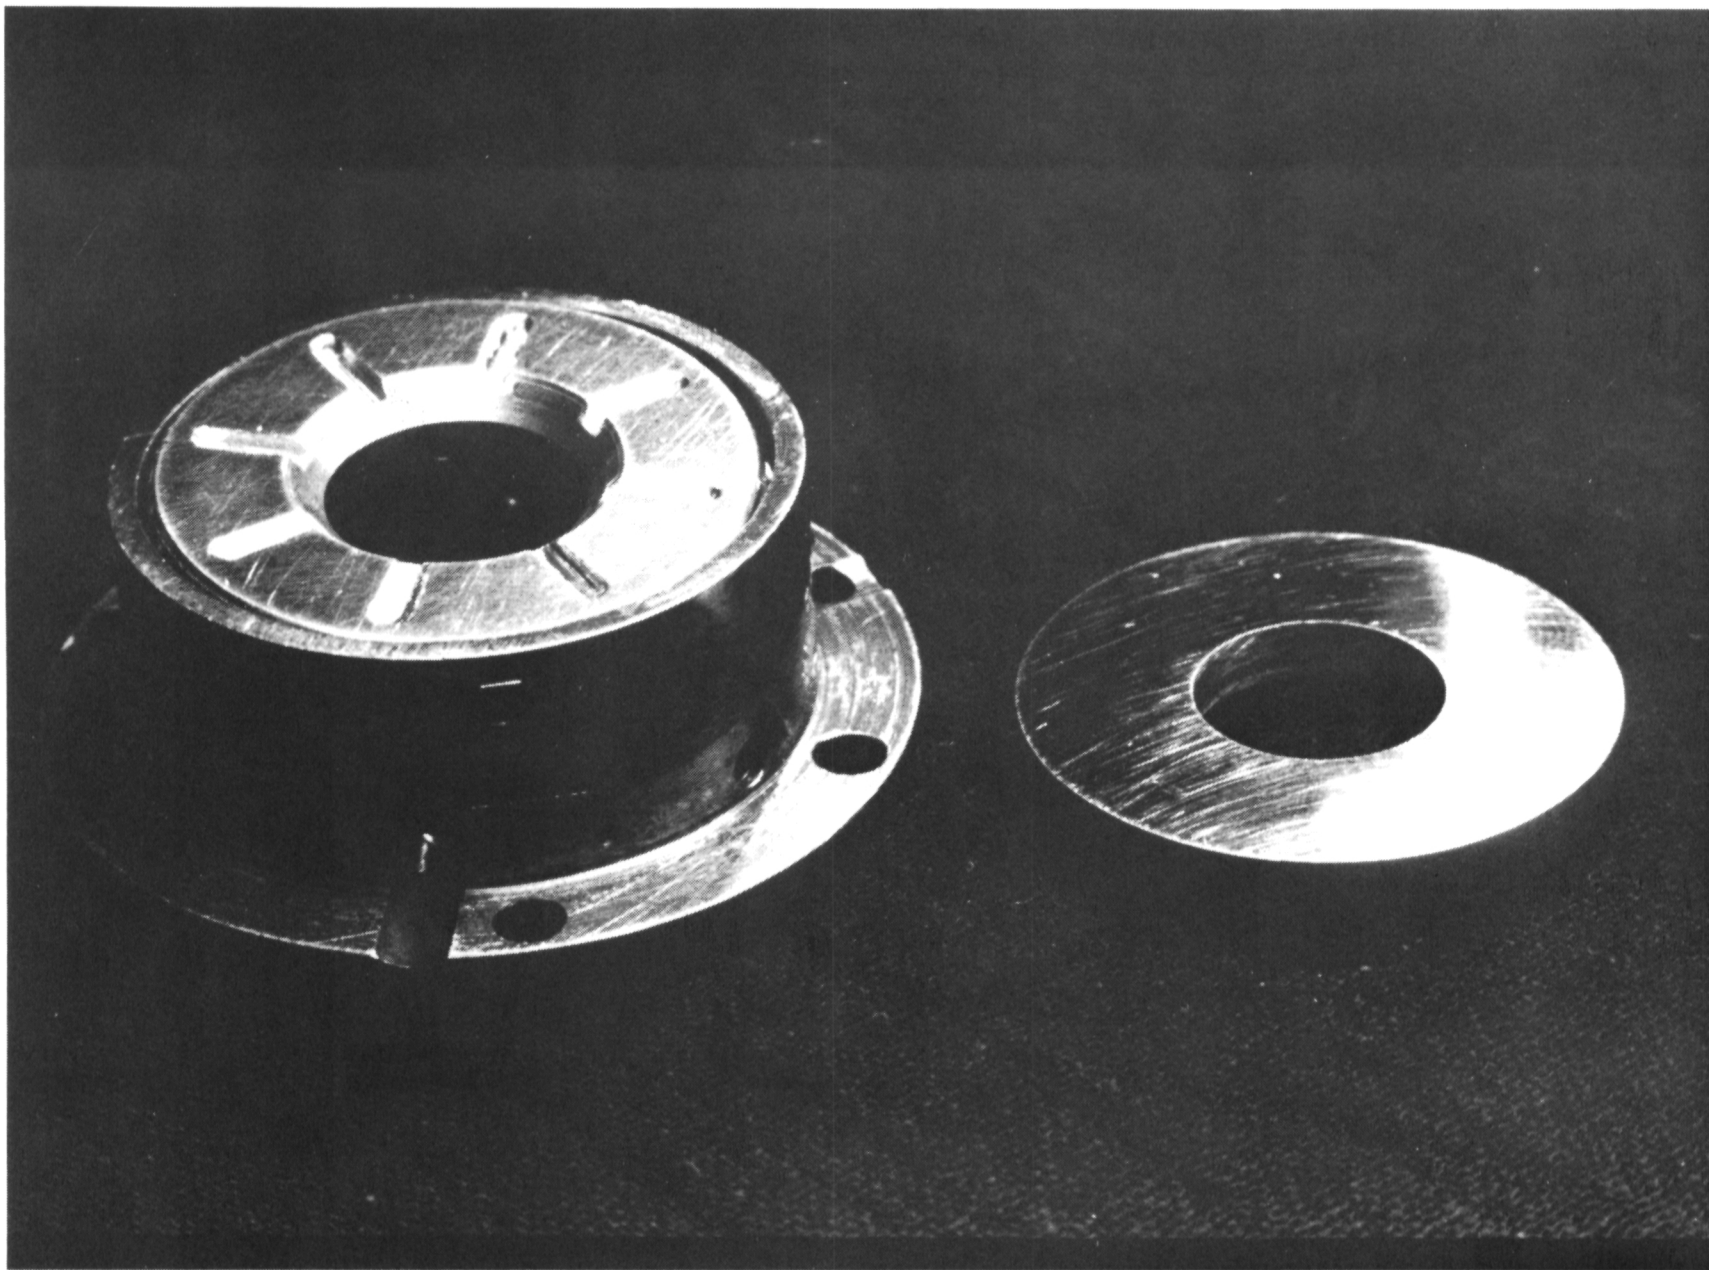
All accelerometer measurements were extremely high and fluctuating both in frequency and amplitude, making conclusive results impossible. In TAP build 8 the turbine end thrust bearing was redesigned to increase the diameter from 1.19 to 1.5 in., and the bearing material was changed from bronze to flame-sprayed babbitt on 52100 steel (Figure 3-4). The thrust runner diameter was also increased, and the material was changed from 304 stainless to 17-4 PH steel. A silver flash coating was applied over the babbitt on the journal bearing pads in an effort to further minimize start-up and shutdown contact wear.

Figure 3-4. Thermal Wedge (Fogg) Turbine End Thrust Bearing (left) made of 52100 Steel with Flame-Sprayed Babbitt Surface and Thrust Runner (1.5-in. diameter) made of 17-4 PH Steel

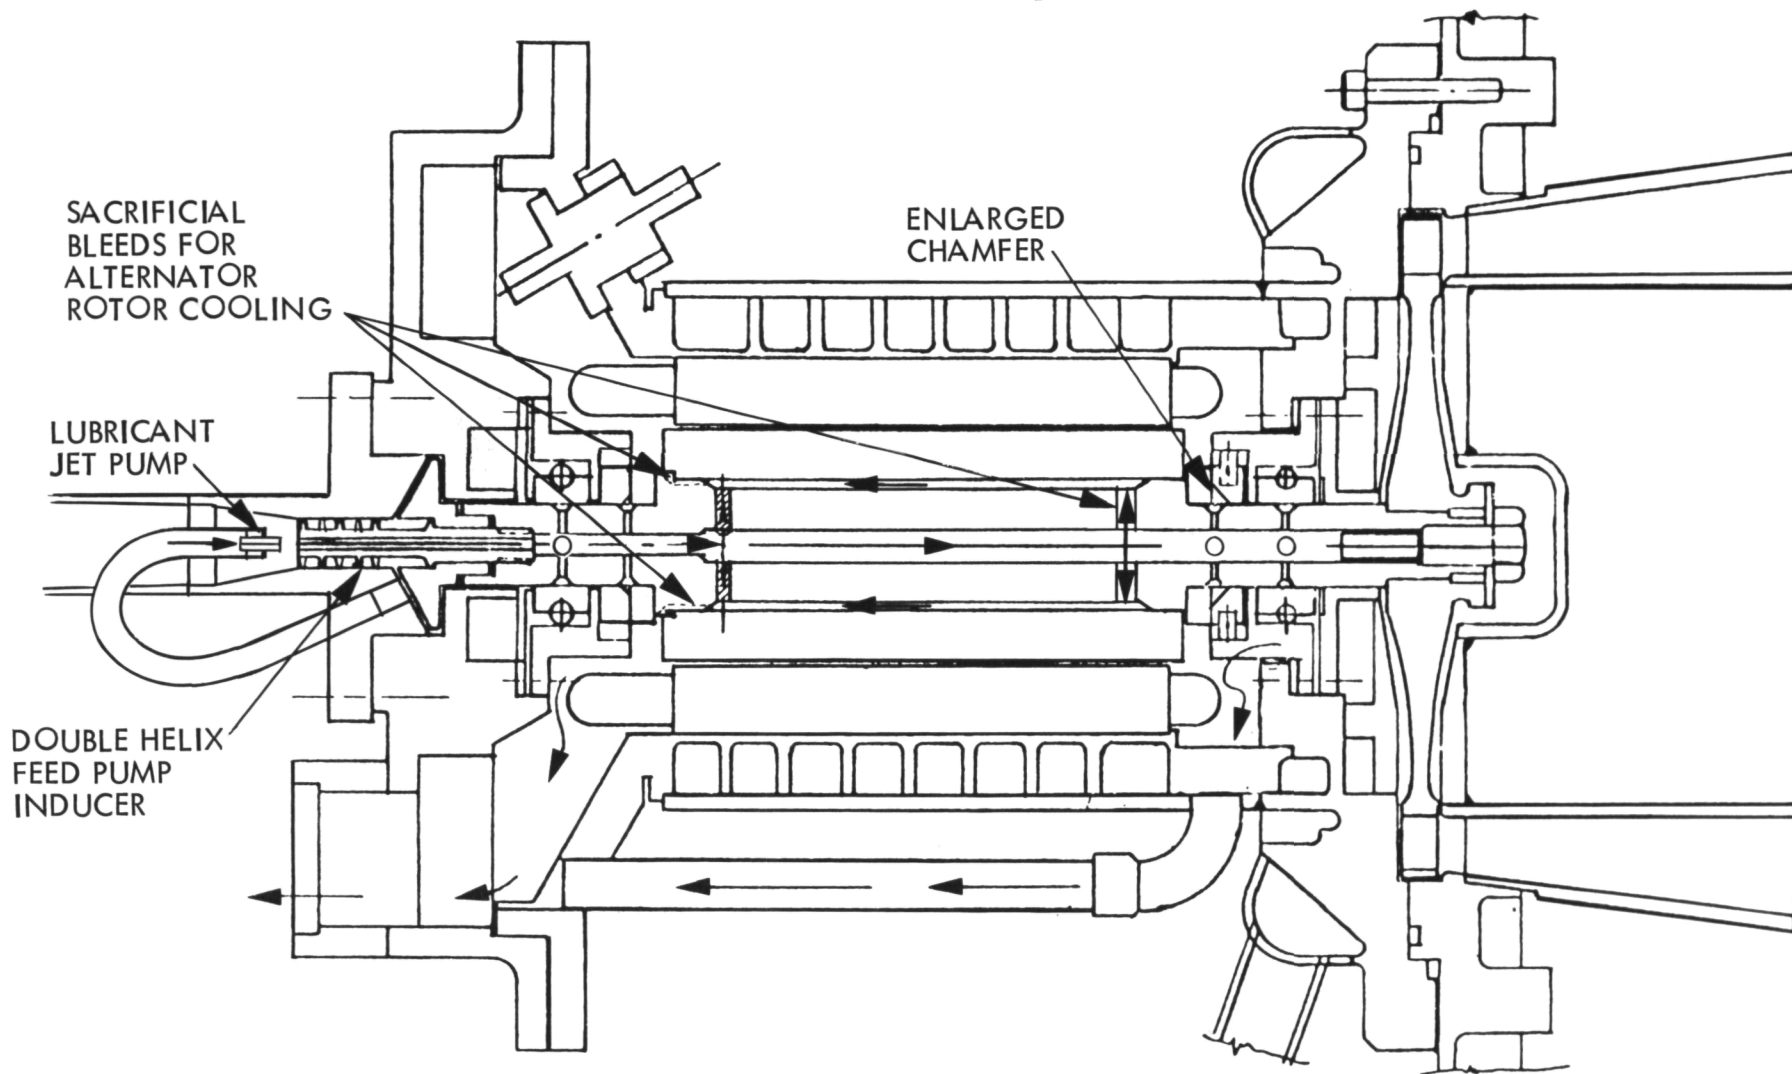
TAP build 11 used for the PDTs tests included modifications to the bearing lubrication system, the feed-pump inducer, and a general emphasis on quality control. Modifications to the lubrication system required the fabrication of a shaft with two radial lubrication holes at the pump end thrust bearing and four radial holes at all other bearings. The chamfer at the inside diameter of the turbine end thrust bearing was enlarged to function as a reservoir to provide additional immediately available lubrication to the bearing. The turbine end thrust bearing surface was improved to a 6-microinch finish. The shaft lubricant channel was made into a single straight-through shaft centerline hole (Figure 5-1) by boring through the shaft from the turbine end until the hole connected with the pump end center line channel. Both PMA rotor cooling holes were plugged except for a sacrificial bleed into the larger diameter annulus to cool the rotor (Figure 5-2). A small jet pump was installed at the shaft lubricant inlet that extracts fluid from the feed pump to increase the total lubricant flow to the bearings. The feed pump housing (Figure 5-3) shows the jet pump nozzle in the center and the off-center extraction port. The feed pump inducer was changed from a single to a double helix with a smooth entrance to increase load and flow symmetry (Figure 5-4).

Figure 5-1. Shaft with Straight-Through Center Line Lubrication Channel (TAP Build 11)

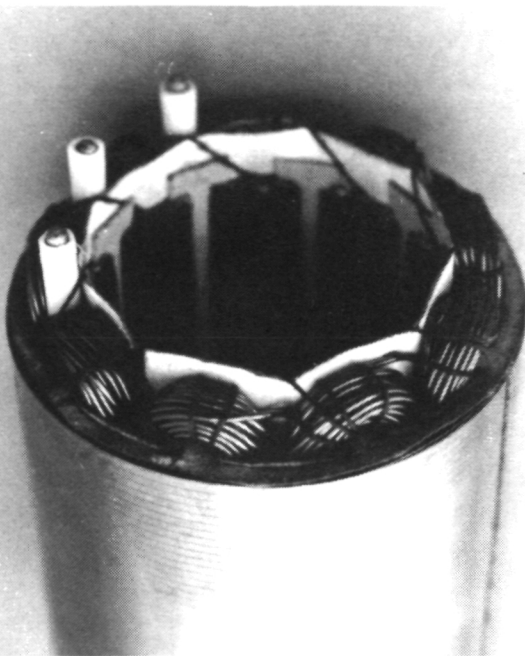
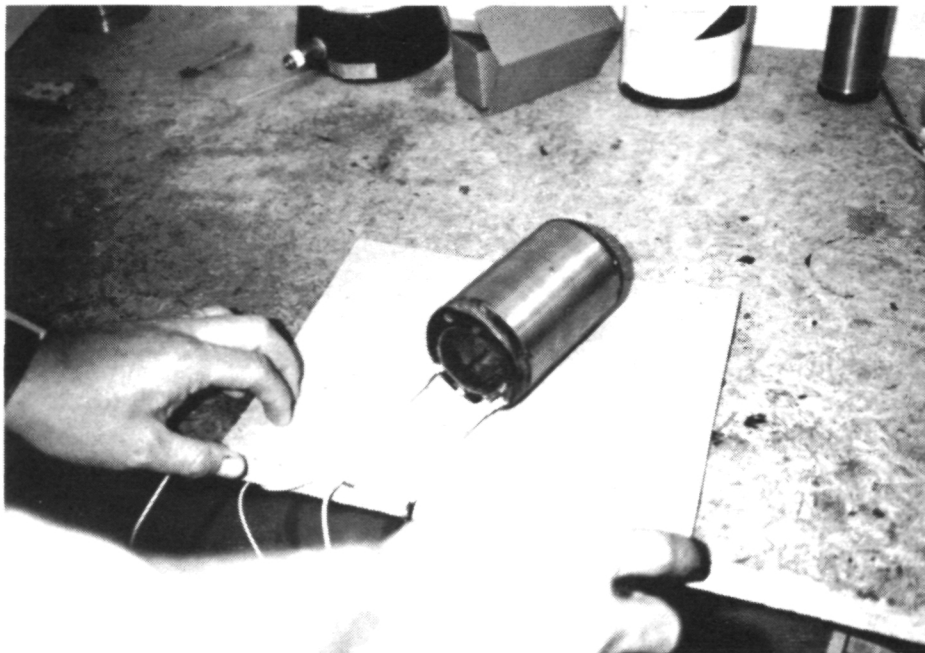
Figure 5-7. (a) Rewound Stator and (b) Rewound Stator after Potting and Encapsulation

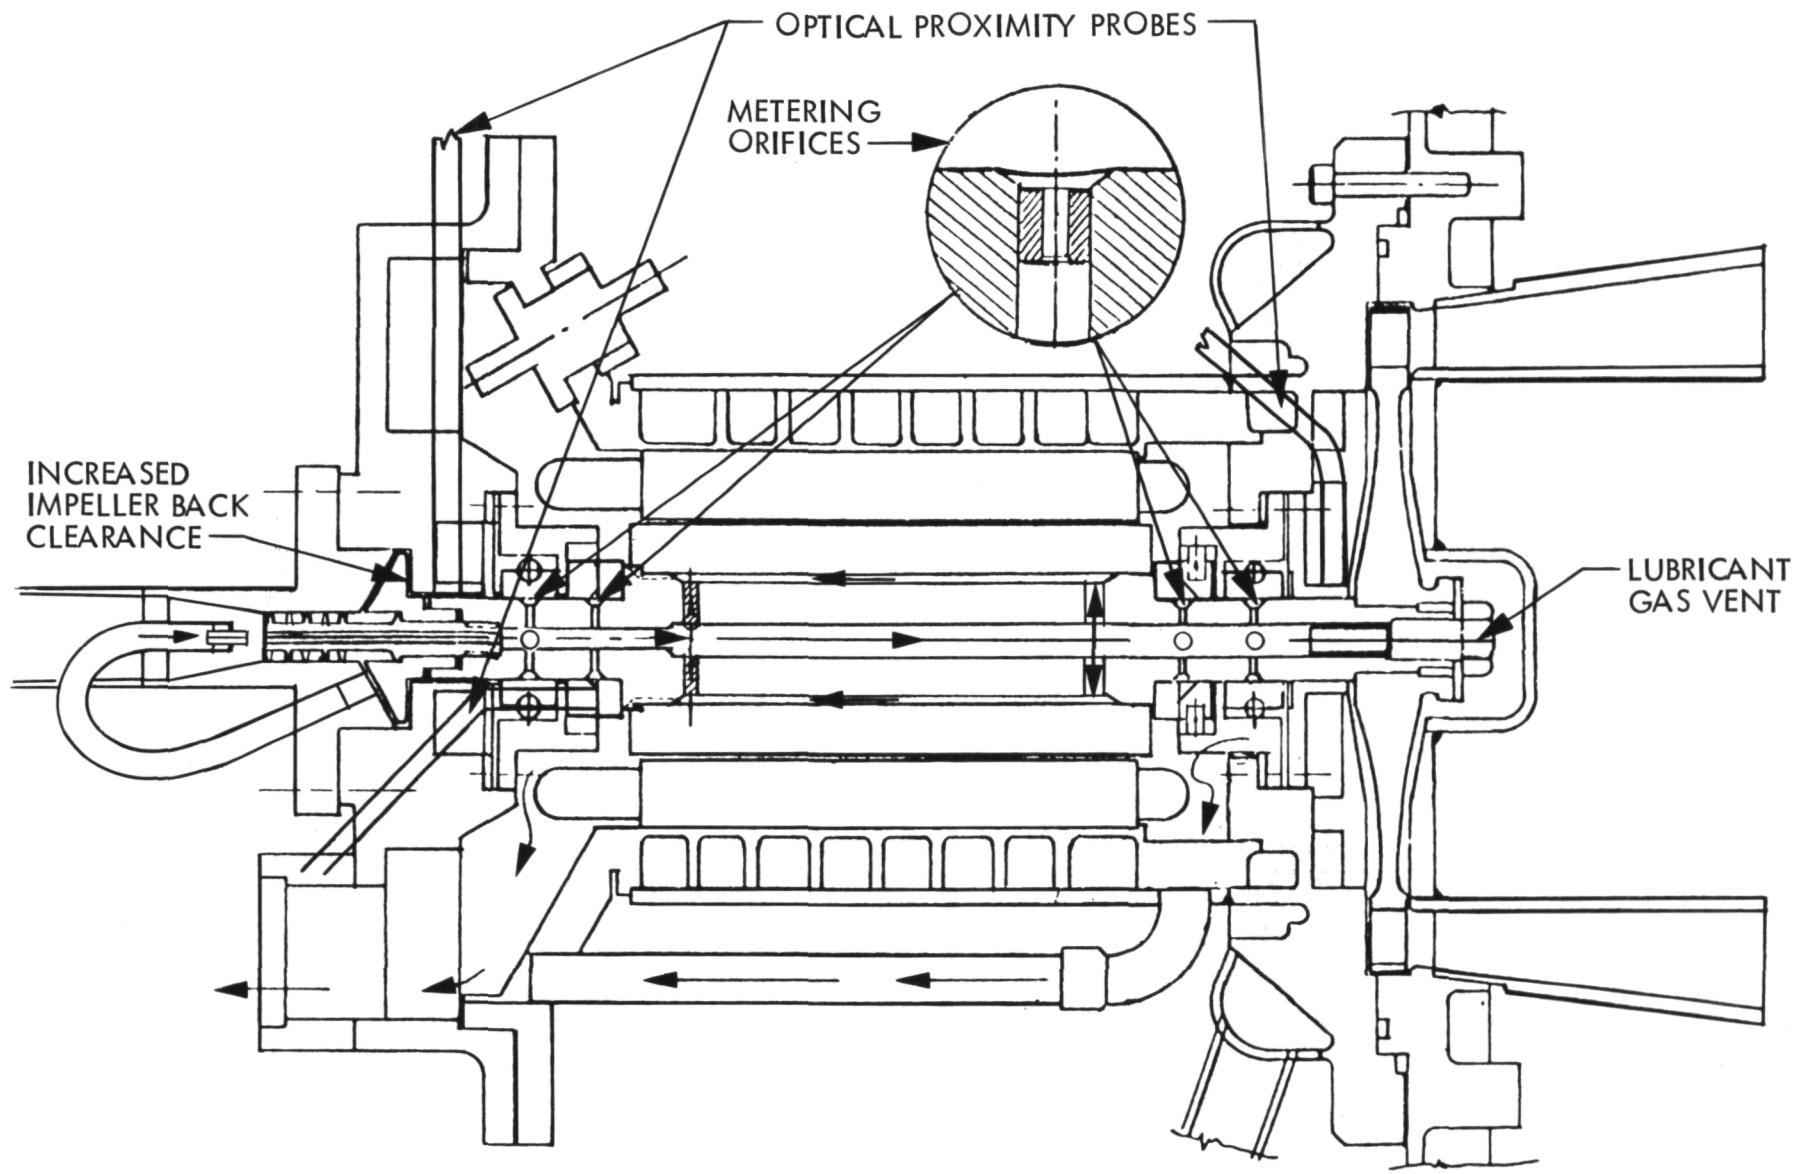
The bearing lubrication and rotor coolant channels within the rotating shaft were the most obvious unconventional aspect of the TAP design and were extensively analyzed by B-N, FACC, and JPL personnel. Because of the extreme complexity of the fluid dynamics, only a few general conclusions were made. Cavitation was occurring at the entrance of each radial bearing lube hole and limiting the amount of fluid delivered to each bearing. The combination of cavitation and fluid momentum introducing vapor and dividing the hydrodynamic film under the pad may have significantly altered the stiffness and damping of the bearings and thus introduced rotordynamic instabilities. Modifications made to reduce this possibility were: (1) to install small orifices at the exit of each radial lube hole to minimize cavitation in the lube channels (Figure 7-2), (2) to enlarge the jet pump exit and shaft lubricant inlet to

Figure 7-2. Metering Orifices Installed in each Radial Lubricant Hole (TAP Build 14)

increase total flow and pressure, and (3) to install a small vent on the shaft centerline at the turbine end to eliminate any possibility of trapped gases restricting flow to the bearings.

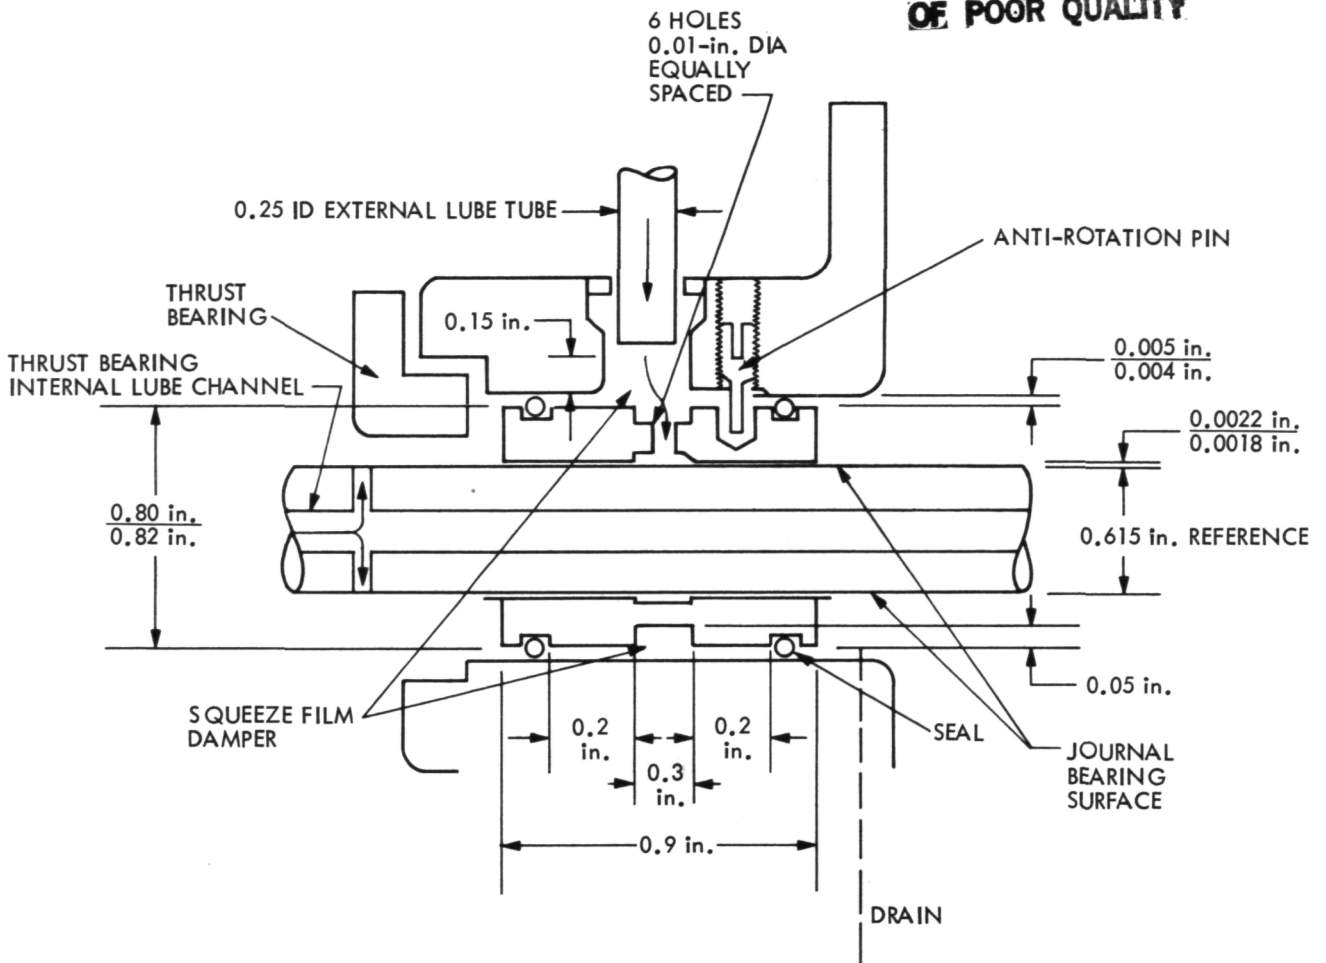
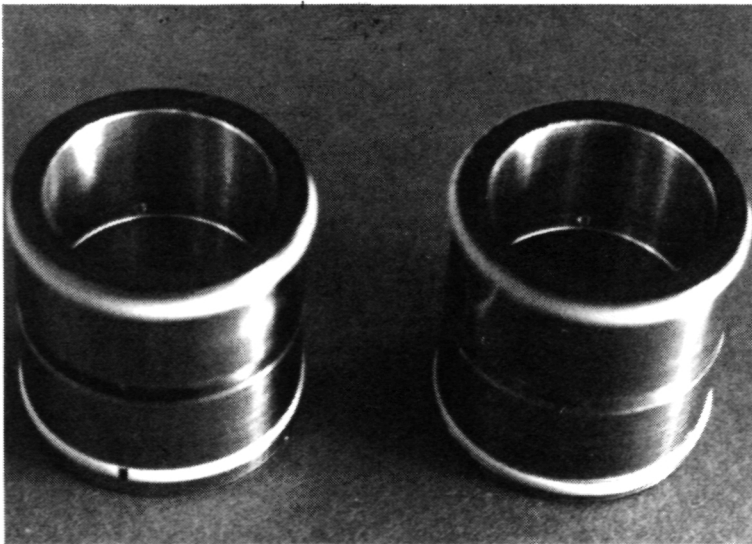
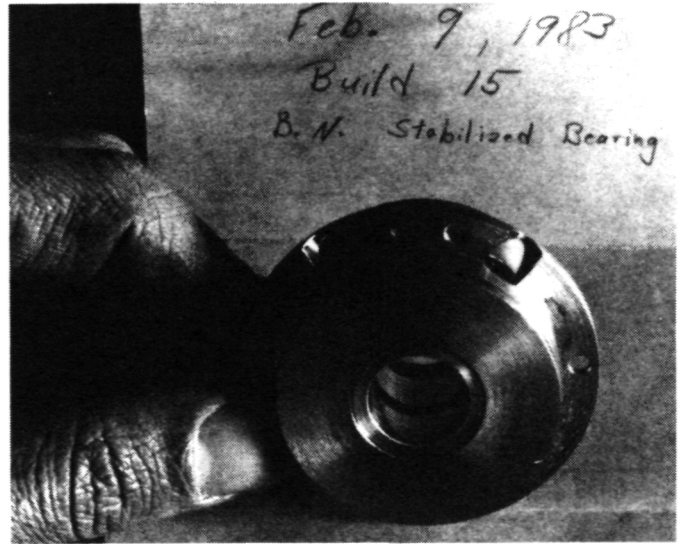
After extensive analysis of the proximity probe data, three concurrent courses of action were initiated in an attempt to resolve the rotordynamic instability problem. The squeeze-film-damped journal bearings (designed, installed, and tested by B-N) were the first to be tested because they had the shortest lead time (Figure 7-4). It was thought that by providing the proper amount of external damping to a simple journal bearing, the rotor bearing system could be stabilized. This was considered to be only a temporary fix to continue testing because vertical operation eventually would be required, and the journal bearing would probably be unstable in that position. The second parallel approach was a fully flooded five-pad tilting-pad journal bearing (from Waukesha Bearings Corporation) that was lubricated by externally supplied fluid from a dedicated bearing lube pump. This more conventional approach would eliminate all bearing and shaft dynamic uncertainties introduced by the lubrication system. A final backup approach was for Mechanical Technology, Inc. (MTI) to analyze and design a four-pad tilting-pad bearing and deliver drawings to Centritek for fabrication if the first two approaches failed.

Figure 7-4. Squeeze-Film-Damped Journal Bearing (Stabilized Bearing)
(a) Schematic, (b) Journal Bearing with Elastic Damper Seals Attached, and (c) Complete Bearing and Carrier

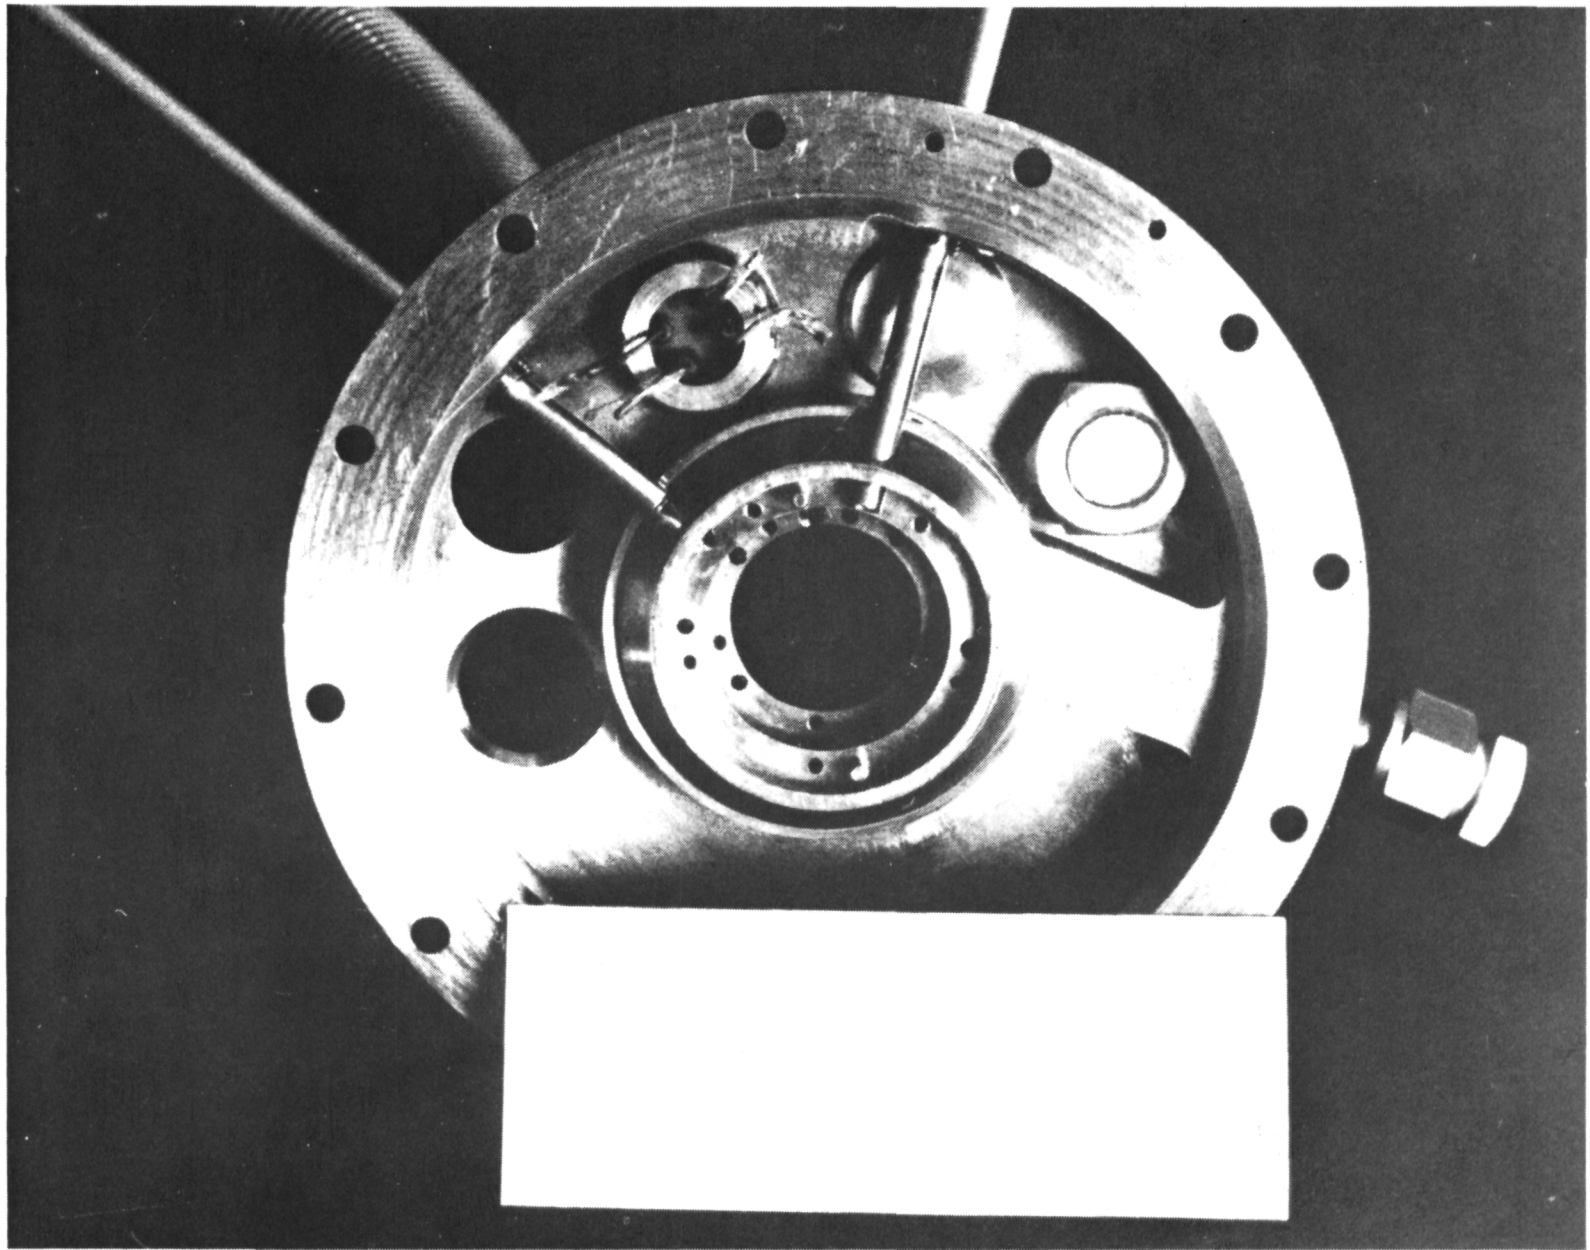
TAP builds 15 through 19 incorporated two squeeze-film-damped journal bearings with external lubrication (Figure 7-5) and two internally lubricated thrust bearings.

Figure 7-5. Method of External Lubrication for Stabilized Bearings

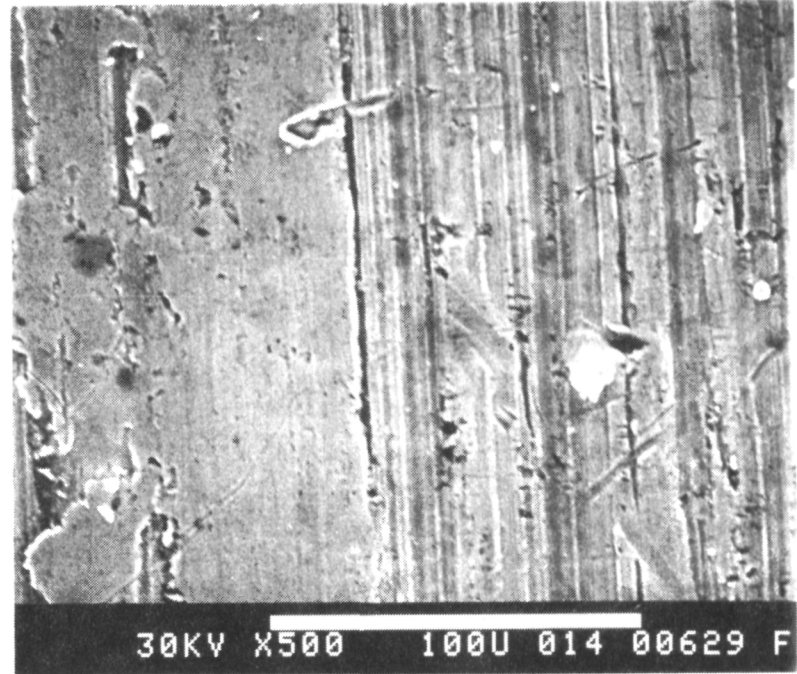
An extensive analysis of the build 21 damaged bearing surfaces was conducted by FACC using an electron beam microscope. The damaged surface on each pad had a frosted appearance, which was determined to be a number of separate but closely packed pits. Figures 7-12 and 7-13 show various magnifications of the pitted surfaces and compare them to unpitted zones. A chemical analysis inside the pits revealed high concentrations of zinc and chlorine, which were not present in the virgin babbitt or bearing material. This change is shown in Figure 7-14 where the virgin material analysis and an analysis inside a single pit are compared on one plot.

Figure 7-13. Leading Edge Surface of a Waukesha Pad without Electrical Discharge Pitting

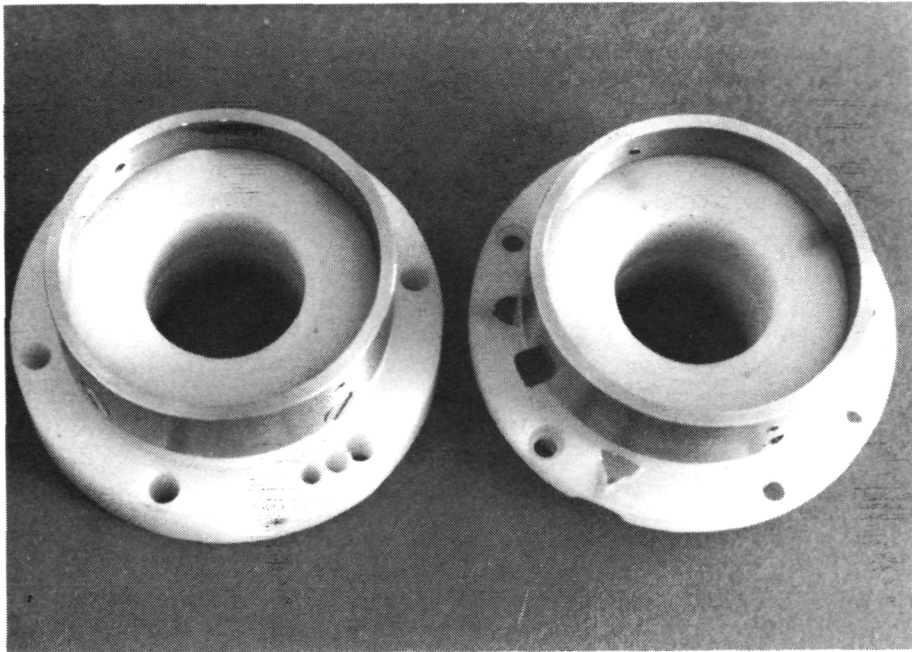
The previously described process of electrical discharge across bearing surfaces was addressed in TAP build 26. A set of electrically insulated bearing carriers was fabricated. A copper grounding strap was added to further ensure that the shaft was grounded independently of the shaft drive system. Inspection of the TAP, following 1.1 h of horizontal operation delivering electrical power, revealed no bearing wear; however, an unrelated problem discovered was a small portion of the PMA coating material (stycast) separated from the stator and coated one-third of the rotor.

The five-pad Waukesha tilting-pad bearings, using B-N-fabricated pads and mounted in an electrically insulated nylon bearing carrier (Figure 7-16), were used in TAP builds 30 to 35 with essentially no changes. Figure 7-17 shows the pump and turbine end thrust bearings mounted on the insulated bearing carriers and provides a good view of the grooves that disperse the lubricant over the bearing face and the holes supplying fluid from the flooded bearing reservoir to the grooves. A total of approximately 21 h of operation were accumulated on these builds with no bearing distress or electrical arcing. The success of these tests at various altitude angles from horizontal to vertical and various powers and speeds indicated that the bearings were ready for hot testing in the engine.

Figure 7-16. Electrically Insulated Bearing Carriers

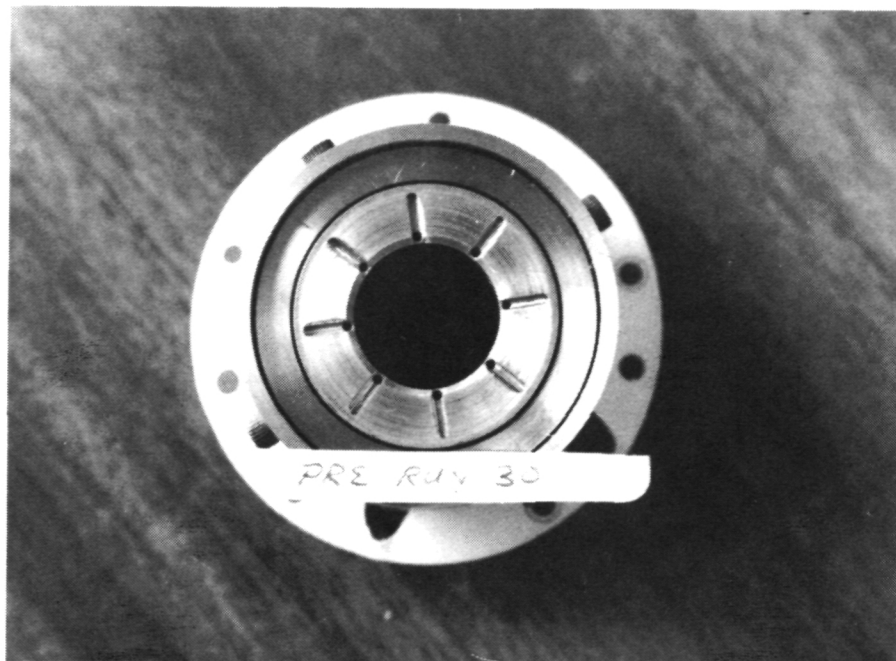
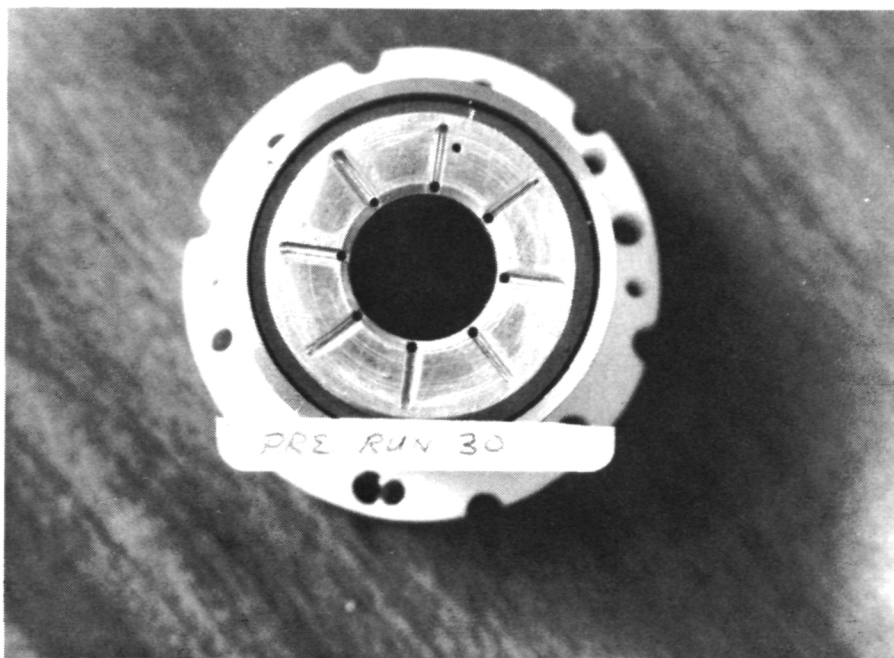
Figure 7-17. Electrically Insulated Bearing Carriers with (a) Pump End and (b) Turbine End Thrust Bearings Mounted

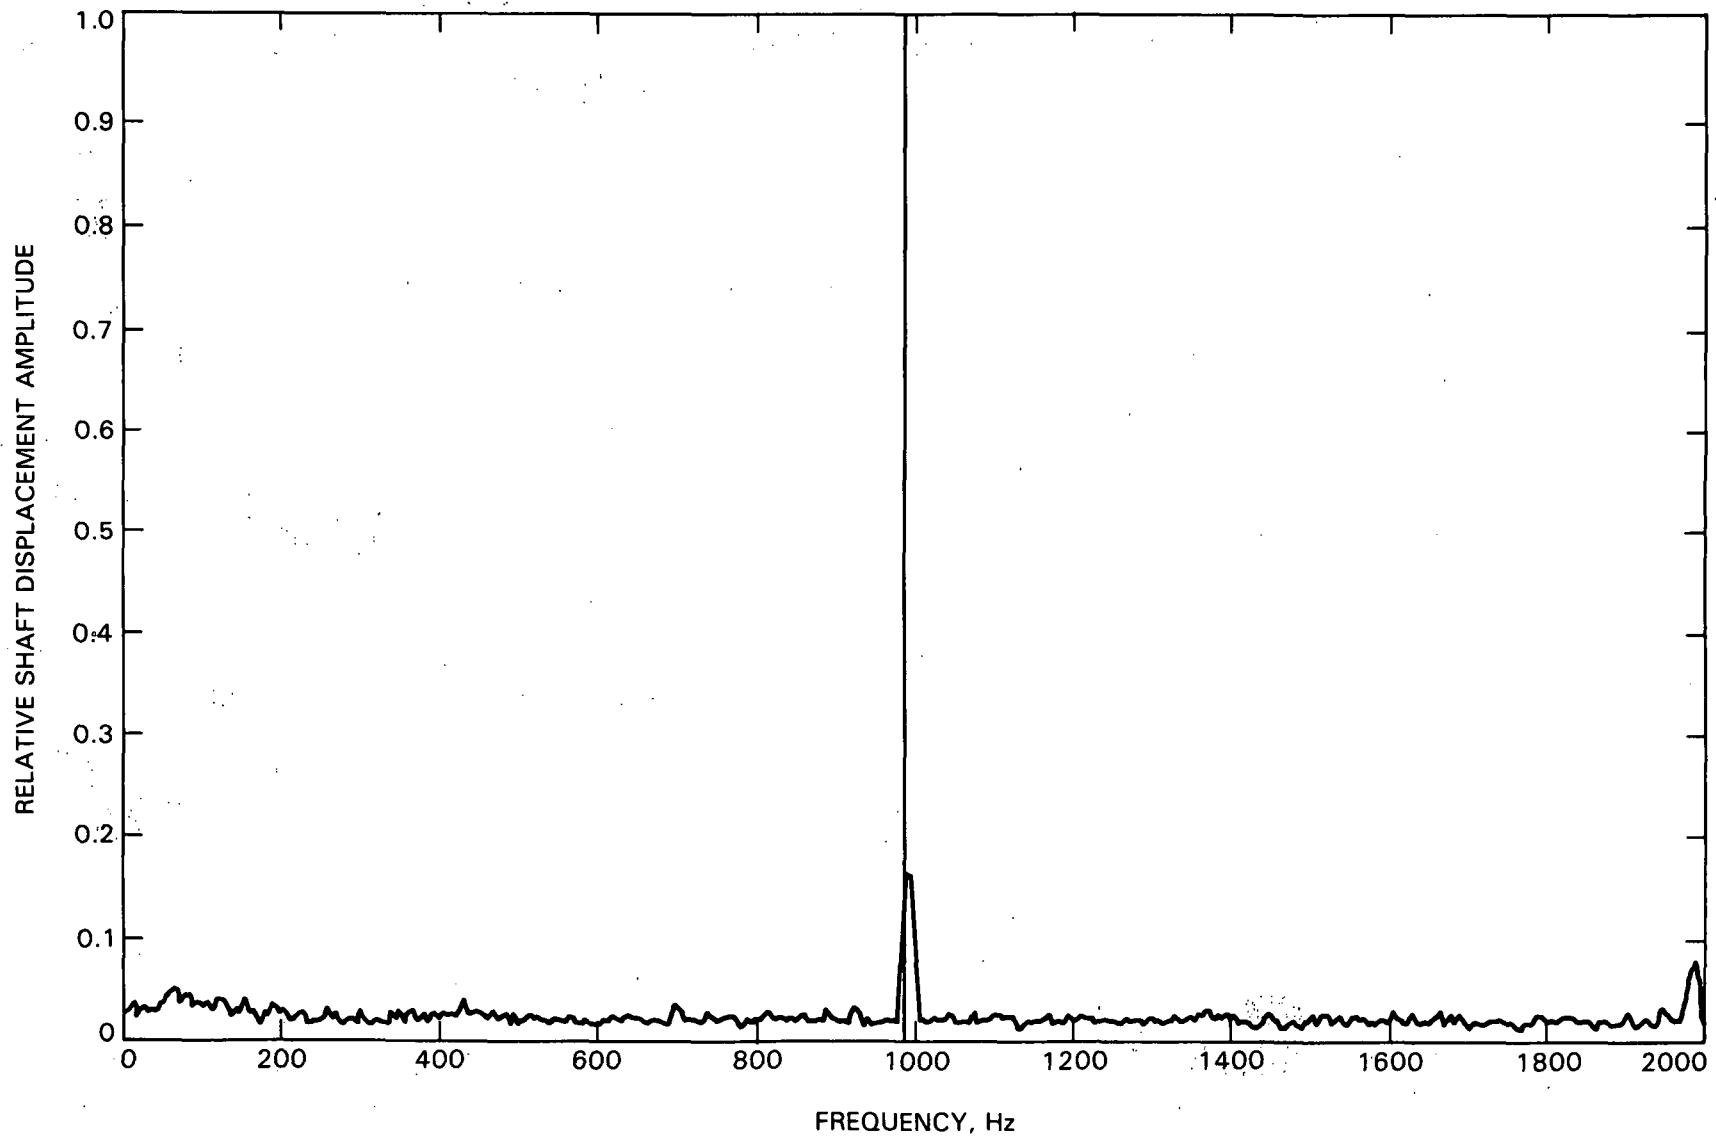
allowing the 100-h test results to be available for the November 1, 1983, DOE-scheduled ORC review. The only effect this had was that additional hours were run at 5 and 90 deg, and fewer hours were run at 45 deg. Figures 8-1 and 8-2 are shaft displacement amplitude versus frequency for TAP builds 38 and 39 (90- and 5-deg inclination) using comparable amplitude scales. Results of the test showed inclination angle does not seem to affect shaft dynamics and no bearing wear or component damage was observed.

Figure 8-2. Typical Shaft Displacement Spectrum of Waukesha Five-Pad Bearing at 5 deg on October 29, 1983 (Pump End "X" Probe, TAP Build 39)

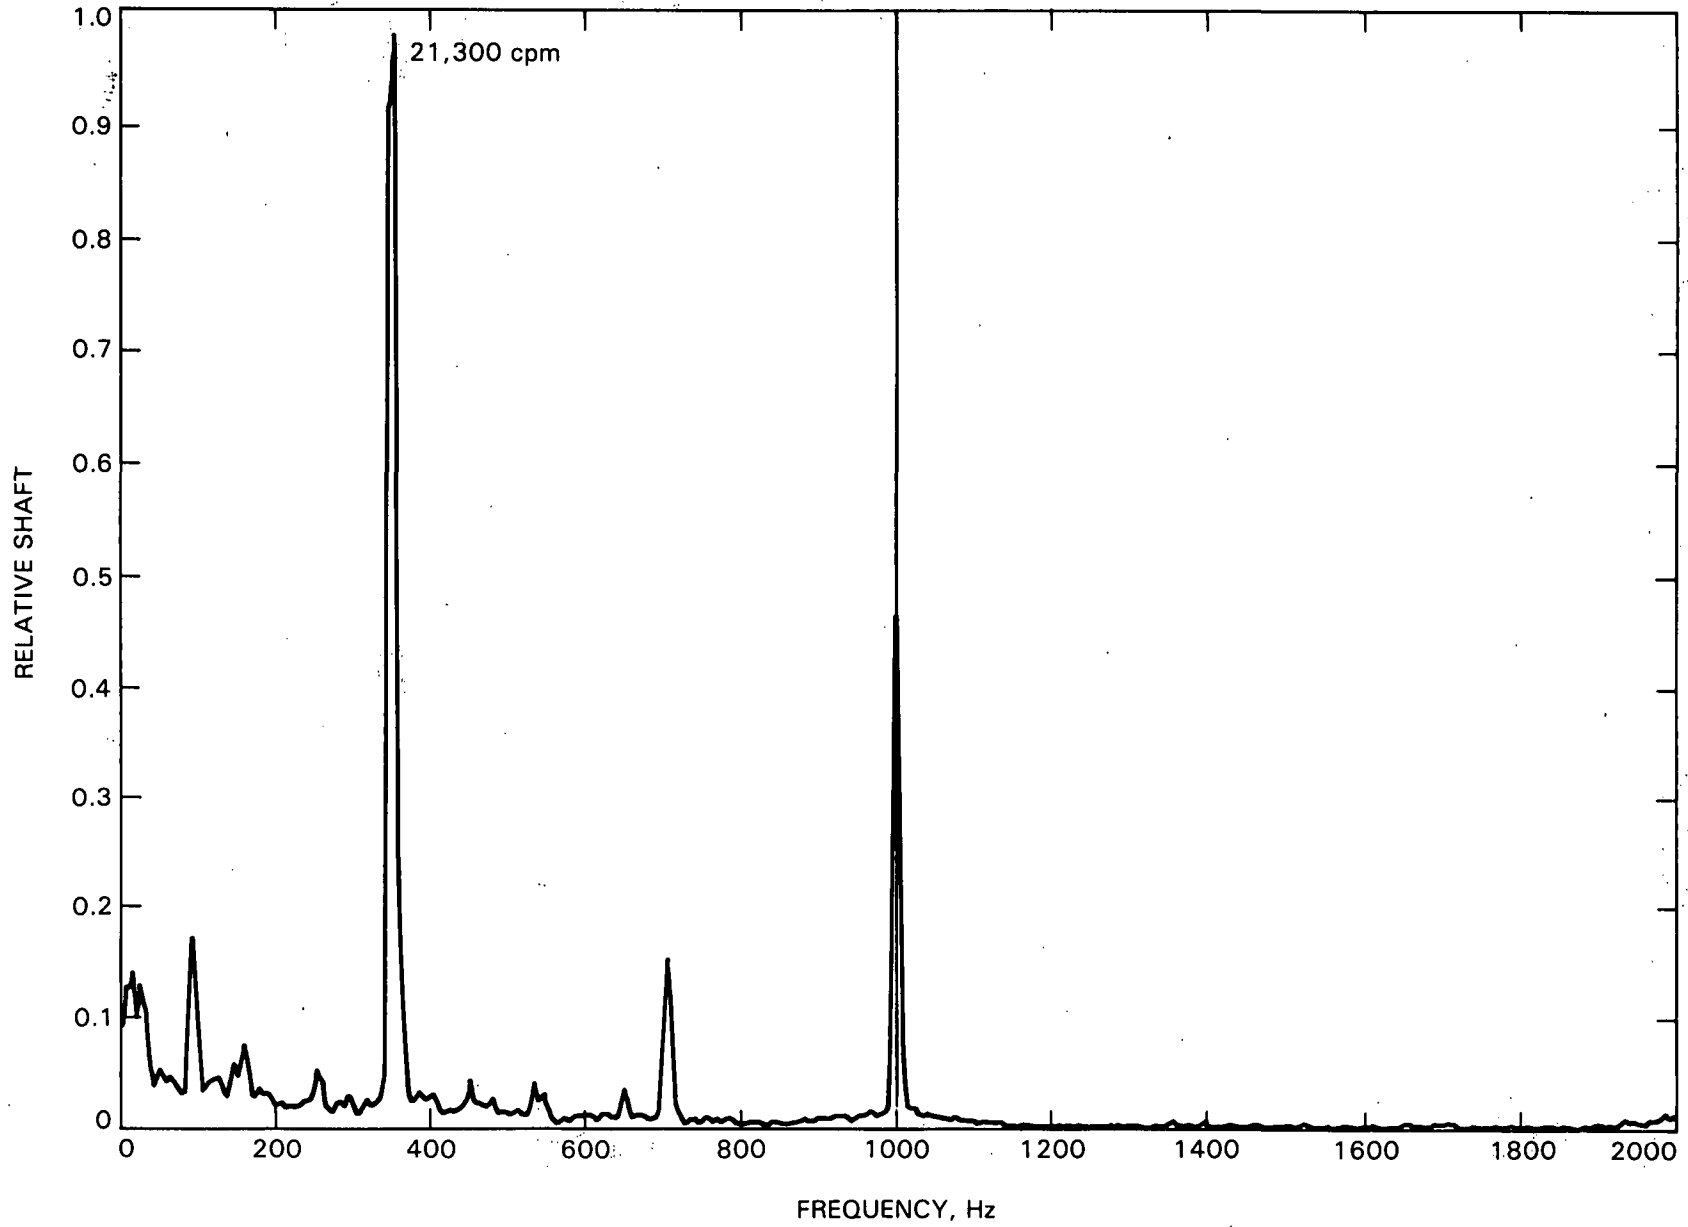
The rotor bearing problems experienced in this high-speed, toluene-lubricated bearing high-power density engine development program resulted from combined rotordynamic instability and electrical dynamic discharge across the bearing surfaces. The rotordynamic instability was observed to varying degrees in all TAP builds with the lubricant flowing down the center line of the shaft and discharging fluid radially out onto the bearing surfaces. This instability phenomenon is easily seen when shaft proximity probe amplitude versus frequency plots are compared for TAP build 14 (Figure 9-1) and TAP builds 38 and 39 (see Figures 8-1 and 8-2). All three of these figures are on directly comparable amplitude scales, and the largest peak in Figure 9-1 represents a rotordynamic instability. Fully externally lubricated five-pad tilting-pad journal bearings, a Rayleigh step turbine end, and a Fogg flat pad pump end thrust bearing were included in the final design. The effects of the electrical discharge across the bearing surfaces are readily observable even after the rotordynamic instability was corrected (see Figures 7-11 and 7-12). The solution to the electrical discharge problem was to mount all bearings onto an electrically insulated bearing carrier. This design interrupted the electrodynamic circuit through the PMA stator, bearings, and shaft and forced all stray currents to flow through their respective grounding straps.

Figure 9-1. Typical Shaft Displacement Spectrum of Barber-Nichols Three-Pad Bearings, December 1982 (Turbine End "Y" Probe, TAP Build 14)
