## NICKEL-HYDROGEN CELL TEST PROGRAM SUMMARY

Vernon C. Mueller

McDonnell Douglas Astronautics Company - St. Louis Division

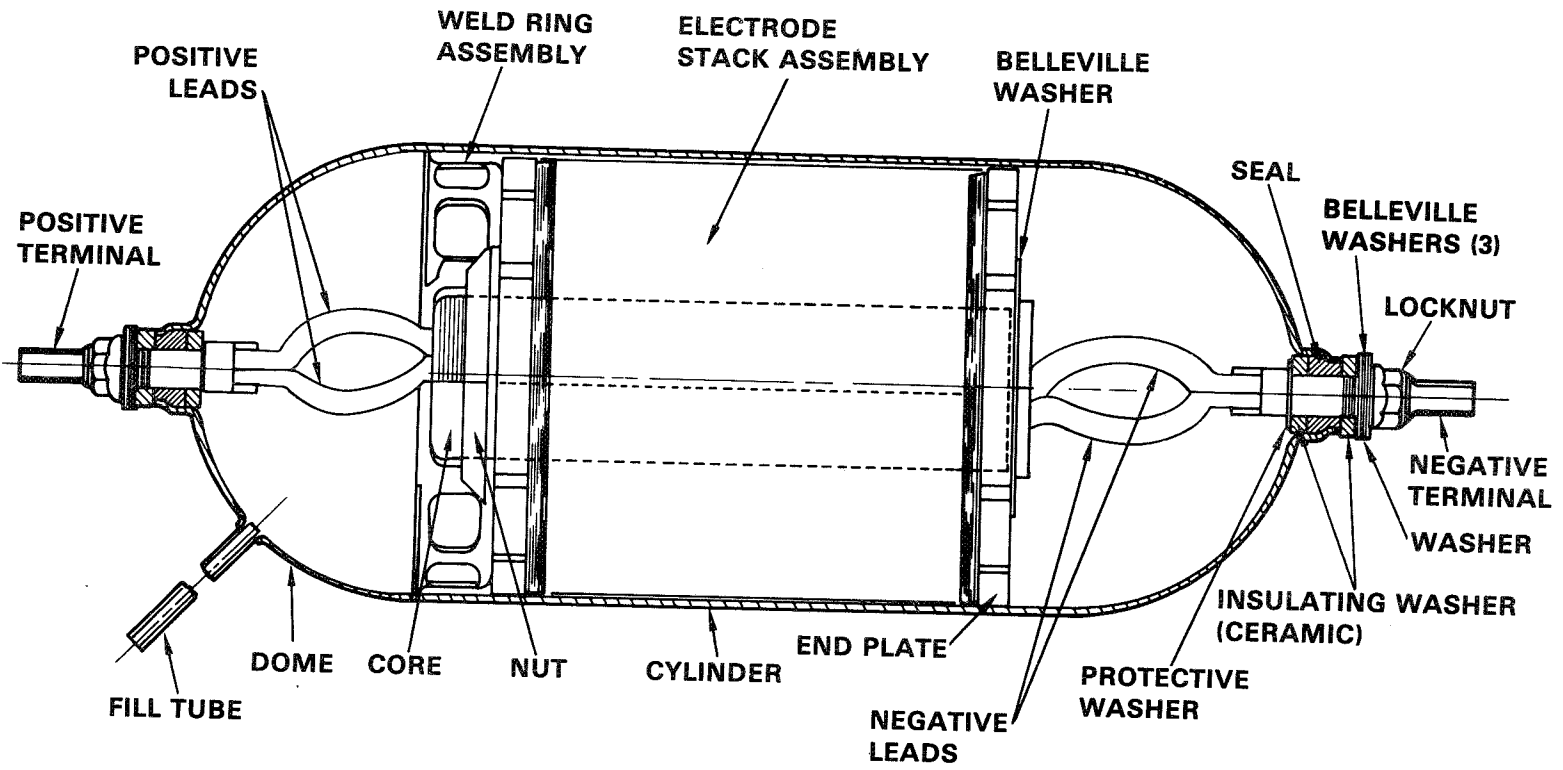
Figure 1. 50 Ampere-Hour Nickel-Hydrogen Cell

Each of the cells was dissected to determine the cause of failure. A dry nitrogen purge was used prior to disassembly to eliminate any residual hydrogen. Then the cell was cut open with a lathe just below the weld toward the negative terminal (see Figure 1). The negative end of the pressure vessel was then removed, exposing the electrode stack assembly. Figure 6 is a sketch of the electrode stack assembly. For purposes of identification, the electrodes are numbered consecutively from the positive end of the cell (weld ring end). Elements of the electrode stack assembly were removed individually, and photos, observations, etc. were accomplished as the disassembly progressed.

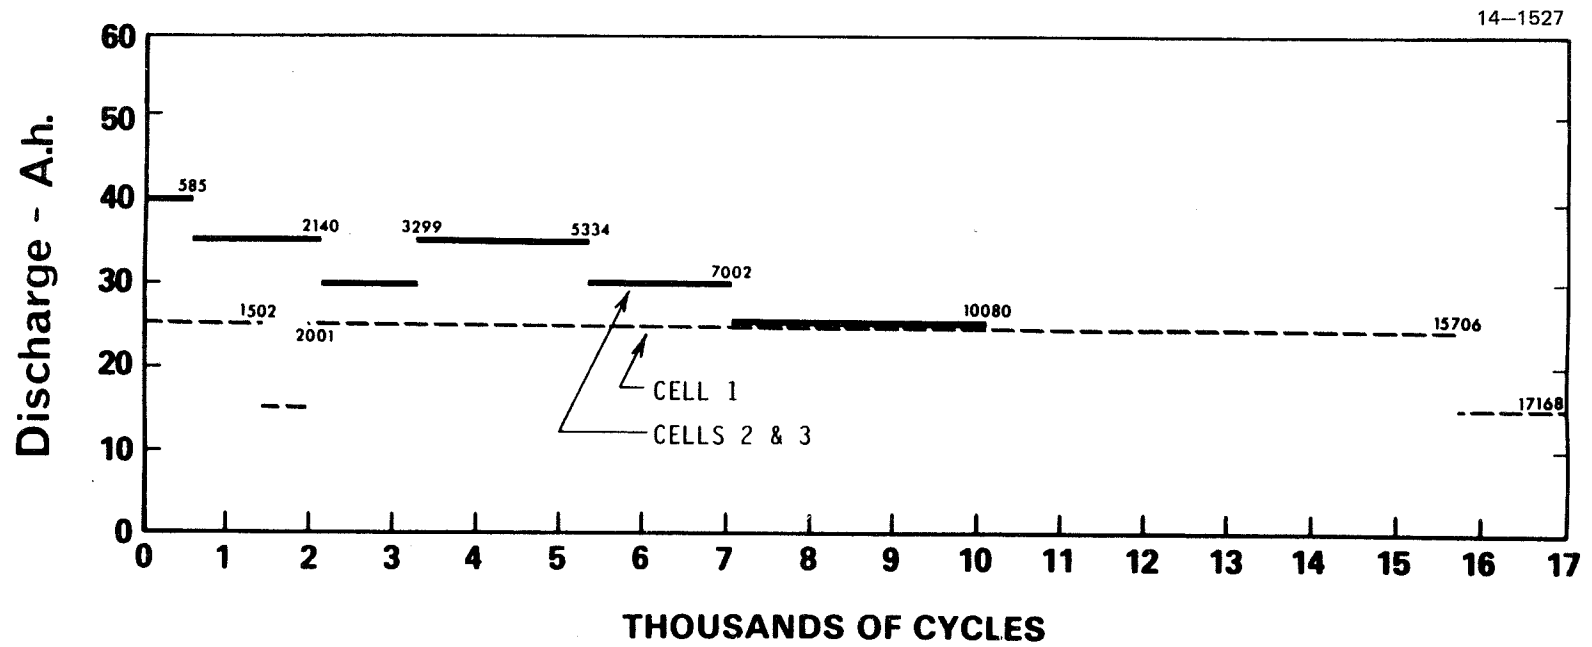
Figure 3. Discharge versus Cycles

Cell 1 was cycled independently and Cells 2 and 3 were cycled in series. The control point temperature was set to 8°C for the first 2000 cycles, and to 23°C subsequently. Figure 3 shows energy removed on discharge as a function of cycles completed for these cells. The desired depth of discharge (DOD) for Cells 2 and 3 was 80 percent of rated capacity. However, this resulted in low end of discharge (EOD) voltage and DOD was reduced to 70 percent after 585 cycles. Further reduction occurred subsequently, again in response to low EOD voltage. Cell 1 DOD was reduced to 25 percent early in the test for 500 cycles to obtain data to support another study then in progress. It was then returned to 50 percent DOD to cycle 15706 at which time it was reduced due to low EOD voltage.

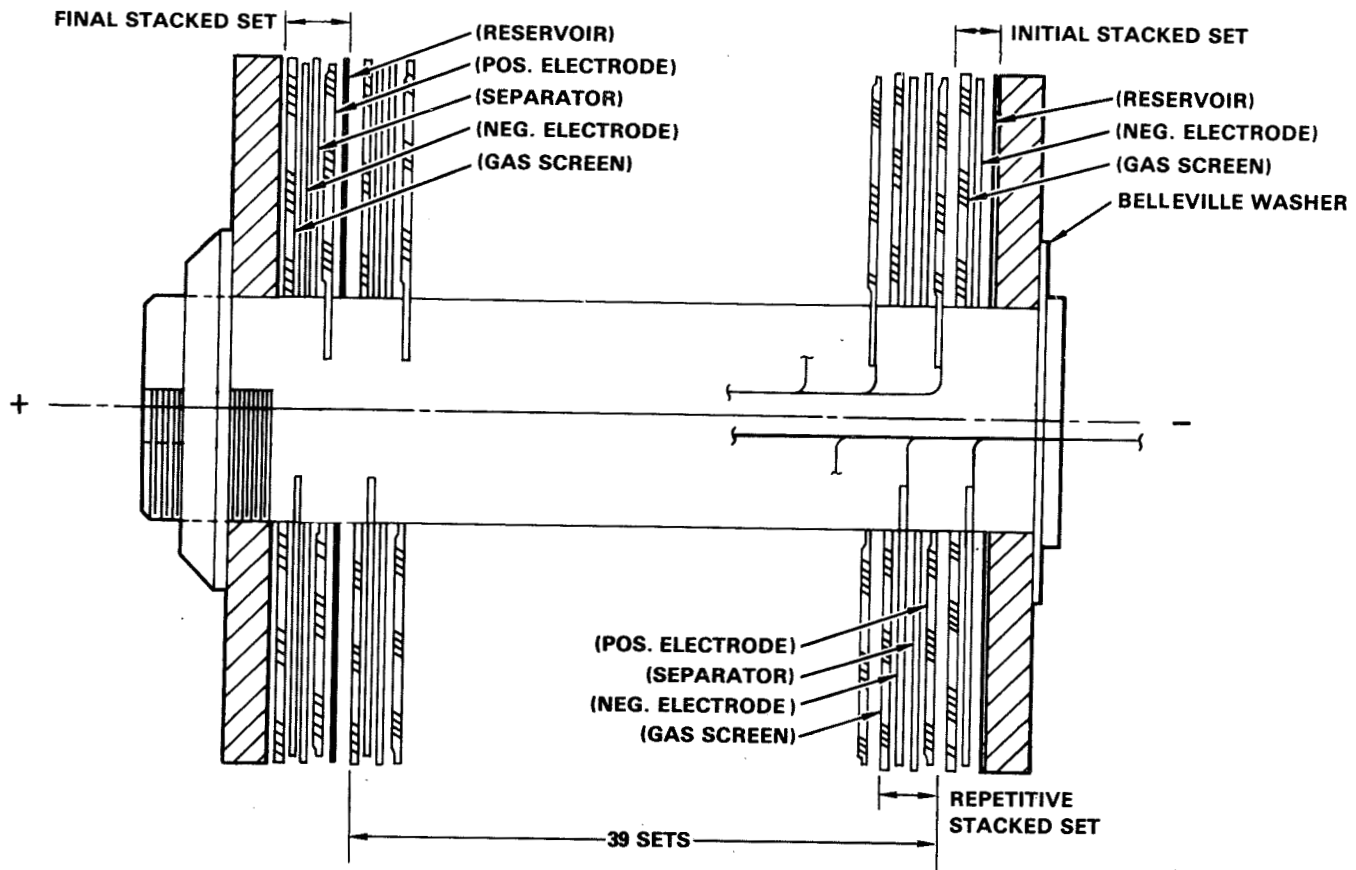
Figure 6. Electrode Stack Sketch

Positive plate thicknesses were measured during disassembly and ranged from 0.038 to 0.048 inches. Assuming that each positive plate was fabricated at the maximum dimension of 0.032 inches, the thickness of the electrode stack assembly increased by 0.451 inches during cycling. The cell failed in a nearly identical manner to Cell 3, and we believe the failure history was also the same. Positive plate growth of this magnitude cannot be accommodated; and, after the stack relieves, a short occurs at a pressure point between adjacent pairs of electrodes which ultimately results in the massive internal damage observed.
