DOE/NASA/20320-63
NASA TM-86983

Government Review of the Mod-2 Wind Turbine (As-Built)

June 1985

A Government committee was formed to conduct an as-built review of the three Mod-2 wind turbine units at Goldendale, Washington. The purpose of the review was (1) to identify any critical components and subassemblies which may be deficient in either strength or predicted service life, the failure of which would cause safety hazards or significant downtime and expensive repairs; and (2) to recommend any corrective action necessary to enable continued safe attended and unattended machine operation.

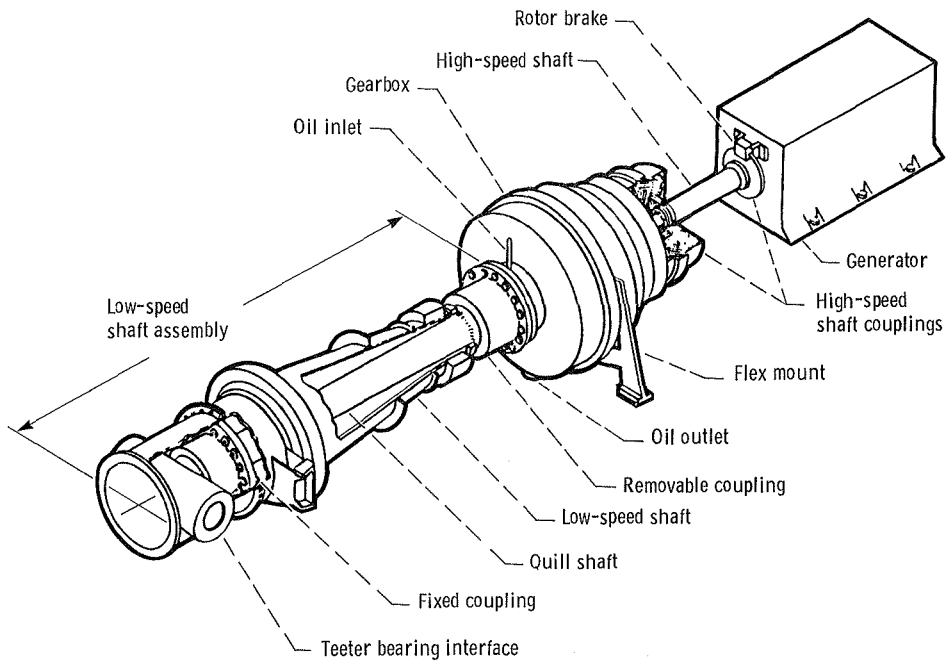
Figure 17. - Drive train assembly.

Item No. 15 - Generator. - The generator converts the rotational energy of the drive train into electrical energy. It is a three phase, 60-Hz, 4160-V synchronous generator, operated at 1800 rpm, and rated to provide 3125 kVA at 0.8 power factor (i.e., 2500 kW). The generator incorporates the disk and calipers for the rotor parking brake, as shown in figure 17.

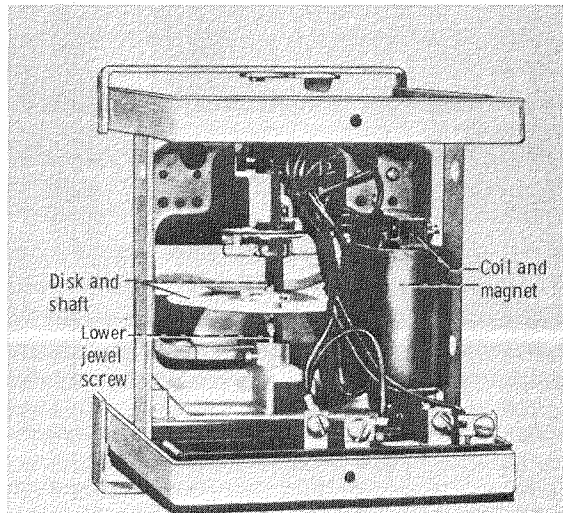
Figure 20. - Typical induction disk relay.

Five of the induction disk relays were opened to permit examination of the shaft, bearing, and bearing surface. Figure 20 shows a back view of a typical induction disc relay. The disk is mounted on a vertical shaft which pivots on upper and lower pins. The top bearing consists of a pin in the relay body which fits into a sleeve insert in the shaft. The bottom bearing consists of a pin which protrudes from the bottom of the disk shaft that rides on a jeweled surface. The disk is actuated by an induced magnetic field. The disk shaft is restrained by a spiral spring and its motion is retarded by a permanent magnet acting on the disk to give the correct time delay. The differential relay (87) and the loss of excitation relay (40) were not opened for examination because of the difficulty to "tear down".

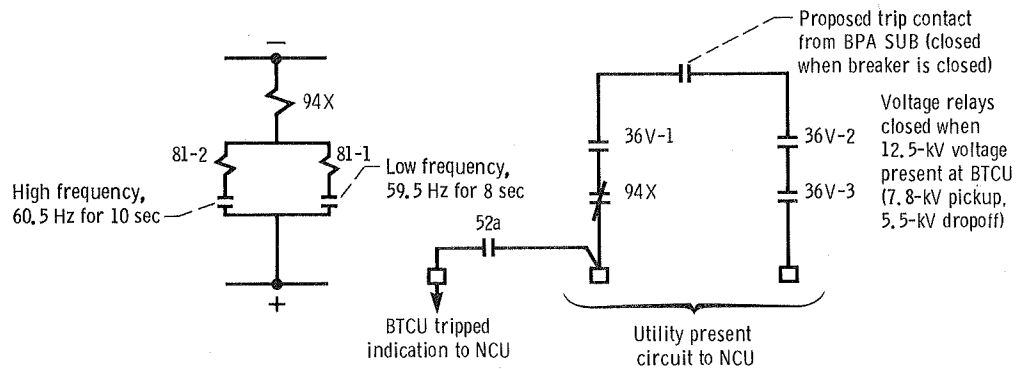
Figure 21. - Loss of utility power relay trip circuit.

The signal from these relays is used by the nacelle control unit (NCU) to indicate an absence of utility power. A significant amount of time (ranging from 8 sec to more than 1 min) can pass before the NCU senses and responds to a loss of utility power. An added trip contact placed in series with the contacts of relays 94X and 36V (see fig. 21) would provide an immediate signal to the NCU of loss of utility power resulting in WT shutdown.

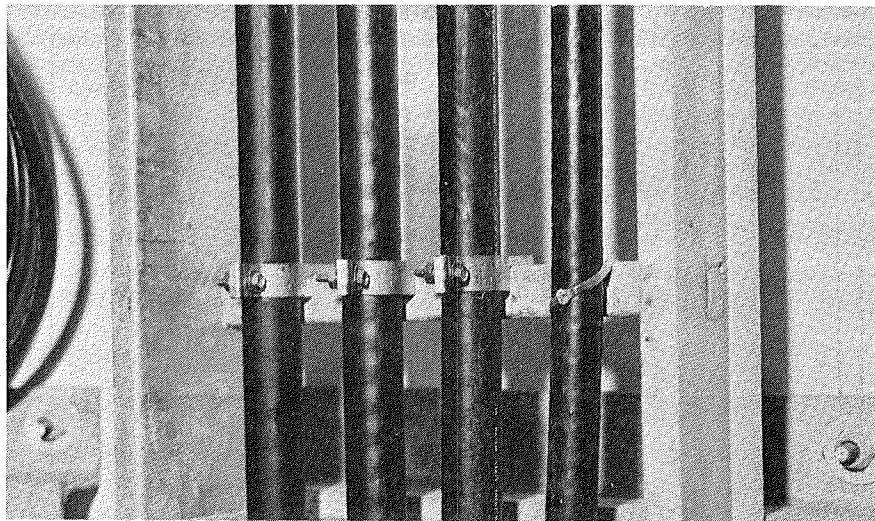
Figure 22. - Phase conductor (4, 16-kV) cable ladder clamps.

Item No. 22 - Tower Power Cable Mountings. - Three individually jacketed cables are used to carry the 4.16-kV alternator output to the base of the tower. These conductors are secured by individual metal clamps (see fig. 22) to the cable ladder. These clamps are placed about 1.5 ft apart, at every

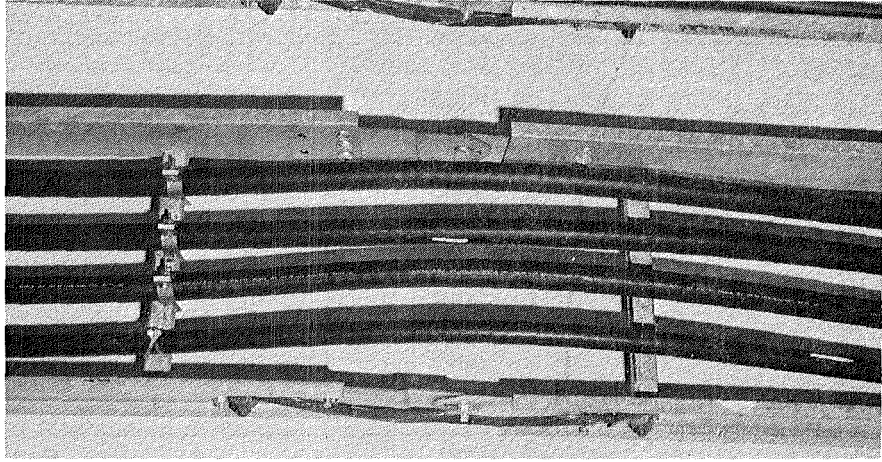
Figure 23. - Power cable ladder extension joints.

ladder rung, except one rung is skipped at the cable ladder extension joints (every 12 ft) (see fig. 23). Nylon tie-wraps are used to secure the 2/0 neutral cable to the ladder.

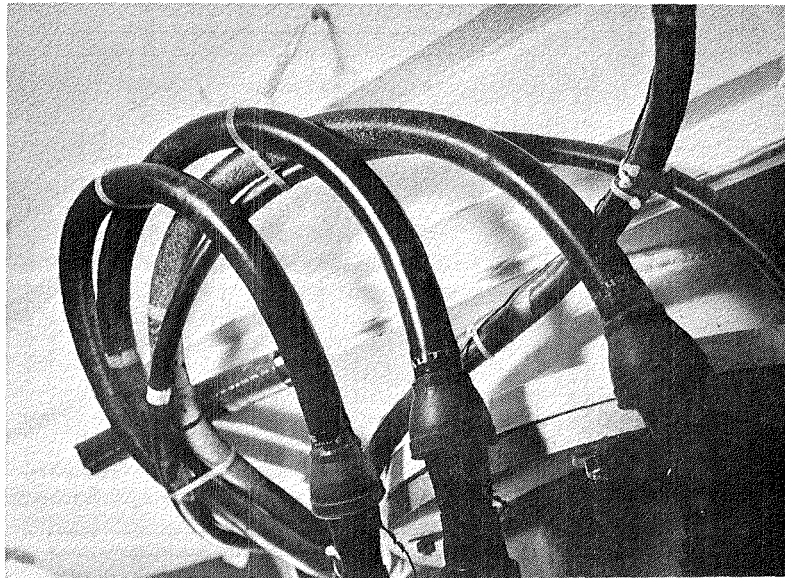
Figure 24. - Wind turbine HV cable suspension at yaw slipring.

Findings: The high voltage power cables which run from the generator to the yaw slipring assembly had a free run of about 5 ft in length between the point where they emerge from the nacelle floor conduit and attach to the slip ring terminations. The three phase conductors were tied off and supported by a nylon rope in WT3 and nylon tie-wrap in WT2 (see figure 24). The suspension tether supported the conductor weight and relieves strain on the rotation side termination elbows. WT1 was partially disassembled following the LSS failure in November 1982 so its method of suspension could not be determined.

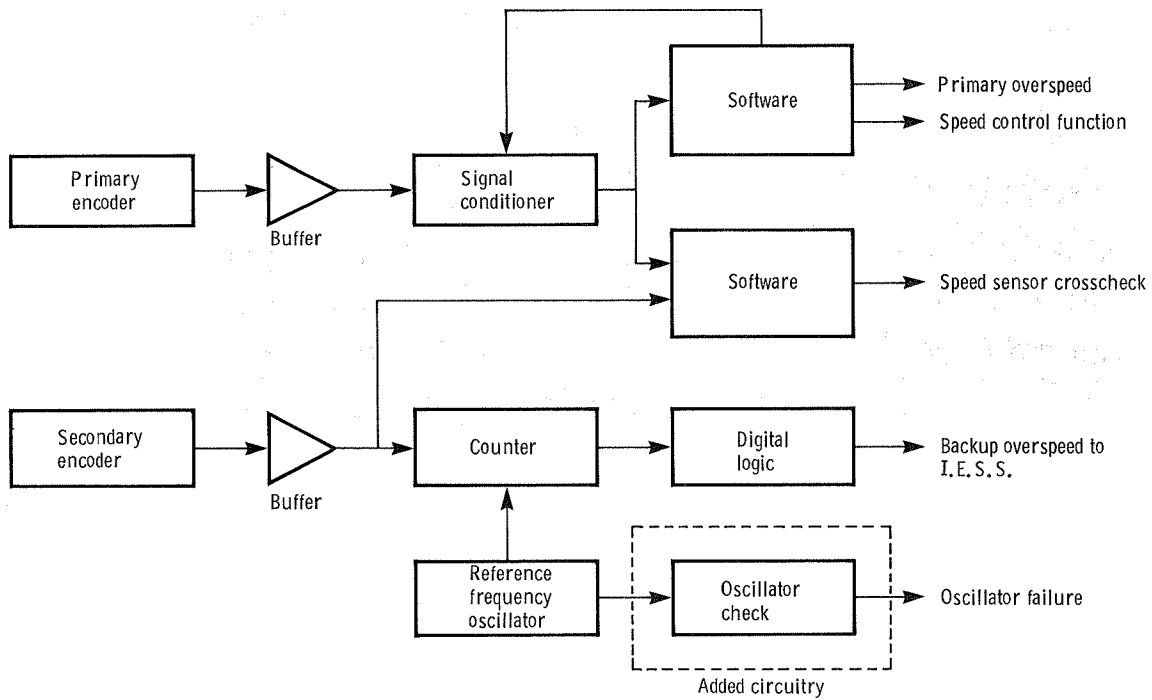
Figure 25. - Overspeed sensing circuitry.

The sensing, shown in figure 25, consists of two encoders of similar but not identical installation and manufacture, thus eliminating the likelihood of simultaneous generic failures. One sensor used for the speed control function, also generates the primary overspeed signal which actuates the start and stop valves. This circuitry, located in the microprocessor rack was used continuously during normal running. Thus, most failures were detectable and failsafe or had a built-in backup mode, such as feathering the blade with servo valves if the start and stop valves did not function.

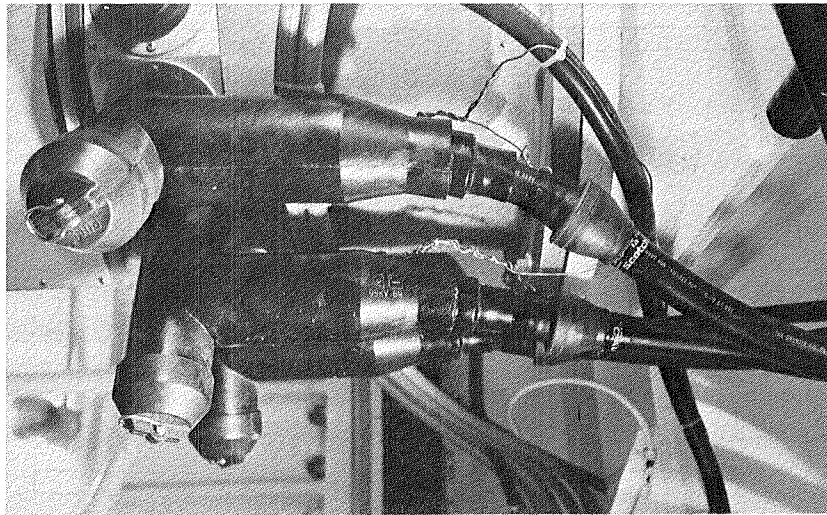
Figure 27. - Wind turbine yaw slipring HV molded cable terminations.

BEC nonconformance reports (NCR's) documented that oil leaks in the nacelle were resulting in oil dripping onto, or potentially dripping onto the HV cables where they attach to the yaw slipring. (See fig. 27.) Oil will eventually deteriorate the insulation of the HV cables, and both the insulation and semiconducting coating of the molded HV connectors, causing faults between phases and from phase to ground.

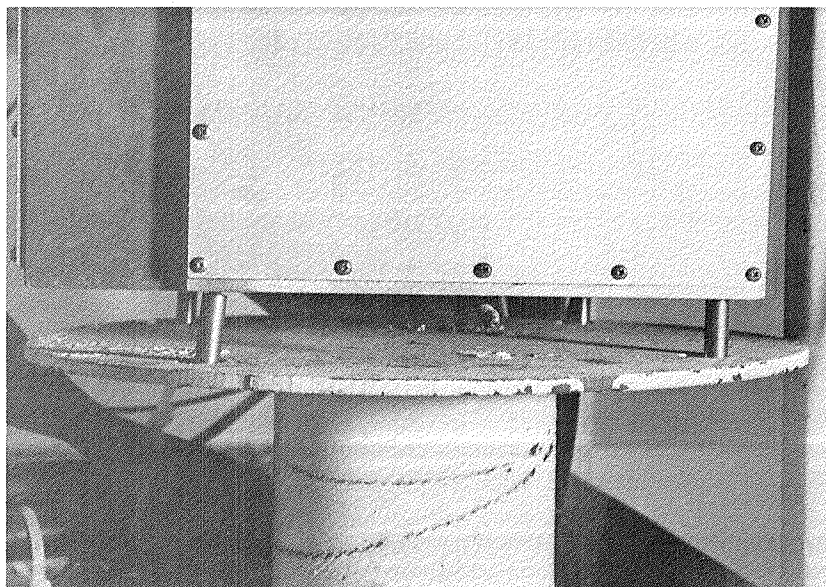
Figure 28. - Wind turbine yaw slipring anti-rotation restraint.

The antirotation bracket on WT2 (see figure 28) showed some deformation where the existing bolts, that act as antirotation restraints were attached. Inspections of this installation and others give the impression that misalignment might exist between the rotating and stationary fixtures of the yaw slipring assembly. This could cause bending loads to be placed on the assembly by the antirotation brackets and bolt restraints.
