NASA
Technical Memorandum 86939

Experimental Study of Ceramic-Coated Tip Seals for Turbojet Engines

Prepared for the
Ninth Annual Conference on Composites and Advanced Ceramic Materials
sponsored by the American Ceramic Society
Cocoa Beach, Florida, January 20-24, 1985

EXPERIMENTAL STUDY OF CERAMIC-COATED TIP SEALS FOR TURBOJET ENGINES

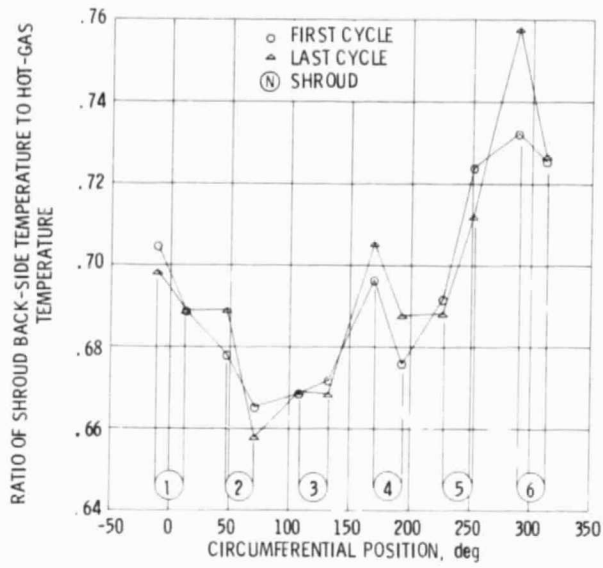
Normalized, steady-state shroud back-side temperatures after the first and the last (1001) cycles are shown in figure 8. Thermocouples on shroud 6 were somewhat out of agreement with the trend established by the other thermocouples. However, the thermocouples showed no visual or electrical signs of distress under post-test inspection. Possible explanations include cooling hole blockage limiting flow to this shroud; excess coolant bleeds to the hot gas path; a thinner than normal ceramic coating; a variation in combustor temperature profile; and a variation in shroud-to-blade clearance from nominal. This problem has not been resolved.

Figure 8. - Normalized shroud back-side temperatures at high power for first and last (1001) cycles.

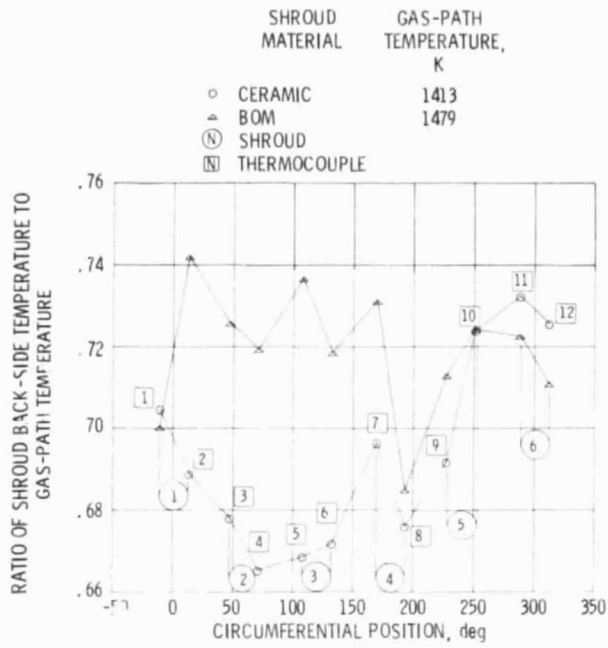
The back-side temperatures for the ceramic shroud after the first cycle were on the whole significantly lower than those for the BOM shroud (fig. 10). However, there were anomalies where the opposite was true, such as for thermocouples 1, 10, 11, and 12. This corroborates the previously observed higher-than-nominal temperatures near shroud 6. Excluding these thermocouples, the average temperature difference between the ceramic and BOM shrouds was approximately 78 deg C (140 deg F).

Figure 10. - Ceramic and BOM shroud back-side temperatures at high power after 1 cycle.

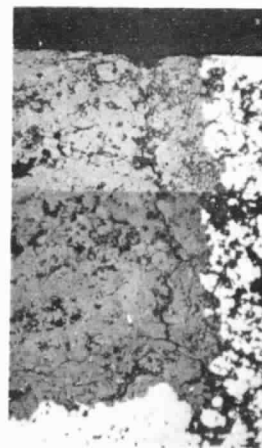
For the sectioned shroud (fig. 11), the bond coat was 1.14 to 1.27 mm (0.045 to 0.050 in) thick. Adjacent to the leading and trailing edges the bond coat was about 50 percent dense (fig. 15). Vertical cracking was also evident in the bond coat.

The ceramic top coat was 0.76 to 0.98 mm (0.030 to 0.039 in) thick. Probably this was closer to 1.27 mm (0.050 in) before grinding. The bond coat had cracked at the trailing edge (fig. 15(b)); the crack extended almost 1.9 mm (0.075 in) from the trailing edge to the leading edge and 12.7 mm (0.500 in) from right to left.

Figure 15. - Low density in bond coat adjacent to leading and trailing-edge frames.

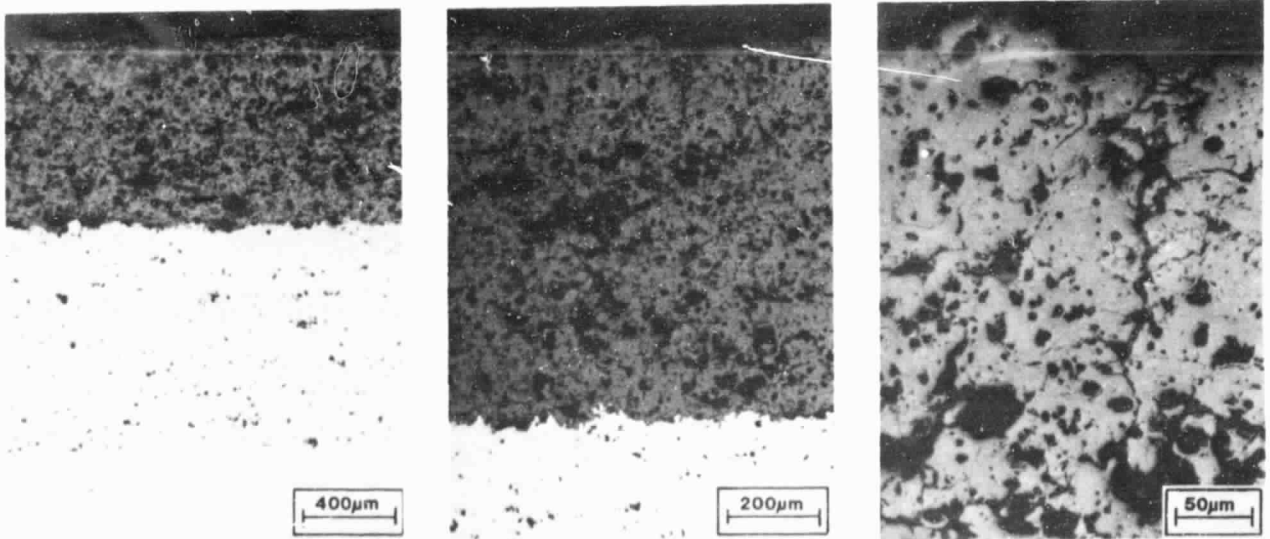
A pretest micrograph (fig. 17(a)) of a quality control specimen that was not run in the engine revealed some vertical cracking, which provides strain relief. The post-test ceramic coating microstructure (figs. 17(b) and (c)) revealed extensive segmentation, commonly called mudflat cracking, and some local areas of lateral cracking and large porosity. Apparently some densification of the ceramic occurred. However, caution must be exercised as microstructures are very dependent on metallographic polishing methods.

(a) Pretest microstructure; cross section B-B.
