NASA Technical Memorandum 85679

VERTICAL DROP TEST OF A TRANSPORT FUSELAGE SECTION LOCATED FORWARD OF THE WING

M. Susan Williams
Robert J. Hayduk

August 1983

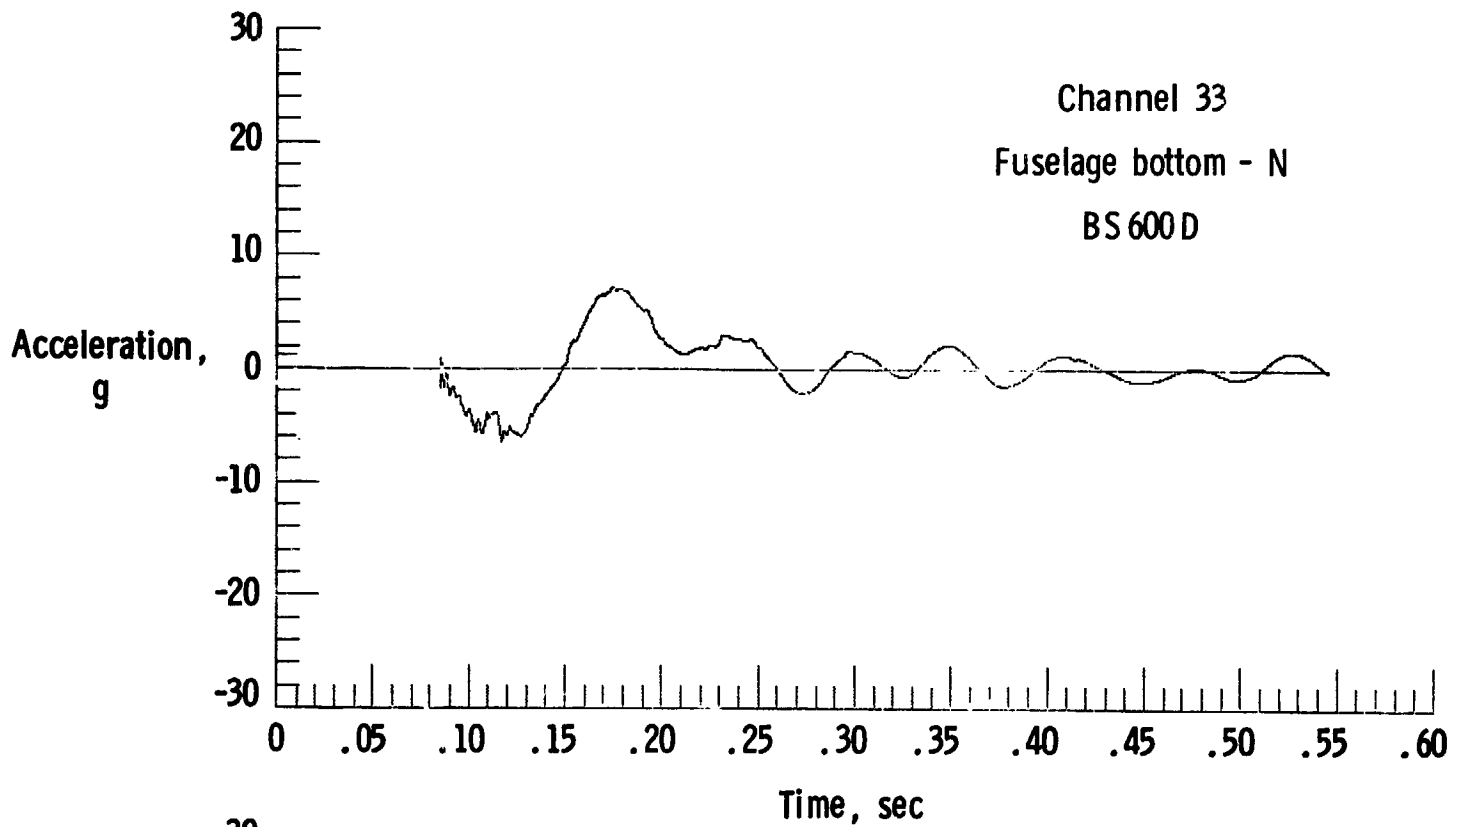
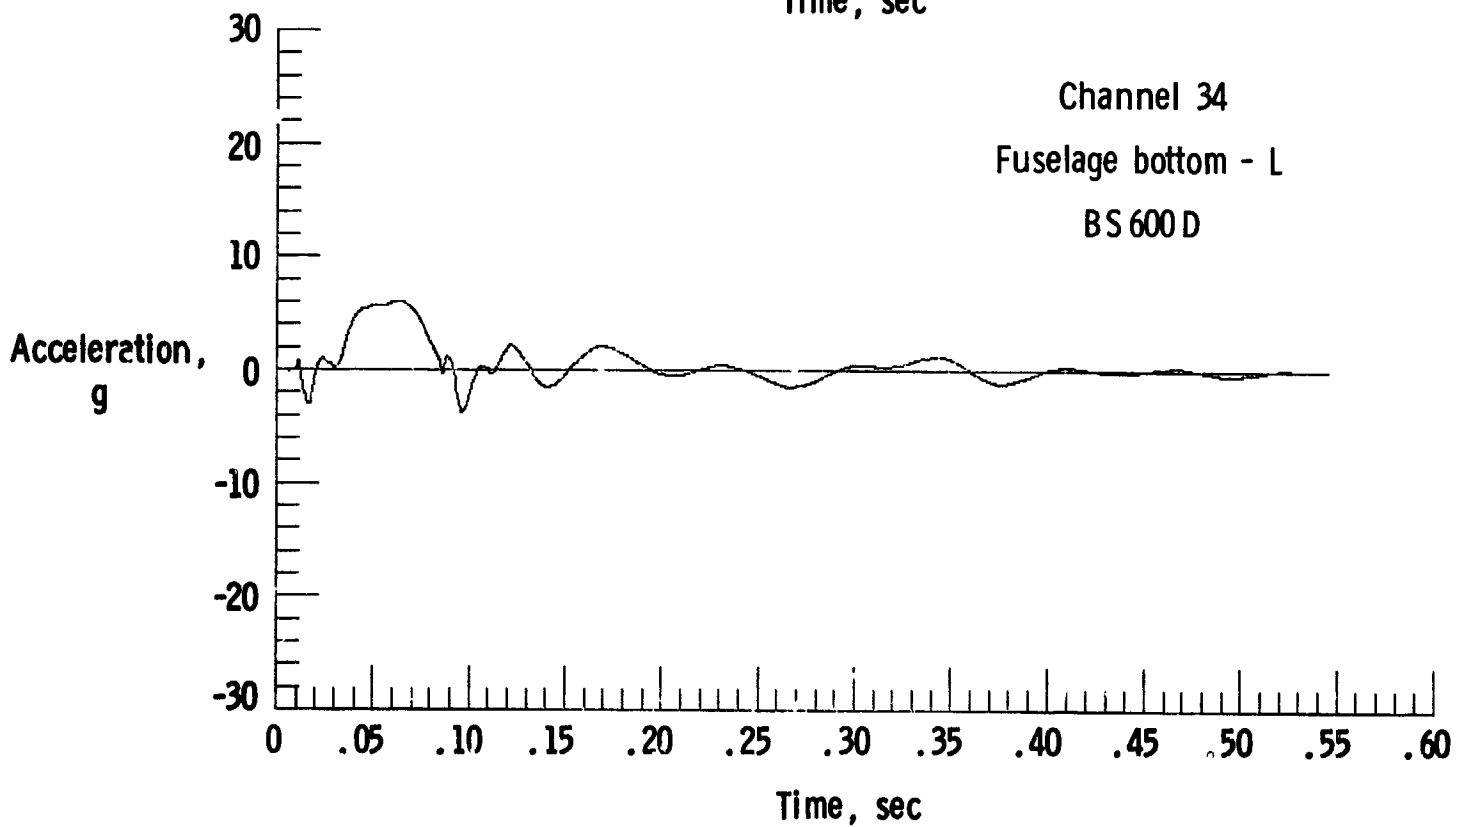
(a) Structural acceleration time histories.
Figure 9.- Acceleration time histories measured on the aircraft structure.

The maximum normal acceleration of the first pulse was measured on the bottom of the fuselage and was approximately 20 g (20 Hz filter) with a time duration of 0.03 sec. Secondary pulses were in the 6 to 12 g range. Normal accelerations measured on the frames approximately one-third and two-thirds the vertical distance between the bottom of the fuselage and floor on the starboard side were characterized by two pulses. The first pulse ranged from 8 to 10 g for approximately 0.03 sec. The acceleration levels dropped soon after the buckling failure occurred and began increasing again as the structure stiffened to a maximum of 10 to 12 g for approximately 0.05 sec (second pulse).
