**NASA  
Technical  
Paper  
2190**

# **Crash Tests of Three Identical Low-Wing Single-Engine Airplanes**

**Claude B. Castle  
and Emilio Alfaro-Bou**

**Claude B. Castle  
and Emilio Alfaro-Bou**  
*Langley Research Center  
Hampton, Virginia*

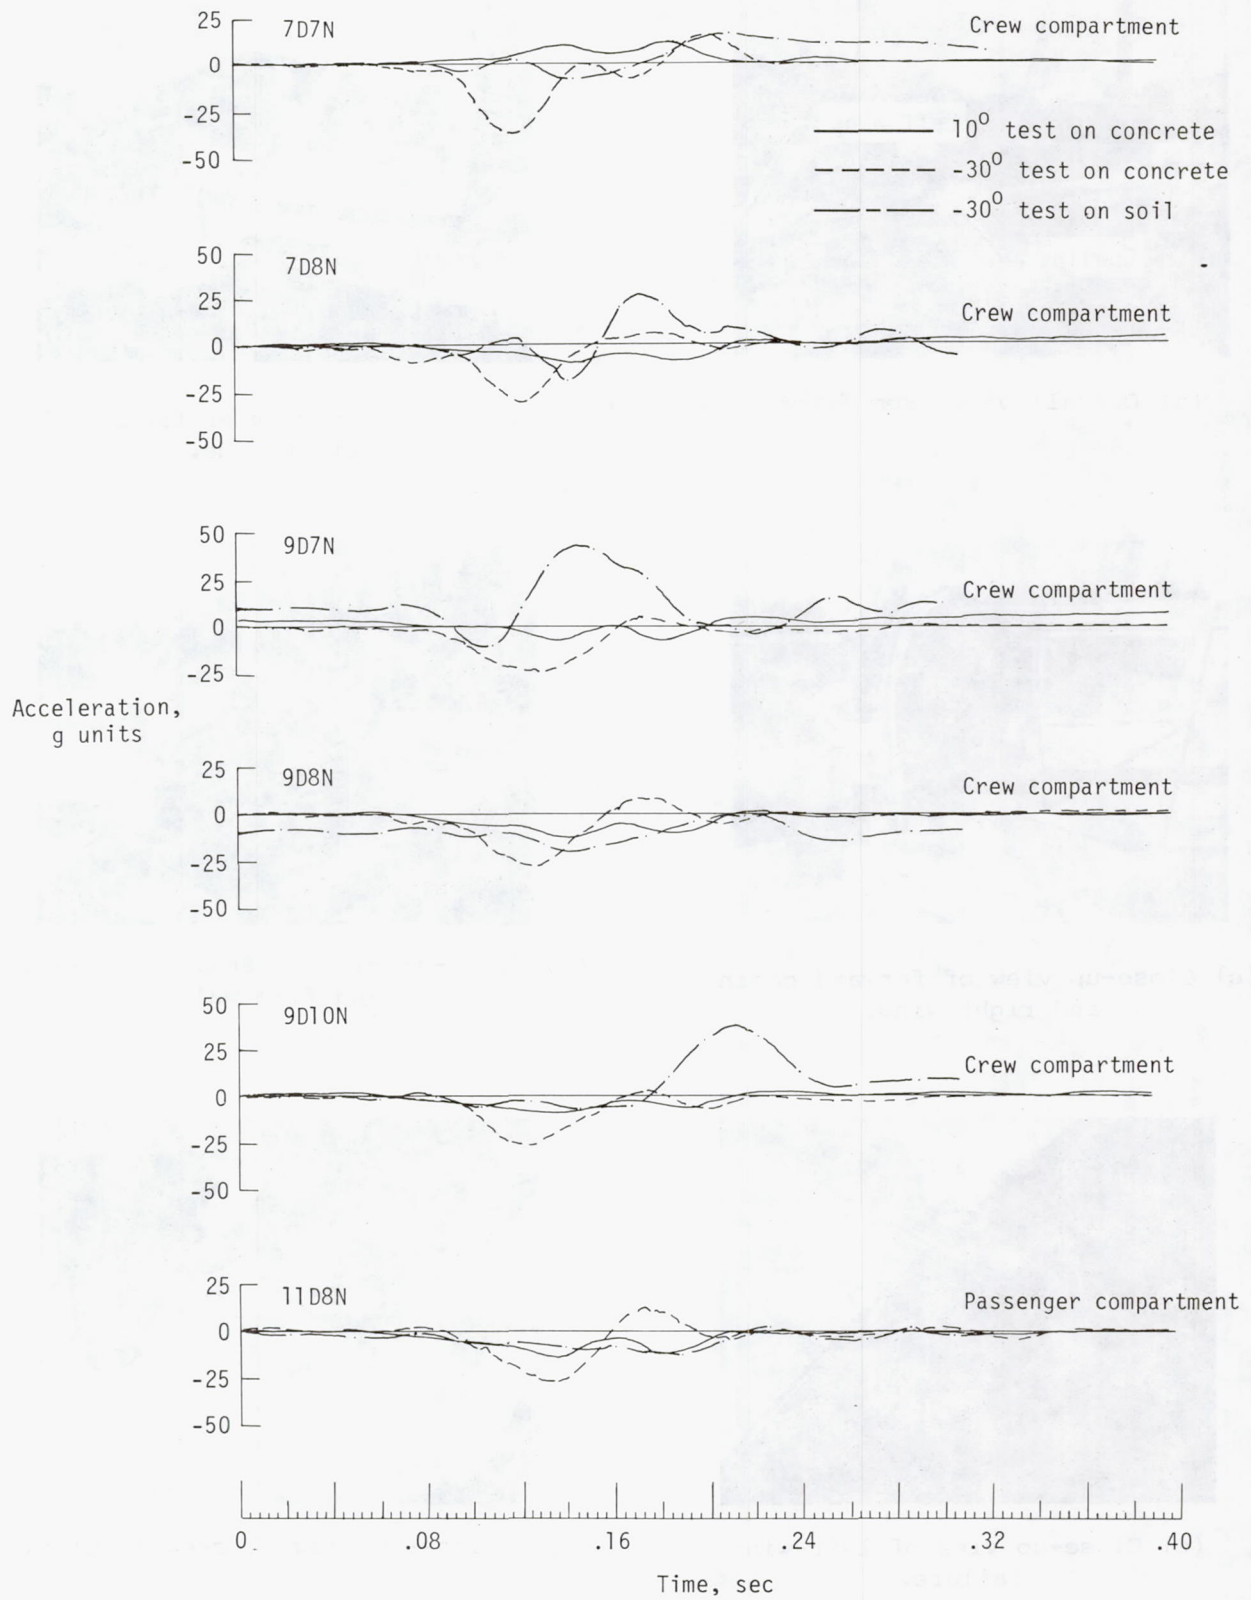
Figure 15.- Normal accelerations on cabin floor in crew and passenger compartments.

Cabin floor.- Normal accelerations on the cabin floor in the crew and passenger compartments for the three tests are presented in figure 15. The crew compartment is located forward of the main spar, and the passenger compartment is located immediately aft of the main spar. Floor accelerometers were placed adjacent to each leg of the pilot's seat, to the right rear leg of the copilot's seat, and to the front inboard leg of the first-passenger's seat. To obtain an overall acceleration value for the cabin floor in each test, three peak accelerations on the inboard floor beam located under the seats of the pilot and first passenger were averaged and compared. The beam was chosen for its location (toward the center of the fuselage) and for its rigidity (accelerations less susceptible to local deformations). In the discussion that follows, it should be noted that only the first significant acceleration peaks are being compared.

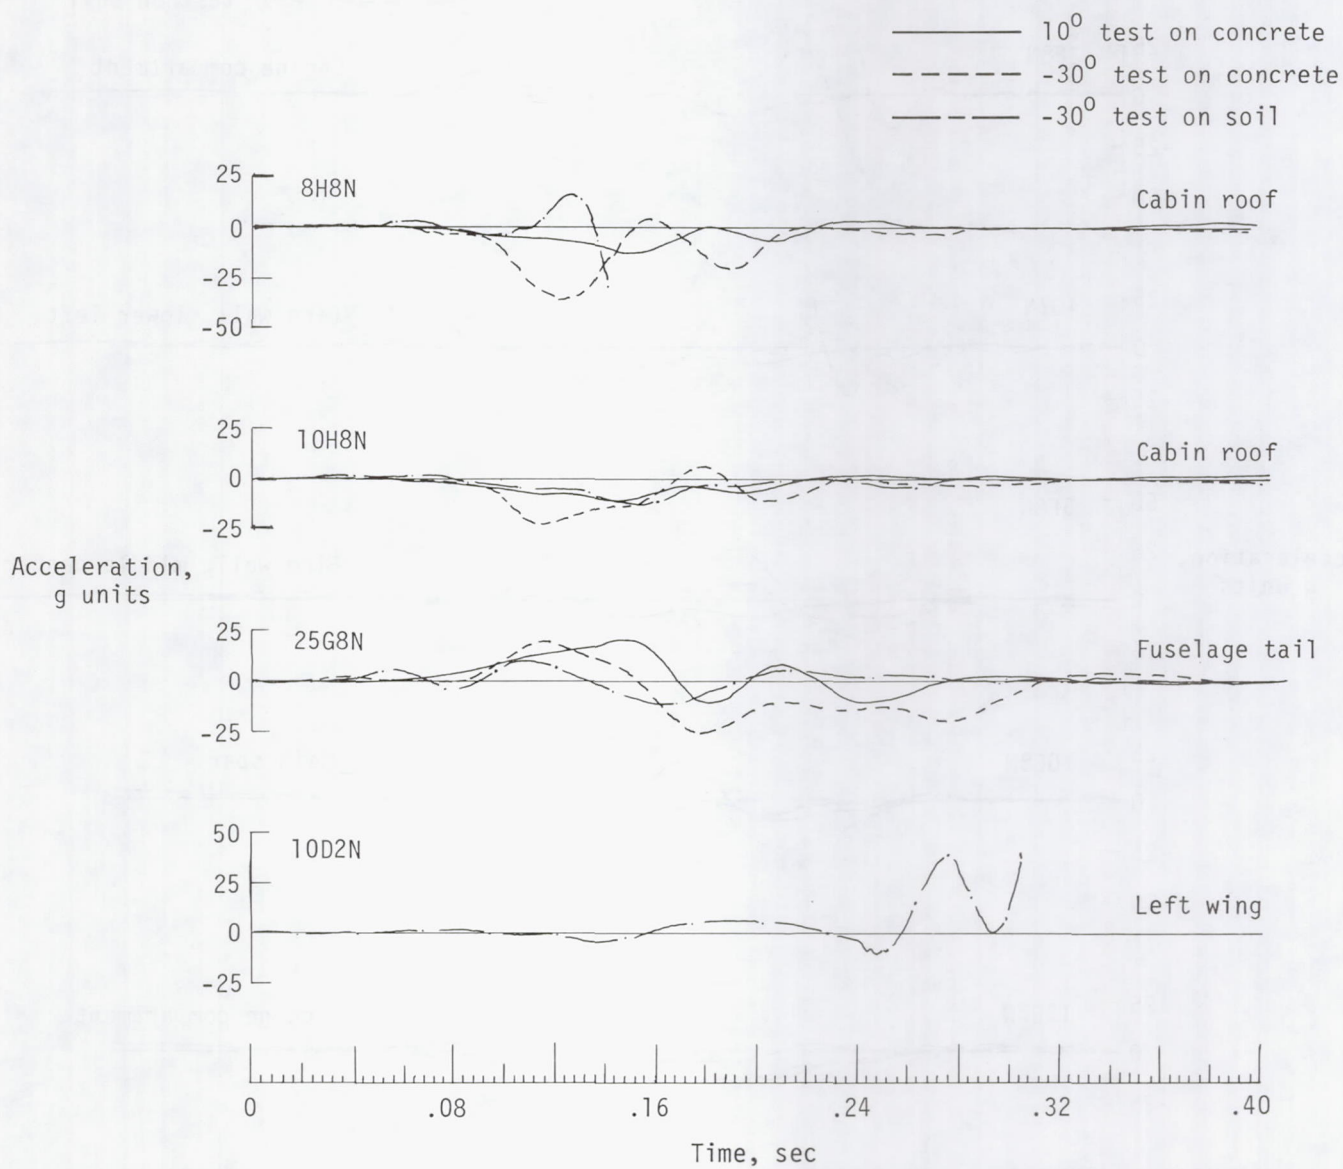
Figure 16.- Normal peak accelerations on cabin roof, fuselage tail, and left wing.

Cabin roof, fuselage tail, and left wing.- Normal peak accelerations on the cabin roof, fuselage tail, and left wing are presented in figure 16. Peak accelerations on the roof in the crew compartment averaged -12g for the 10° test on concrete, -31g for the -30° test on concrete, and -10g for the -30° test on soil. On the tail, the peak accelerations, apparently because of the structural flexibility, varied from 20g to -12g for the 10° test on concrete, 19g to -27g for the -30° test on concrete, and 10g to -11g for the -30° test on soil. On the wing, a -5g peak acceleration occurred at impact for the -30° test on soil, with a maximum acceleration of 39g as the wings were torn from the fuselage. Wing accelerations for the other two tests were not recorded.

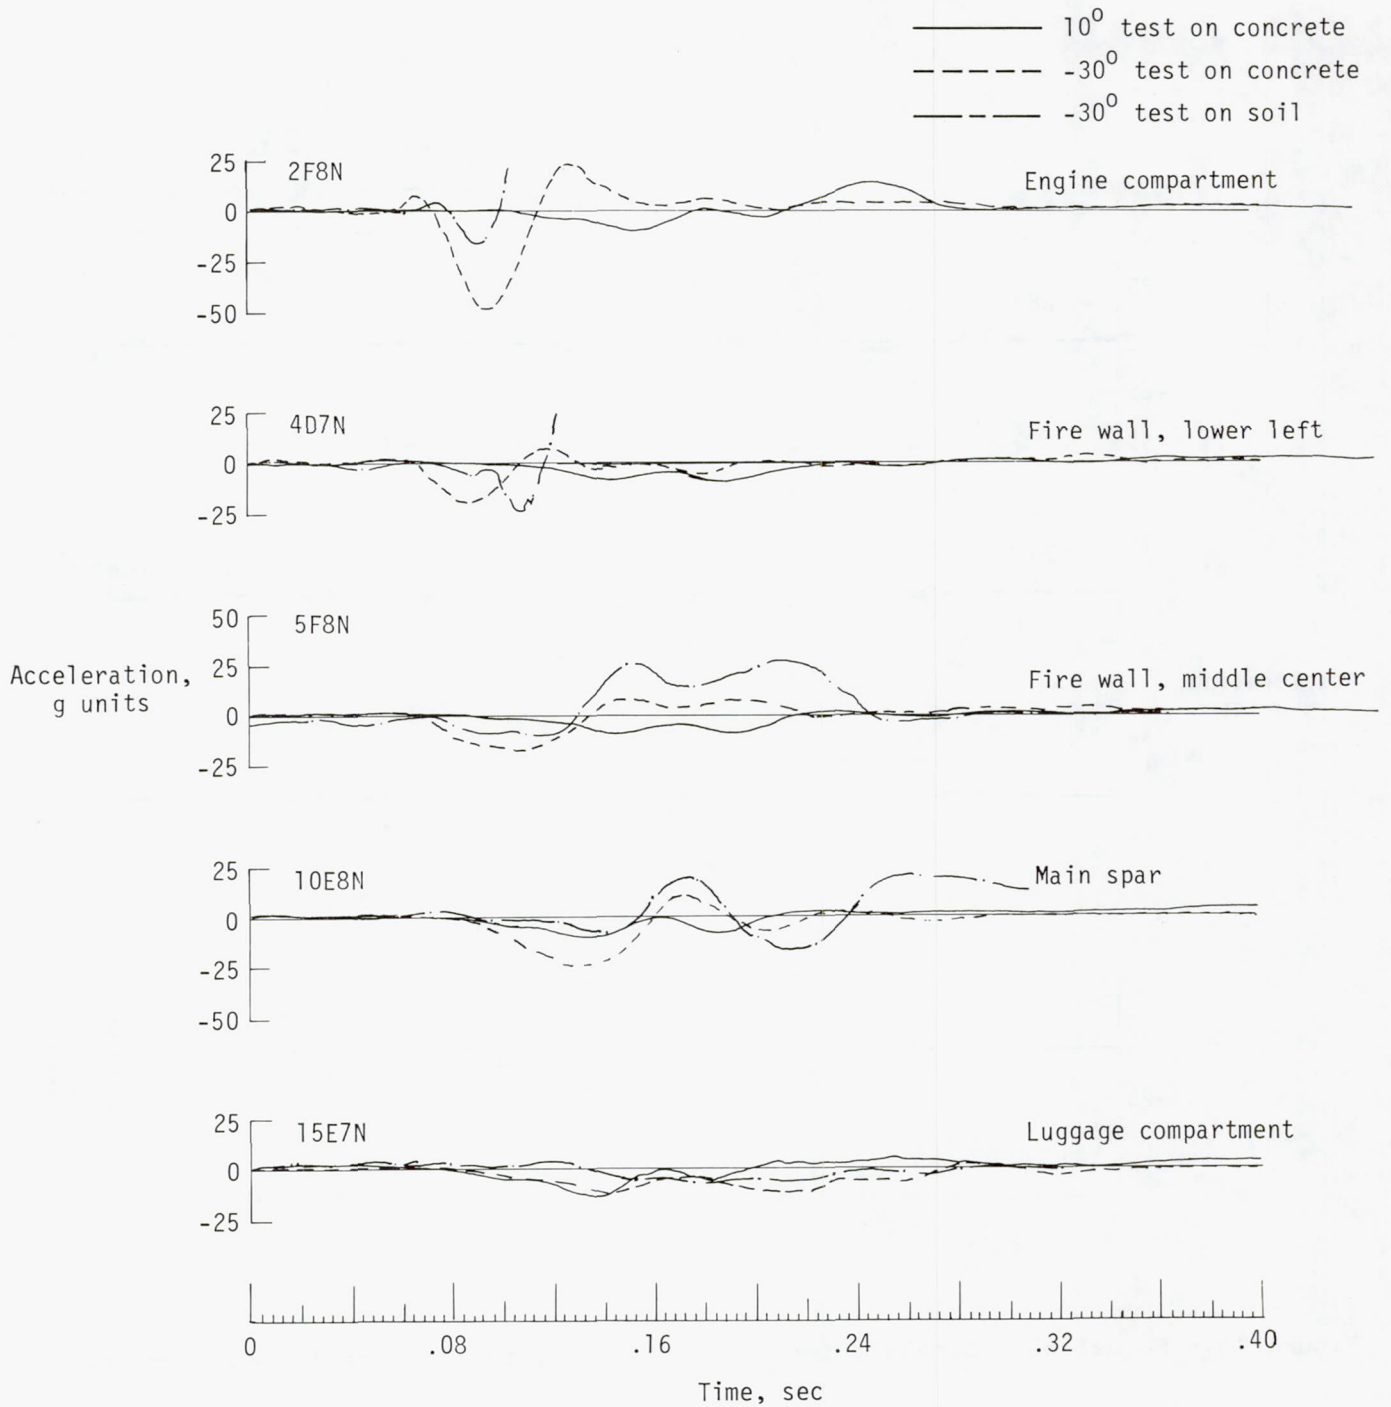
Figure 17.- Normal accelerations in engine compartment and fire wall, main spar, and luggage compartment.

Engine compartment, main spar, and luggage compartment. Normal accelerations in the engine compartment, main spar, and luggage compartment are presented in figure 17. Normal accelerometers mounted on the engine recorded -12g in the 10° test on concrete, -52g in the -30° test on concrete, and -18g for the -30° test on soil. On the fire wall, the average peak accelerations were -12g, -20g, and -25g, respectively; on the main spar, they were -12g, -25g, and -9g, respectively; and in the luggage compartment, they were -11g, -13g, and -7g, respectively. In general, the normal peak accelerations at these locations were highest for the -30° test on concrete, with the exception of an accelerometer on the middle of the fire wall that

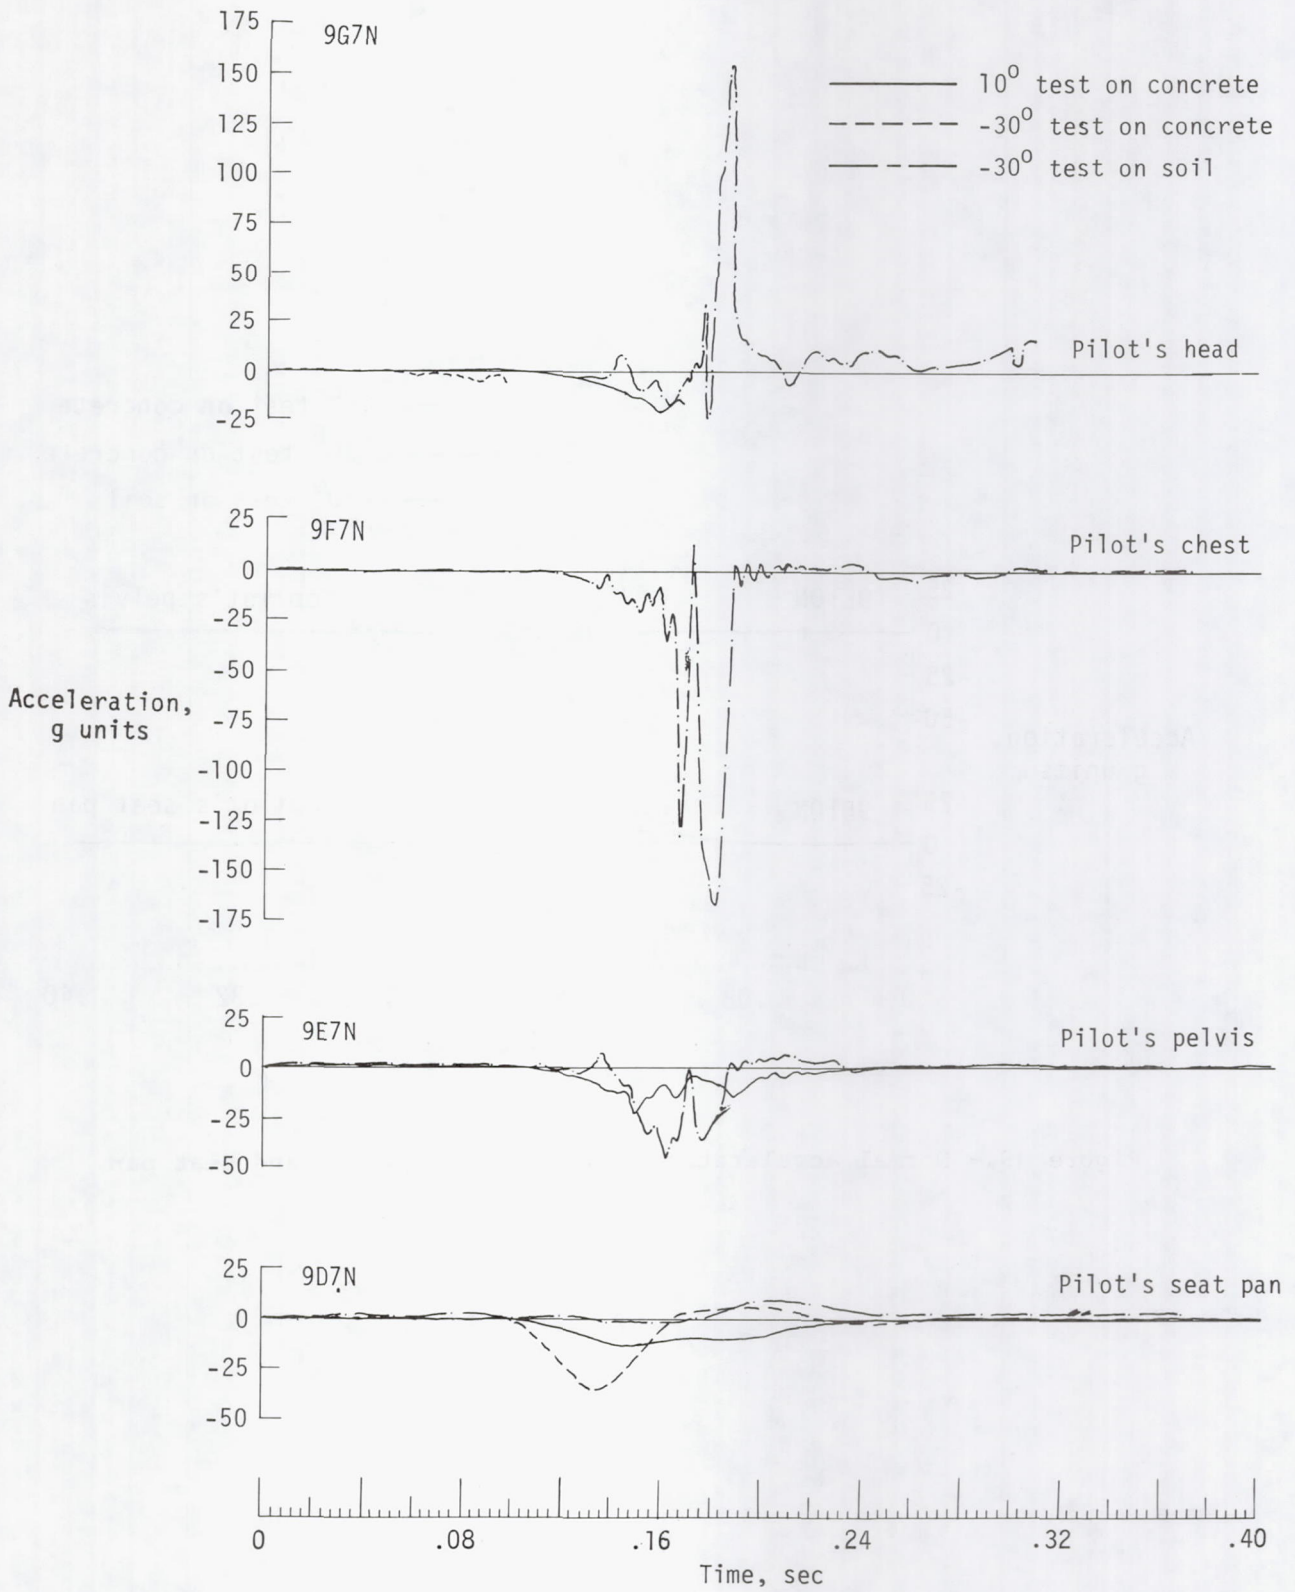
Figure 18.- Normal accelerations in pilot's body and seat pan.

Pilot's body and seat pan.- Normal accelerations in the pilot's body and seat pan are presented in figure 18. In the 10° test on concrete, peak accelerations of -20g and -22g were recorded in the pilot's head and pelvis, respectively. A peak acceleration of -14g was recorded at the seat pan. No acceleration was recorded on the pilot's chest for this test. In the -30° test on concrete, a peak acceleration of -37g was recorded at the pilot's seat pan. No accelerations were recorded at the head, chest, or pelvis. In the -30° test on soil, peak accelerations of 155g, -168g, -46g, and -8g were recorded in the pilot's head, chest, pelvis, and seat pan, respectively. From a high-speed motion-picture analysis, it was observed that during the impact of the airplane on the soil, the dummy's head impacted the instrument panel on the right side of the control stick. The high positive acceleration value (155g) recorded in the head and the negative value (-168g) in the chest are a consequence of this impact. The normal acceleration of -8g in the seat pan occurred primarily because the soil impact was essentially a high longitudinal loading in which the dummies' moving forward unloaded the seat-pan area.

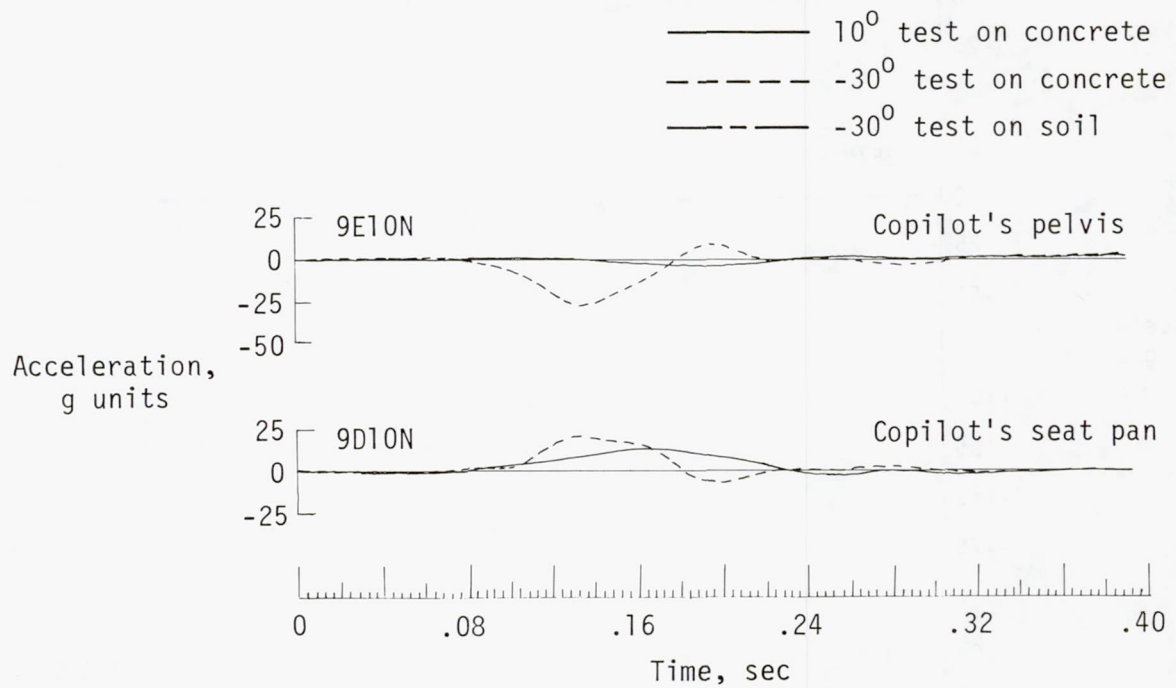
Figure 19.- Normal accelerations in copilot's pelvis and seat pan.

Copilot's pelvis and seat pan.- Normal accelerations in the copilot's pelvis and seat pan are presented in figure 19. In the 10° test on concrete, the peak acceleration recorded in the dummy's pelvis was -4g and in the seat pan was -14g. In the -30° test on concrete, the peak acceleration recorded in the pelvis was -29g and in the seat pan was -20g. Acceleration data at these locations were lost for the -30° test on soil.

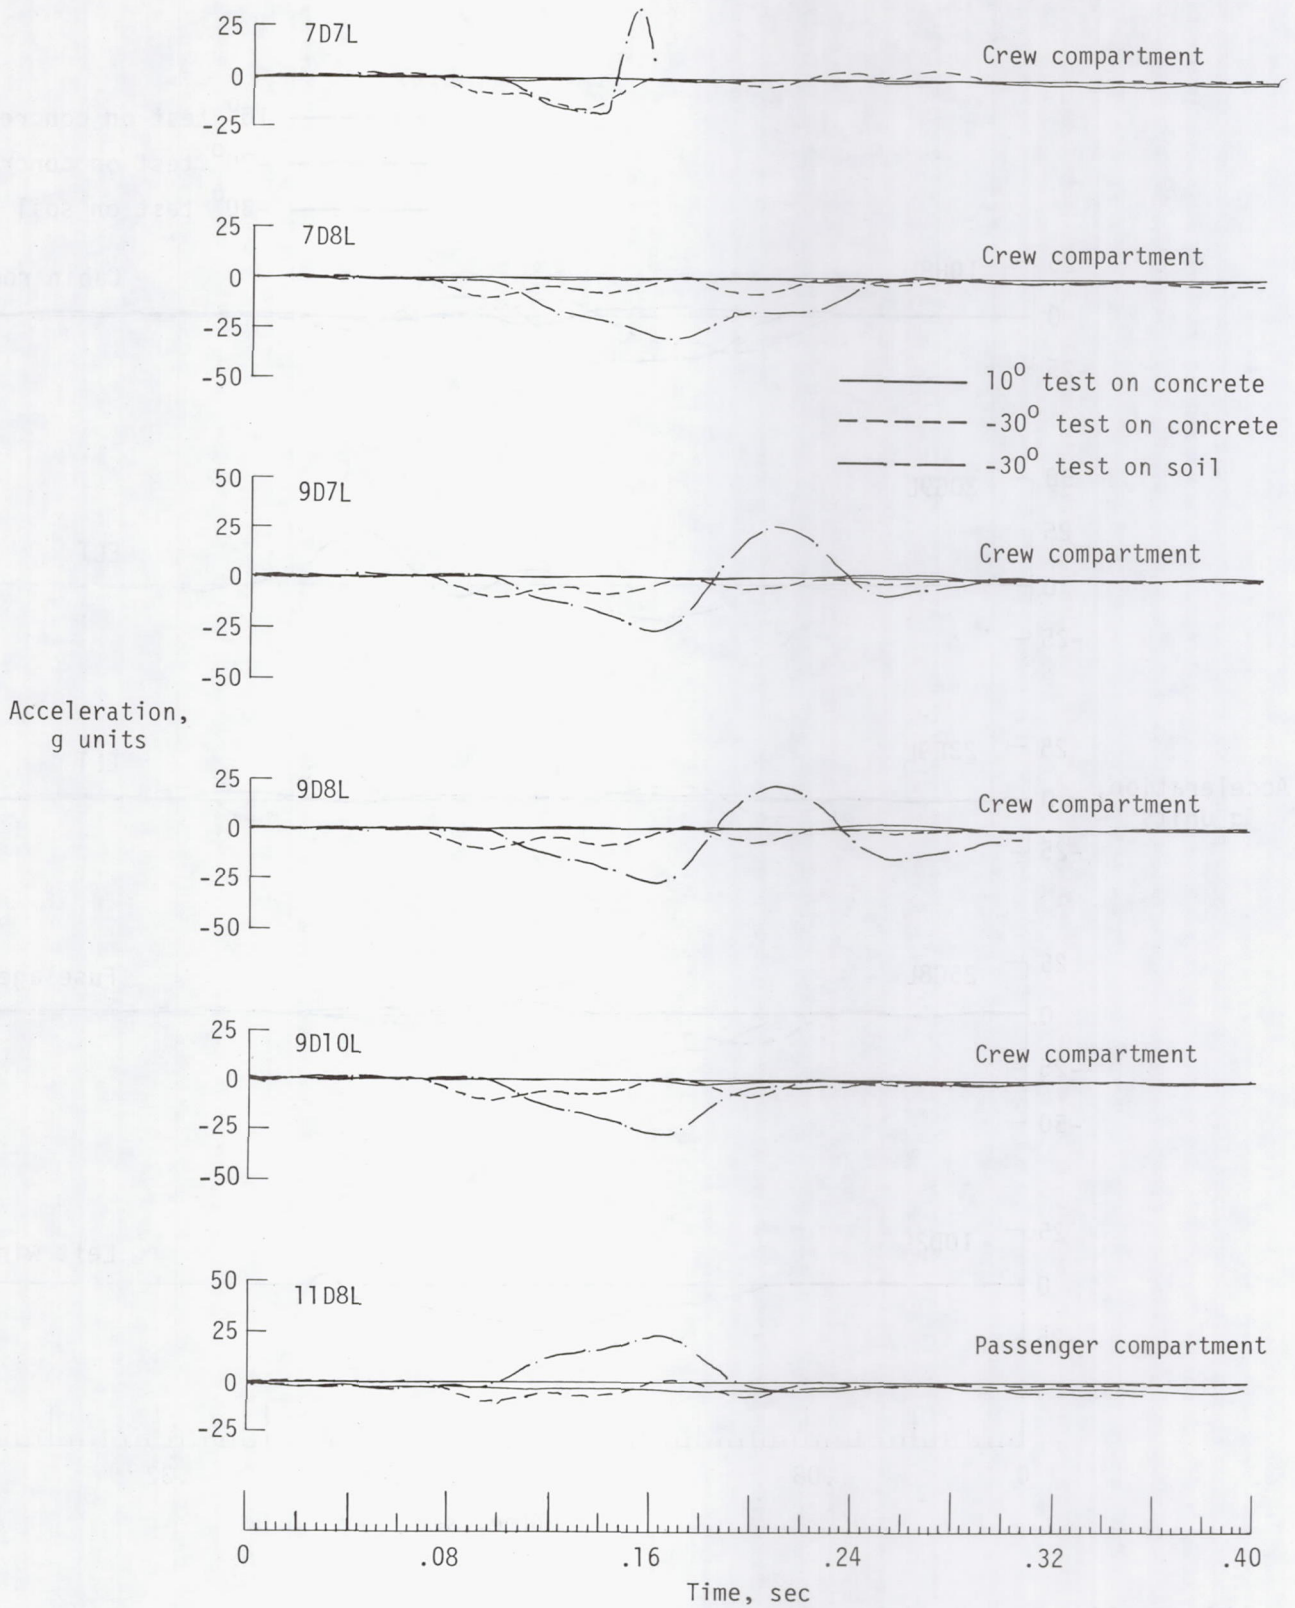
Figure 20.- Longitudinal accelerations on cabin floor in crew and passenger compartments.

Cabin floor.- Longitudinal accelerations on the cabin floor in the crew and passenger compartments in the vicinity of the pilot, copilot, and first-passenger locations for the three tests are presented in figure 20. Peak accelerations taken at three locations along the inboard floor beam under the pilot and first passenger were averaged for each test to obtain a representative cabin-floor peak acceleration. Average floor peak acceleration were -2g for the 10° test on concrete, -11g for the -30° test on concrete, and -26g for the -30° test on soil. Local accelerations for each test were distributed rather evenly both in the crew compartment and across the floor beam. Longitudinal accelerations are a function of the velocity change during initial impact. The tests with longer slide-out distances produced lower longitudinal accelerations because a lower longitudinal velocity change occurred at initial impact.

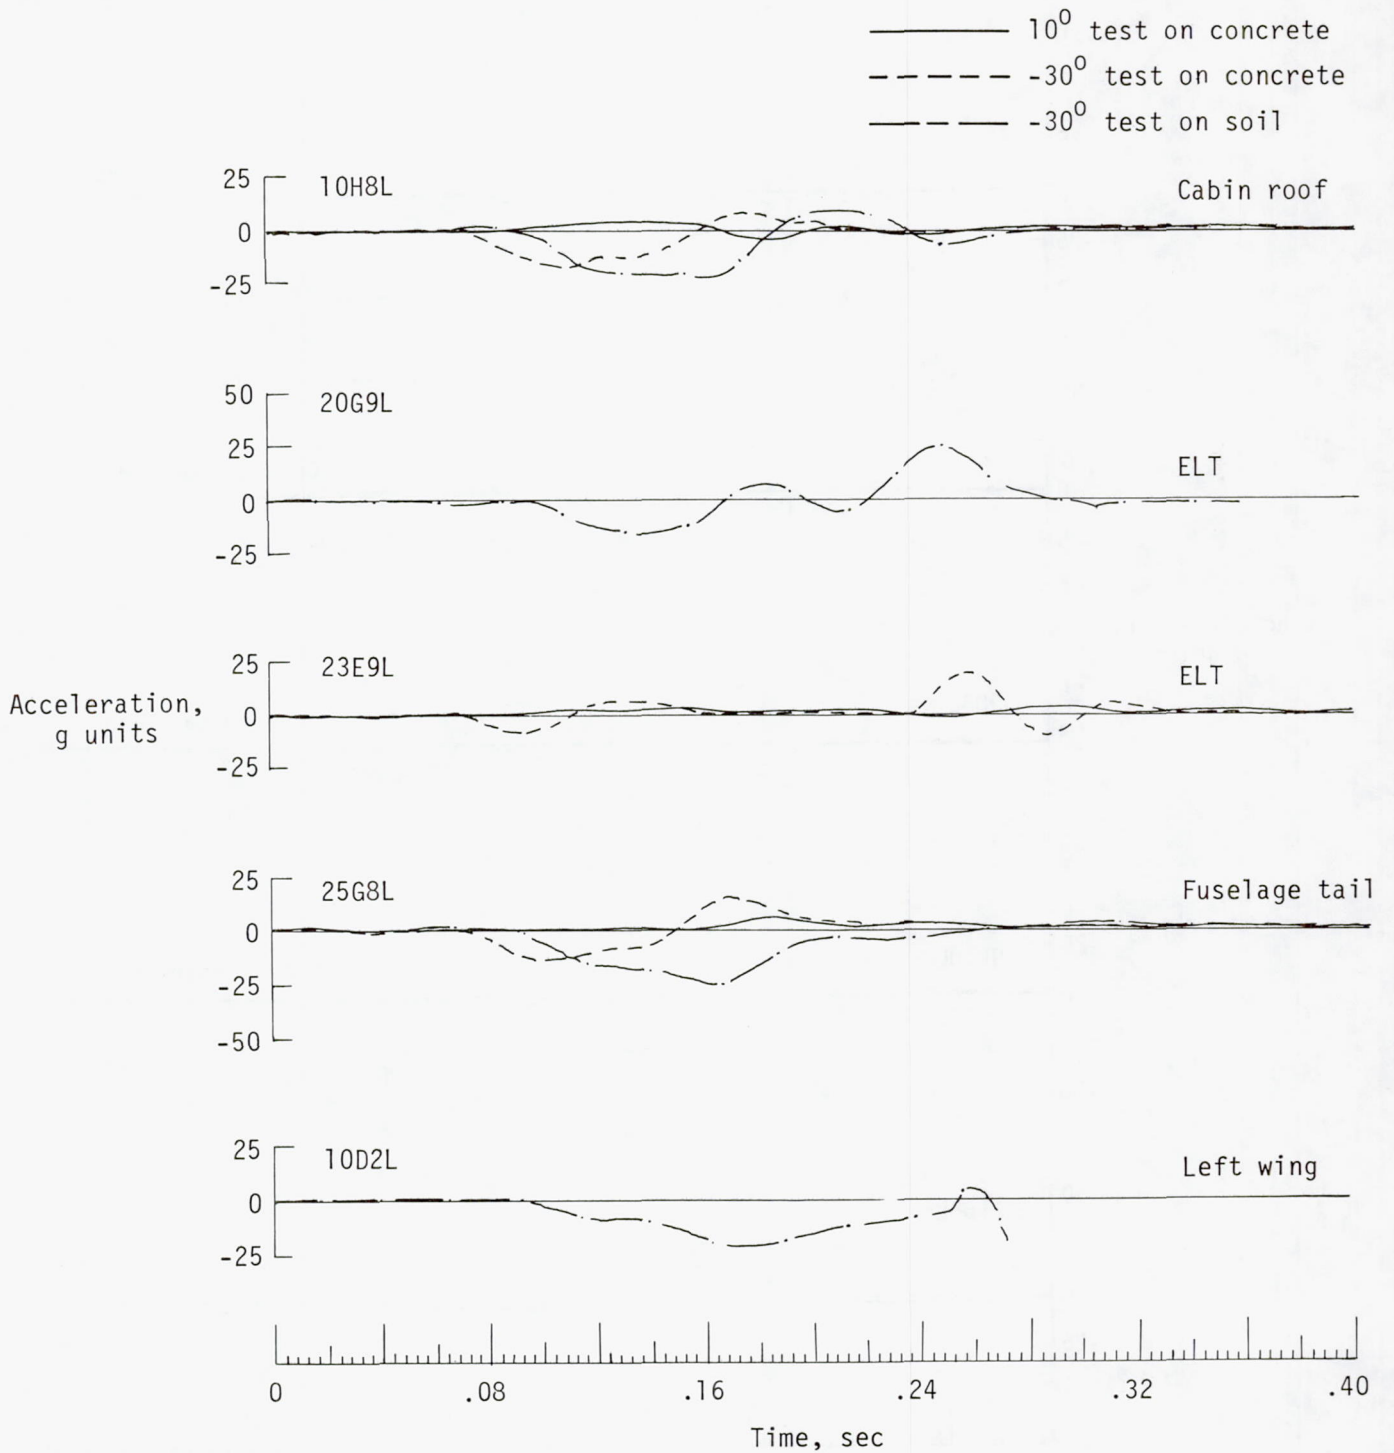
Figure 21.- Longitudinal accelerations on cabin roof, fuselage tail, left wing, and at ELT location.

Cabin roof, fuselage tail, and left wing.- Longitudinal accelerations on the cabin roof, fuselage tail, and left wing are presented in figure 21. The highest accelerations were recorded for the -30° test on soil, and the lowest were for the 10° test on concrete. On the cabin roof, peak accelerations were small and varied from 5g to -5g for the 10° test on concrete, 8g to -17g for the -30° test on concrete, and 9g to -22g for the -30° test on soil. Accelerations at the Emergency Locator Transducer (ELT) location were -3g, -8g, and -14g for the 10° test on concrete, the -30° test on concrete, and the -30° test on soil, respectively; whereas on the tail at the fuselage top, the peak accelerations were -5g, -15g, and -25g,

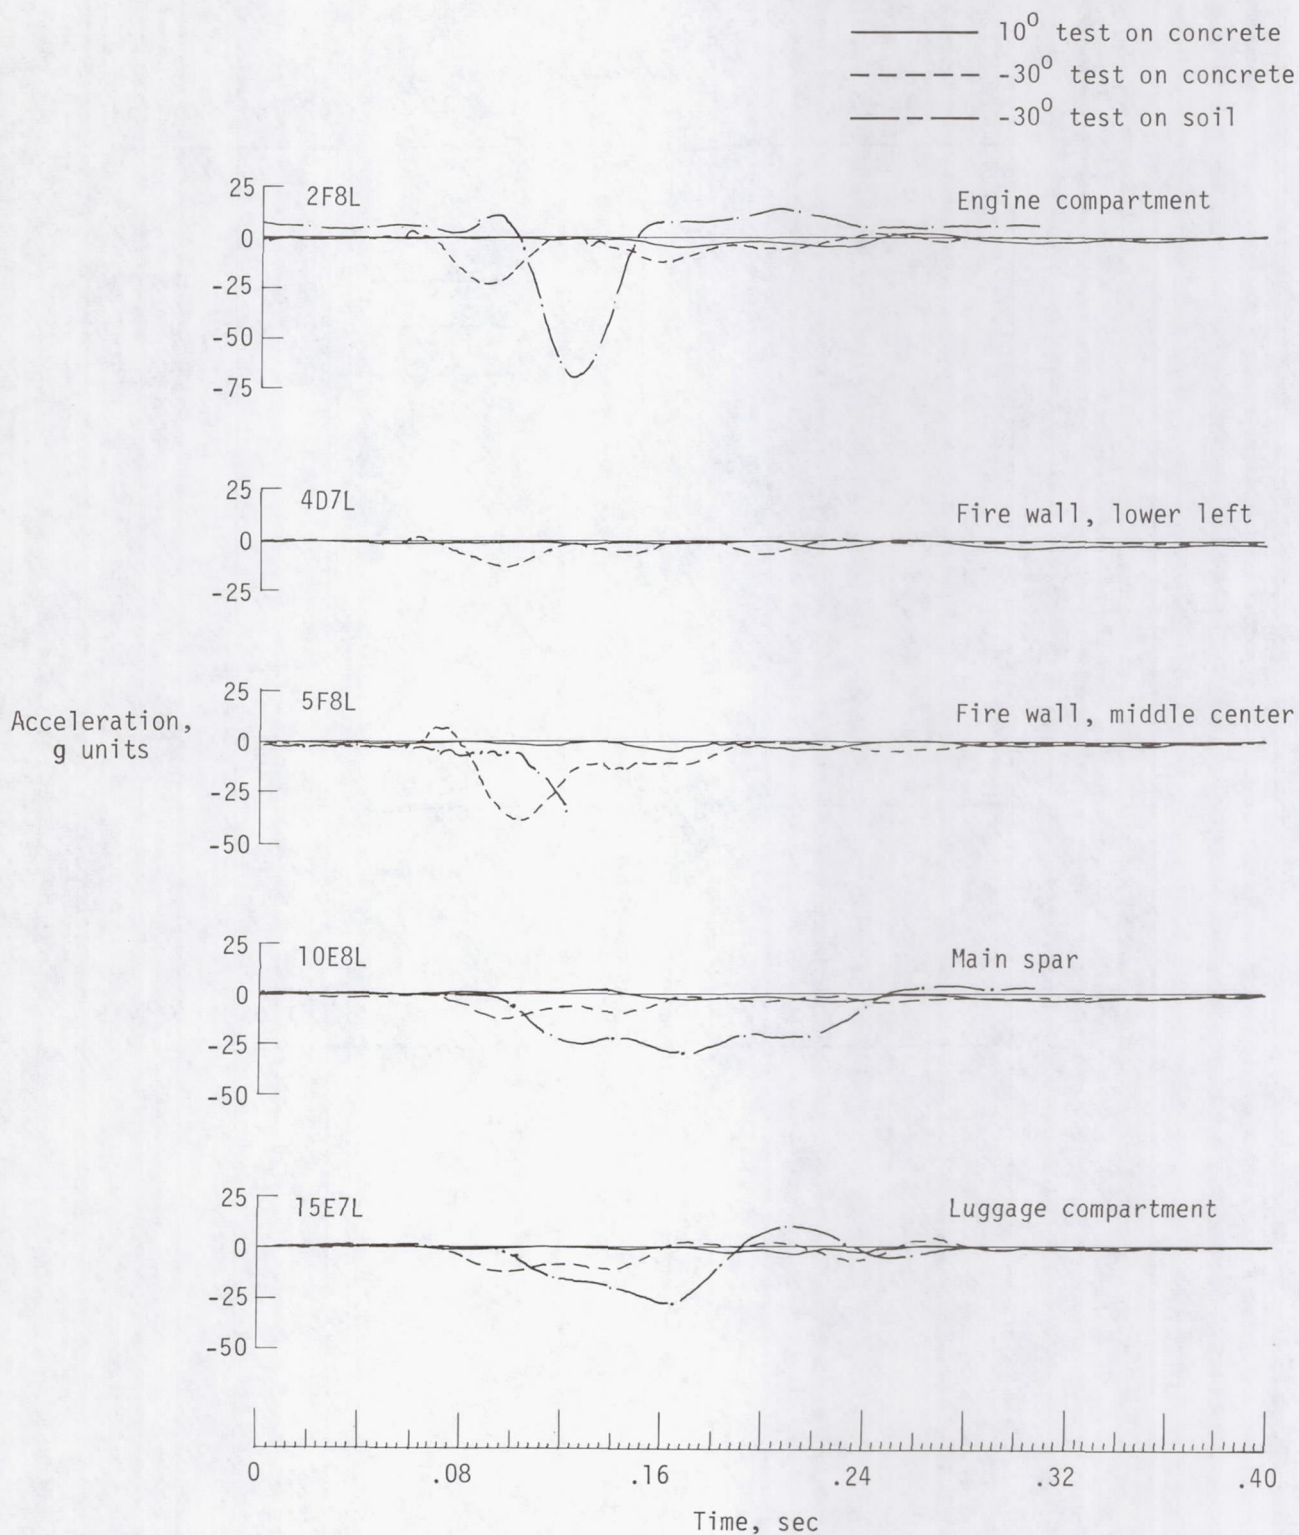
Figure 22.- Longitudinal accelerations in engine compartment and fire wall, main spar, and luggage compartment.

Engine compartment, main spar, and luggage compartment.- Longitudinal accelerations in the engine compartment, main spar, and luggage compartment are presented in figure 22. Peak longitudinal accelerations recorded on the engine were -5g for the 10° test on concrete, -24g for the -30° test on concrete, and -77g for the -30° test on soil. For the 10° test on concrete, peak accelerations were -2g on the lower left portion of the fire wall and -3g on the middle portion. For the -30° test on concrete, the peak accelerations were -14g and -38g, respectively. Fire-wall data were lost for the -30° test on soil. In the main spar, the longitudinal peak accelerations were -4g for the -10° test on concrete, -13g for the -30° test on concrete, and -30g for the -30° test on soil. In the luggage compartment, the peak accelerations were -5g, -12g, and -27g, respectively. In general, the acceleration magnitudes at these locations were highest for the test on soil and lowest for the 10° test on concrete.

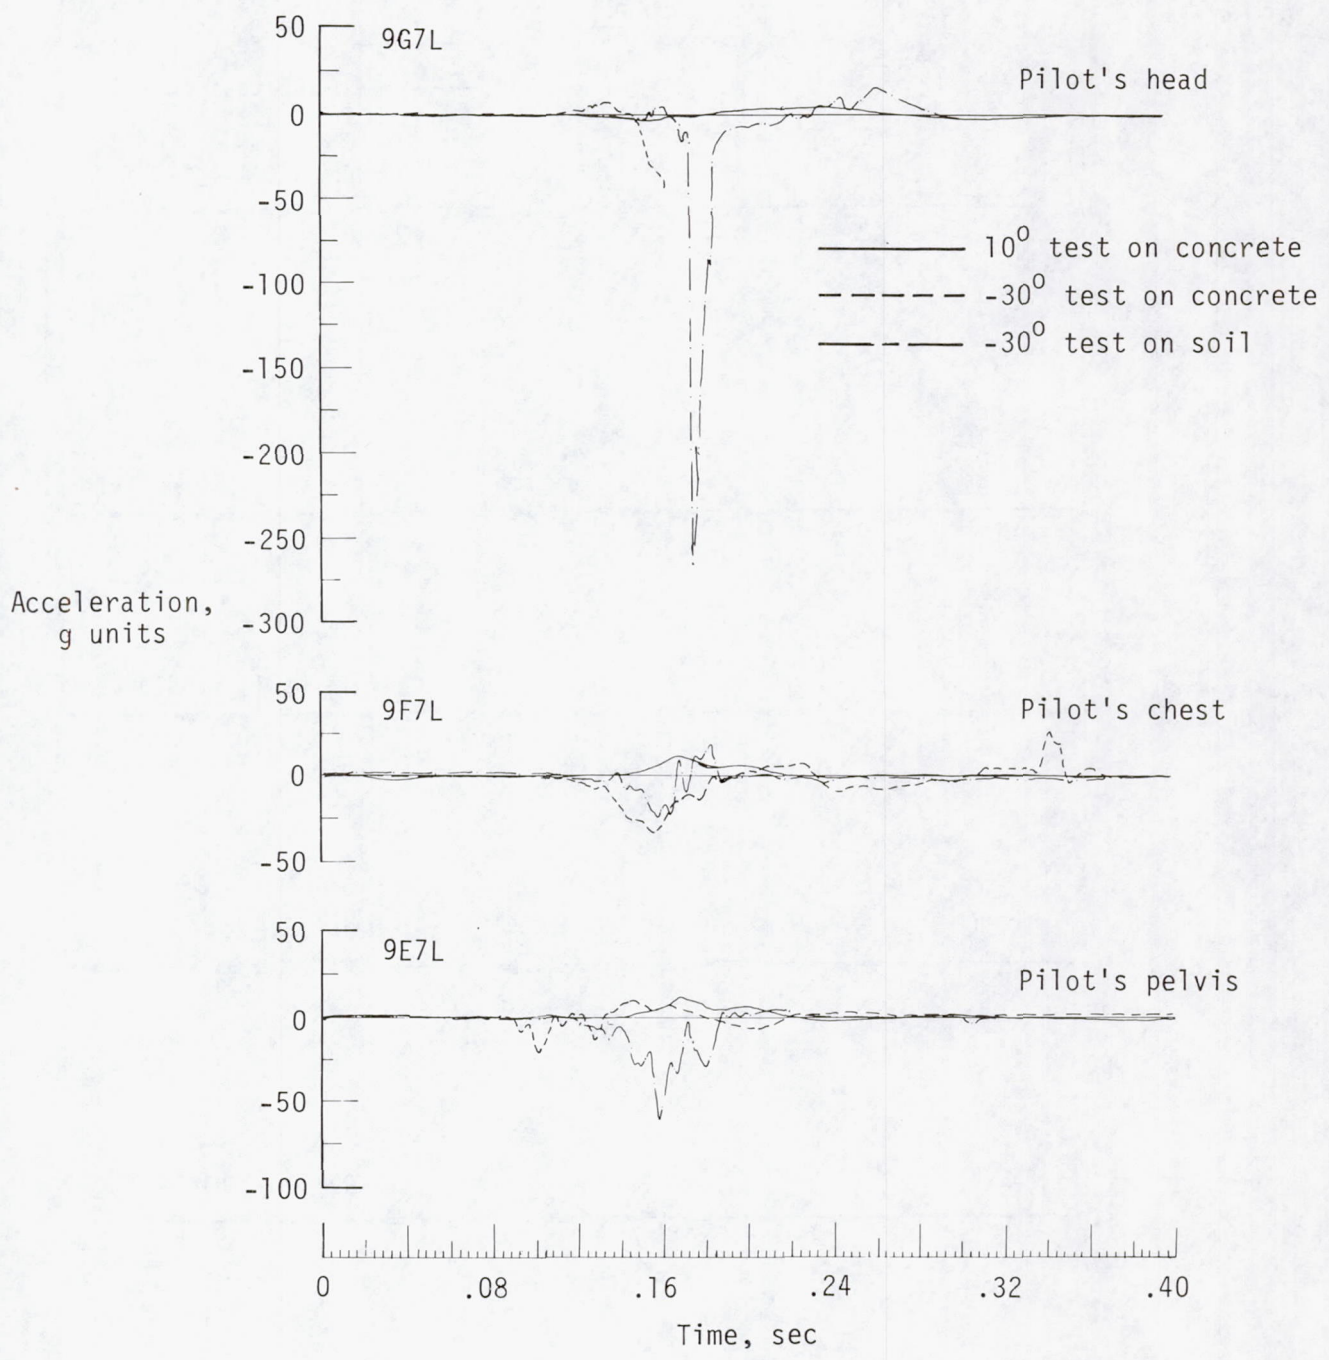
Figure 23.- Longitudinal accelerations in pilot dummy.

Pilot dummy.- Longitudinal accelerations in the pilot's head, chest, and pelvis are presented in figure 23. In the pilot's head, a peak acceleration of -5g was obtained in the 10° test on concrete. In the -30° test on concrete, a partial acceleration trace with a value of -40g was obtained before the data were lost. An acceleration of -240g occurred in the -30° test on soil because high-speed motion-pictures for this test showed the pilot's head striking the instrument panel. A high-acceleration spike of short duration is indicative of such an impact. In the pilot's chest, the longitudinal peak accelerations were -12g in the 10° test on concrete, -33g in the -30° test on concrete, and -24g in the -30° test on soil. In the pilot's pelvis, the longitudinal peak accelerations were -6g in the 10° test on concrete, -23g in the -30° test on concrete, and -60g in the -30° test on soil. No longitudinal accelerations were measured in the copilot dummy.

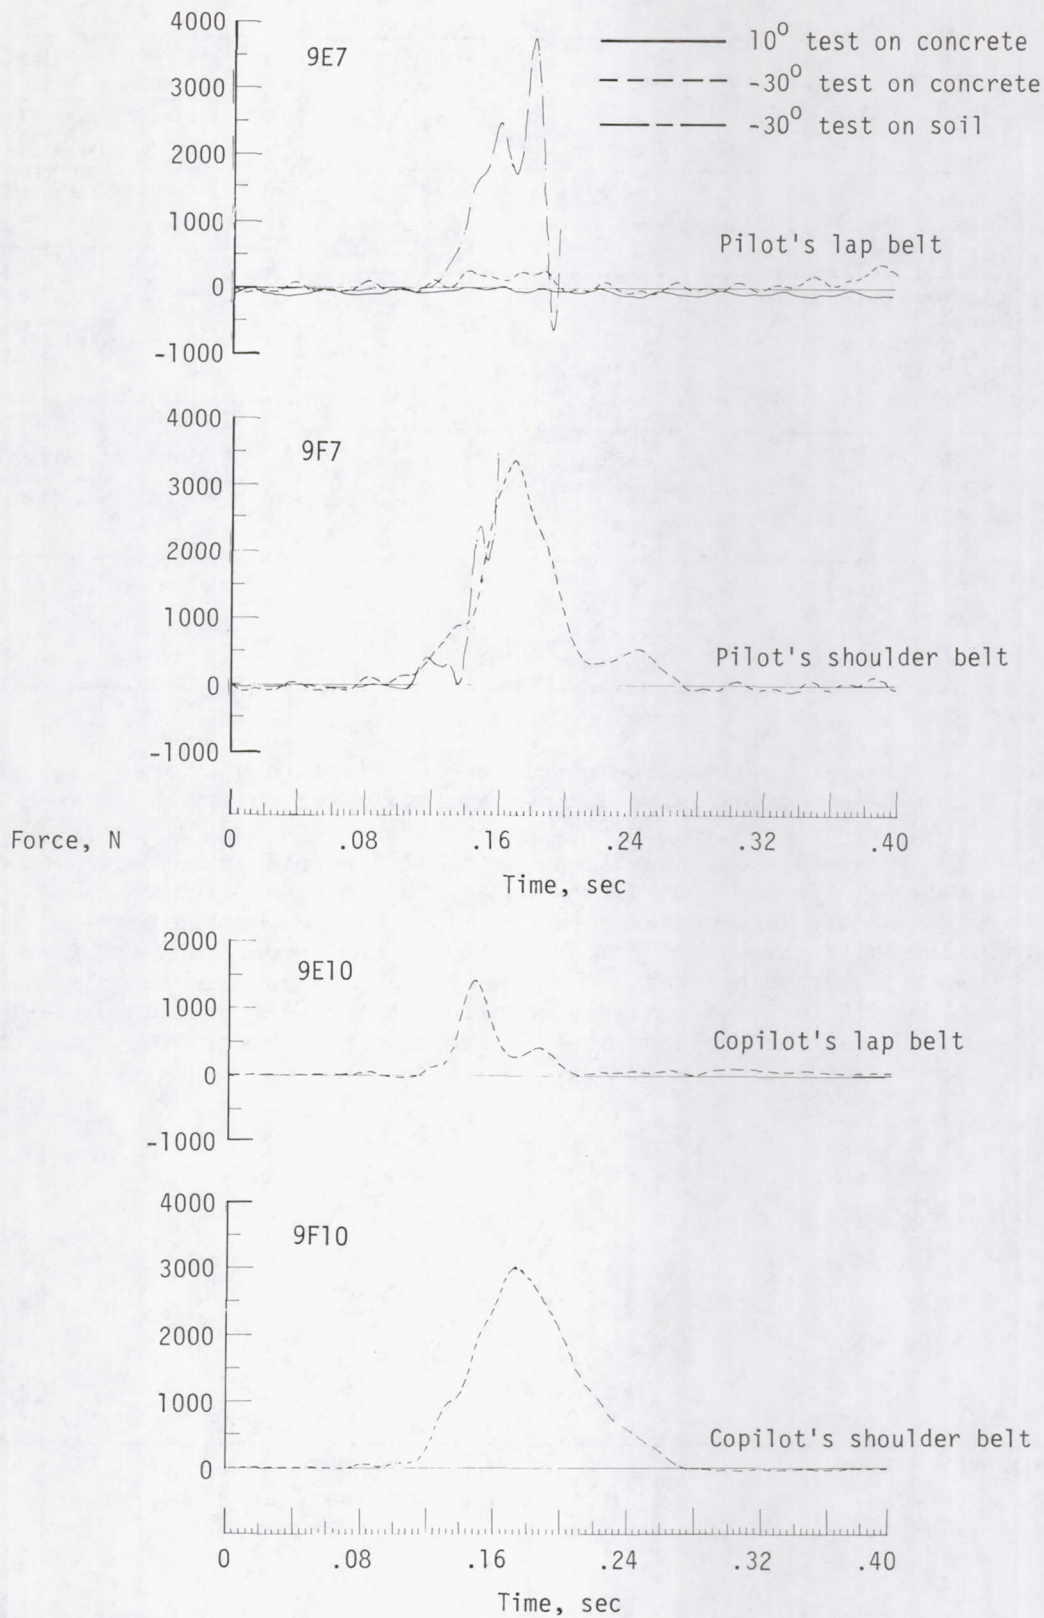
Figure 24.- Tension in restraint-harness system.

Tension for the lap belt and shoulder harness in the pilot and copilot dummies are shown in figure 24. Loads in the pilot's lap belt were negligible for the 10° test on concrete, 200 N for the -30° test on concrete, and 3700 N for the -30° test on soil. In the pilot's shoulder harness, the loads were negligible for the 10° test on concrete, 3400 N for the -30° test on concrete, and 3800 N for the -30° test on soil. In the copilot's lap belt and shoulder harness, the loads were negligible for the 10° test on concrete; but they were 1400 N and 3000 N, respectively, for the -30° test on concrete. For the -30° test on soil, no measurements were made on the copilot's lap belt and shoulder harness. Attempts to correlate restraint loads with accelerations of the dummies and seats were not made because loads are measured in directions other than the accelerations, seat/occupant interactions may be different for different seats under the same apparent loadings, and dummies striking the airplane structure alter drastically the various responses of dummies and seats.
