DOE/NASA/1005-1
NASA TM-83407

Test Results and Description of a 1-kW Free-Piston Stirling Engine with a Dashpot Load

Jeffrey Schreiber
National Aeronautics and Space Administration
Lewis Research Center

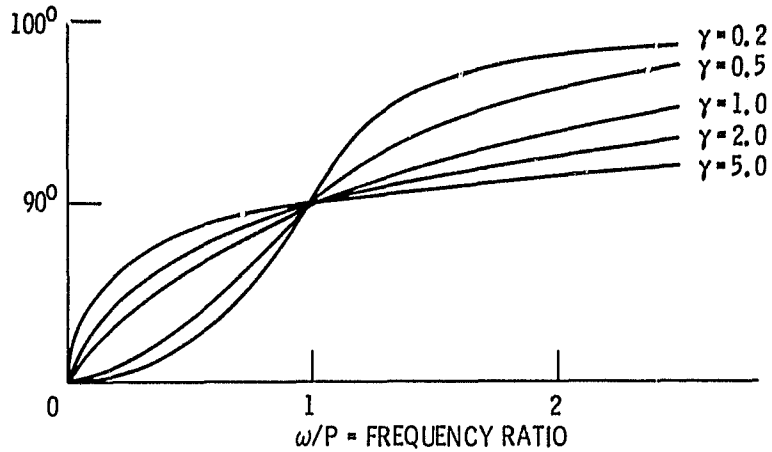
Figure 6. - Relationship of phase angle vs frequency ratio at several damping values.

The RE-1000 is designed such that the natural frequency of the displacer is approximately 28 Hz. Since the engine operates at 30 Hz due to the dominant mass of the power piston, the ratio of the driving frequency to the natural frequency of the displacer is $30/28 = 1.07$. It can be seen in Figure 6 that for the case of forced vibration with viscous damping, at a frequency ratio of 1.07, the phase angle between the driving force and the driven response would decrease as the damping increased (Ref. 2) on the RE-1000. However, the phase angle between the power piston and displacer is not the same as the phase angle being shown in Figure 6. This is explained more fully in the following.

With the frequency ratio at 1.07, Figure 6 shows that the phase angle between the driving force and driven response will decrease as the damping increases. This is the same as saying that the phase angle between the power piston and displacer will increase as the damping increases. The remachining of the heat exchanger stack up was intended to reduce the damping by eliminating the slight rub and therefore should reduce the phase angle between the power piston and displacer.

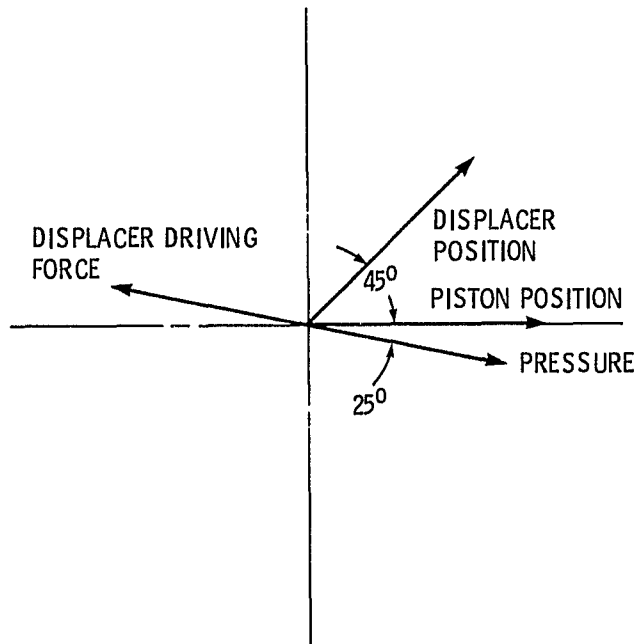
Figure 7. - Typical RE-1000 phasor diagram operating point.

Figure 7 is a phasor diagram of a possible operating point, similar to the design point, for the RE-1000. The phasor diagram is used to show the amplitudes and phase relationships of the different sinusoidal engine parameters. The displacer motion is shown to lead the power piston motion by 45° and the pressure in the compression space lags the piston motion by 25° . Since there is no kinematic linkage in the free piston Stirling engine to drive the displacer, the only forces exerted on the displacer body come from the internal gas spring and the pressure in the working space. To preserve proper sign convention, the driving force on the displacer caused by pressure variations in the working space is along the negative pressure vector. The phase angle between the negative pressure vector and the displacer motion vector is the phase angle represented in Figure 6. It can be shown that this phase angle is 110° .
