NASA Technical Memorandum 84637

FLIGHT SERVICE EVALUATION OF COMPOSITE COMPONENTS
ON BELL 206L AND SIKORSKY S-76 HELICOPTERS

DONALD J. BAKER

MARCH 1983

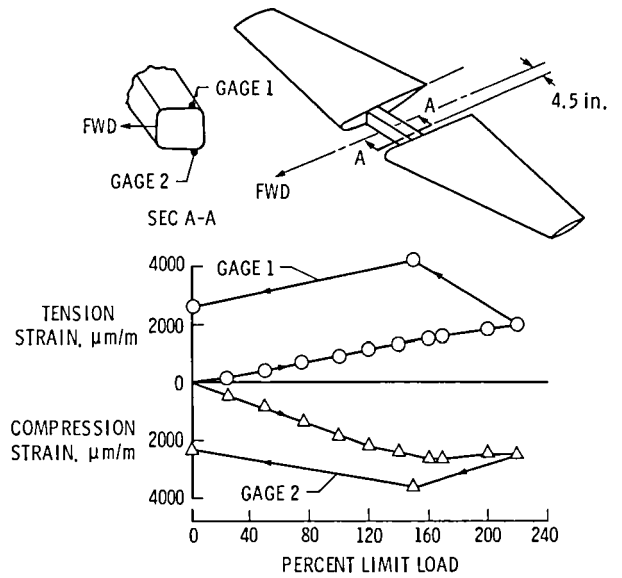
Figure 17. Strain as a Function of Percent Limit Load on S-76 Horizontal Stabilizer Spar, .1 m (4.5 in.) from Centerline.

The first horizontal stabilizer removed from service had accumulated 1600 flight hours over a 17 month period in the Lake Charles, LA area. No defects were found during inspection of the stabilizer. Deflection from the proof load was the same as in the initial acceptance test. Plots of strain as a function of limit load are shown in figure 17. The tension strain response was linear up to 160 percent of design limit load (DLL) and then increased at a reduced slope until the maximum applied load of 220 percent of DLL was reached. The compression strain response was linear to 120 percent of DLL and then increased at a reduced slope until 170 percent of DLL was reached. There was no increase in compression strain after 170 percent of DLL. At 220 percent of DLL a loud "snap" was heard and the load dropped to 150 percent of DLL. Attempts to increase the load beyond the 150 percent DLL resulted in deflection until the test fixture limit was reached. Visual inspection of the stabilizer indicated a buckle in the splice plate on the left hand leading edge of the spar. Teardown of the component indicated a loss of shear transfer capabilities between the composite material and the metal honeycomb (figure 18). At 220 percent of DLL, the shear load had been transferred to the Kevlar/epoxy torque box and eventually buckled the splice plate. The structure still supported 150 percent of DLL but with reduced rigidity. The stabilizer tested for certification did not fail but reached the maximum deflection allowed by the fixture at 268 percent of DLL. Additional tests will be necessary to determine if the change in failure mode is the result of environmental degradation of the composite

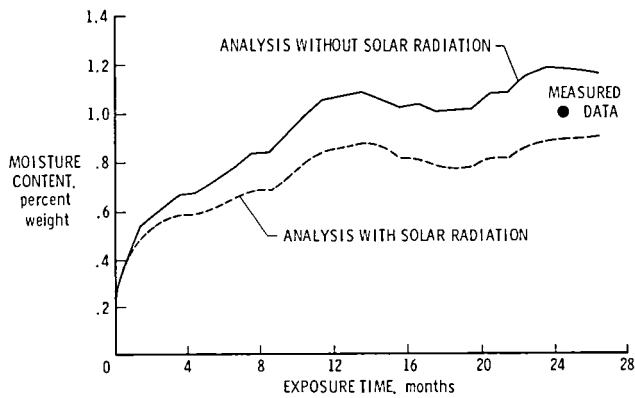
Figure 16. Moisture Absorption of a 6-ply Graphite/Epoxy Panel Exposed At West Palm Beach FL.

The environmental panels were removed from the Stratford, CT and West Palm Beach, FL (WPB) locations after 2 years of exposure. Data on moisture absorption are presented in Table 8 and figure 16. The 5-ply Kevlar-49/epoxy panel absorbed the most moisture (1.6 percent) whereas a 33-ply graphite/epoxy panel absorbed the least amount of moisture (.18 percent). The average monthly weather data for both locations and predicted moisture content are given in reference 3. Moisture absorption data for the 6-ply graphite/epoxy specimens are compared with predicted moisture absorption in figure 16.

The predicted moisture absorption compares well with the measured moisture absorption.

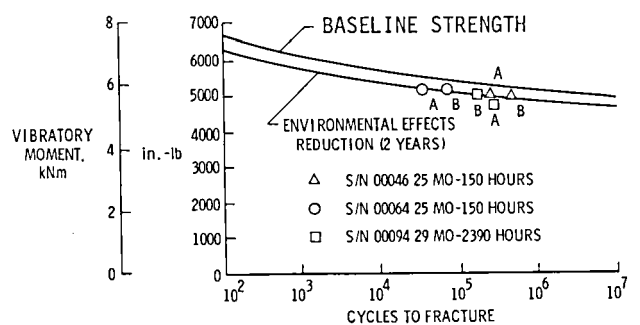
Figure 19. S-76 Tail Rotor Spar, Moment-Cycle Fatigue Curve.

The first tail rotor spar (Serial Number 00094) removed from service had accumulated 2390 flight hours over a 29 month period in the Lake Charles, LA area. No defects were found during the inspection of the spar. The spar was fatigue tested and the results are given in figure 19 along with data from spars labeled serial numbers 00046 and 00064 (reference 3). These spars were removed from a Sikorsky flight test aircraft that was at West Palm Beach, FL. The points designated "A" represent the first fracture on one side of the spar. Testing was continued on the other side until fracture occurred and the results are designated "B". The data indicate a 94 percent retention in fatigue strength for the spars exposed 2 to 2 1/2 years compared to the strength of dry spars tested at room temperature for FAA certification. Four coupons were machined from the failed spar (No. 00094) and dried. The average moisture content was 0.26 percent. The two spars (S/N 00046 and 00064) removed from a flight test helicopter had 150 hours of service each and contained .29 percent (S/N 00046) and .32 percent (S/N 00064) of moisture, respectively. The 94 percent strength retention for the spars with 2 to 2 1/2 years service compares well with the 95 percent strength retention projected from laboratory conditioned specimens (reference 3).
