NASA Technical Memorandum 84554

William E. Howell and J. Anderson Plumer

October 1982

EFFECTS OF SIMULATED LIGHTNING ON COMPOSITE AND METALLIC JOINTS

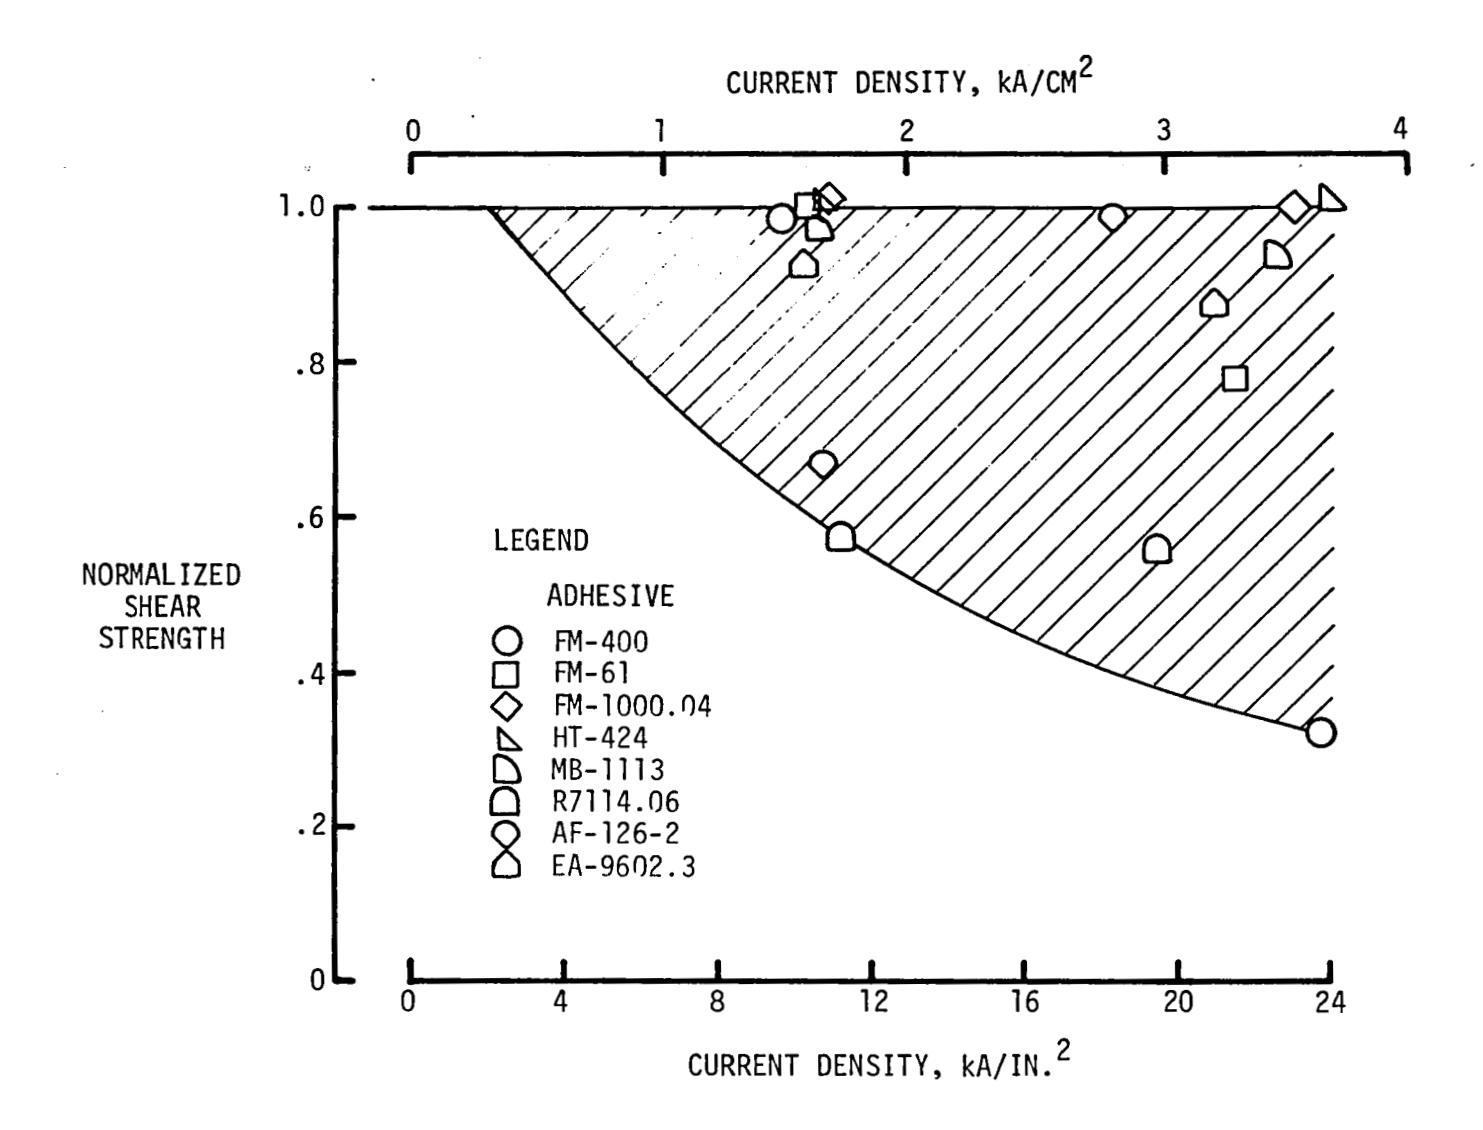
Figure 9. - Effect of current density on shear strength of aluminum single-lap joint specimens.

<u>Aluminum adherends</u>. - Test results for the first set of specimens (the ones not deburred and with bondline thickness not controlled) are presented in figure 9. Tests were conducted at current levels of 2, 10, 20, and 100 kA/ in.² (0.31, 1.55, 3.10, and 15.50 kA/cm²). Tensile tests conducted on specimens exposed to no current and to 2 kA/in.² (0.31 kA/cm²) showed no shear strength degradation for all the adhesives tested. A current density of 2 kA/ in.² (0.31 kA/cm²) represents the normally expected lightning threat. Some of the adhesive systems tested experienced no damage at current densities as high as 24 kA/in.² (3.72 kA/cm²). Other adhesives were significantly degraded at a current density of 10 kA/in.² (1.55 kA/cm²). Damage was caused by sparking through the adhesive as shown in figure 10. All specimens tested at a current density of 100 kA/in.² (15.50 kA/cm²) were totally destroyed. With the facing burs, most of the joints were electrically conductive. Even so, the specimens experienced external sparking, from the end of one adherend to the surface of the other adherend, at all current levels.

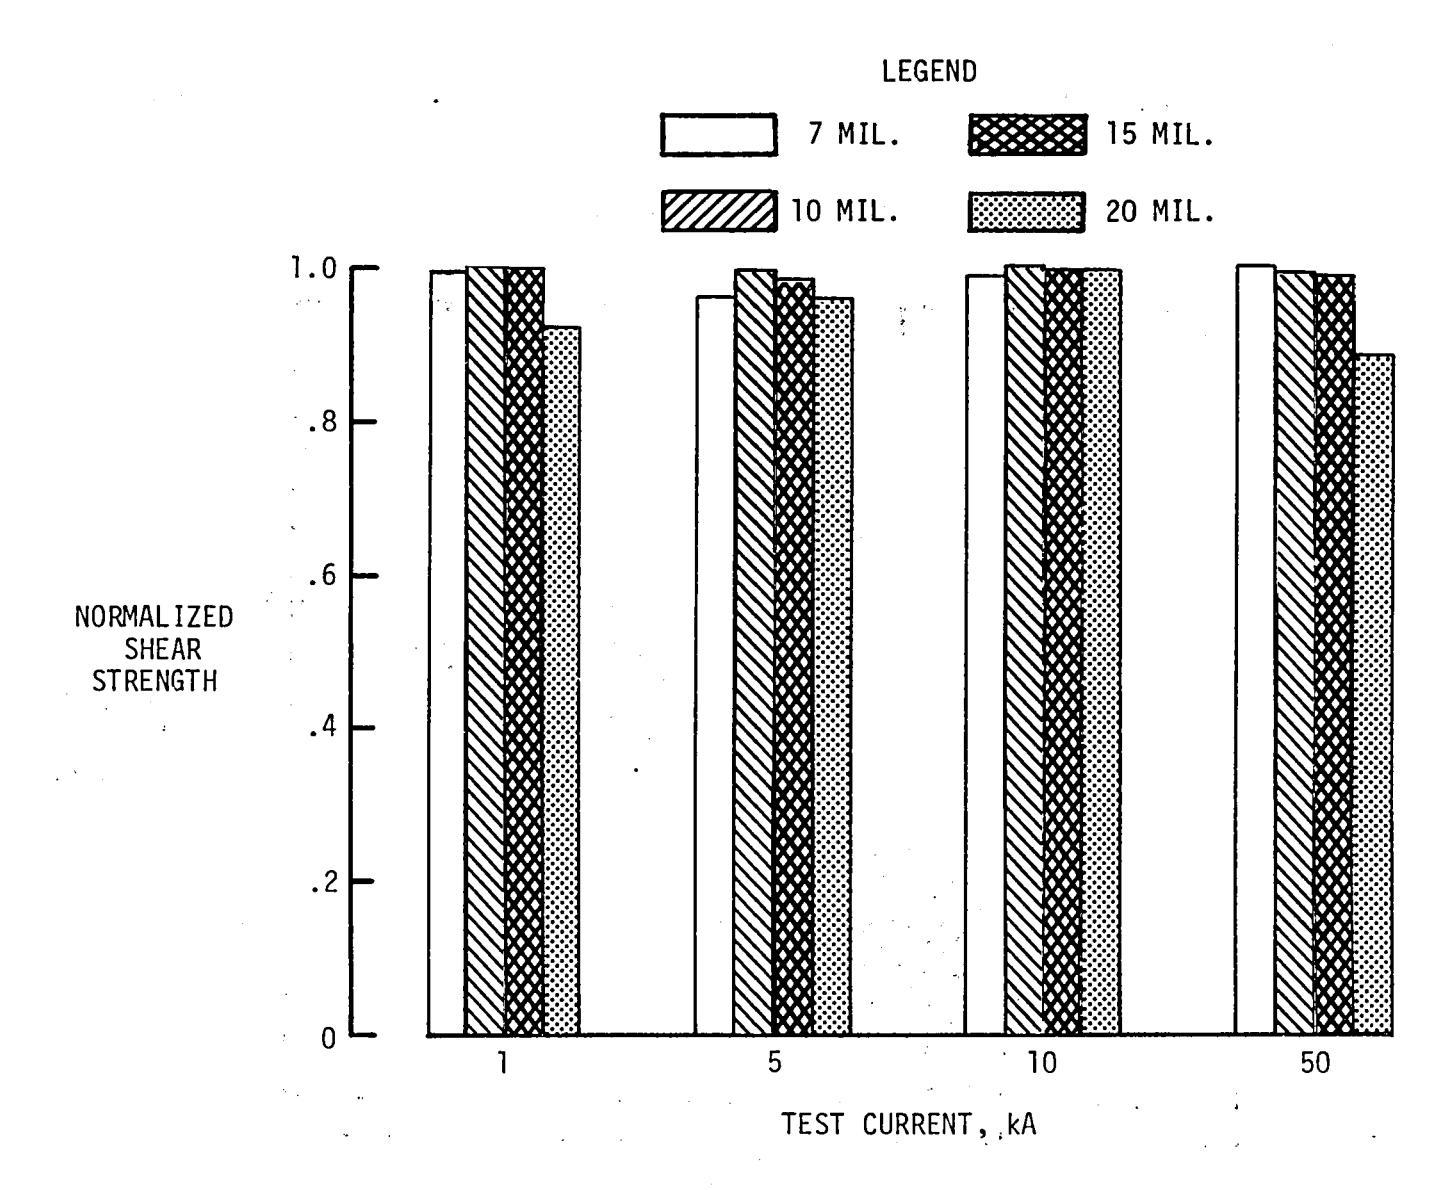
Figure 11. - Effect of bondline thickness on shear strength of aluminum single-lap joint specimens.

The second set of specimens with aluminum adherends (the ones deburred and with controlled bondline thicknesses) experienced no appreciable strength degradation through the entire current density range (fig. 11). The specimens with the thickest bondline did, however, experience a slight decrease in strength at test current levels of 1 and 50 kA. There was no tendency for sparking to occur through the adhesive. All the specimens sparked externally from the edge of one adherend to the surface of the other adherend at all test current levels.

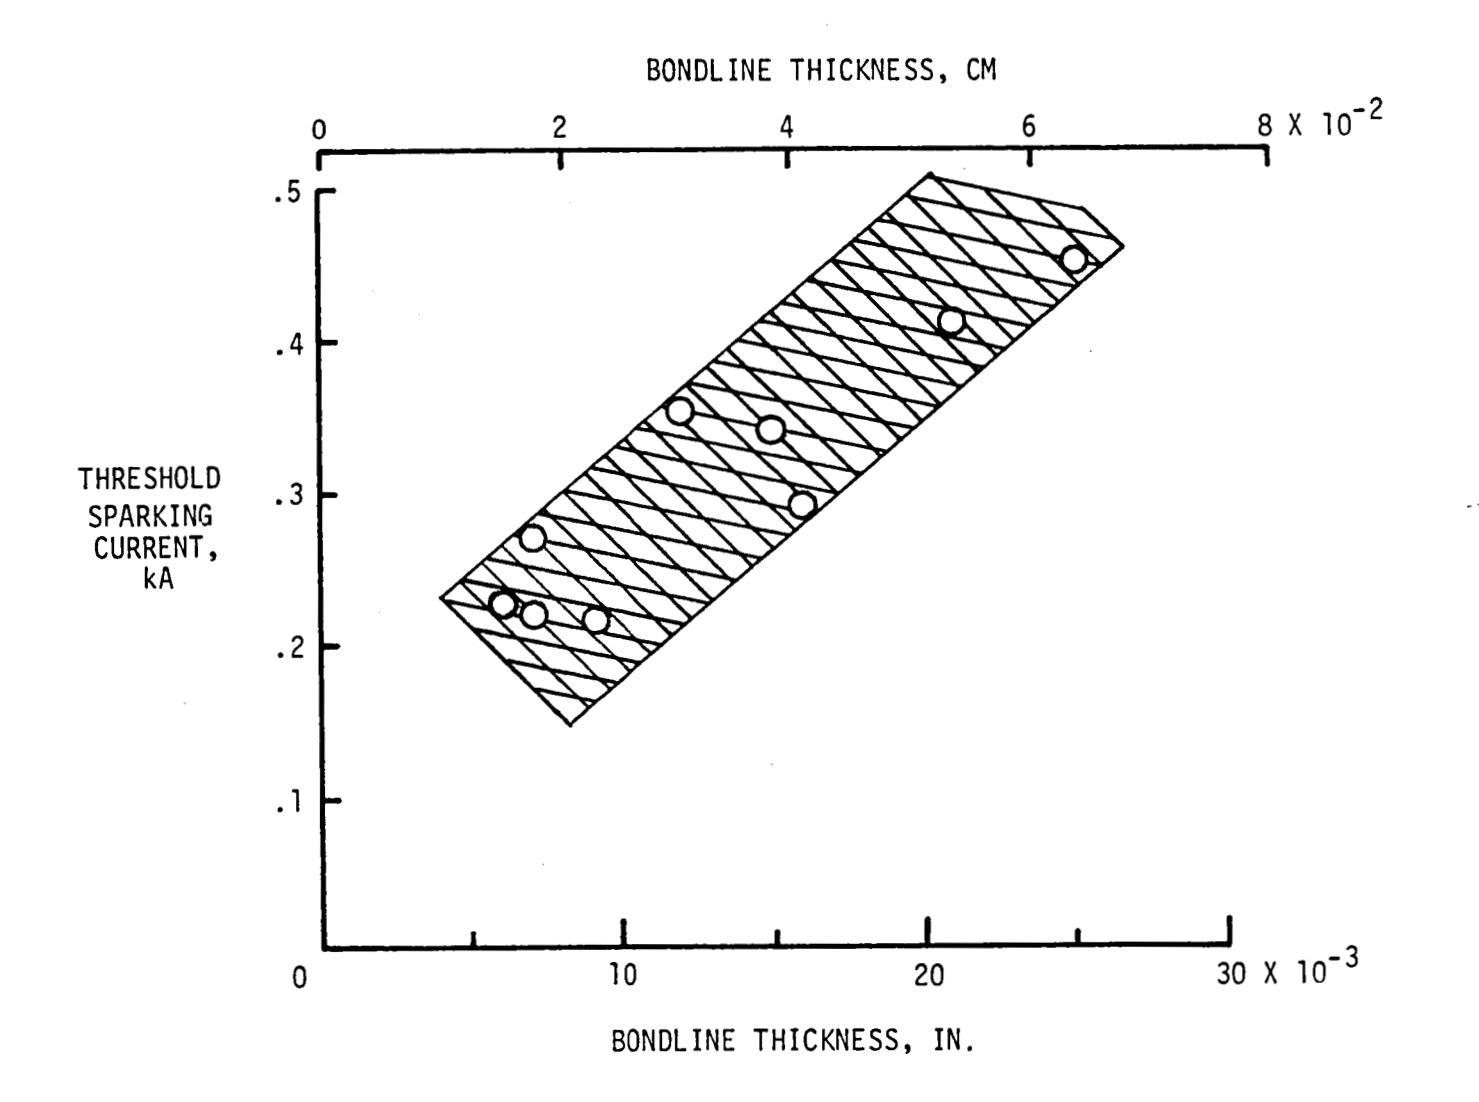
Figure 12. - Sparking threshold as a function of bondline thickness for graphite/epoxy single-lap joint specimens.

<u>Graphite/epoxy adherends.</u> - The first set of specimens (the ones with an overlap of only 0.25 in. (0.64 cm)) experienced external sparking at current levels between 0.215 and 0.450 kA as shown in figure 12. There was no evidence of sparking through the adhesive; therefore, no shear strength degradation should have been caused by the current. The sparking occurred across the joint from the edge of one adherend to the surface of the other adherend.

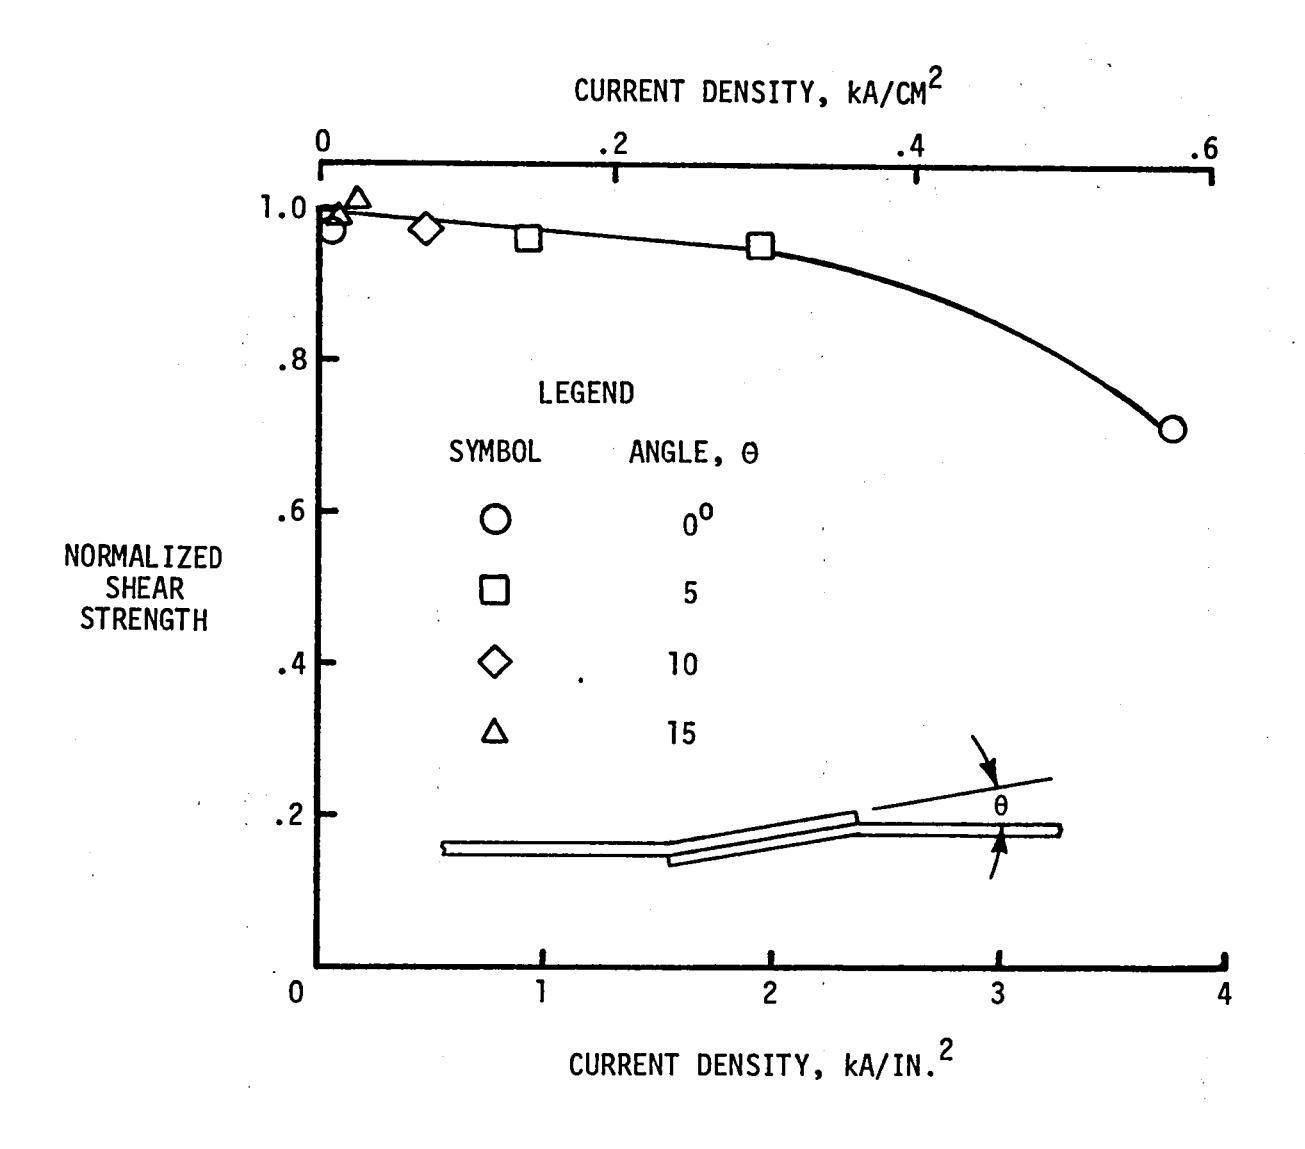
Figure 13. - Effect of current density on the shear strength of graphite/epoxy single-lap bonded joint specimens.

The data obtained for the second set of specimens (the ones with an overlap of 0.75 in. (1.91 cm)) are presented in figure 13. In order to isolate any effect of overlap angle on the test results, the data were normalized to baseline shear strength data for specimens with the same overlap angles. The curve is drawn through individual data points. For the test range of 0-2 kA/in.² (0-0.31 kA/cm²), the scatter in the data is typical of bonded joint tests. At a current density of 3.75 kA/in.^2 (0.58 kA/cm²), however, structural damage was induced in the joint as indicated by a 30 percent decrease in the joint shear strength.

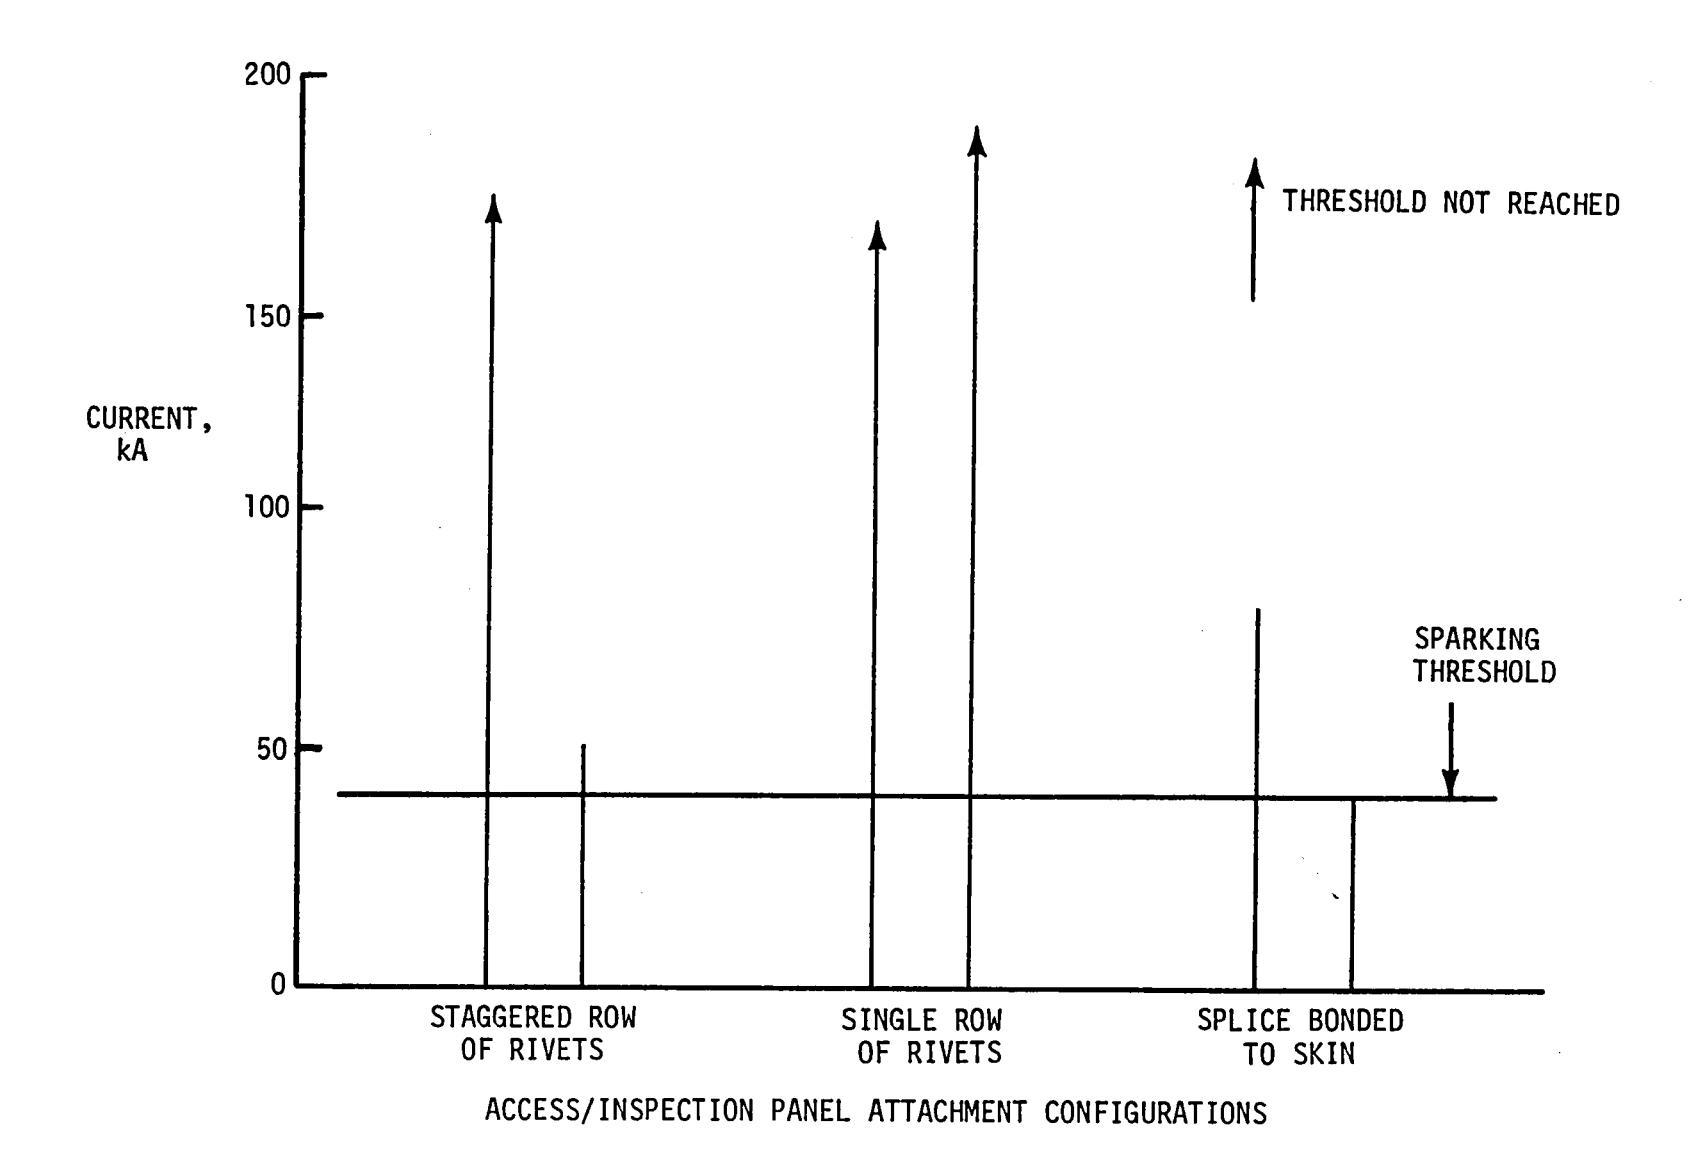
Figure 14. - Sparking threshold for the aluminum access/inspection panels.

<u>Aluminum skins</u>. - The sparking threshold determined for these specimens is shown in figure 14. As indicated in the figure, there is considerable scatter in the sparking threshold of similar specimens. Safety dictates, however, that the minimum observed sparking current values be of primary importance. For the rivet patterns tested, no sparking through the fuel tank sealant occurred below approximately 40 kA. For the limited number of tests performed, 40 kA was the minimum sparking current observed. More tests are required to statistically determine the minimum sparking threshold. Except for the single row of rivets, which did not exhibit sparking throughout the range of test currents, the rivet pattern did not significantly affect the sparking threshold. Figure 15 shows the location of sparking and damage in aluminum access/inspection panels. For the test configuration with the splice bonded to the skin, a strike or restrike with a current level higher than 40 kA could cause sparking past the "0" ring seal which would destroy the fuel tank integrity (fig. 15(c)).
