**NASA Contractor Report 166002**

# **Flight Service Evaluation of Composite Components on the Bell Helicopter Model 206L: Design, Fabrication, and Testing**

**Bell Helicopter Textron Inc.  
Fort Worth, Texas**

**Contract NAS1-15279  
November 1982**

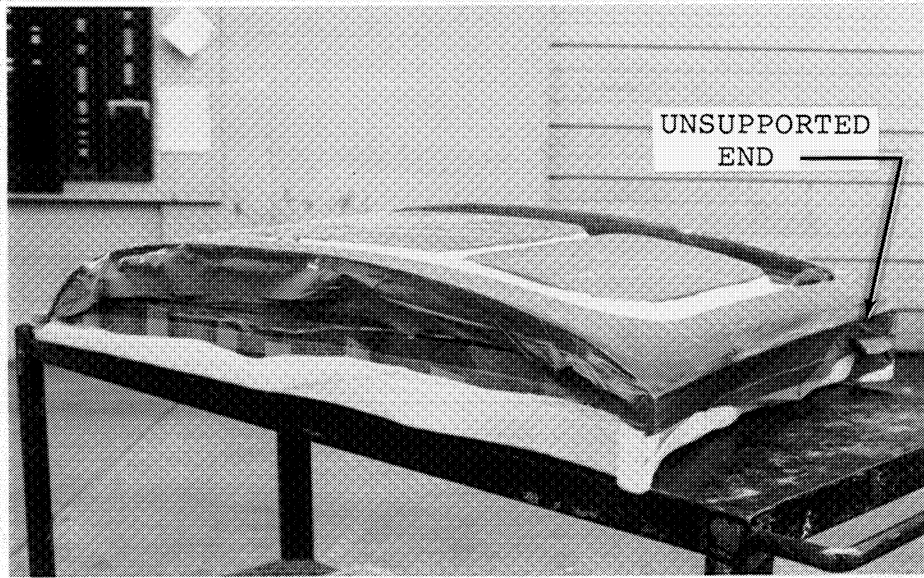
a. View of door half in fixture.

Figure 15. Litter door bow caused by flexibility of fixture.

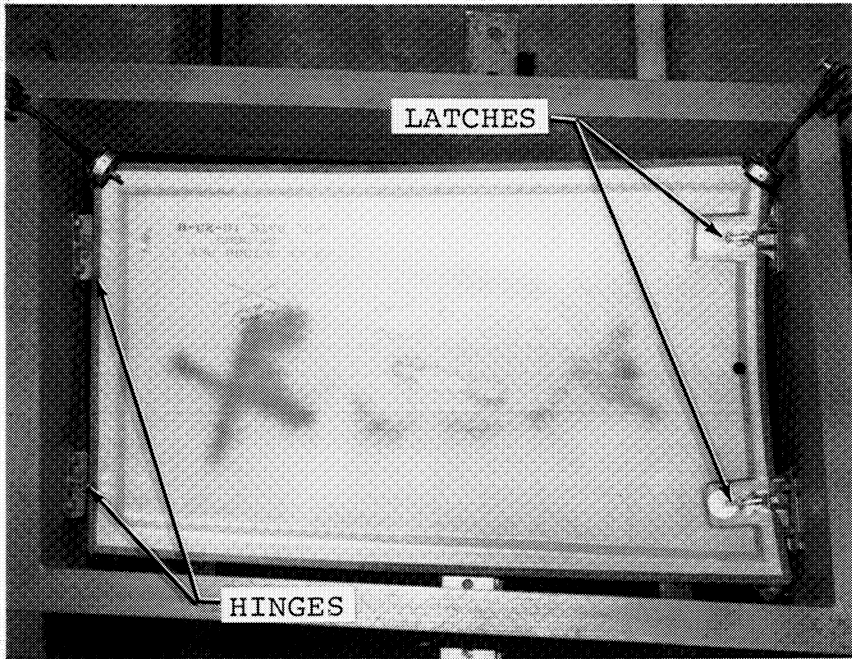
For the pressure test, the door was tested in the fixture shown in Figure 22a. The door was attached to the jig by two hinges and latches. Pressure was applied by means of water bags. Failure occurred at 0.794 psi, or a total of 695 pounds in the metal hinges, as shown in Figure 22b. This is technically a margin of safety of 13.4 percent, but is based on a metallic hinge failure, not a failure of the composite material.

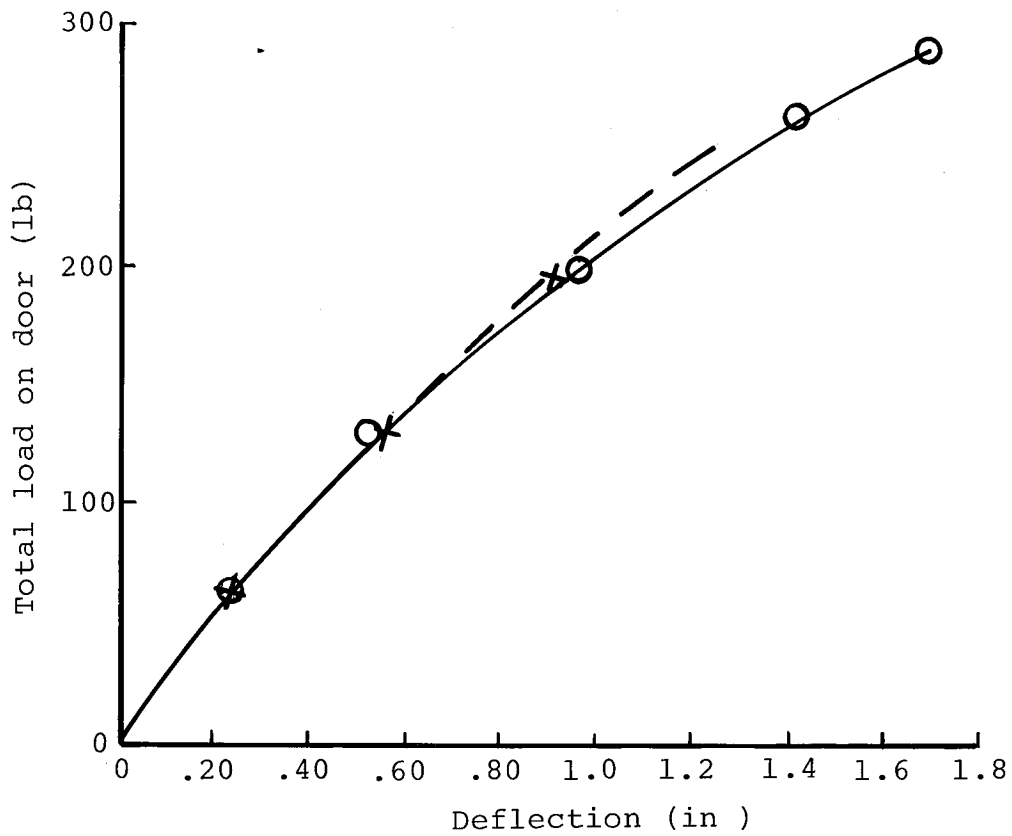
Figure 23. Deflection of geometric center of two baggage doors under test load.

The load-deflection curves of the geometric center of two doors are shown in Figure 23. The curves are nonlinear, so it would appear that there would be a significant permanent set when the load was removed. In the test represented by the x's and dotted lines, the load was removed after 192 pounds had been applied. Despite the nonlinearity of the load-deflection curve, the permanent set was a negligible 0.018 inches.

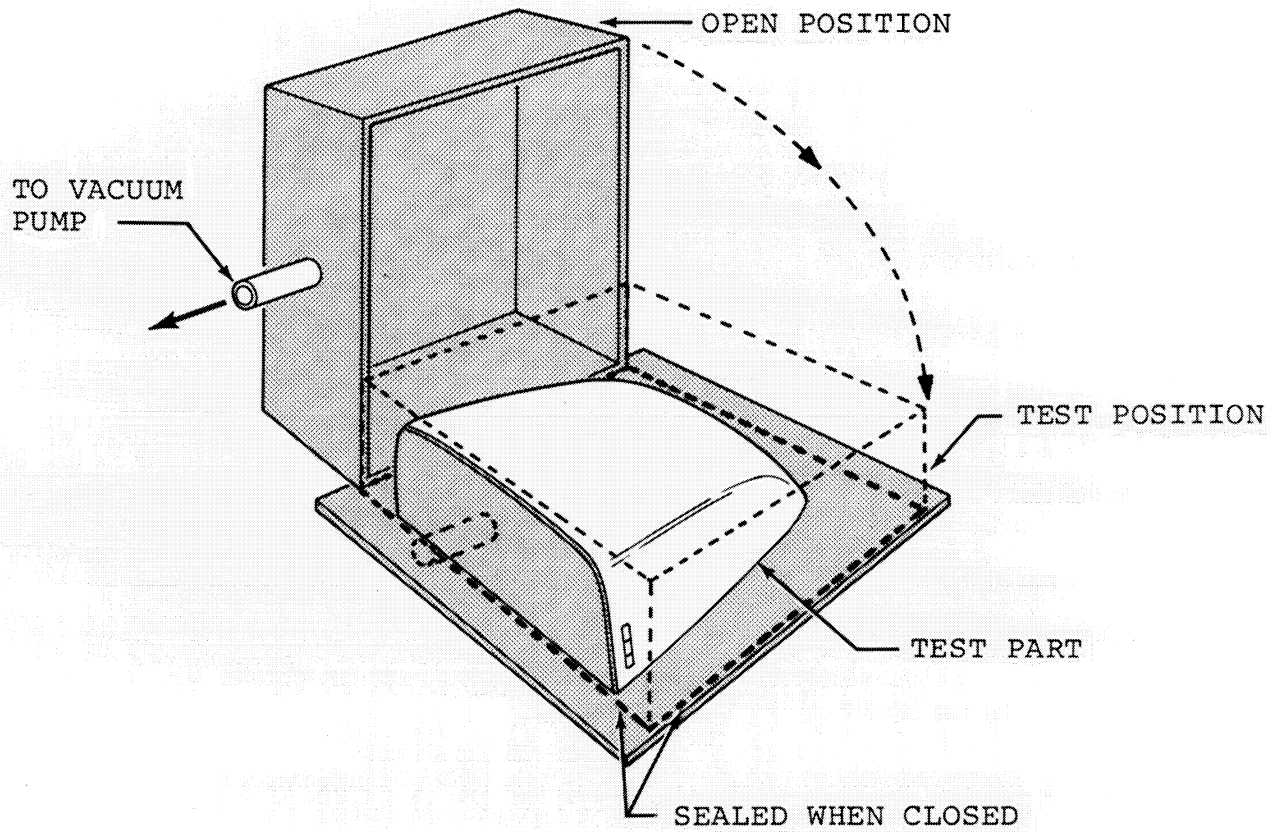
Figure 26. Pressure test setup on forward fairing.

Two fairings were tested to failure. The first one failed at 1.51 psi at the inner corner splice, as shown in Figure 27. The second fairing failed at 1.94 psi, but was not a composite failure. At 1.94 psi the right-hand aft latch slipped, causing some local, noncatastrophic failures of the surrounding structure.

Subsequent examination of the test parts revealed a possible knife cut in the failed area of the first specimen and the probability of a faulty latch on the second specimen. (The much higher load that five subsequent fairings withstood supports this theory. This is discussed in Section 6.2.6).
