**NASA
Technical
Paper
2087**

December 1982

Lightning Attachment Patterns and Flight Conditions for Storm Hazards '80

Bruce D. Fisher,
Gerald L. Keyser, Jr.,
and Perry L. Deal

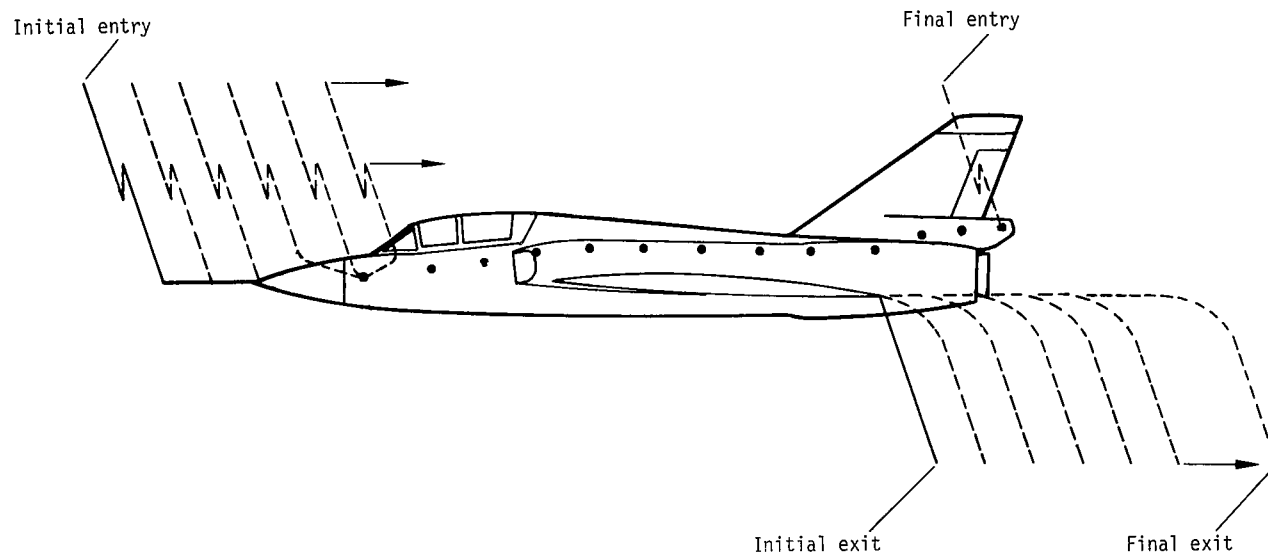
Figure 2.- Typical path of swept-flash attachment points.

of the channel on the airplane are described in reference 11. These points, which occur simultaneously, are typically located at airplane extremities. In the example shown in figure 2, the initial entry point is shown at the tip of the nose boom and the initial exit point at the trailing edge of the left wing tip, which are typical entry and exit points for a delta-wing airplane. Besides the initial entry and exit points, there may be other subsequent attachment points that are caused by the motion of the airplane through the relatively stationary flash channel. For example, when a forward extremity, such as a nose boom, becomes an initial attachment point, its surface moves through the lightning channel, and thus the channel appears to sweep back over the airplane surface, as illustrated in figure 2. This occurrence is known as the swept-stroke phenomenon. The flash channel will continue to sweep back along the airplane surface until the flash dies or the airplane flies out of the flash channel. In the example shown in figure 2, the final entry point is located on the speed brake. The exit portion of the flash continues to trail back from the left wing tip throughout the flash. More details on the swept-stroke phenomenon may be found in reference 11.

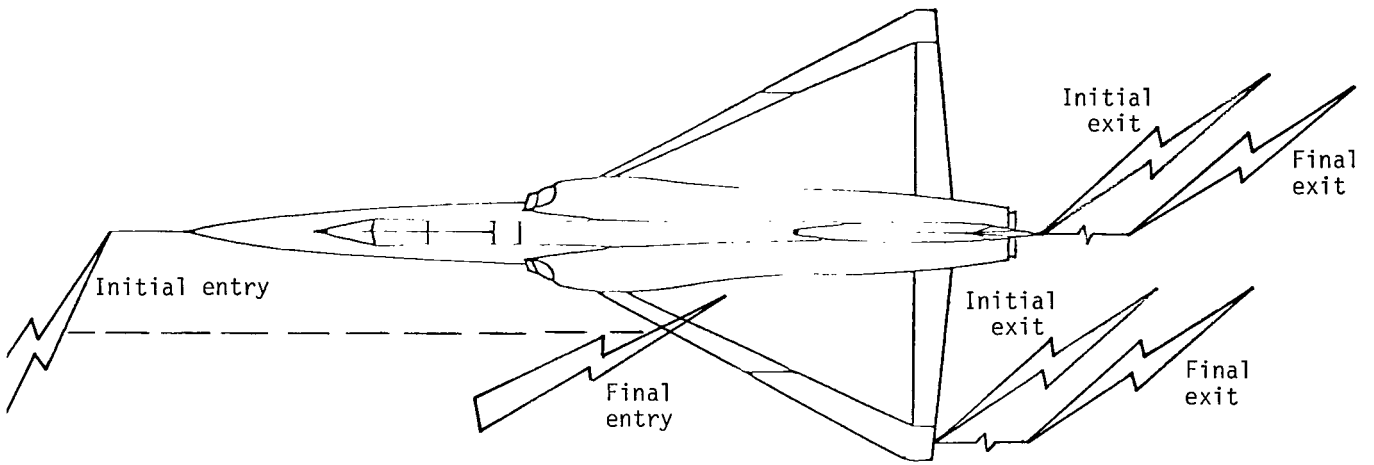
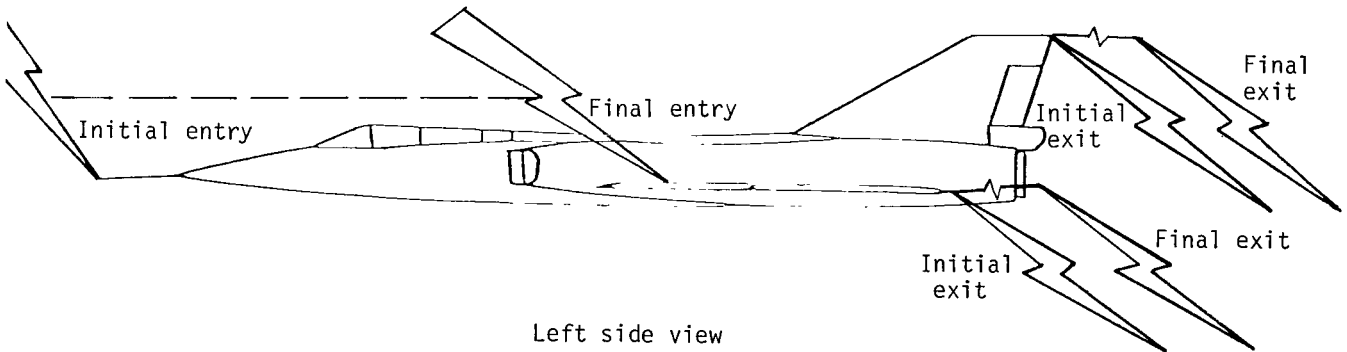
Figure 5.- Lightning strike scenario for strike 1, flight 80-018, June 17, 1980.

Based on the attachment point locations and the pilot comments, the strike scenario shown schematically in figure 5 was developed. It is believed that the strike entered from above and to the left of the airplane and exited to the right and downward.

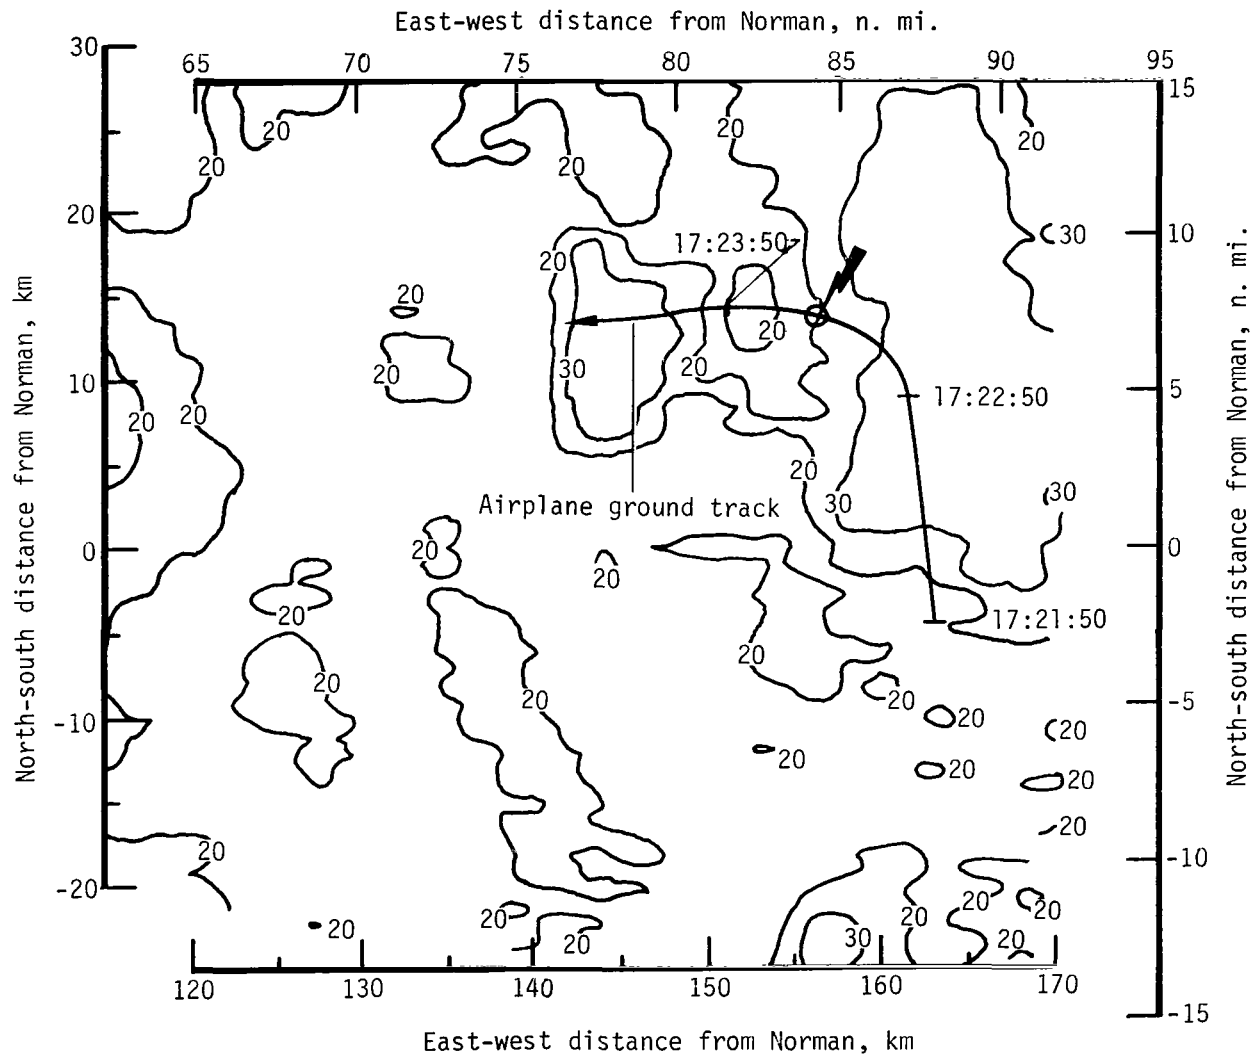
Figure 6.- Airplane ground track and precipitation reflectivity contours for lightning strike 1 at 17:23:24.0 GMT on June 17, 1980 (flight 80-018). Reflectivity data taken from NSSL Doppler radar at Norman, Okla., and interpolated to constant height of 4.5 km (14 800 ft).

The relative location of the airplane in the thunderstorm at the time of the direct strike is shown in figure 6, in which the airplane ground track has been superimposed on a contour map of precipitation reflectivity factor measured by the NSSL Doppler radar at Norman, Okla. The reflectivity data have been interpolated to a constant altitude of 4.5 km (14 800 ft), whereas the airplane altitude at the time of the strike was 5 km (16 400 ft). The time of the strike and the accompanying \dot{D} measurement are indicated by a lightning symbol and circle on the ground track. As can be seen, the airplane was in an area indicating 20 dBZ of reflectivity.

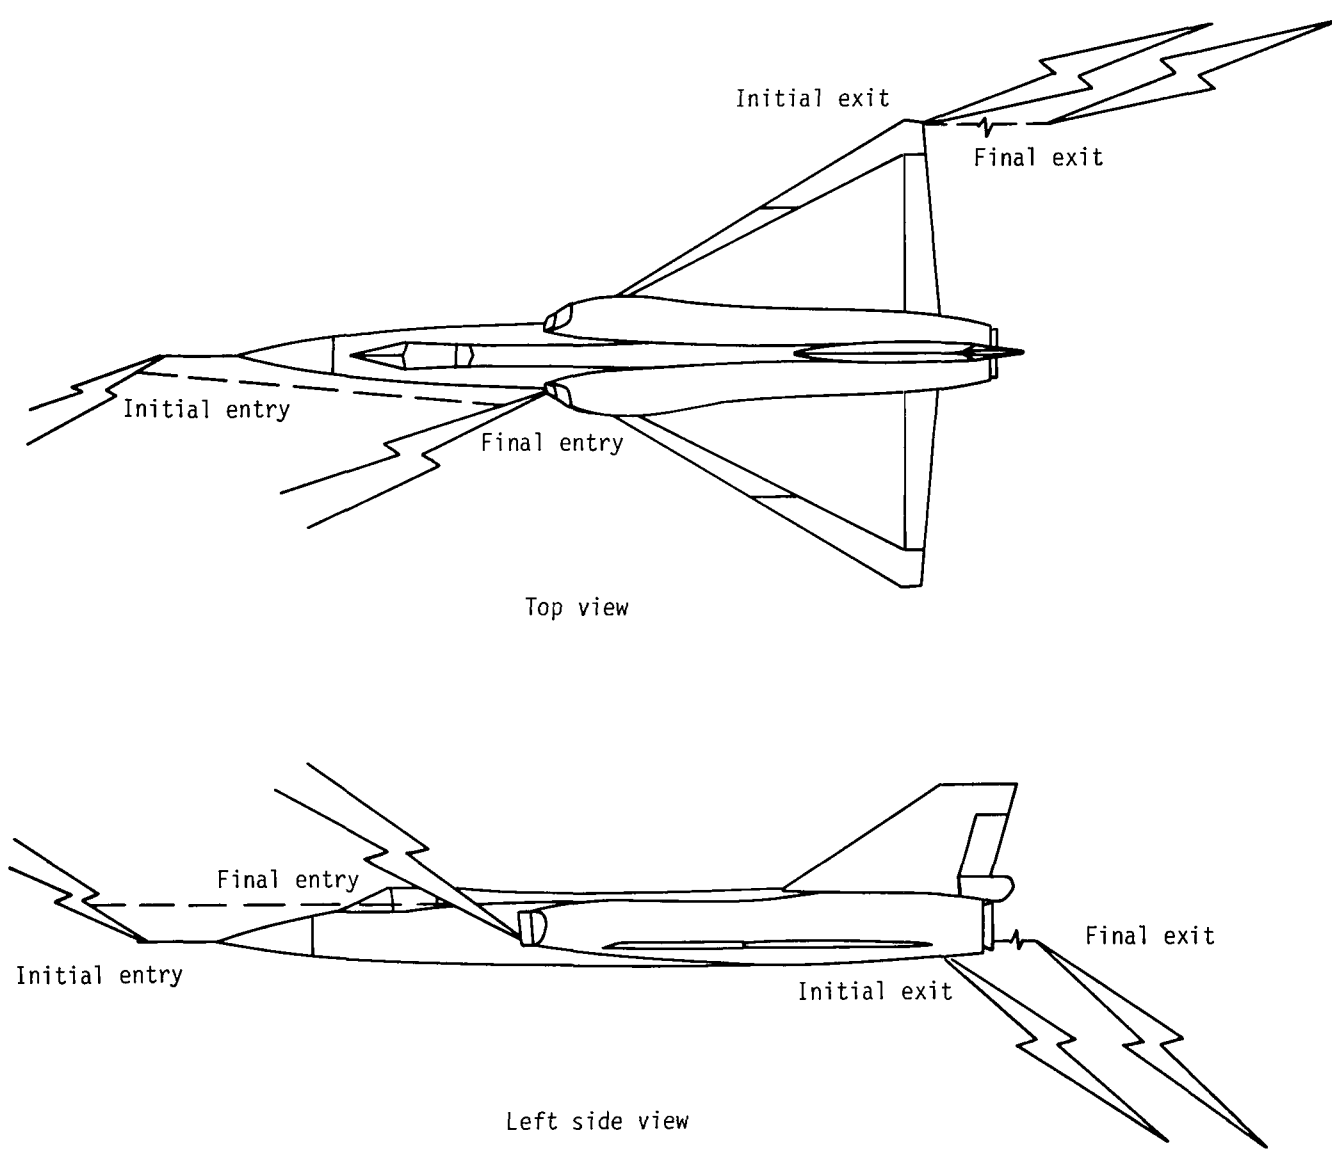
Figure 32.- Lightning strike scenario for first strike to single USAF F-106A airplane.

The lightning attachment points in figure 30 are believed to have been caused by the first (head-on) strike described by the pilot. The lightning scenario developed for this strike is shown in figure 32. The initial entry point was the nose boom, with the flash entry sweeping back along the left side of the nose boom, jumping back to the radome-fuselage juncture and then to the angle-of-attack sensor, and finally jumping to the leading edge of the inlet lip. The initial exit point was the right wing tip. The flash channel entered from above and to the left of the airplane flight path and exited downward and to the right.

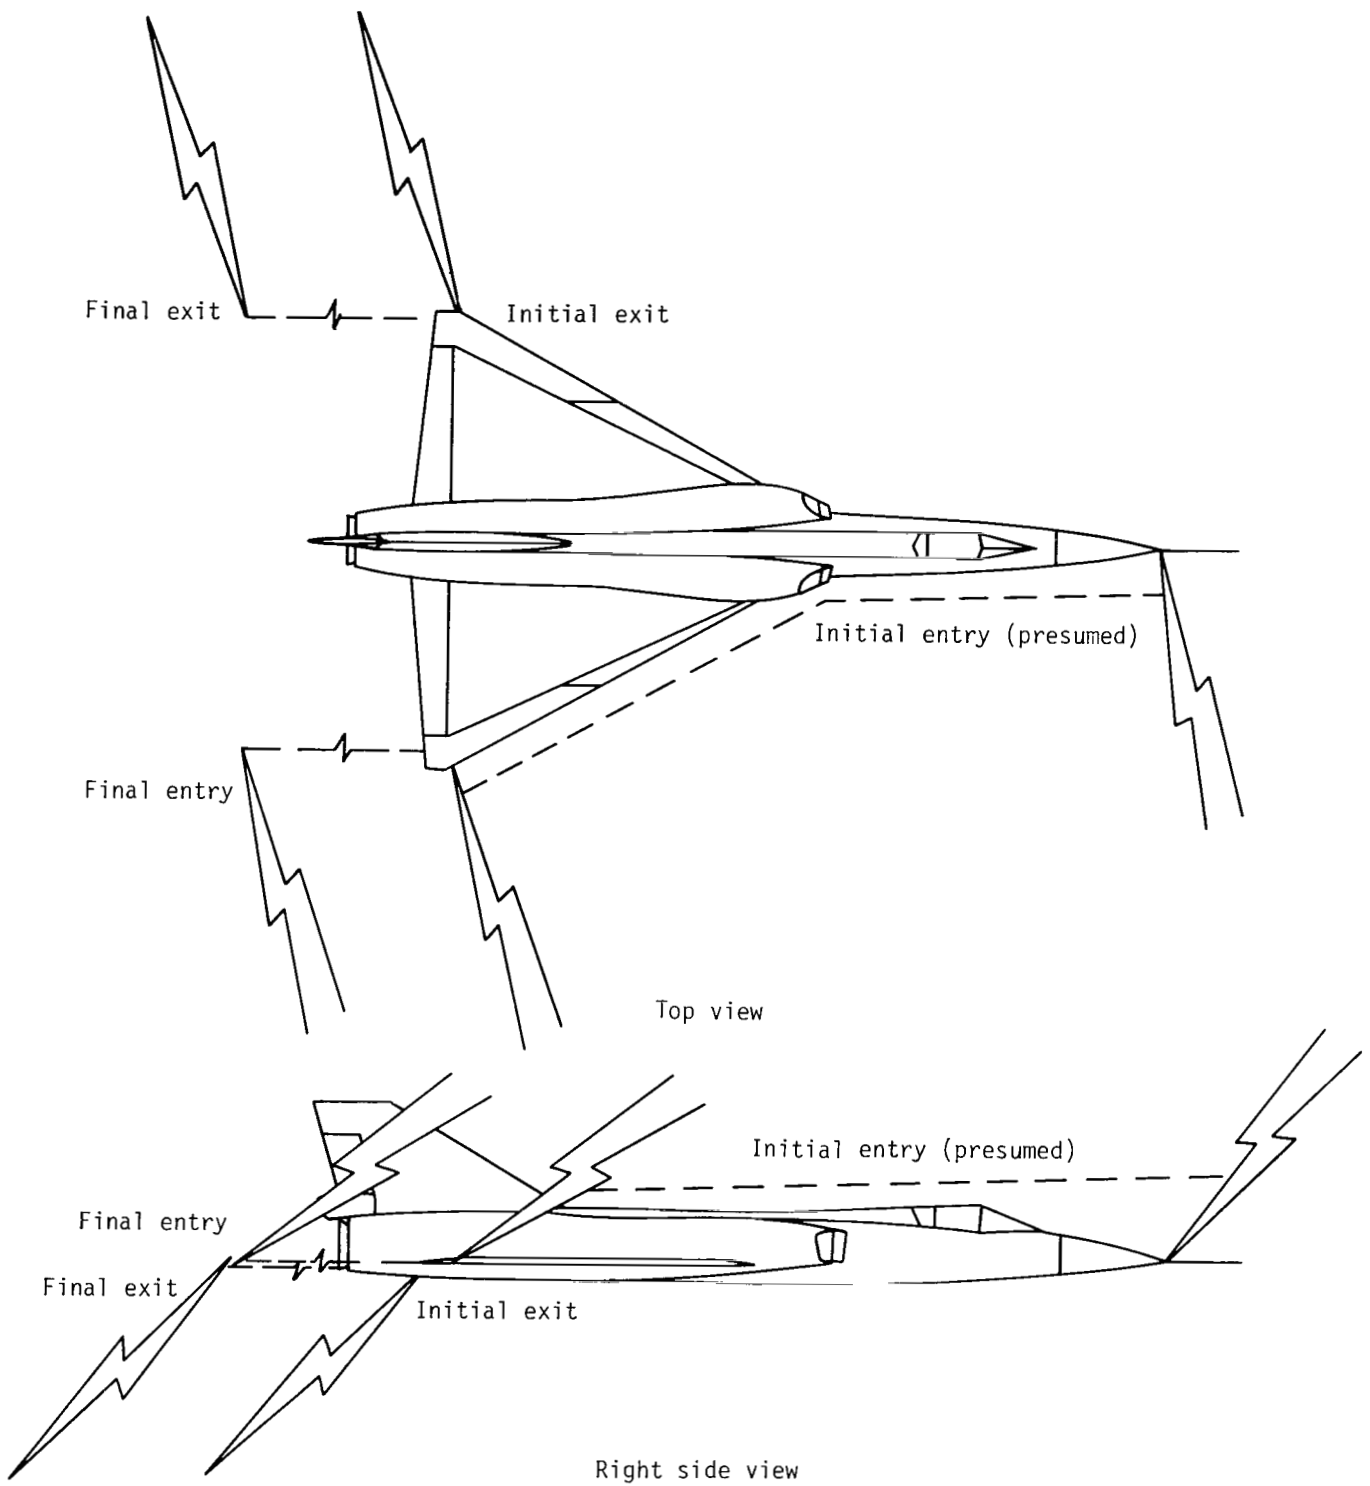
Figure 33.- Lightning strike scenario for second strike to single USAF F-106A airplane.

The second strike, figures 31 and 33, was produced by one of the branches of the forked lightning flash. Initial entry is presumed to have occurred on the nose boom, with the entry point jumping back to the nose-boom/radome juncture, then back to the inlet, and finally back to the right wing tip, hanging on there until the flash ended. The initial exit point was the left wing tip. This point geometry implies that the flash entered from above and from the right of the flight path and exited downward and to the left. This orientation is in agreement with the pilot's description of the flash orientation of the forked flash.
