737 GRAPHITE COMPOSITE FLIGHT SPOILER FLIGHT SERVICE EVALUATION

SEVENTH ANNUAL REPORT
MAY 1980 THROUGH APRIL 1981

Prepared under Contract NAS1-11668 by
BOEING COMMERCIAL AIRPLANE COMPANY
FEBRUARY 1982

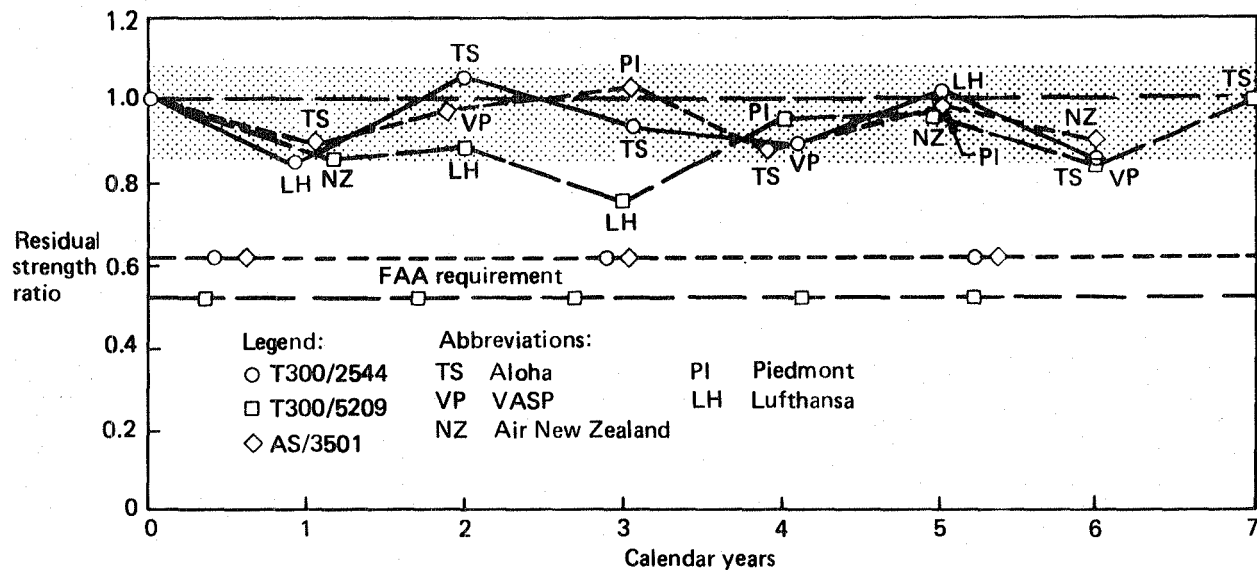
Figure 13. Summary of Residual Strength After Exposure

Table 4 gives data from all of the scheduled sixth-year removals and summarizes the strength and stiffness data from the two units that were statically tested. Table 5 gives similar data for the seventh-year removals. Figure 13 shows the residual static strength data accumulated to date. Each symbol represents one test of a particular spoiler dash number (i.e., type of skin material) after a predesignated period of time. Initials near the symbols indicate the airline from which the spoiler was removed. The data are shown as a residual strength ratio, where 1.0 is the original unexposed certification test value for each material system. The shaded area represents the scatterband for a total of 16 ultimate tests run on unexposed -2 units. Although limited to one production run of only one of the

three types of material, the band provides some idea of the minimum scatter that could be expected. The FAA ultimate load requirement for each material system is also shown in the figure. It can be seen that the three units tested after 6 years have residual strengths that are near the lower bound of the scatterband but well above the FAA requirement. The seventh-year unit had a residual strength only slightly lower than the unexposed baseline failure strength. Figures 14 and 15 are plots of the load-deflection data for these two panels. There is no discernible difference between baseline and residual stiffness for either unit.

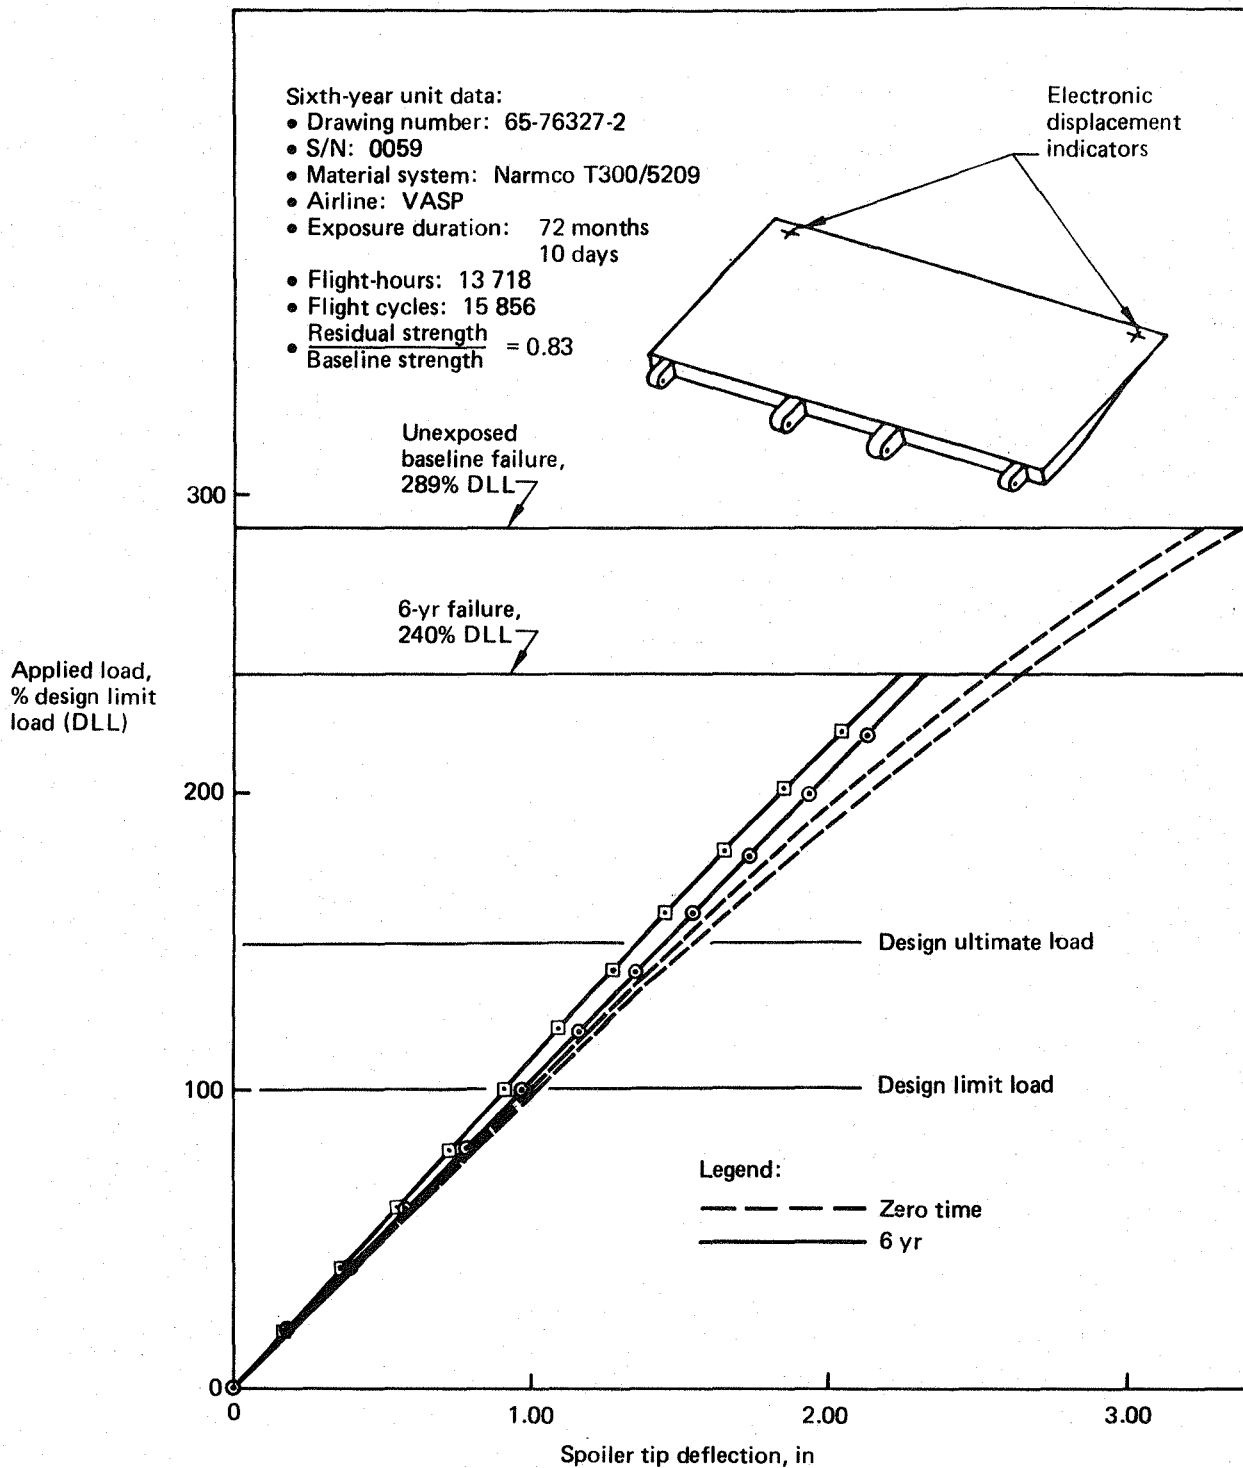
Figure 14. Residual Strength and Stiffness of Spoiler S/N 0059 After 6 Years of Service

Figures 17 through 27 are photographs of the spoiler panels after testing. On both units, the exfoliation corrosion blisters locate the failure by allowing the compression-loaded lower skin to buckle at the blister location. As expected, these defects did not significantly reduce residual panel strength or stiffness.

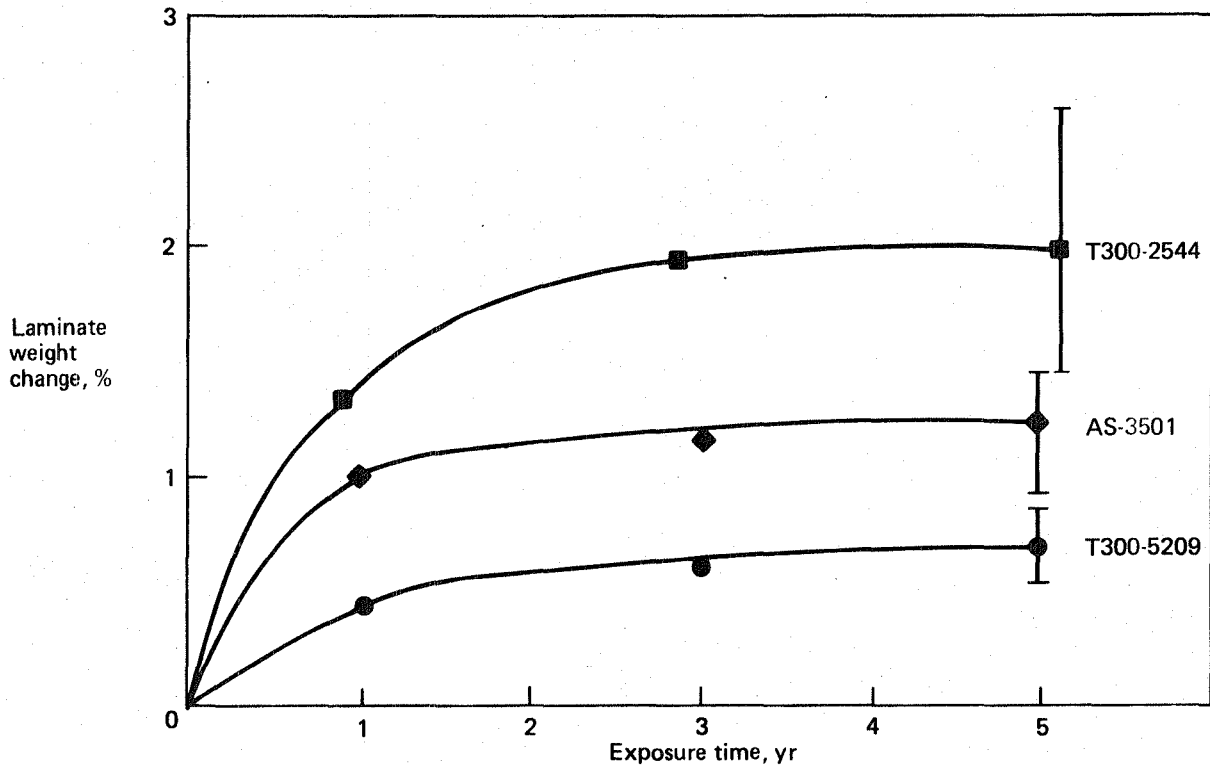
Figure 30. Moisture Pickup After Worldwide Exposures

The absorbed moisture content of the flexure specimens is calculated after the specimens are dried and weighed. The 7-year flexure specimens are not yet fully dried and, therefore, information on moisture content is not yet available. The moisture content data for 1-, 3-, and 5-year exposure periods, previously reported in reference 7, are shown in figure 30.

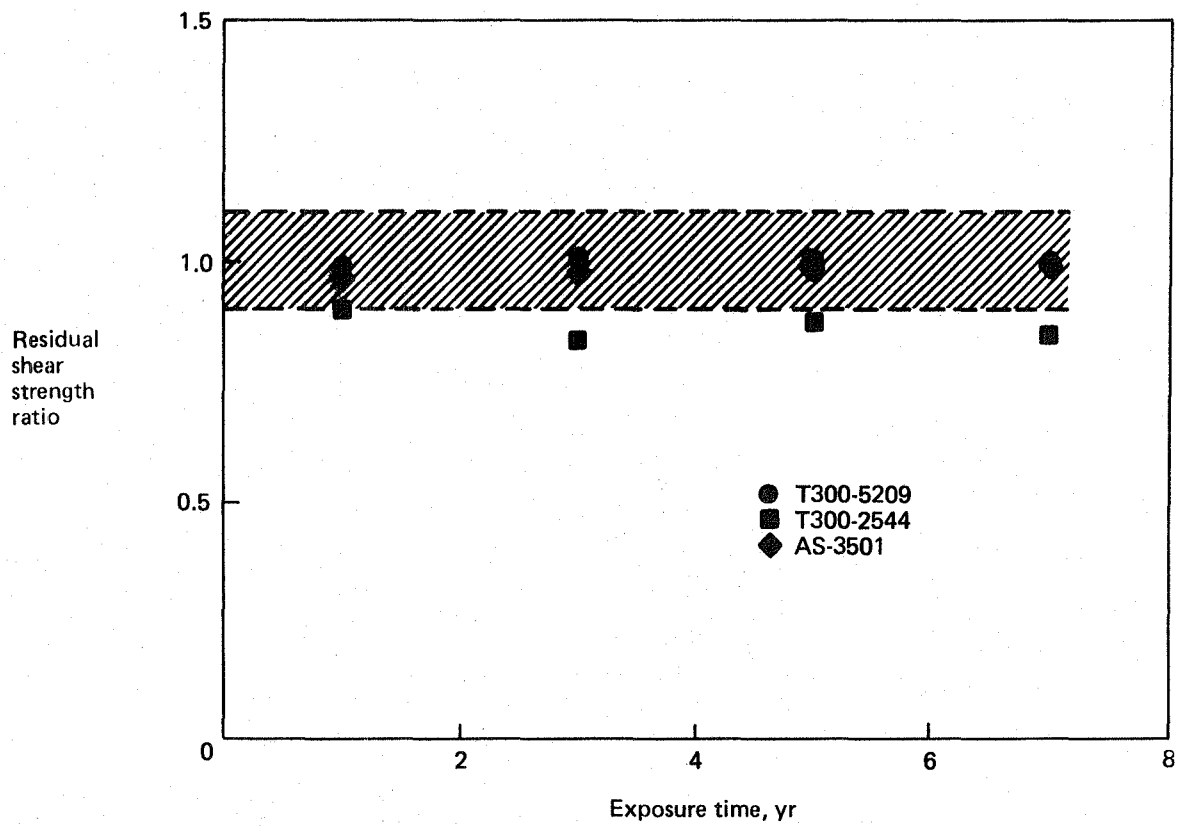
Figure 31. Residual Shear Strength After Worldwide Exposure

The average residual strength ratios for the shear, flexure, and compression specimens are plotted in figures 31, 32, and 33. These values represent a comparison of the average strength values for all six exposure sites with the average baseline strength value for that material system. A $\pm 10\%$ bandwidth, which represents the strength scatter in the baseline specimens, is shown on each graph. The shear strength ratio values remain within the scatterband for all material systems except T300-2544, which continues to be slightly lower than baseline values. Flexure strength values are also within the scatterband except

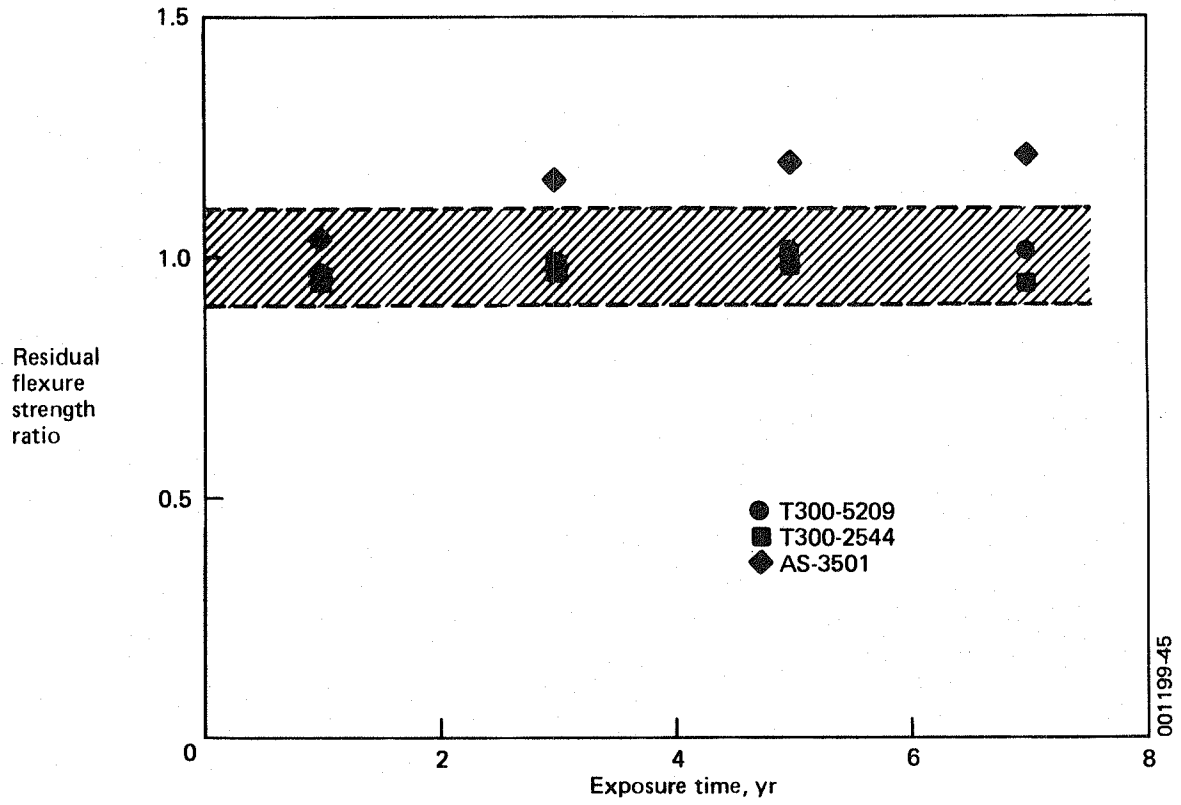
Figure 32. Residual Flexure Strength After Worldwide Exposure

for the AS-3501 material system, which has been consistently high (between 5% and 10% above the baseline) over the 3-, 5-, and 7-year exposure periods. The compression strength ratio has increased about 10% with 7 years of exposure for all material systems after a steady decline for the previous 5 years bringing the 7-year values very near the baseline strength values.
