(NASA-CR-164742) LIGHTNING PROTECTION SYSTEM FOR SPACE SHUTTLE Final Report
 (Planning Research Corp.) 154 p
 HC A08/MF A01

LIGHTNING PROTECTION SYSTEM FOR SPACE SHUTTLE

PREPARED BY
 PLANNING RESEARCH CORPORATION
 Systems Services Company
 for
 DESIGN ENGINEERING
 JOHN F. KENNEDY SPACE CENTER, NASA

August 1977

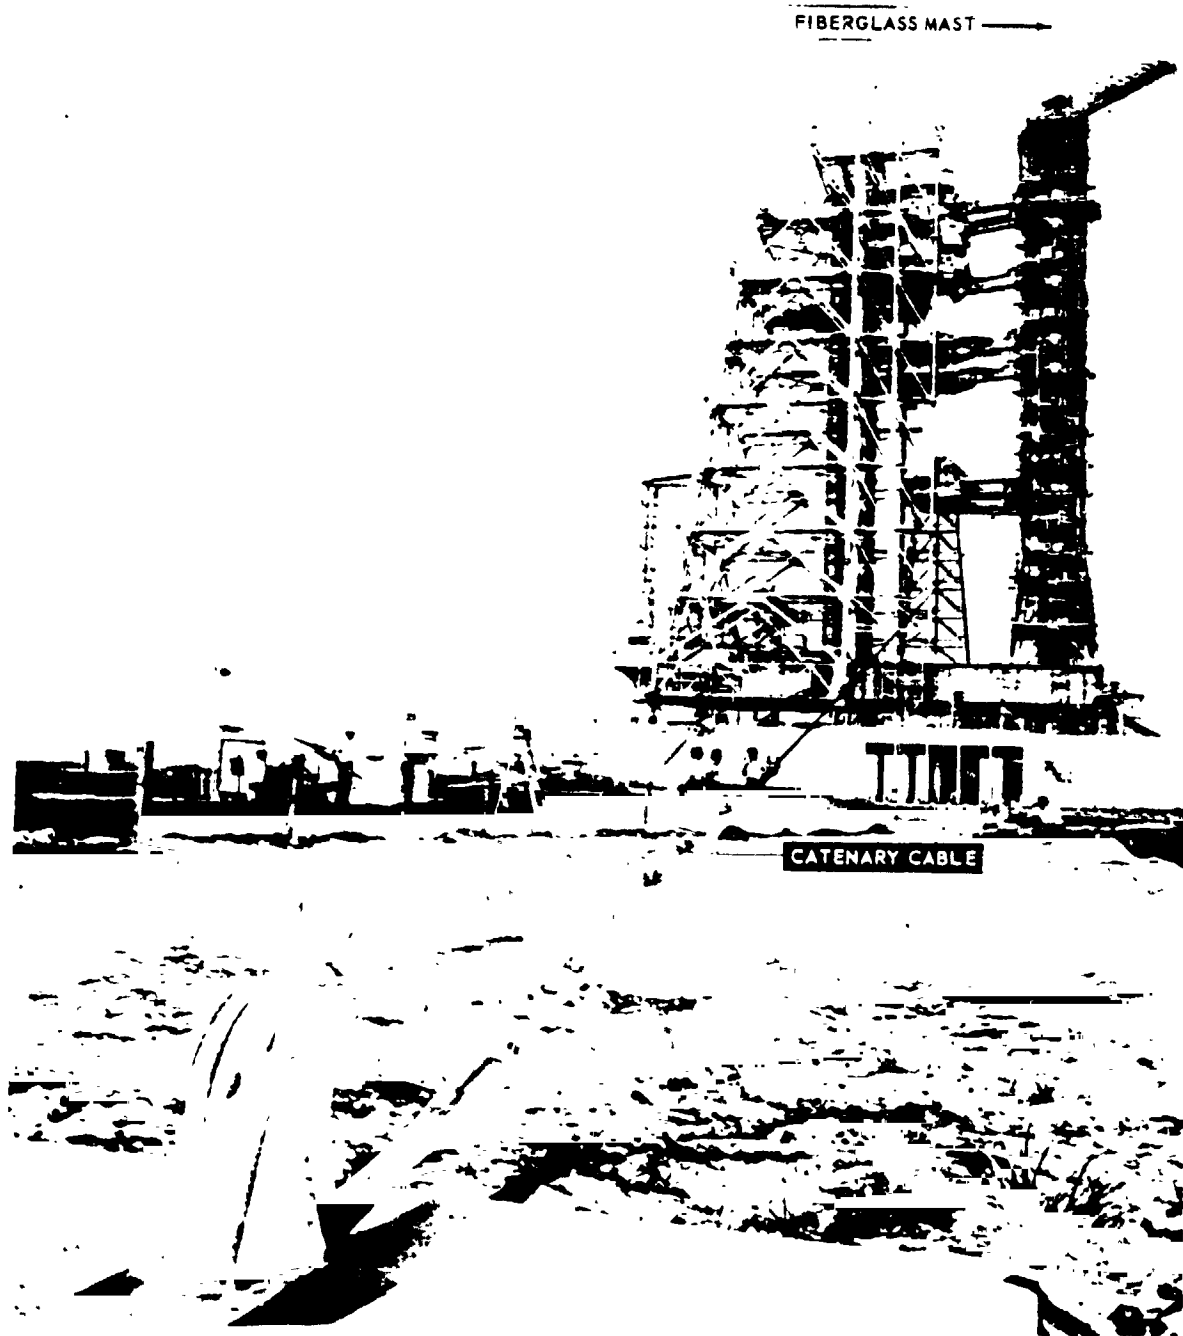
Figure 3-11. Grounded Catenary Cable Viewed From East Anchor Point to Top of Fiberglass Mast. A Similar Anchor Point Is on the West Side.

3.2.1 ASTP LIGHTNING WAVEFORM INSTRUMENTATION. For ASTP two shielded enclosures were provided at each end of the protective catenary cable to house separate sets of instrumentation. The east end of the cable is shown in figure 3-11. The cable is isolated from the anchor point by insulators and grounded by a down lead and ground rod (figure 3-12). Two current sensors, one a Pearson coil to obtain the current waveform and the other a Kirtland coil to obtain the rate of change of current, are coupled to the ground rod. The Pearson coil is used with a compactor digital recorder and the Kirtland coil with a biomation digital recorder, each housed in separate shielded enclosures (figure 3-13). Peak reading voltmeters (PVM's) are also used to obtain the sensor peak voltages. The compactor instrumentation is shown in figure 3-14 and the biomation instrumentation in figure 3-15. A complete block diagram of the two sets of instrumentation is shown in figure 3-15.

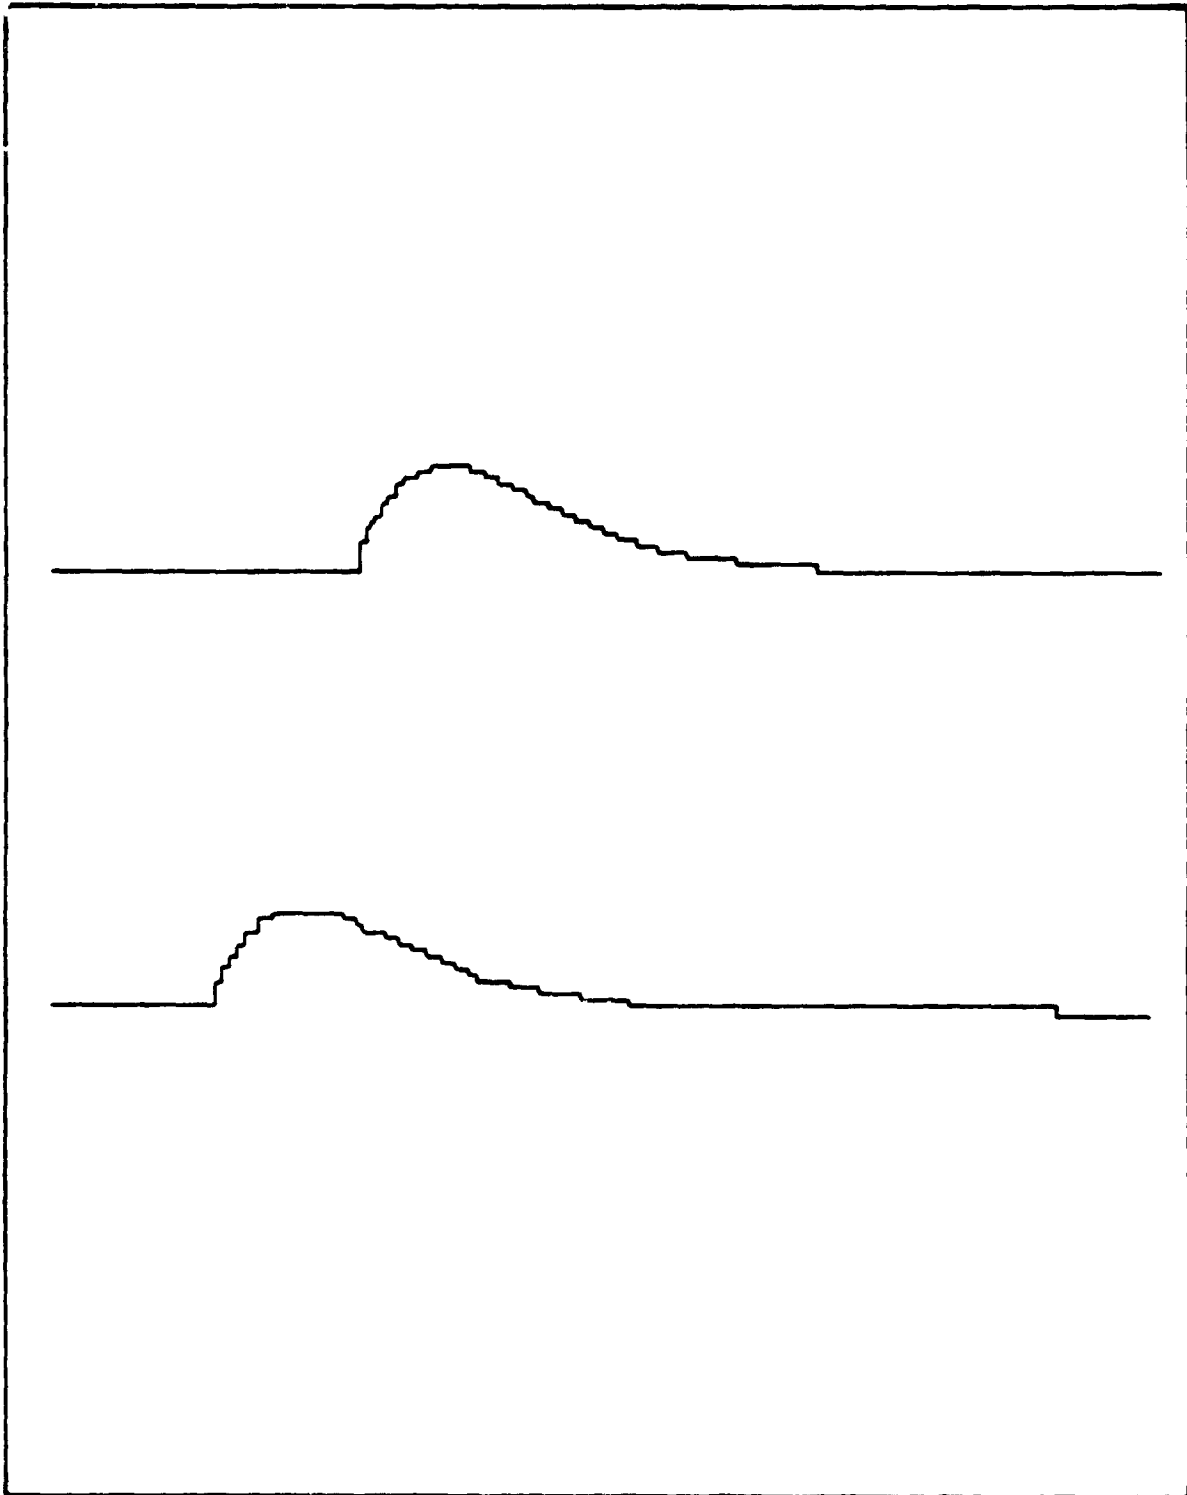
Figure 3-20. Exponential Waveforms Reproduced After Acquisition by Compactor

This instrumentation was tested with exponential and oscillatory current waveforms. Typical waveform recordings are shown in figures 3-20 and 3-21. The interval increase during the slowly varying portion of the waveform is shown in figure 3-20. The waveform at the top of figure 3-21 was obtained with the
