NASA TM-82424

LOX/GOX RELATED FAILURES DURING
SPACE SHUTTLE MAIN ENGINE DEVELOPMENT

By C. E. Cataldo
Materials & Processes Laboratory

May 1981

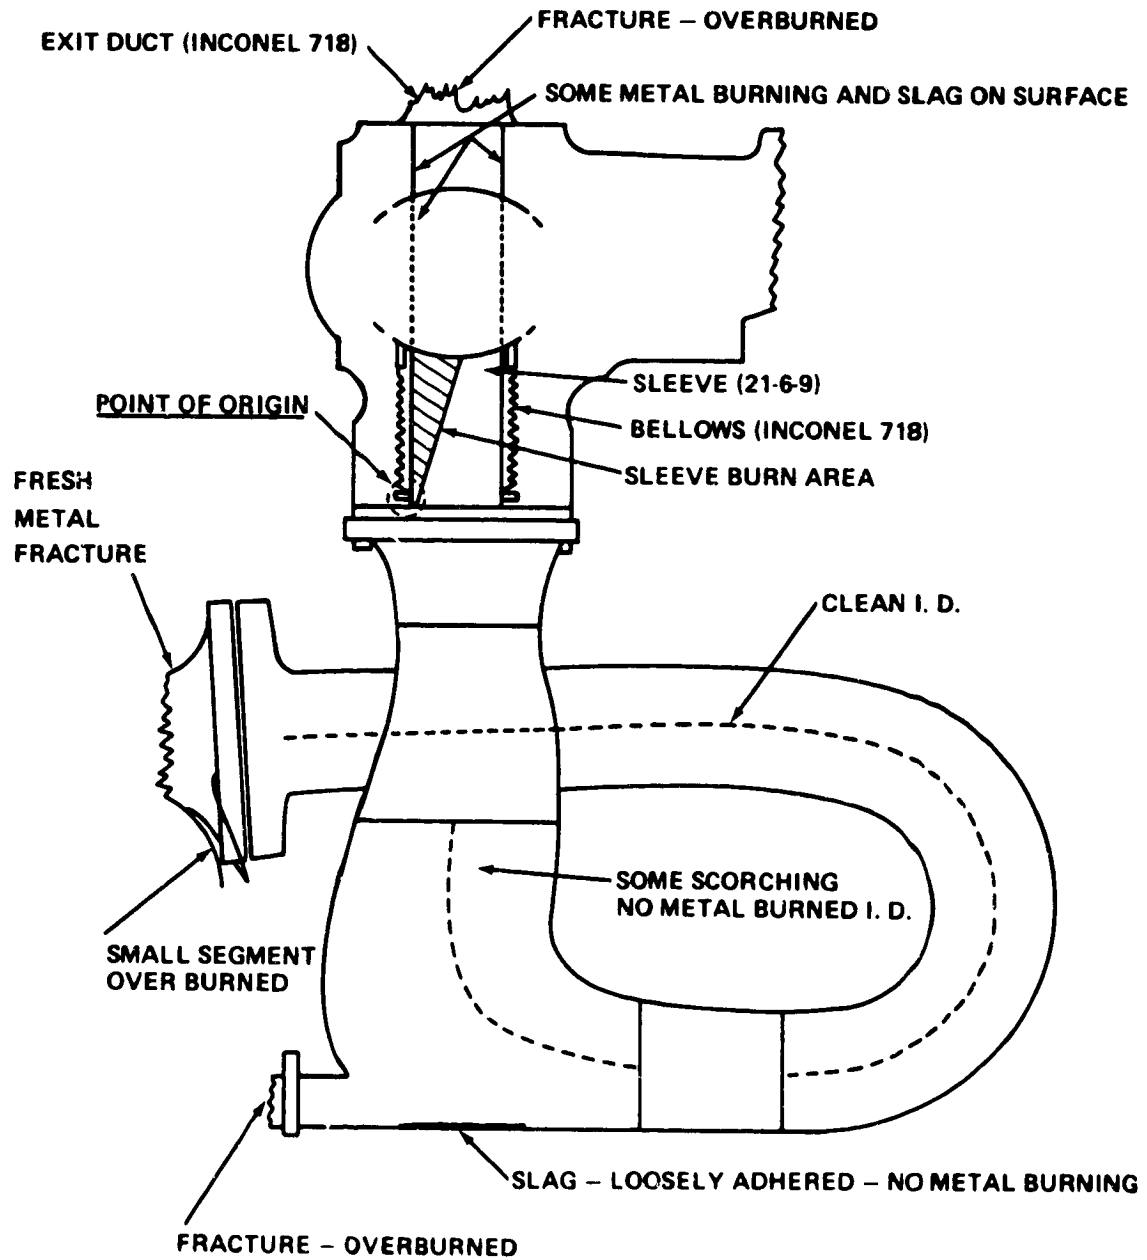
Figure 45. Origin of fire.

A cross-sectional of the MOV is shown in Figure 44. Figure 45 is a sketch of the MOV and duct assembly with notations of the damage observed and other observations relative to the failure cause.

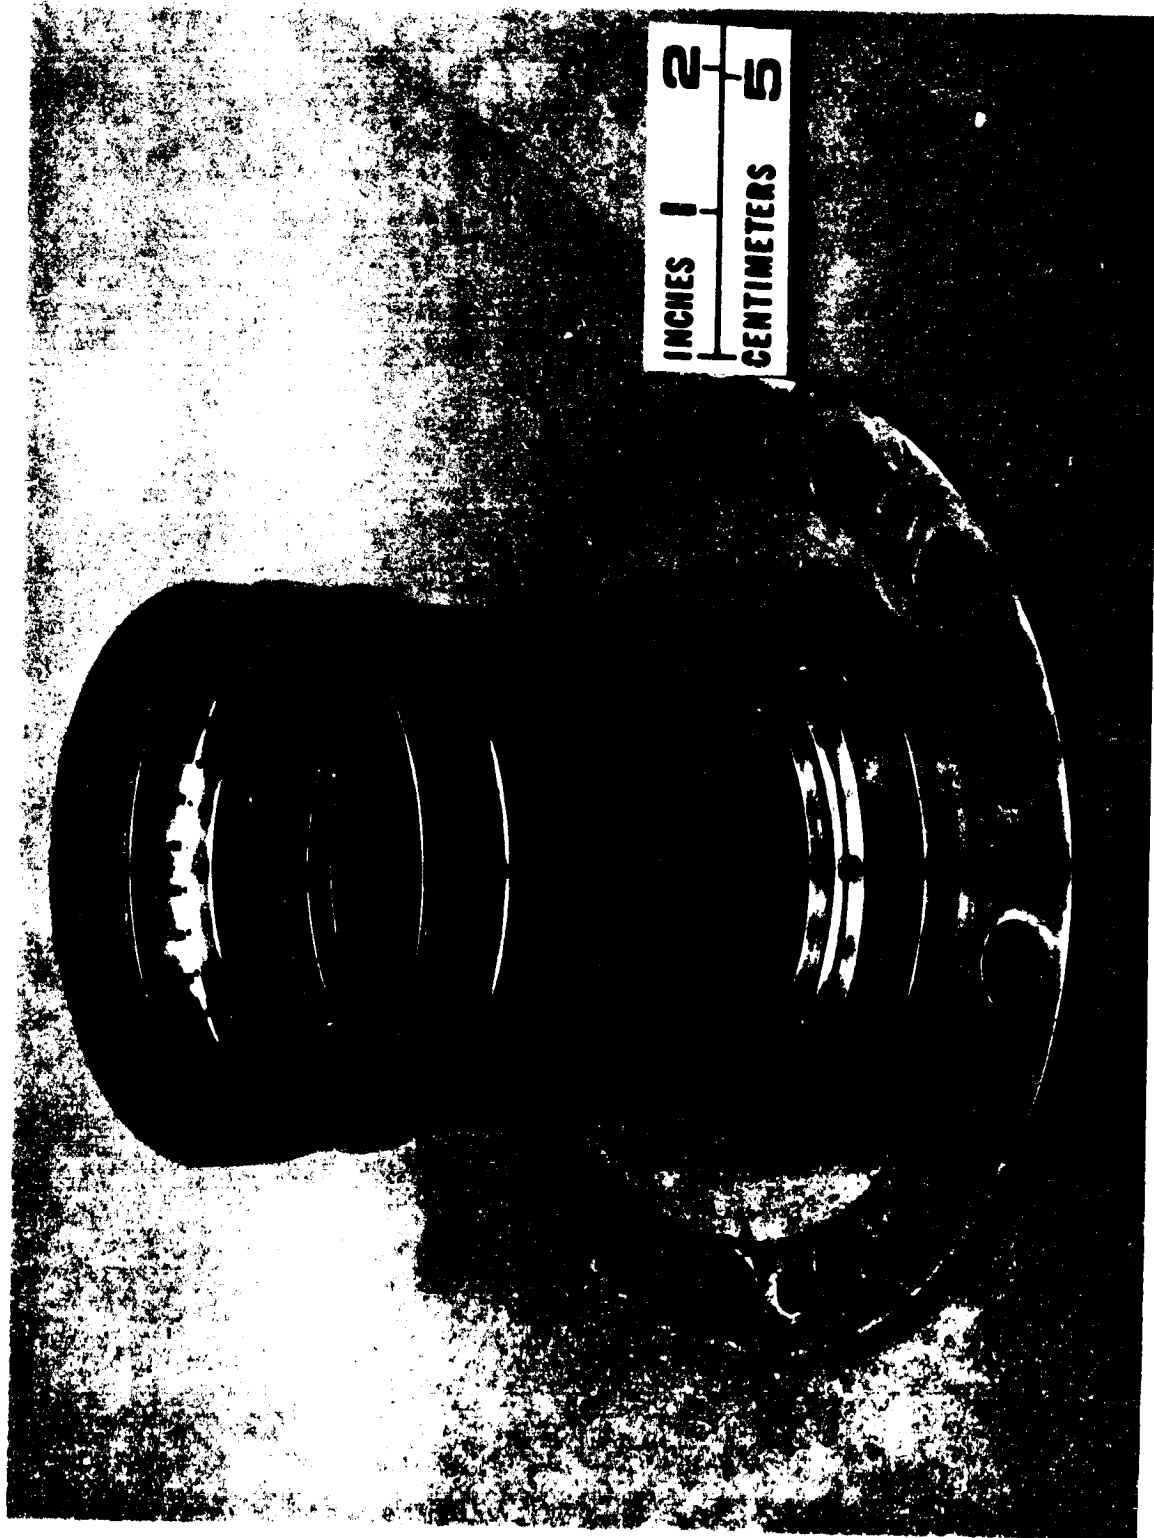
Figure 48. MOV inlet liner and bellows assembly removed from another valve and the evidence of severe fretting in the flange area.

This failure scenario was supported by the pressure/temperature time-lines in the test. Also, subsequent examinations of other MOV's in different engines substantiated that the severe vibrations and fretting were occurring in these units also. Figures 47 and 48 show an MOV inlet liner and bellows assembly removed from another valve and the evidence of severe fretting in the flange area. In addition to the design changes made subsequently to reduce the high frequency vibrations, most all close fit mating parts in the valves were dry film lubricated with lox compatible lubricants. Various types of lubricants were used for the several applications. Inlox 88, a phosphoric bonded moly-disulfide type was applied to several close fitting parts; Everlube 811, a silicate bonded moly-disulfide type was used where thicker films could be allowed.
