NASA-CR-159562
VOLUME 2 OF 2
AIRESEARCH 21-2063-E

MATERIALS FOR ADVANCED TURBINE ENGINES

PROJECT COMPLETION REPORT
PROJECT 1

LOW-COST DIRECTIONALLY-SOLIDIFIED
TURBINE BLADES

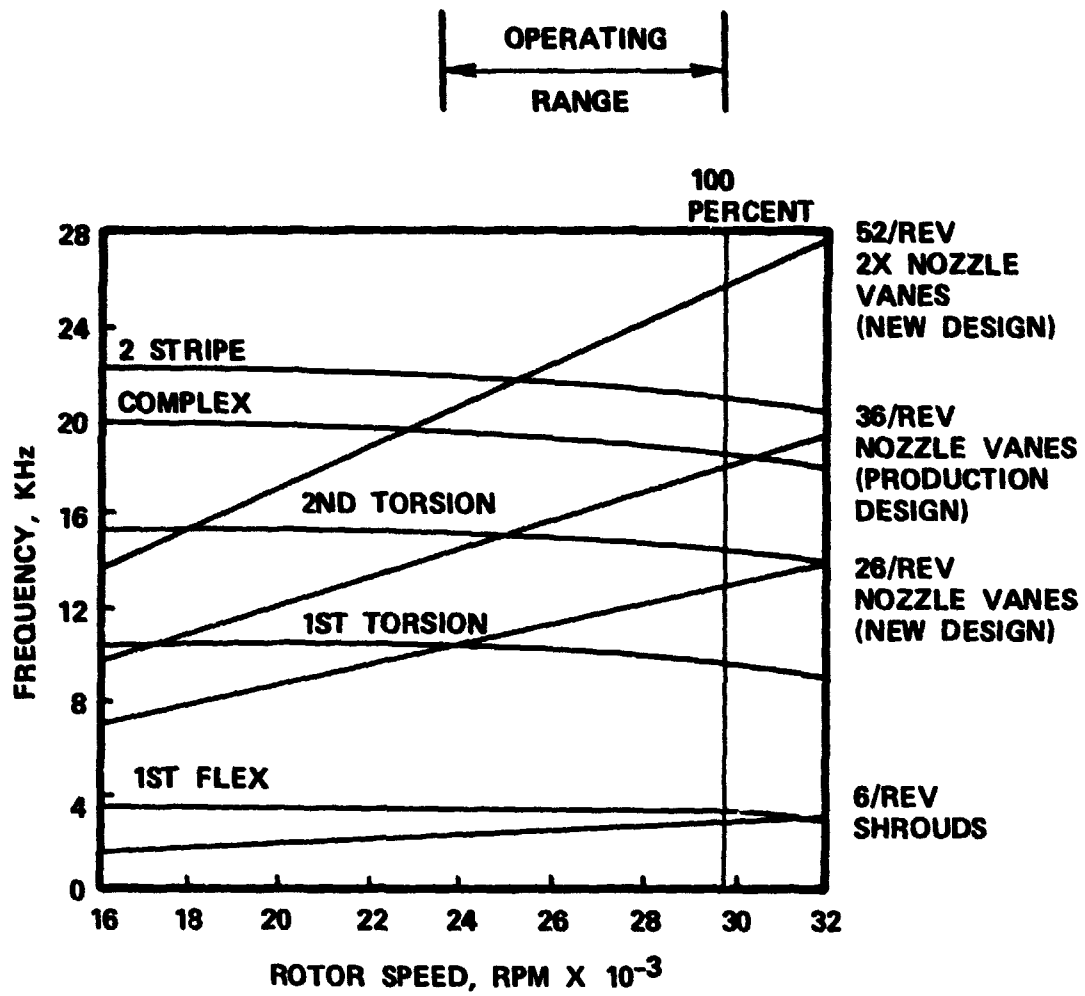
Figure 7. Interference Diagram for the MATE TFE731-3 Turbine Blades

During the performance test with the MATE hardware, a problem developed with the turbine shroud segments. In the production configuration the cooling air that exits from the tips of the cooled turbine blades reduces the temperature of the turbine shrouds; but with the uncooled MATE blades, the cooling air was

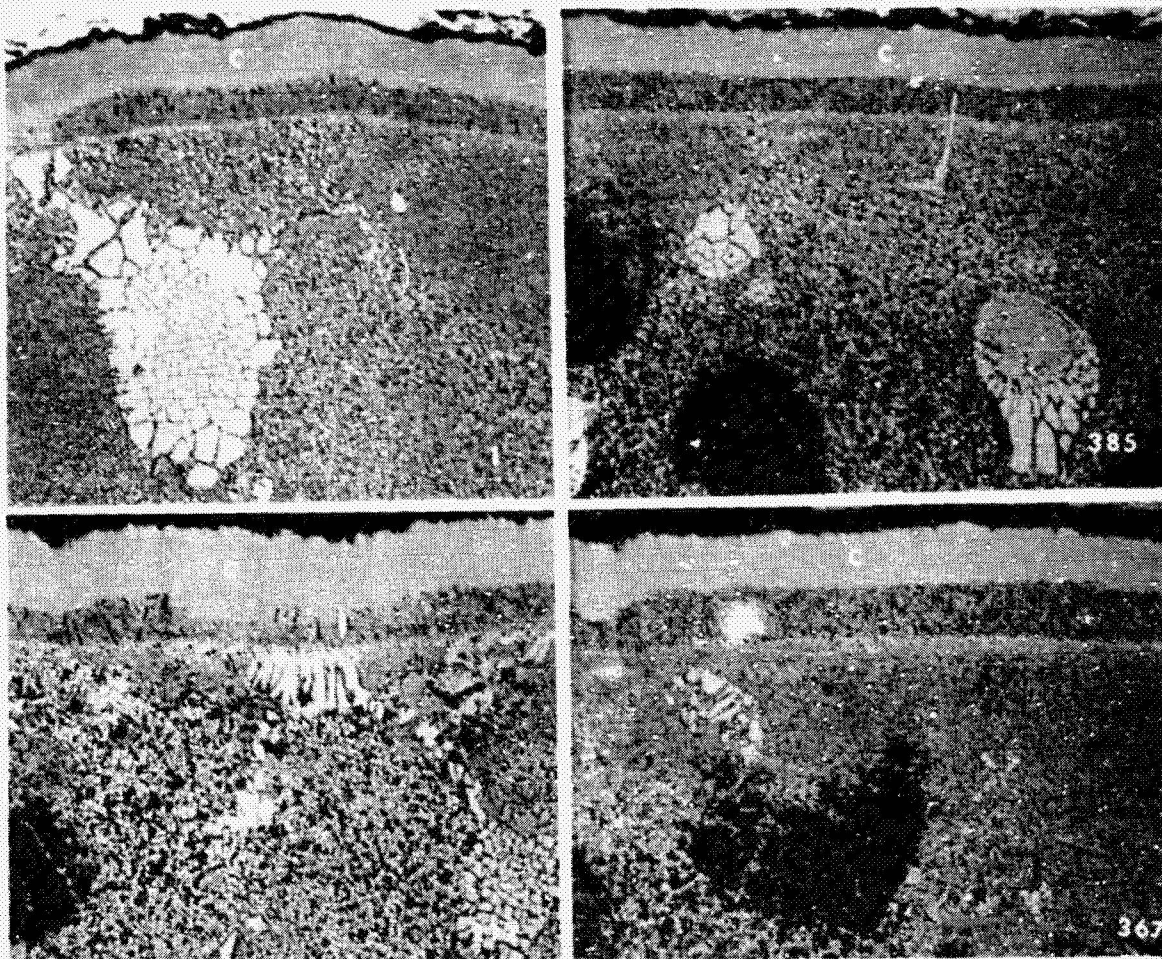
Figures 13 and 14 present typical microstructures of the DS blades--blade S/N 341 (MAR-M-247) and blade S/N 13 (MAR-M 200 +Hf), respectively. These blades suffered tip-rub damage during the performance test but were tested for the full 150 hours. As anticipated, oxidation and alloy depletion occurred at the tip where the coating was removed during the tip-rub, but other areas of the blades showed normal alloy and coating microstructures. More eutectic is evident in the MAR-M 200+Hf blade than the MAR-M 247 blade--probably due to the higher hafnium content of MAR-M 200+Hf alloy. Figure 15 presents the mid-span structure of four other engine-tested blades, both the alloy and coating structures are normal.

Figure 15. Representative Mid-Span Microstructures at Location 2 of Figure 12. Photos At Left Are MAR-M 200+Hf and the Photos At the Right Are MAR-M 247. The Letter C Denotes Coating. The Blade Serial Numbers Are At the Lower Right of Each Photo. No Abnormalities Were Found on These 50- and 100-Hour Test Blades (Etchant: Oxalic Acid) (Mag.: 500X)
