NASA CR-159867

ENGINE DIAGNOSTICS PROGRAM CF6-50 ENGINE PERFORMANCE DETERIORATION

General Electric Company
Aircraft Engine Business Group
Evendale, Ohio 45215

November 1980

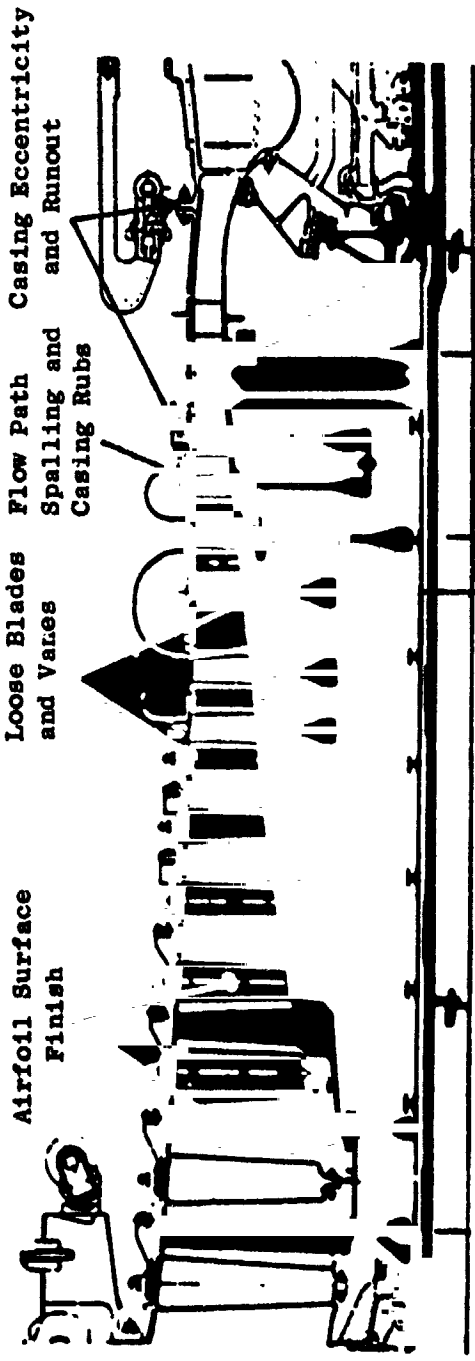
Figure 4-44. CF6-50 Deterioration Modes - HP Compressor Section.

High Pressure Compressor Section - Performance deterioration of the high pressure compressor (HPC) can result from a number of factors. These factors can be generally classified as either airfoil tip clearance changes, airfoil quality degradation, or leakage. A cross section of the HPC module showing the deterioration modes is presented in Figure 4-44.

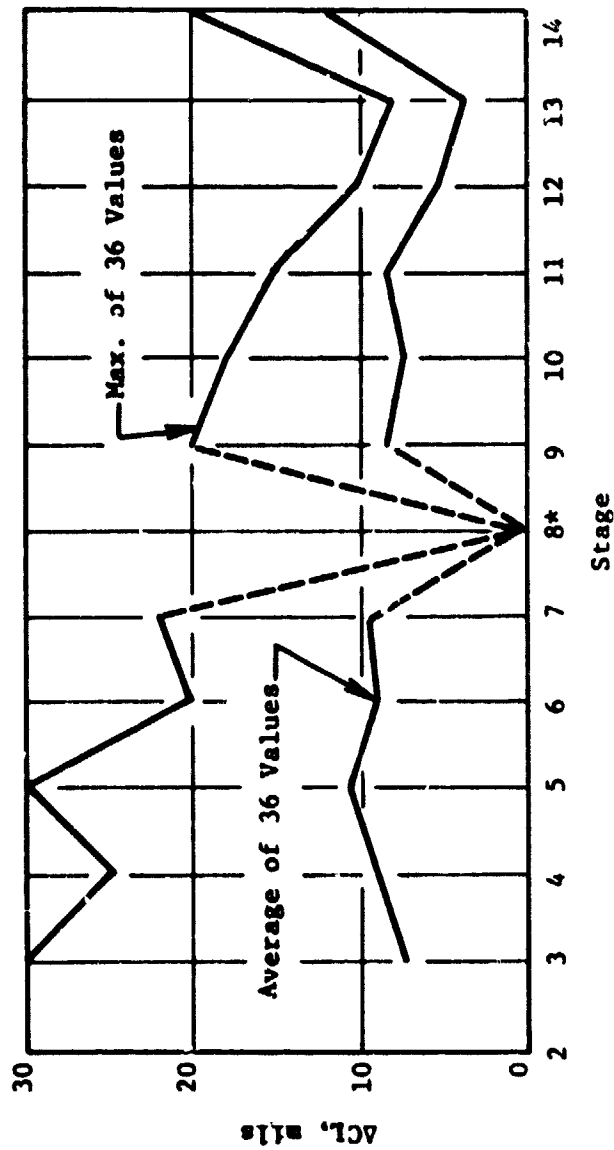
Figure 4-51. Clearance Difference from Nominal Versus Stage - Short Vanes Result of Assembly Rework.

* Stage 8 Vanes are not Reworked.

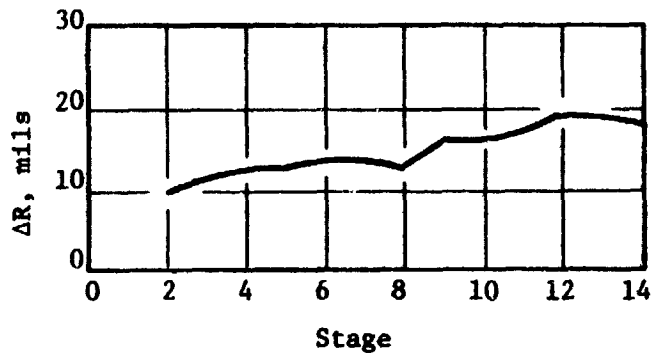
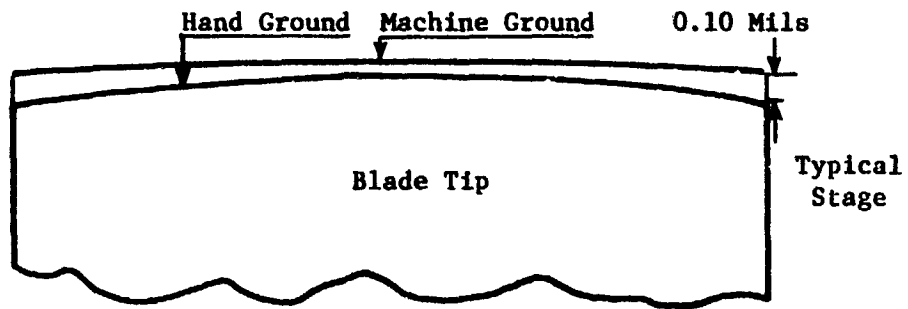
Figure 4-52. Types of Deterioration Modes: Casing Out of Roundness and Hand Grinding of Blade Tips.

A specific engine that failed to meet minimum performance standards after having been refurbished was disassembled and inspected. Inspection of the HP compressor which had been refurbished prior to the test cell run, indicated a large out-of-roundness condition of the casing as shown in Figure 4-52. An inspection of the rotor blade tips revealed a generally rounded condition rather than the expected square shape; a sketch showing this condition is included in Figure 4-52. This shape resulted from hand grinding during engine buildup to achieve the required minimum clearance. As noted in Figure 4-52, casing out-of-roundness was less than 0.020 inch in Stage 13, but the blades were up to 0.040 inch shorter at the leading and trailing edges. This was typical for this engine, and is a good example of how the average clearance effects from eccentric and/or out-of-round casing can be magnified. Hand grinding cannot be as closely controlled as machine grinding, and sometimes requires several "trial and error" rework cycles to produce the required minimum clearances. The procedure is also time consuming to recheck clearances and to reapply the wax strips, and the rework man tends to remove "more than enough" material the first time to avoid repeat cycles. A procedural change has been specified to require remachining rather than hand grinding if the required rework exceeds a specified level.

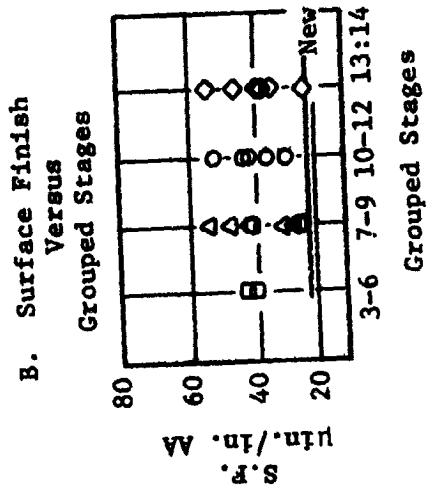
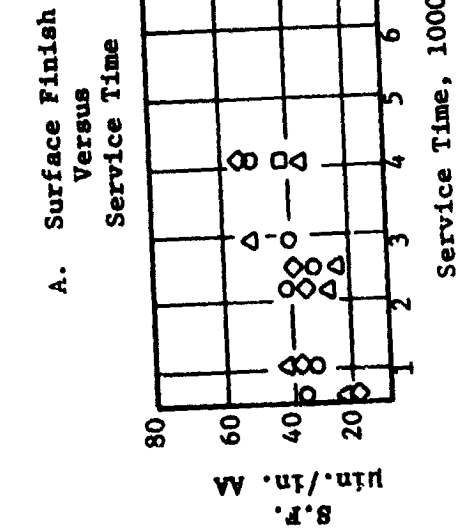
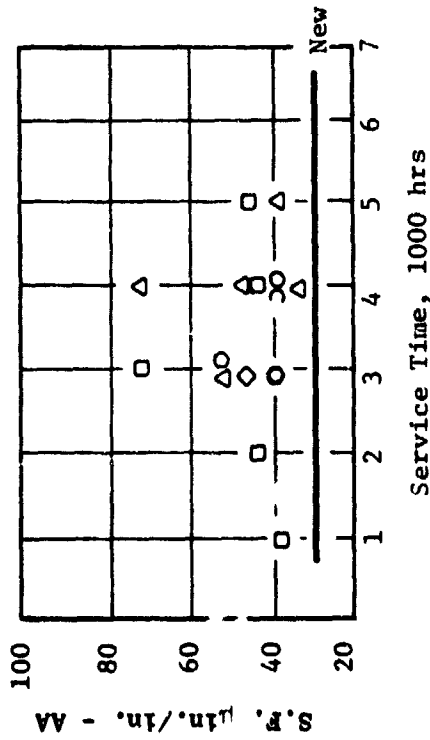
Figure 4-55. Degradation of Rotor Blade Surface Finish.

Surface Finish measurements of some blades and vanes are made for varying service times, and the data obtained are summarized in Figure 4-55 and 4-56. The results are plotted versus service time and also versus stages, and no definitive trend was indicated. It is evident that the finish deteriorates in service, but there is no clear indication as to which stages are affected the most, or how long it takes to stabilize. Surface finish may be affected by the environment which also produces blade erosion, and this may explain the rather wide spread in the data.

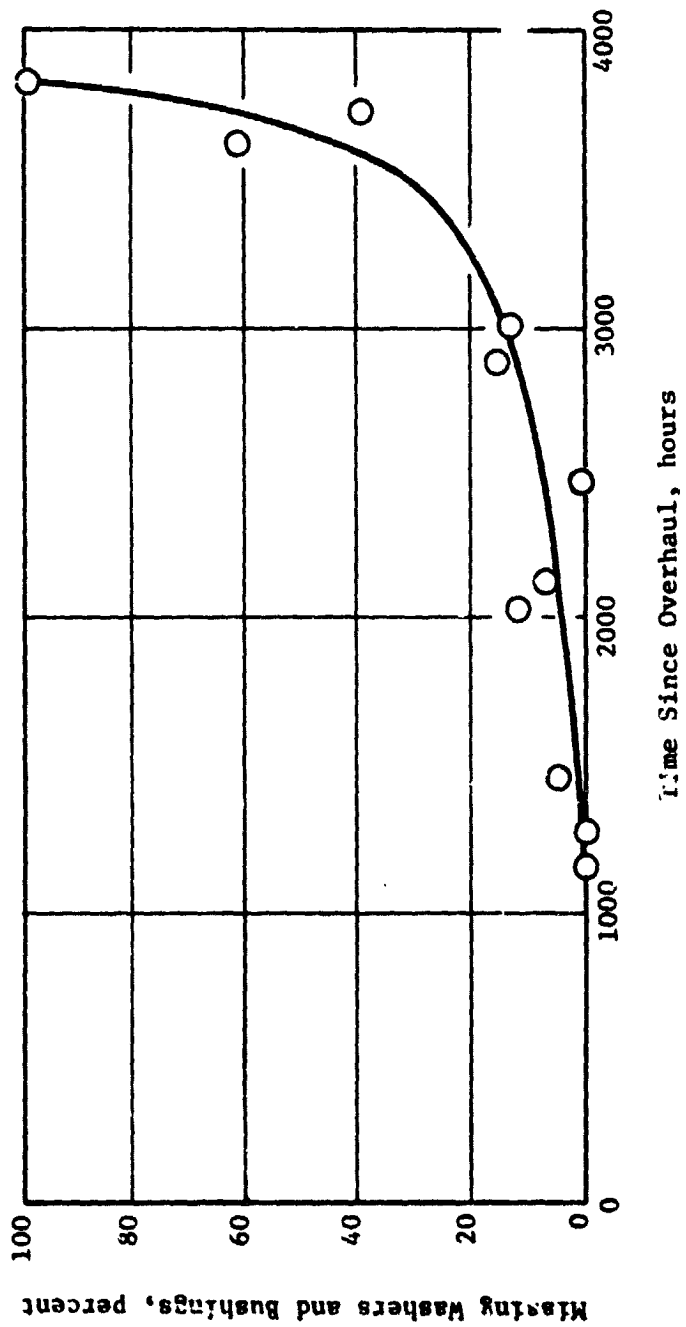
Figure 4-59. Stage 5 VSV Bushing Life.

Loose Vanes caused by wear of the washers and bushing of the vane-to-casing bearing surfaces, result in external air leakage (Reference Figure 4-57). The wear is most pronounced in Stage 5 because of the highest unit bearing loads and the operating temperature. Furthermore, for a given clearance, the losses are greatest in Stage 5 because of the greatest pressure drop across the leakage path. The average life of bushings and washers for Stage 5 is shown in Figure 4-59.

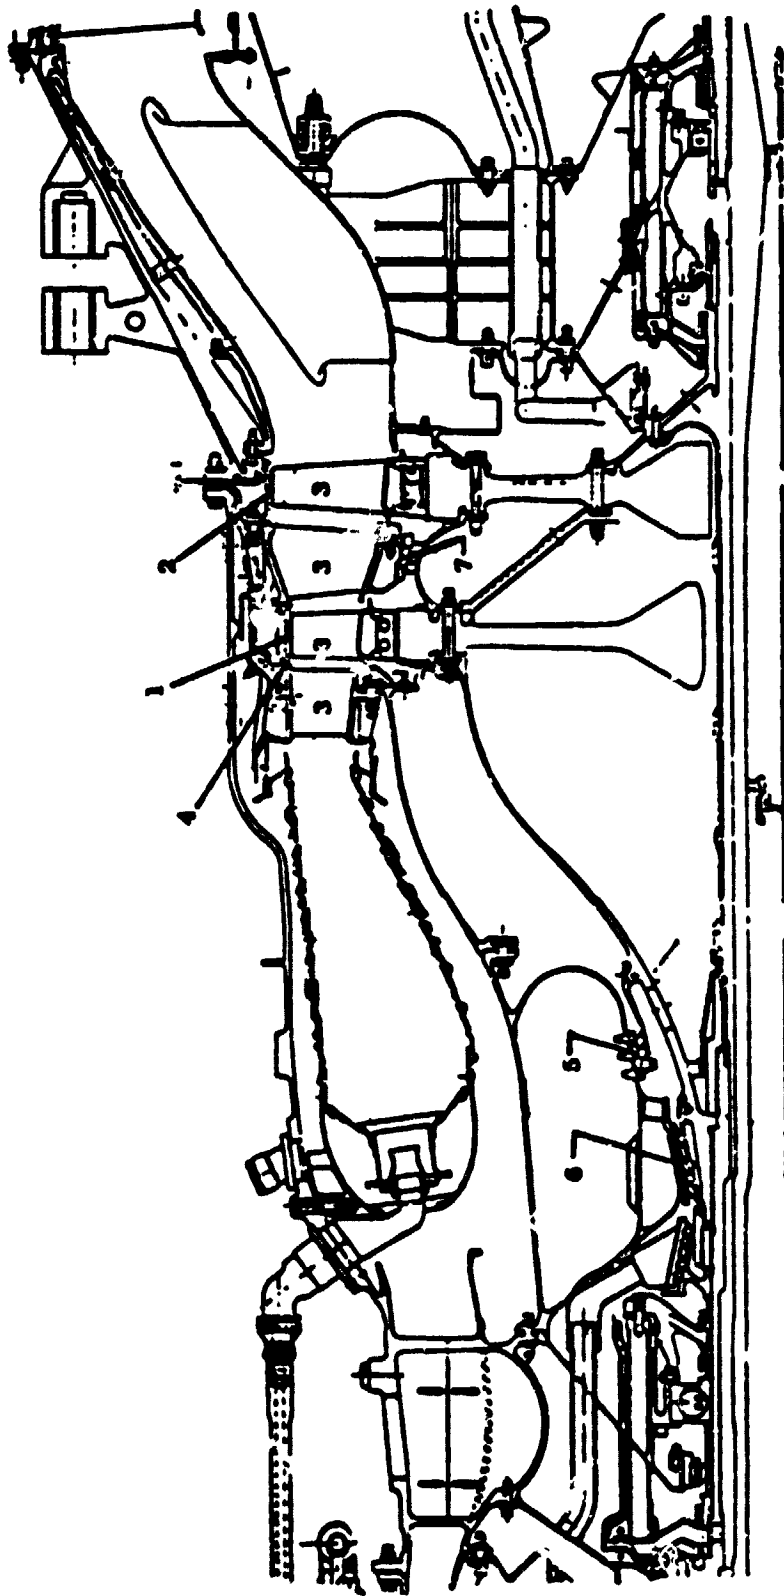
Figure 4-61. CF6-50 Deterioration Modes - HP Turbine Section.

High Pressure Turbine Section - The primary causes of high pressure turbine (HPT) deterioration are changes in blade tip-to-shroud clearance, airfoil surface finish, and internal leakage (parasitics). Figure 4-61 is a schematic indicating areas of interest.

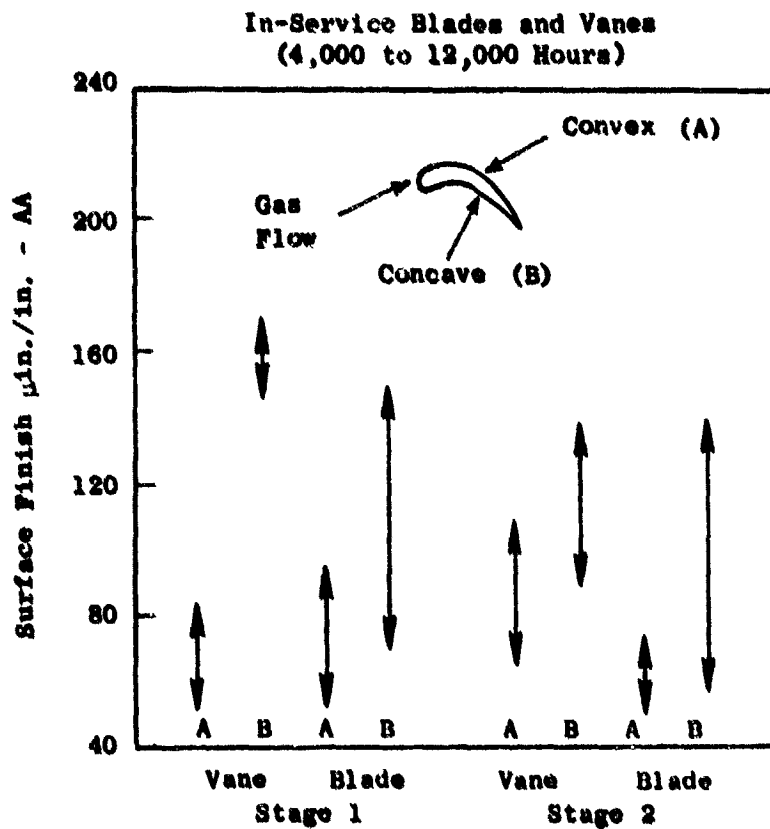
Figure 4-75. CF6-80 HPT Airfoil Surface Finish Range.

Surface finish measurements were obtained on parts with approximately 4,000 to 12,000 hours of accumulated service time. These data produced a considerable range in the surface roughness levels as shown in Figure 4-75. There was no correlation or trend of the data for surface finish with accumulated service time. The concave surface was consistently rougher; its performance effect, however, was minimal when compared with the convex surface since the same change in surface roughness produces only one-fifth the effect for the concave surface as it does for the convex (suction) side.

The Concave Surface is Consistently Rougher than the Convex Surface but has Less Effect on Turbine Efficiency.

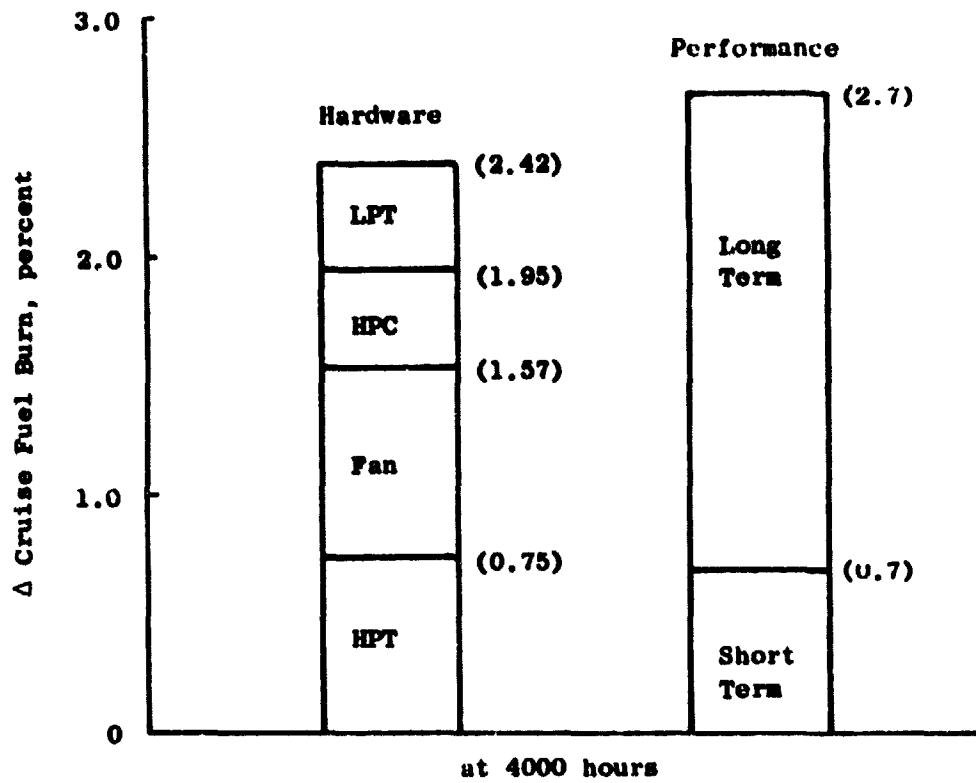
Figure 4-88. Initial Installation Engine at 4000 Hours.

A comparison of the cruise performance and hardware inspection results for the initial installation engine is presented in Figure 4-88. As shown, the comparison produced good agreement.

The comparative values of 2.42 percent in cruise fuel burn based on hardware inspection results, and 2.7 percent based on cruise performance results as shown in Figure 4-88 indicate these data are reasonable and, therefore, the hardware results were considered representative for the initial installation engine.

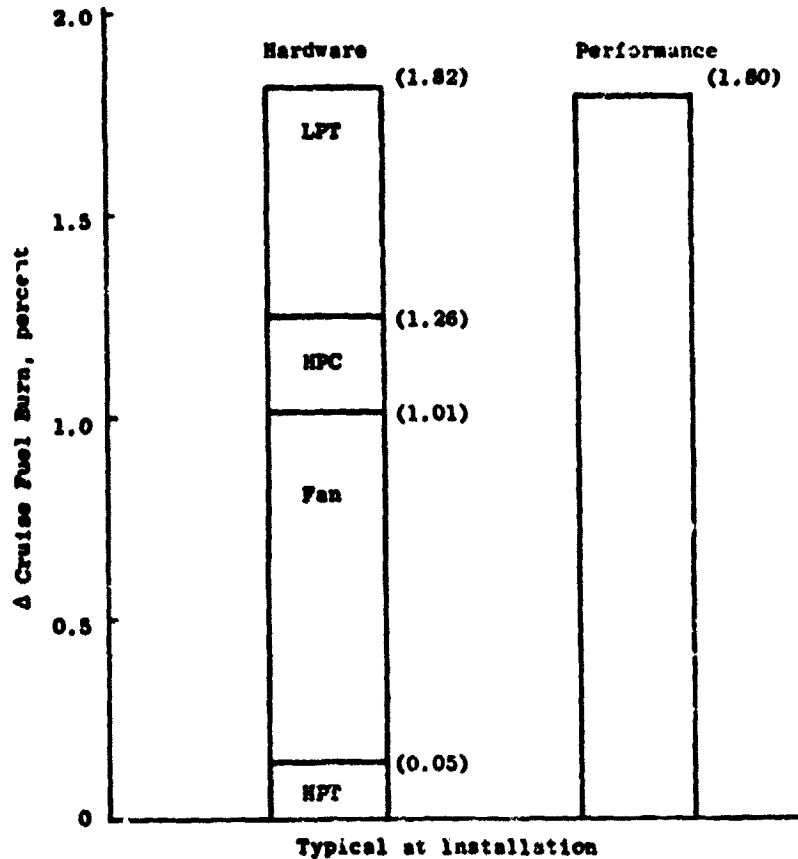
Figure 4-89. Unrestored Losses for Typical Engine.

The performance losses documented for the refurbished engine based on hardware inspection results noted in Section 4.0 were compared with the average test cell calibration run for the refurbished engine. These data are presented in Figure 4-89.

The good agreement between the fuel burn losses assessed from hardware inspection results for the refurbished engine and the corresponding performance levels measured during the engine recalibration in the test cell as shown in Figure 4-89 indicate that the hardware inspection data documenting the unrestored losses are realistic.

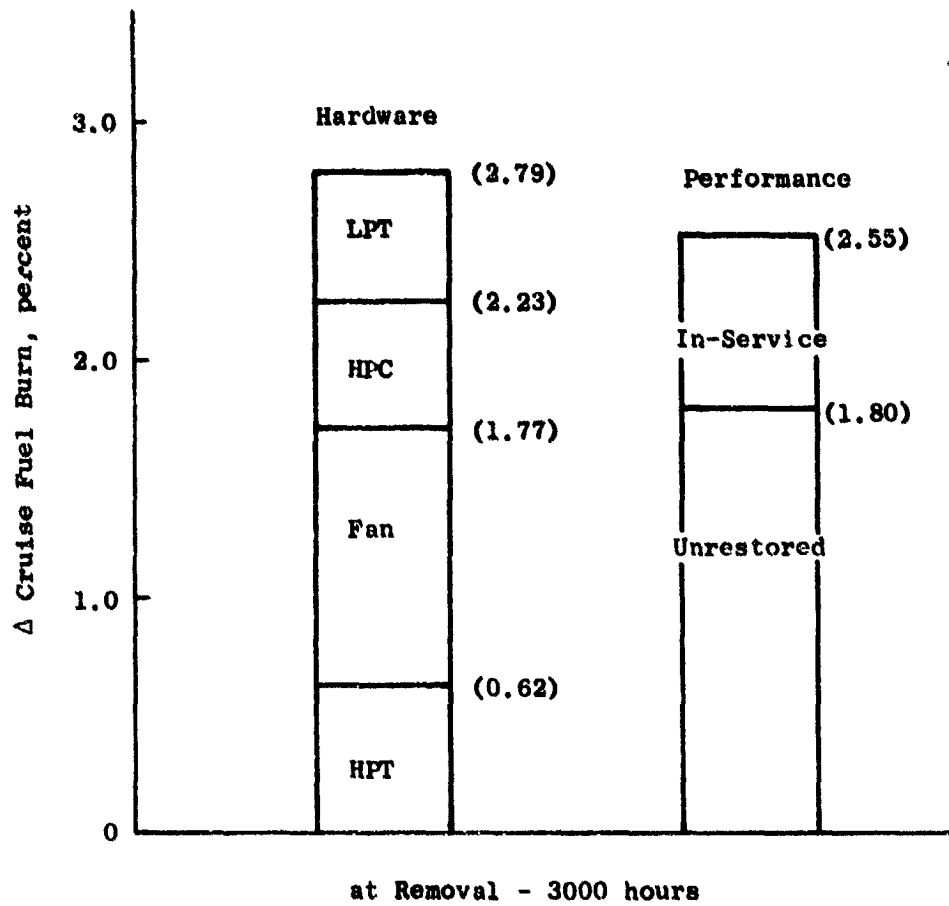
Figure 4-90. Multiple Build Engine at Removal.

The comparison of the performance deterioration assessed from measured performance data with that assessed from the hardware inspection results for the average multiple-build engine after 3,000 hours of operation is presented in Figure 4-90. This good agreement indicates the assumptions were realistic, and the data presented for the multiple-build engines are reasonable representations for the fleet. These data also tend to verify that the other comparisons are valid, since the construction of the multiple-build model is heavily dependent on the results presented for those models.
