CF6-6D ENGINE PERFORMANCE DETERIORATION

GENERAL ELECTRIC COMPANY
AIRCRAFT ENGINE GROUP
CINCINNATI, OHIO 45215

(NASA-CR-159786) CF6-6D ENGINE PERFORMANCE
DETERIORATION (General Electric Co.) 286 p
HC A13/MF A01 CSCL 21E

1. Report No. NASA CR159786		2. Government Accession No.		3. Recipient's Catalog No.	
4. Title and Subtitle CF6-6D Engine Performance Deterioration				5. Report Date January 1980

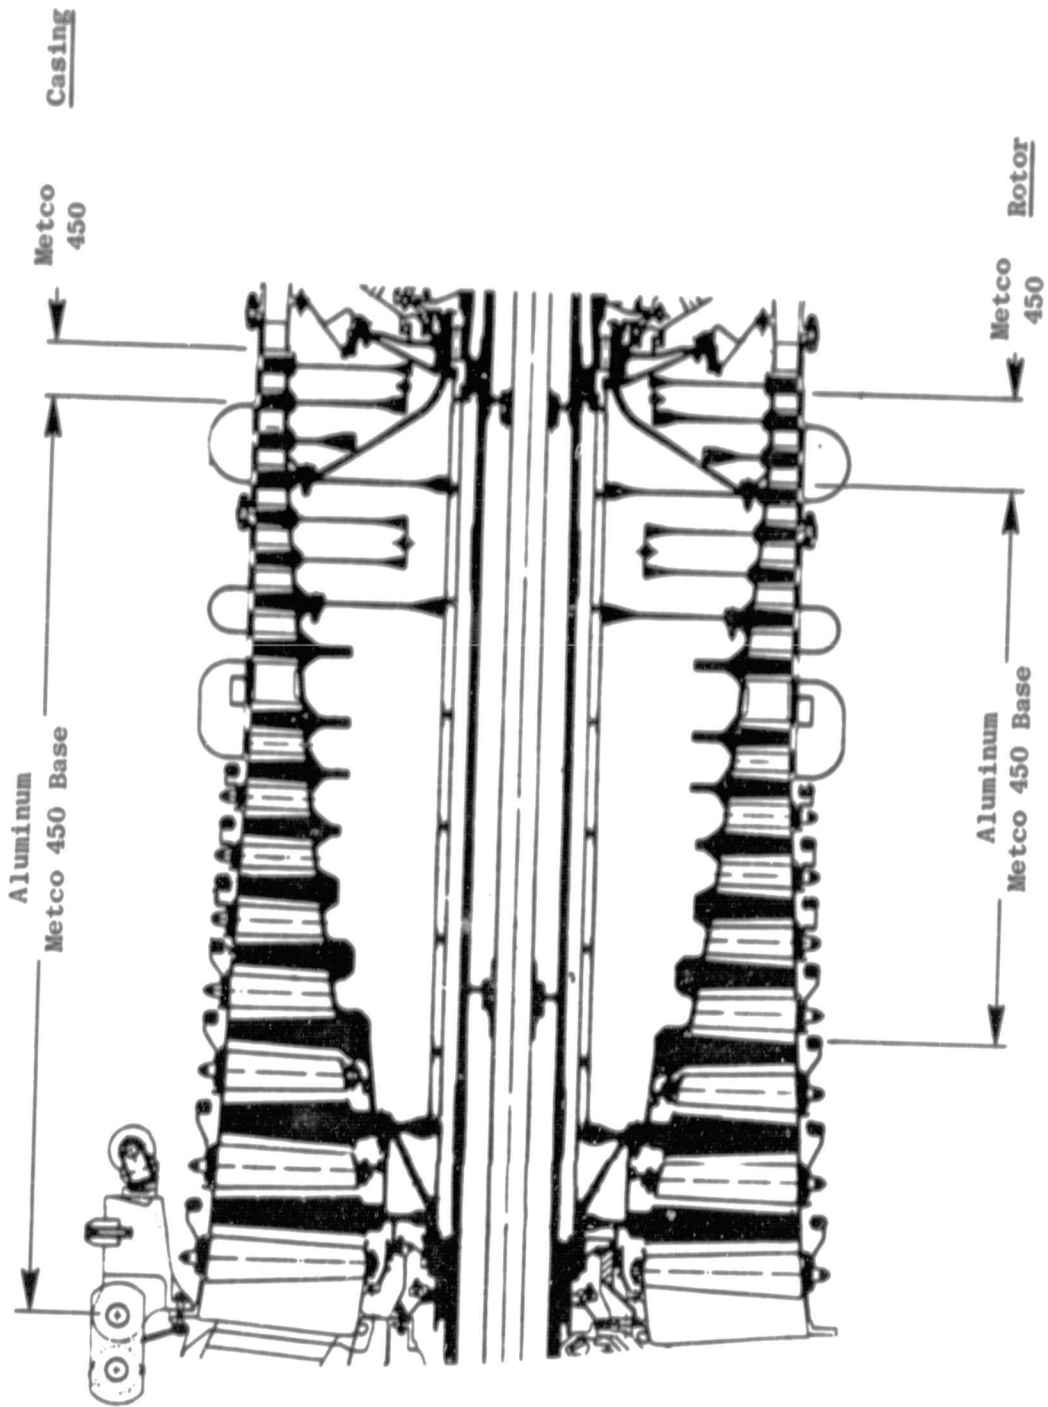
Figure 4-28. CF6-6 Flowpath Coatings - HP Compressor Section.

Flowpath Coatings used in the HPC are intended to provide protection from abrasion of the casing and rotor structure surfaces; to provide an abradable material which tolerates small local rubs without causing a major change in blade or vane length; and to minimize or prevent HPC mechanical damage. A coating, Metco 450 plasma spray, is used to provide abrasive protection for the casing and rotor structural members. This material also provides a bonding surface for an abradable aluminum spray coating used in the forward stages as shown in Figure 4-28. Initially, all stages of casing and rotor lands included the abradable aluminum spray coating. Revenue service experience indicated, however, that the aft stages of aluminum coating suffered degradation due to spalling. This condition occurs as a result of thermal cycling which causes the aluminum/Metco 450 bond coat interface to fail due to the differences in thermal expansion between the aluminum and structural surface. Since the loss of the aluminum coating produces clearance increases on the order of 0.015 inch and additional performance losses due to surface finish degradation, the aluminum coating was replaced with the Metco 450 coating for the aft stages as shown in Figure 4-28. No Metco coating has been lost in service by spalling. Since most field engines incorporate the Metco 450 coating for the aft stages, this configuration will be used for the long-term deterioration study.

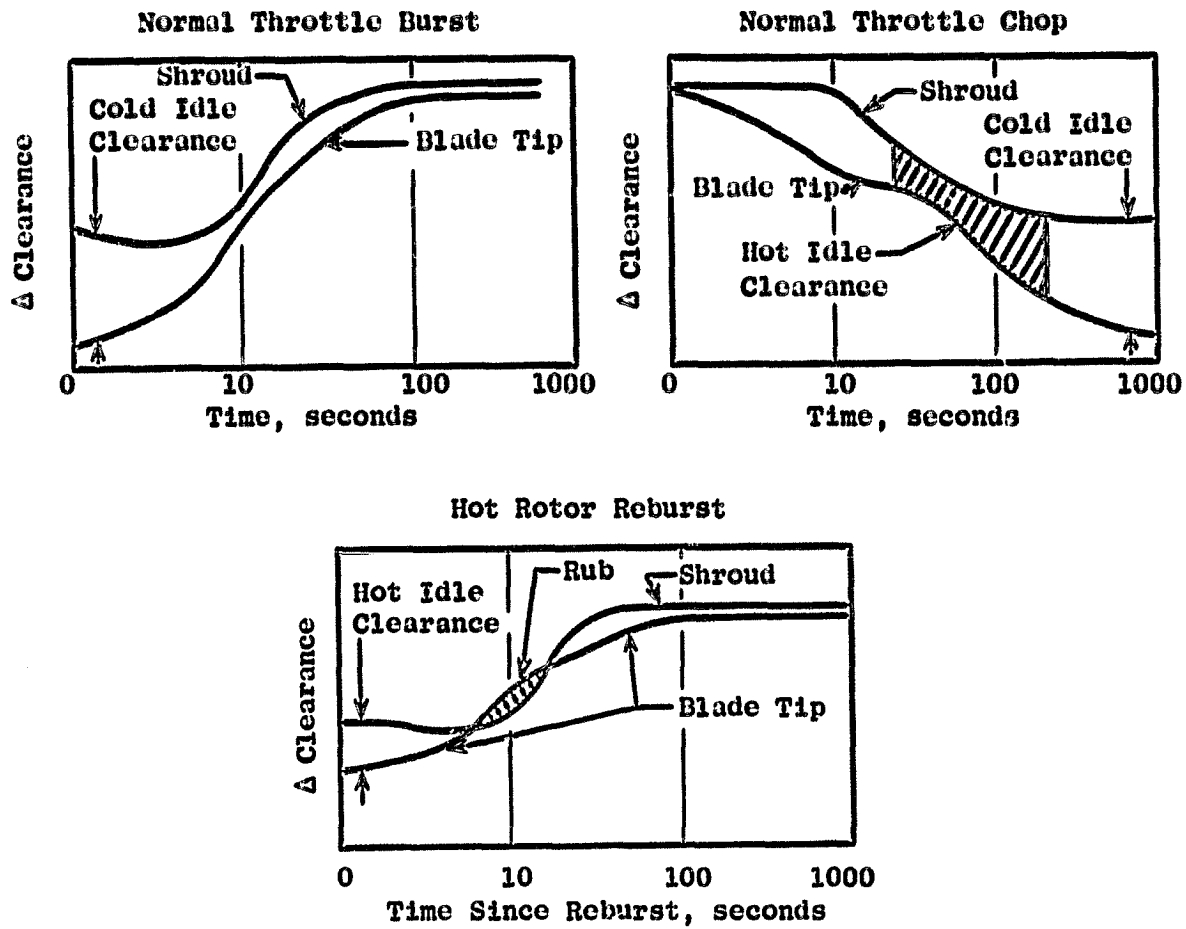
Figure 4-36. Hot Rotor Reburst Typical for Stage 1 HP Turbine.

Hot rotor rebursts can also result in tip rubs and increased blade tip-to-shroud clearances. Figure 4-36 depicts the thermal response of the Stage 1 blade tip clearance when the engine is rapidly accelerated from idle to takeoff, stabilized at takeoff, rapidly decelerated to idle, and then, after a certain period of time, once more rapidly accelerated to takeoff (hot rotor

reburst). These data indicated that while rubs would not be encountered during normal transients, the hot rotor reburst could result in rubs of 0.015 inch depth for Stage 1. It is believed that this, or a similar operational maneuver that produces thermal mismatch between the HPT rotor blade tips and shrouds, is the most likely cause of HPT blade tip rubs in revenue service operation. Revenue service data indicate that blade tip rubs occur randomly and infrequently during a given engine installation. This strongly suggests that HPT tip clearances are event-oriented.

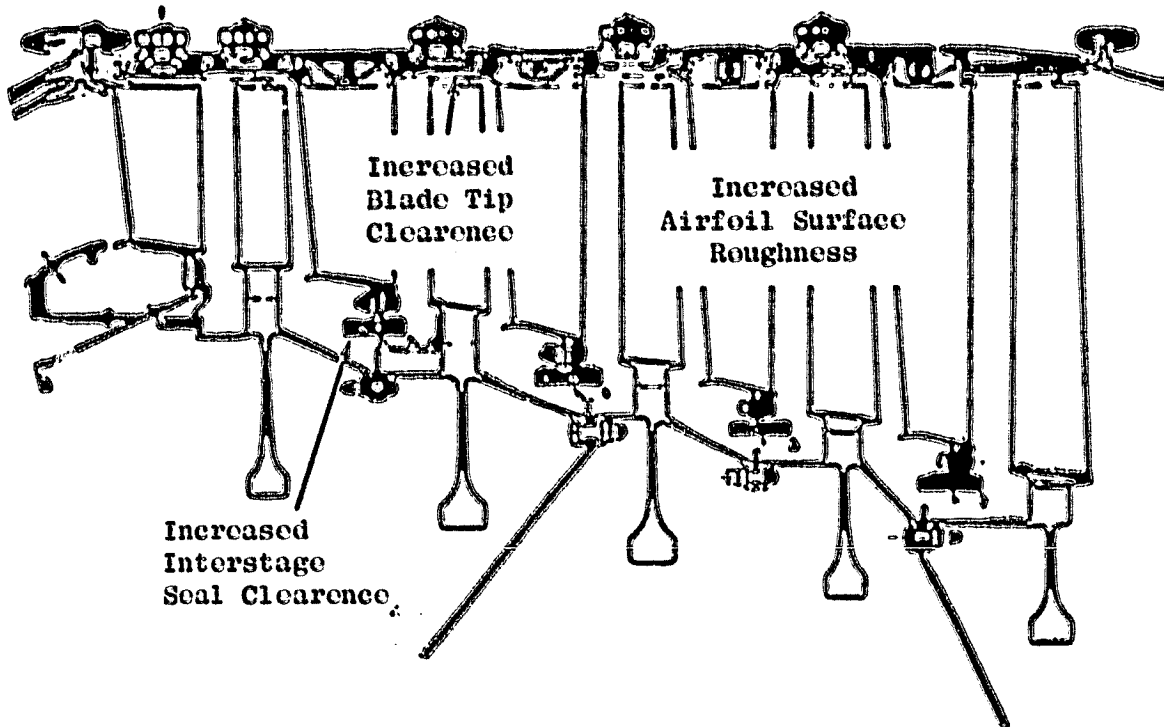
Figure 4-42. CF6-6 LP Turbine Section - Deterioration Modes.

Deterioration of low pressure turbine (LPT) components occurs primarily as a result of increased blade tip/shroud and interstage seal clearances, cracking of the LPT case rail cooling manifold, and increased airfoil surface roughness. These modes of deterioration are illustrated in Figure 4-42.

Another clearance-related deterioration mode is cracking of the LPT case hook cooling tubes. This condition can lead to additional cooling airflow in the cracked area and can also lead to circumferential starving of the flow downstream. These cooling air variations could result in increased operating clearance through hot flowpath gas inflow, loss of hook cooling, and increased thermal distortion. These deterioration modes also result in increased casing temperatures; therefore, it will not be apparent from an examination of honeycomb rub depths. No quantification of this deterioration mechanism will be attempted since it appears to be a random phenomenon and not typical of average CF6-6D LP turbine deterioration. This condition, however, may contribute to differences in deterioration rates for individual modules.

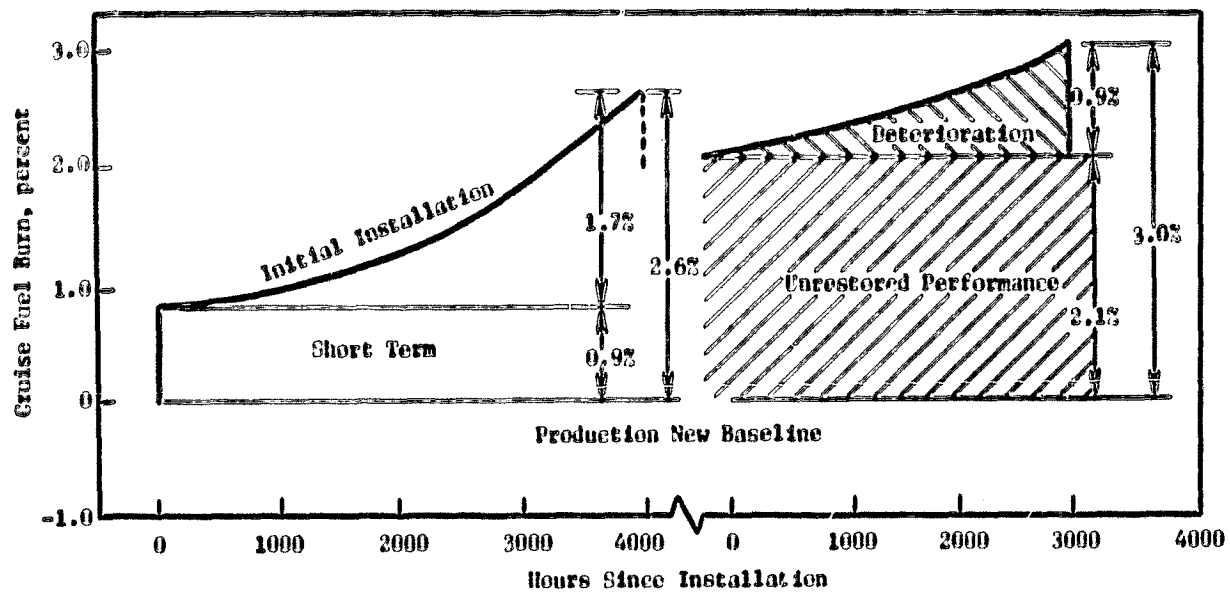
Figure 4-53. Performance Deterioration Model.

Figure 4-53 presents the "Performance Deterioration Model" which describes the magnitude of fuel burn and the rate at which these losses occur with accumulated time. Only performance data is used to construct this model since the necessary hardware data required to describe the curve shape from installation to removal was not available. Sufficient performance data was not available to specifically determine the amount of performance gained for initial installation engines following refurbishment, and is therefore, represented by a dotted line in the schematic.

The deterioration curve shape shown in this model differs from that generally presented to represent airline fleets. The inverted shape of the curve is the result of selectively averaging only a part of the fleet data, to produce a curve that averages individual engines for a very narrow band of engine hours; i.e., 4000 \pm 450 hours for the initial-installation engine and 3000 \pm 250 hours for the multiple-build engine. While the individual engines in the time families from 2000 to 5000 hours all show the same characteristics, the airline fleet average - which includes infant mortality failures as well as long-time removals - produces the classical curve shape where the rate of deterioration decreases with accumulated time. This is shown in the sketch as follows:

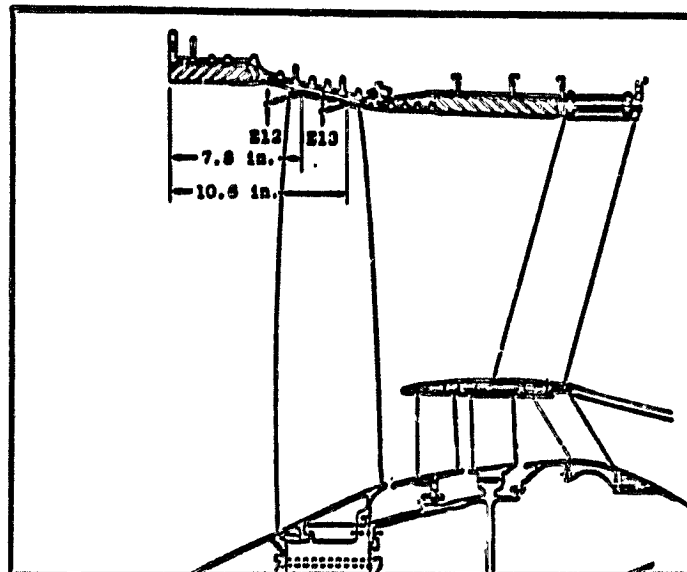
Figure A-1. Locations of Stage 1 Fan Blade Tip Clearance Tip Clearance Measurements.

Fan blade tip clearance changes and their effect on performance are discussed in the portion of Section 4.2.1 entitled "Fan Section".

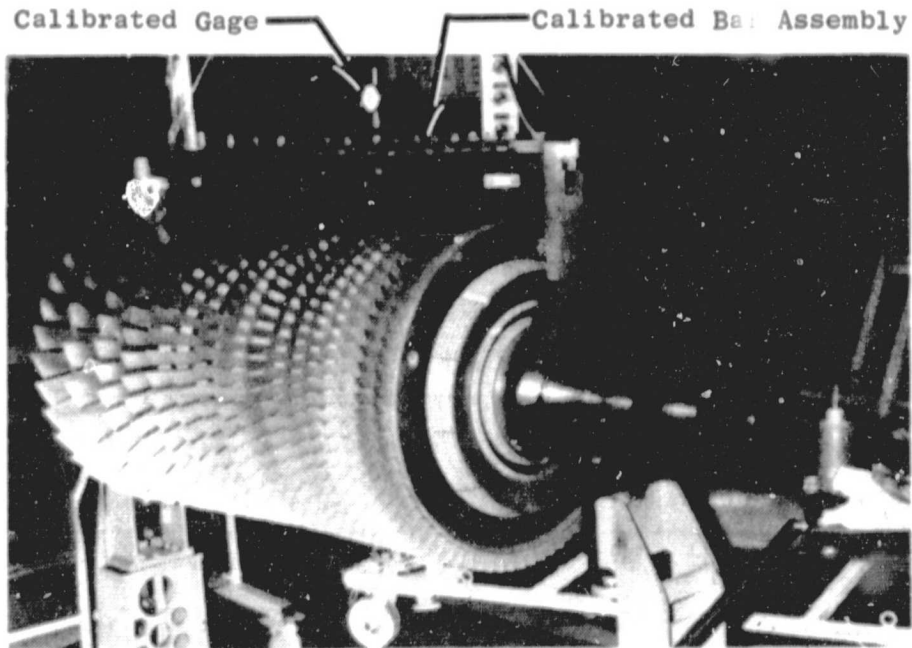
Figure A-2. HP Compressor Rotor in Measuring Fixture.

Table A-II summarizes the accumulated HPCR blade tip radii data. Tables A-IIa through A-IIf present the data taken manually on a "runout" fixture utilizing a calibrated bar assembly set up on the forward and aft shaft straddling the rotor blades as shown in Figure A-2. A calibrated gage is used to measure the distance from the bar to the blade tip. A laser beam Electronic Read Out Machine (EROM) was used to acquire the data presented in Tables A-IIg through A-IIk. Table A-III is a tabulation of the average measurements for each stage for all HPC's inspected. Blade tip clearance and its effect on performance are discussed in the portion of Section 4.2.1 entitled "High Pressure Compressor Section".

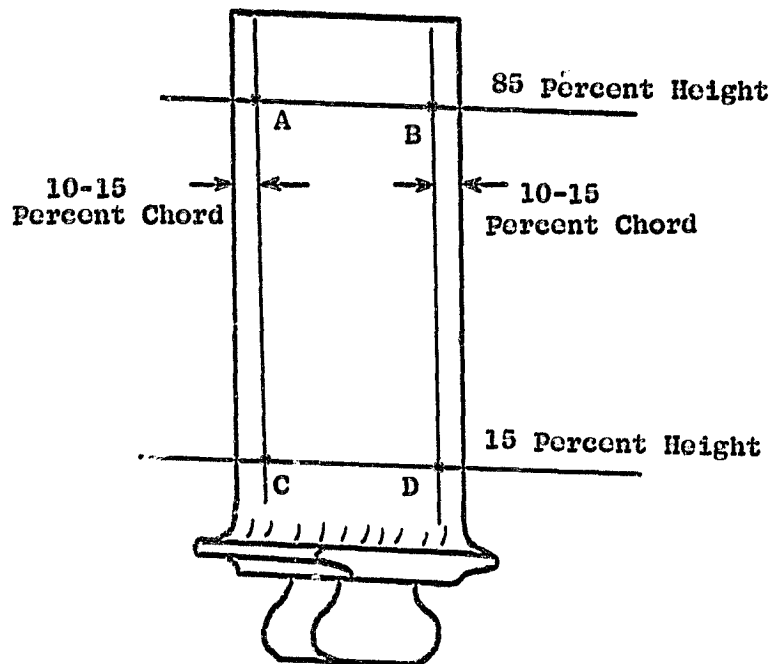
Figure A-4. Location of Surface Finish Measurements - HP Compressor Rotor Blade.

Measurements were taken at 10/15 percent chord distance from the leading and trailing edges at both 15 and 85 percent span position for both the convex and concave surfaces, for a total of eight measurements per blade. (See Figure A-4.) Any usual change in surface condition for the concave (pressure) side is known to have minimal effect on performance; therefore, only changes in the surface quality of the convex (suction) side were considered in assessing performance deterioration.

ESN	TSO	CSO	CONVEX	CONCAVE
451-507(1)	15	28	14	18
451-492	801	259	17	23
451-245	1766	1602	23	22
451-479(2)	4468	1910	26	40
451-380(2)	4595	1270	40	49
451-365	5200	1928	27	28
451-623	6051	2460	25	31
451-390	6085	2605	22	36
451-155	6641	2960	21	30
451-250	6752	2348	22	34
451-116	7648	3288	23	33
451-156	7658	2978	27	34
451-443	9000	2770	28	33
The specification for new blade airfoils is 14-16 μ inch per inch AA.				
(1) Task III Engine (2) Task IV Engine

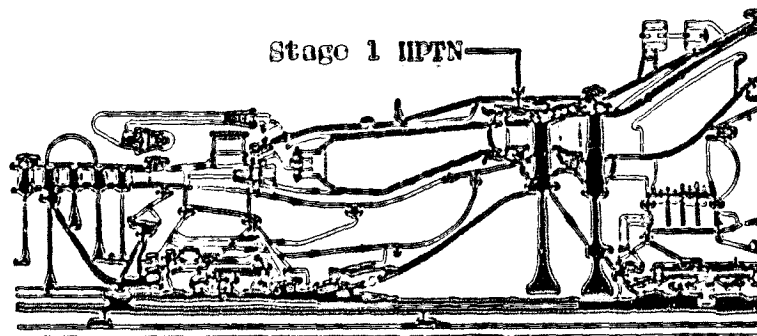
Figure A-9. High Pressure Turbine Nozzle.

The spaces between the outer platforms on adjacent Stage 1 vane segments were measured at 16 places (every other segment) at the vane aft end for both inbound and outbound engines (see Figure A-9). The average gap of all assemblies inspected is presented in Table A-IX.

Because of the potential for thermal expansion problems at engine operating conditions, a minimum gap of 0.015 inch (cold measurement) is required in order to reduce the possibility of vane outer band distortion and resultant performance loss due to cooling air leakage into the flowpath. Internal leakage (parasitics) and its effect on performance are discussed in the portion of Section 4.2.1 called "High Pressure Turbine (HPT) Section".

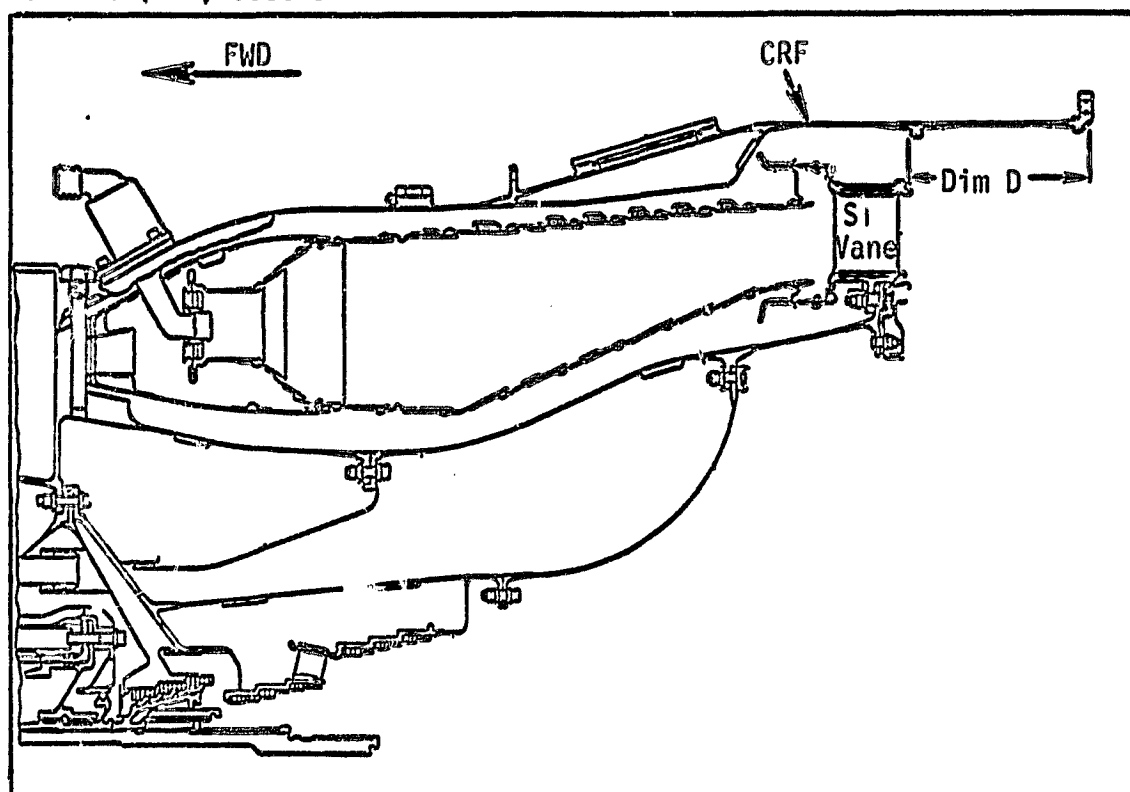
Figure A-10. Dim. "D" - Drop from CRF to S1 HP Turbine Nozzle Vane.

The dimension (Dim "D") minus Dim "K" (defined in Section A.3.4, "Stage 2 HPTN Support") plus 0.020 inch (size of shim installed between the Stage 2 HPTN support forward flange and the CRF aft flange) stacks up the clearance between the forward face of the Stage 2 HPTN support and the aft face of the Stage 1 vane outer hook. The accumulated data show an actual average gap of 0.024 inch. The maximum permitted gap is 0.042 inch, and the minimum is an interference fit of 0.012 inch.

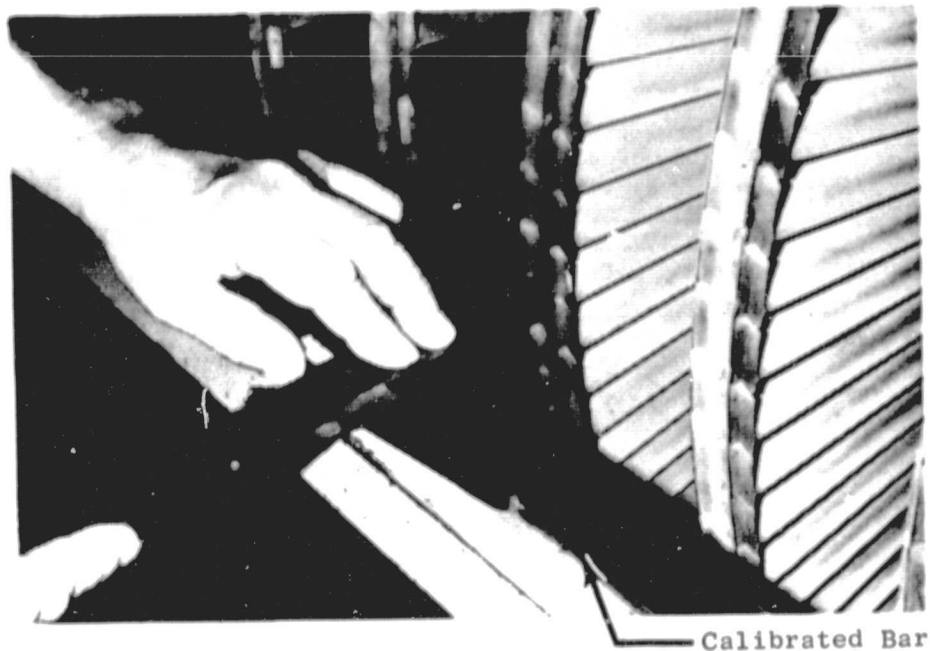
Figure A-23. Setup for LP Turbine Rotor Radii Measurements.

Additional data accumulated are summarized in Table A-XXXV. Measurements of these rotors were obtained using both a Pi tape and a runout fixture similar to the fixture described above.

Low pressure turbine clearances and their effect on efficiency are discussed in the portion of Section 4.2.1 entitled "Low Pressure Turbine (LPT) Section".

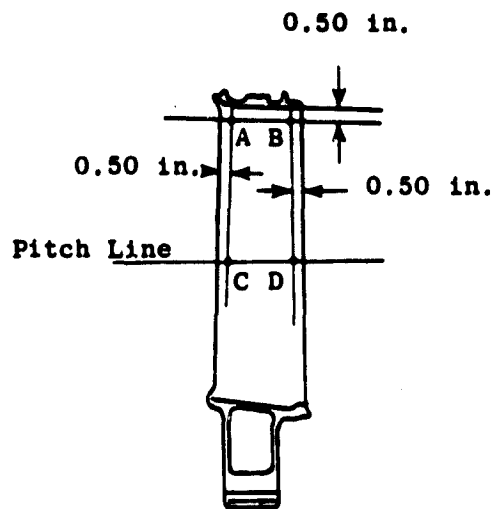
Figure A-24. Location of Surface Finish Measurements on LPT Blades (and Vanes).

A Bendix profilometer was used to measure the airfoil surface finish of several blades and vanes per stage for each of several low pressure turbine (LPT) modules. Measurements were made at approximately 0.5 inch from both the leading and trailing edges at the pitch line and 0.5 inch radially inward from the outer platform on both the convex and concave surfaces of the airfoils (see Figure A-24). However, an assessment of deterioration is made using the suction-side data only, since surface finish roughness on the pressure side is known to have minimal effect on performance. A summary of the data is presented in Table A-XXXV.

LPT airfoil surface finish and its significance are discussed in the portion of Section 4.2.1 entitled "Low Pressure Turbine (LPT) Section".

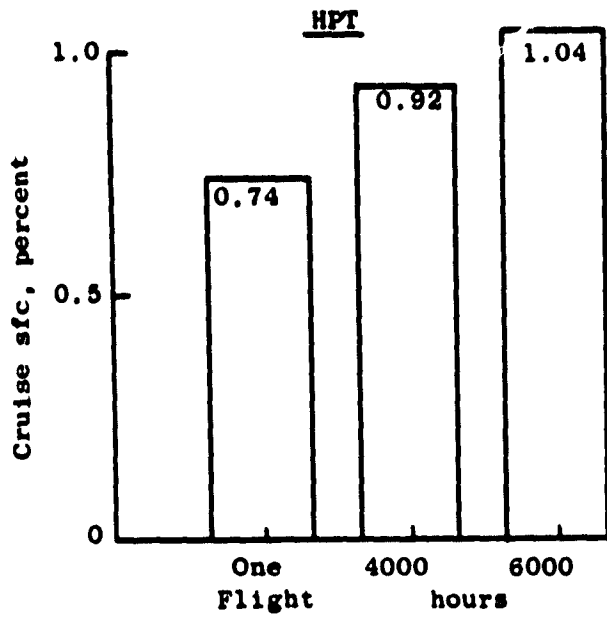
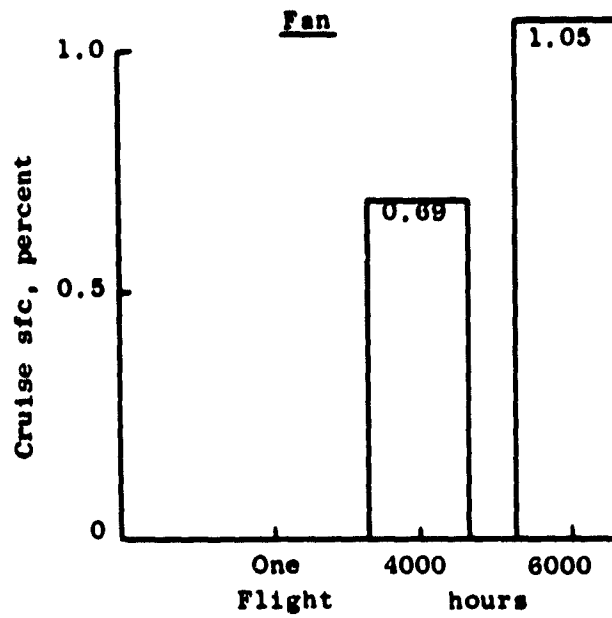
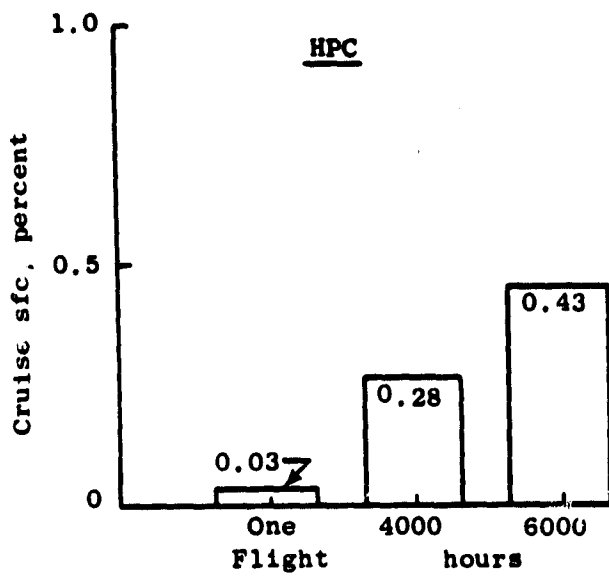
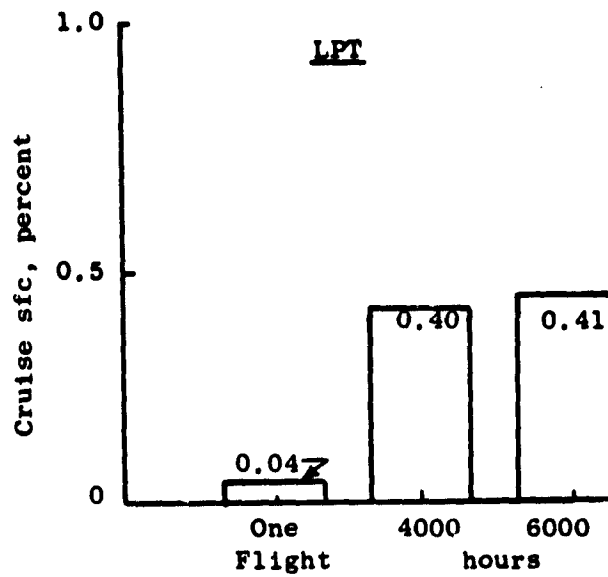
Figure E-2. No-Repair Models - By Component.

As presented, the additional performance deterioration estimated for the period between 4000 and 6000 hours is 0.64 percent cruise fuel burn. This does not include the probable effects from losses associated with loss of mechanical integrity. The data presented in Figures E-2 and E-3 do confirm previous assessments as follows. The clearance effect (Figure E-3) generally occur during the initial 4000 hours, but the surface finish effects continue at about the same rate through 6000 hours. The data presented in Figure E-2 show the additional losses in both turbines to be small beyond 4000 hours, while the fan and HP compressor losses continue at the same rate through 6000 hours. This is as expected since clearance changes dominate the turbine distress, while erosion and loss of airfoil surface finish are the major deterioration modes for the fan and HP compressor modules.

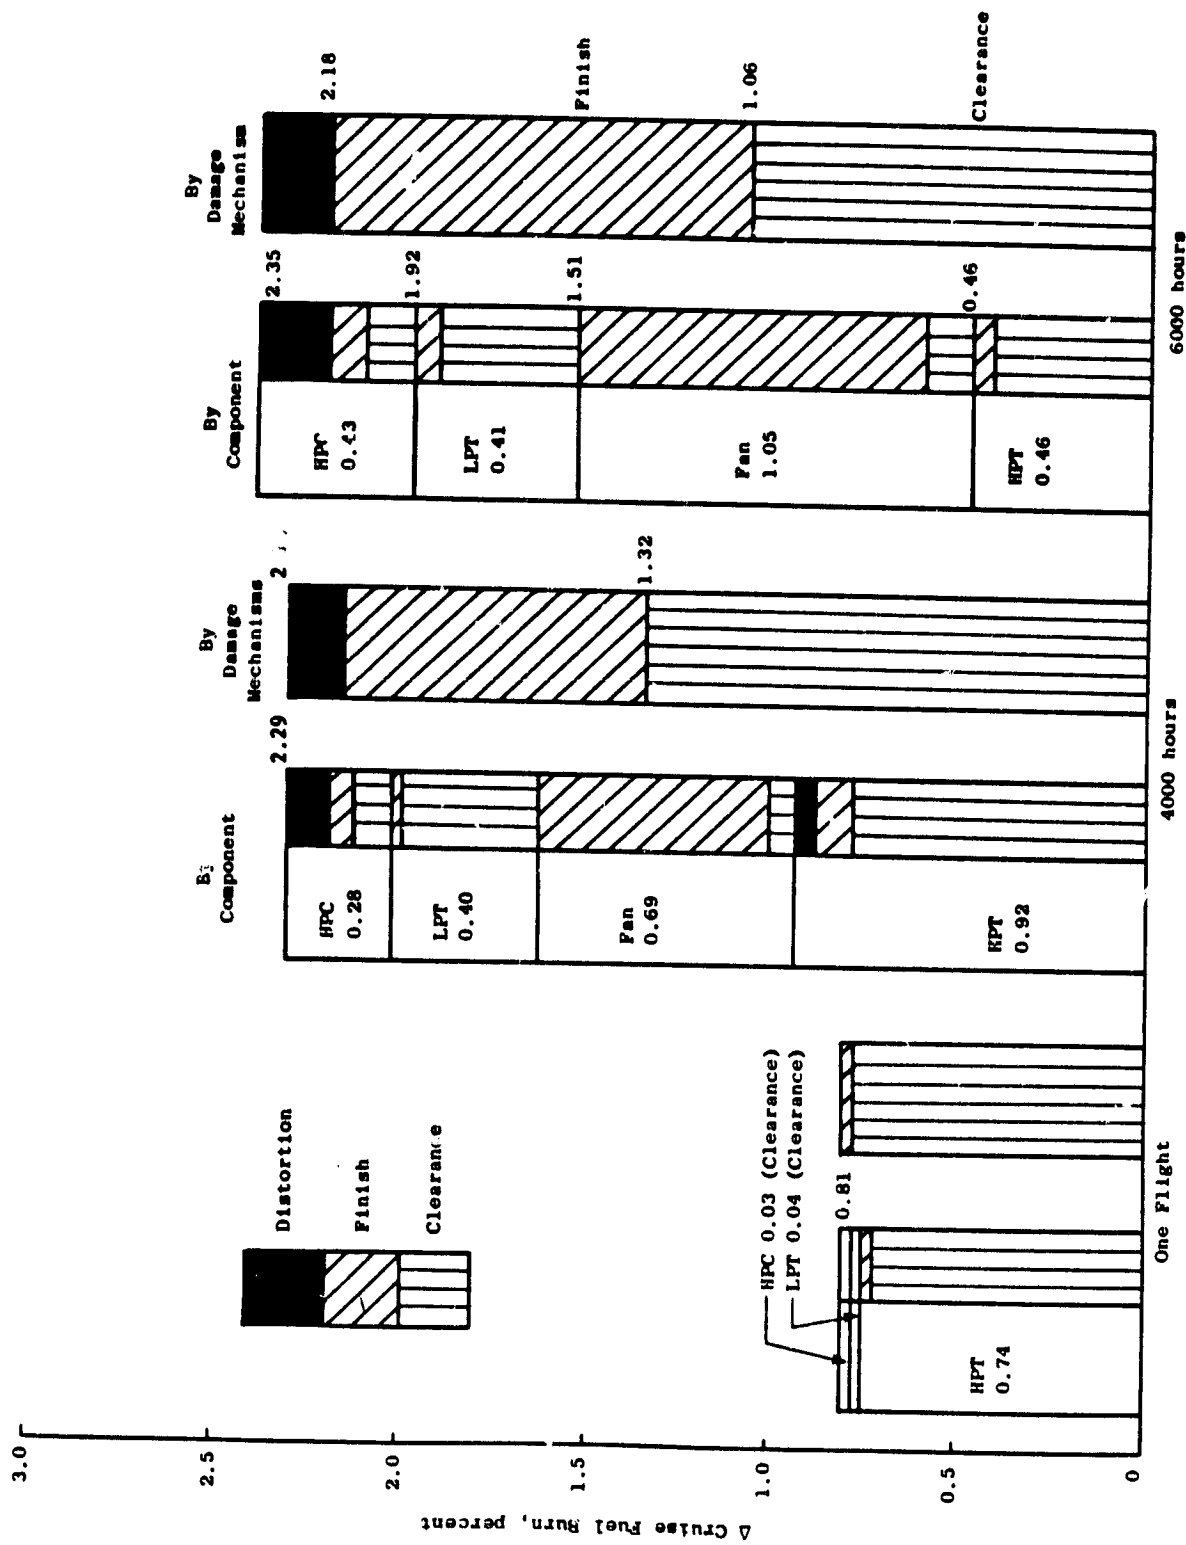
Figure E-4. 6000 Hours With-Repair Model (Composite).

The "6000 Hours With-Repair Model" is shown in Figure E-4 and the assessment by module and damage mechanism is shown separately in Figures E-5 and E-6. These figures also include the deterioration levels without repair after one flight and after 4000 hours for comparison. Note that the total loss at 6000 hours (with repairs after 4000 hours) is very nearly the same as the total loss after 4000 hours prior to repairs. This agrees with an observation noted for the multiple build engines (reference Section 4.1) in that the on-wing loss after shop repairs is the same as that refurbished during the previous shop visit. Since the HPT module is the major source for the on-wing deterioration of a multiple-build engine, and the HPT module was the only modules repaired in this theoretical 6000 hour model, this agreement is not surprising.
