CF6-6D ENGINE SHORT-TERM PERFORMANCE DETERIORATION

W.H. Kramer, J.E. Paas,
J.J. Smith, and R.H. Wulf

GENERAL ELECTRIC COMPANY
AIRCRAFT ENGINE GROUP
CINCINNATI, OHIO 45215

NASA Lewis Research Center
Contract NAS3-20631

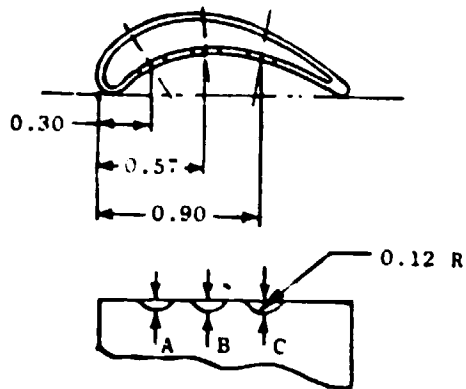
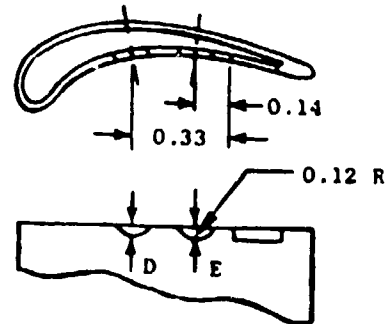
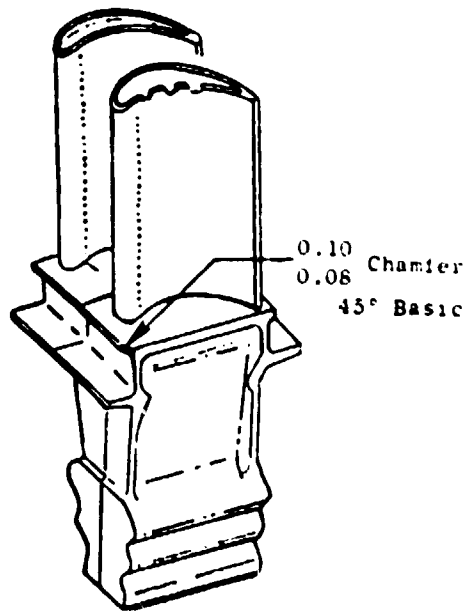
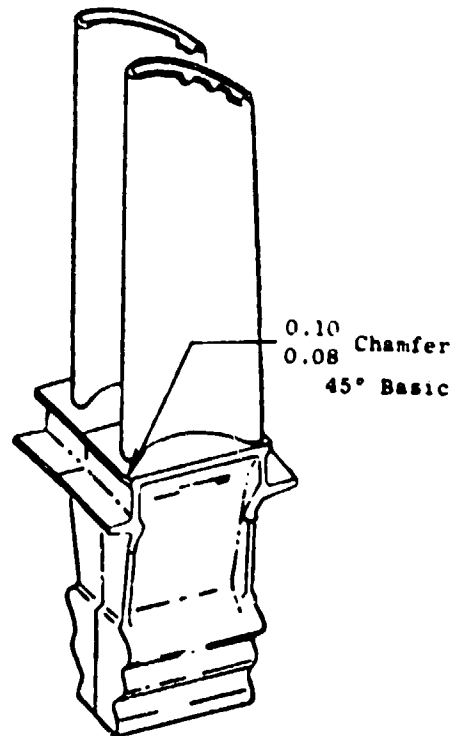
Figure A-1. Notched HF Turbine Blades.

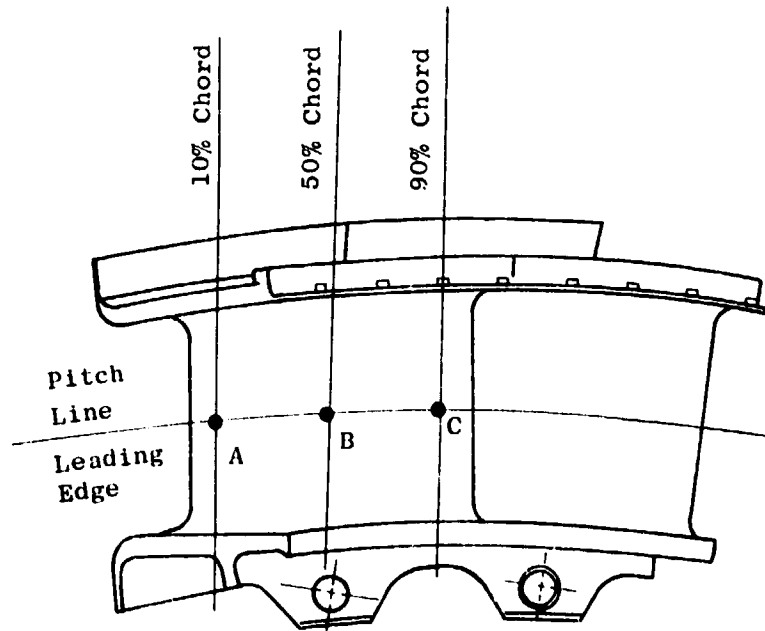
Six nozzles were removed from the Stage 1 high pressure turbine nozzle assembly to have their airfoil surface finishes inspected. Measurements were taken at the pitch line at 10, 50, and 90 percent chord on both the convex and concave surfaces (see Figure B-13). The results, as presented in Table B-XVII, show a small increase over the Shop Manual maximum limits of 39 μ inch for the convex (suction) side and 150 μ inch for the concave (pressure) side.

Figure B-13. HP Turbine Stage 1 Vane.

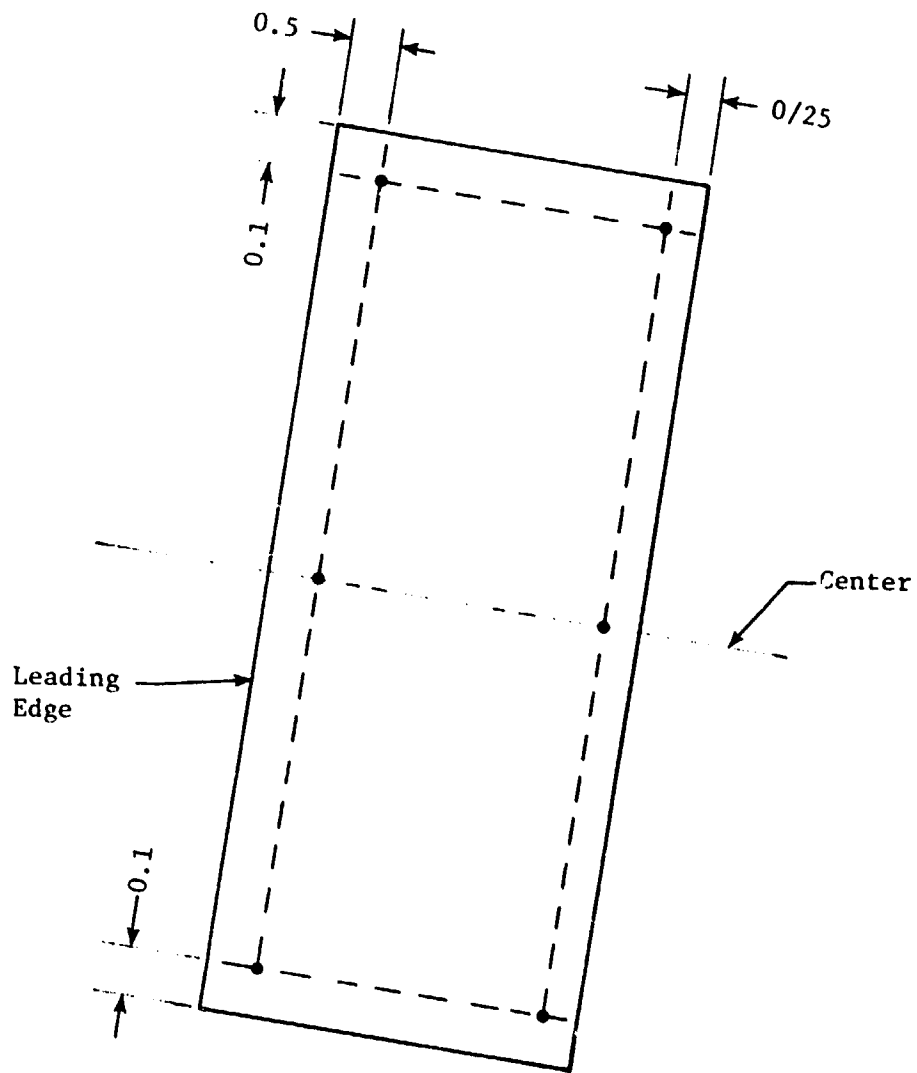
An additional measurement of the Stage 2 shrouds was made at approximately 0.100 inches from the leading edge, which was outside the blade path and, consequently, the rubbed areas. The results are presented in Table B-XXIII. As can be seen, at this axial location there was up to 0.017 inch inward creep of the shroud ends.

Figure B-17. Typical Stage 1/Stage 2 Shroud Measurement Locations.

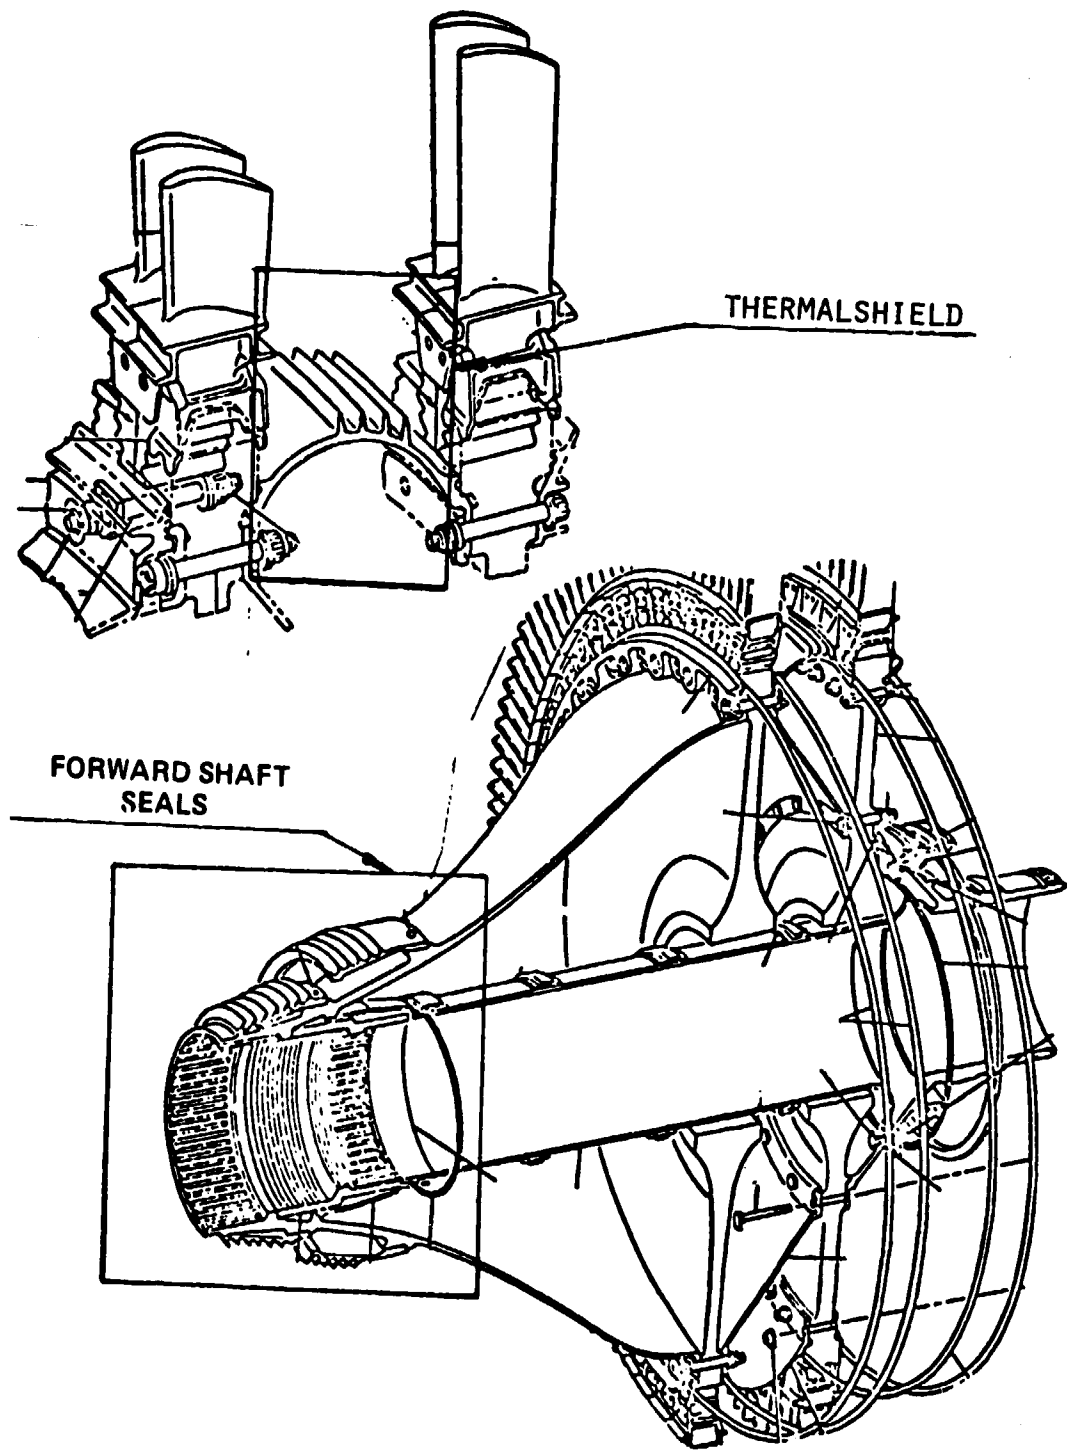
Figure B-27. HP Turbine Rotor Forward Shaft Seals and Thermal Shield.

Measurements of the HP turbine rotor forward shaft seal teeth, also shown in Figure B-27, were made in the same manner as those that were made for the thermal shield teeth; that is, a diameter and 12 equally spaced runouts. Tables B-XXIX and B-XXX show the results. Clearances between these and the stationary seals were presented in Tables B-XII and B-XIII and discussed in Section B.2.3.
