NASA Technical Memorandum 81421

ENDURANCE AND FAILURE
 CHARACTERISTICS OF MODIFIED
 VASCO X-2, CBS 600 AND
 AISI 9310 SPUR GEARS

Dennis P. Townsend and E. V. Zaretsky
 Lewis Research Center
 Cleveland, Ohio

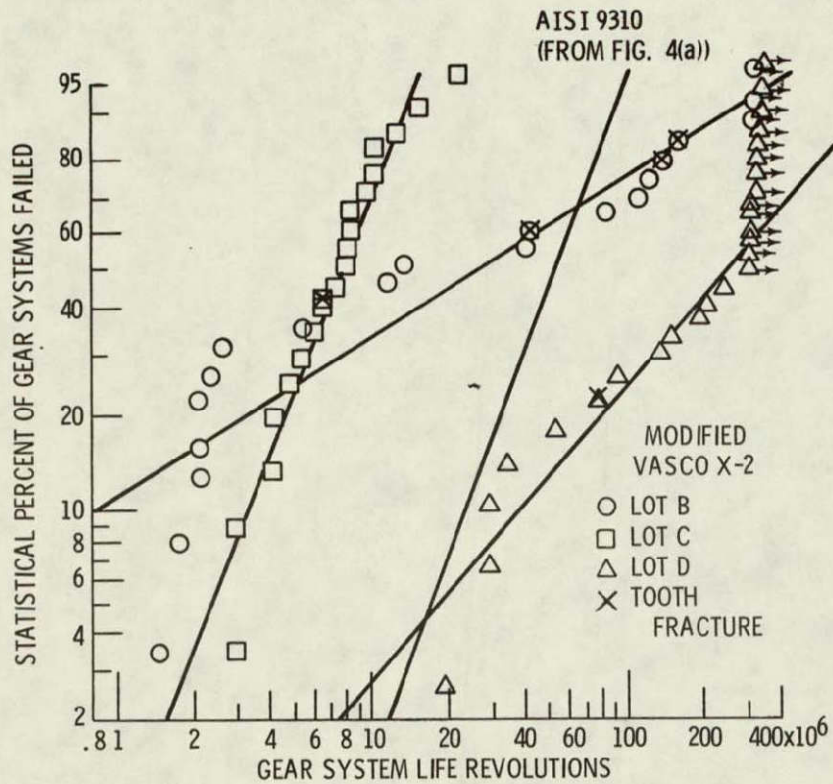
The pitting fatigue life results for the three lots of gears made from the modified Vasco X-2 are shown in Fig. 11. A statistical comparison was made between the gear tooth pitting fatigue life of the three lots of modified Vasco X-2 gears and the CVM AISI 9310 and is summarized in Table 6. The difference between the pitting fatigue life of the AISI 9310 gears and modified Vasco X-2 lot D having the Boeing Vertol heat treatment gears is statistically insignificant with a confidence number of 80 percent. Lots B and C having the NASA and Curtis-Wright heat treatments, respectively, had statistically lower lives than the AISI 9310 gears. In addition, lot B had fracture failures of several of the gears concurrent with the pitting fatigue failure. A representative fracture failure is shown in Fig. 12.

Figure 11. - Surface pitting fatigue lives of CVM modified VASCO X-2 spur gears heat treated to different specifications. Pitch diameter, 8.89 cm (3.5 in.); speed, 10 000 rpm; lubricant synthetic paraffinic oil; maximum Hertz stress, 1.71×10^9 N/m² (248 000 psi).

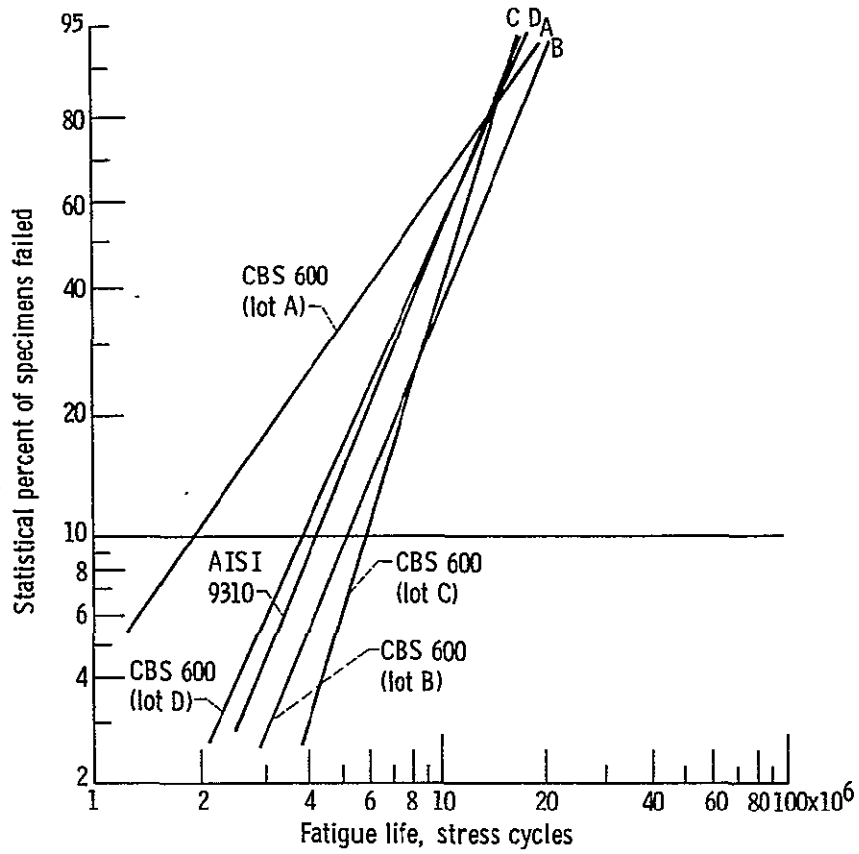
Rolling-element fatigue. - Test bars of one lot of CVM modified Vasco X-2, CVM AISI 9310 and four lots of CBS 600 were tested in the rolling-contact (RC) fatigue tester. The CBS 600 comprised one lot of air-melted material and three lots of consumable-electrode melted (CVM) material. Each lot had a separate heat treatment. The bars were tested at a maximum Hertz stress of 4.8×10^9 N/m² (700 000 psi) and a bar speed of 12 500 rpm. The tests were run at ambient temperature (no external heat source) with a MIL-L-7808 lubricant. The results of these tests are shown in the Weibull plots of Fig. 14 and are summarized in

Figure 14. - Summary of rolling-element fatigue life data with CBS 600 and CVM AISI 9310 in rolling-contact fatigue tested (data from [7]).
