NASA Technical Paper 1481

# Light Airplane Crash Tests at Three Pitch Angles

Victor L. Vaughan, Jr., and Emilio Alfaro-Bou

NOVEMBER 1979

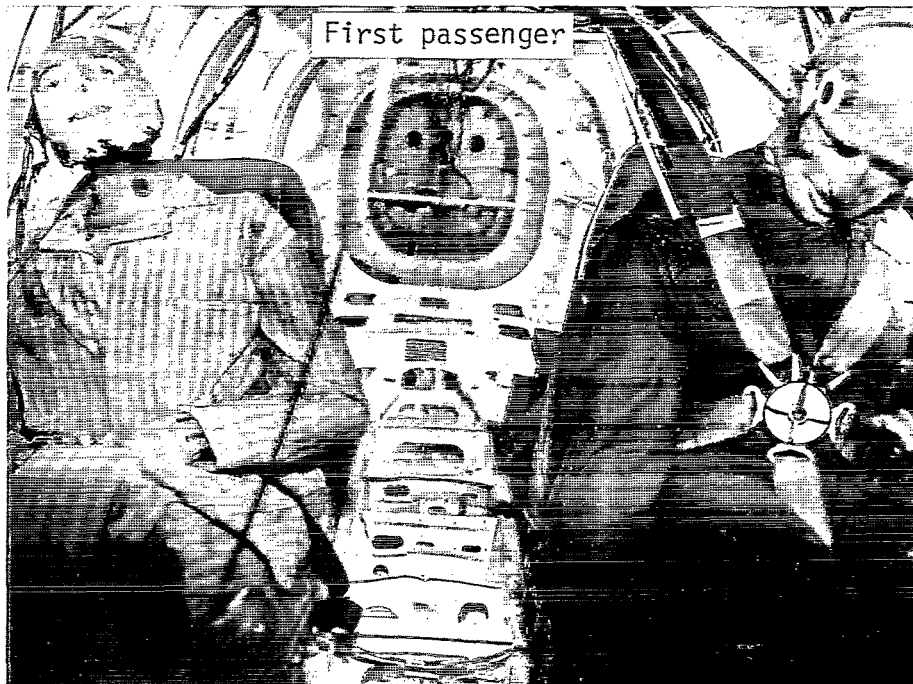
I-74-2638.1

(b) View looking aft.

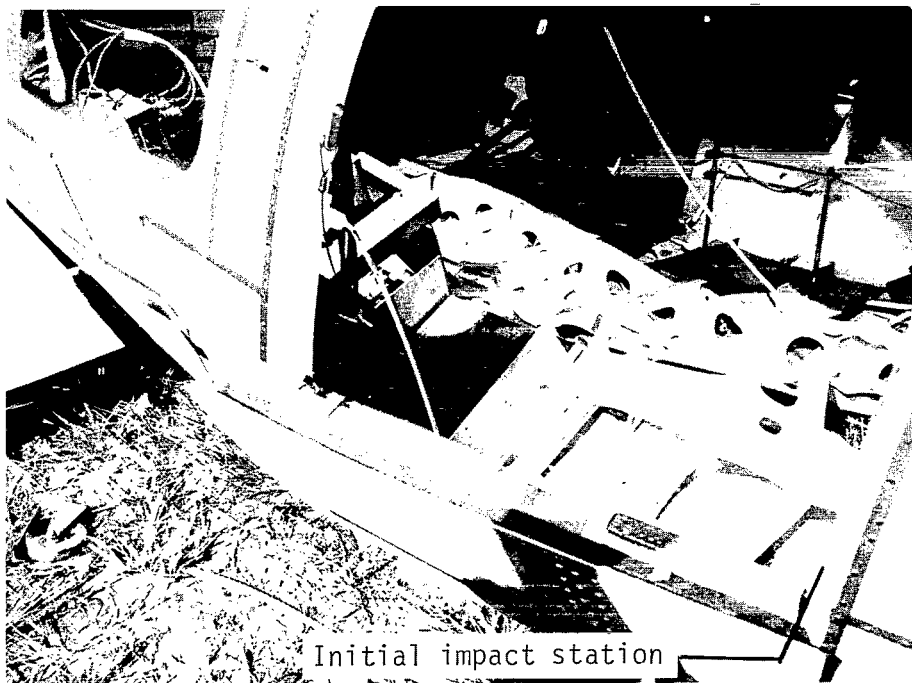
L-74-8079.1

(b) View looking at floor through fuselage door.

Figure 17.- Postcrash interior damage to flat test specimen.

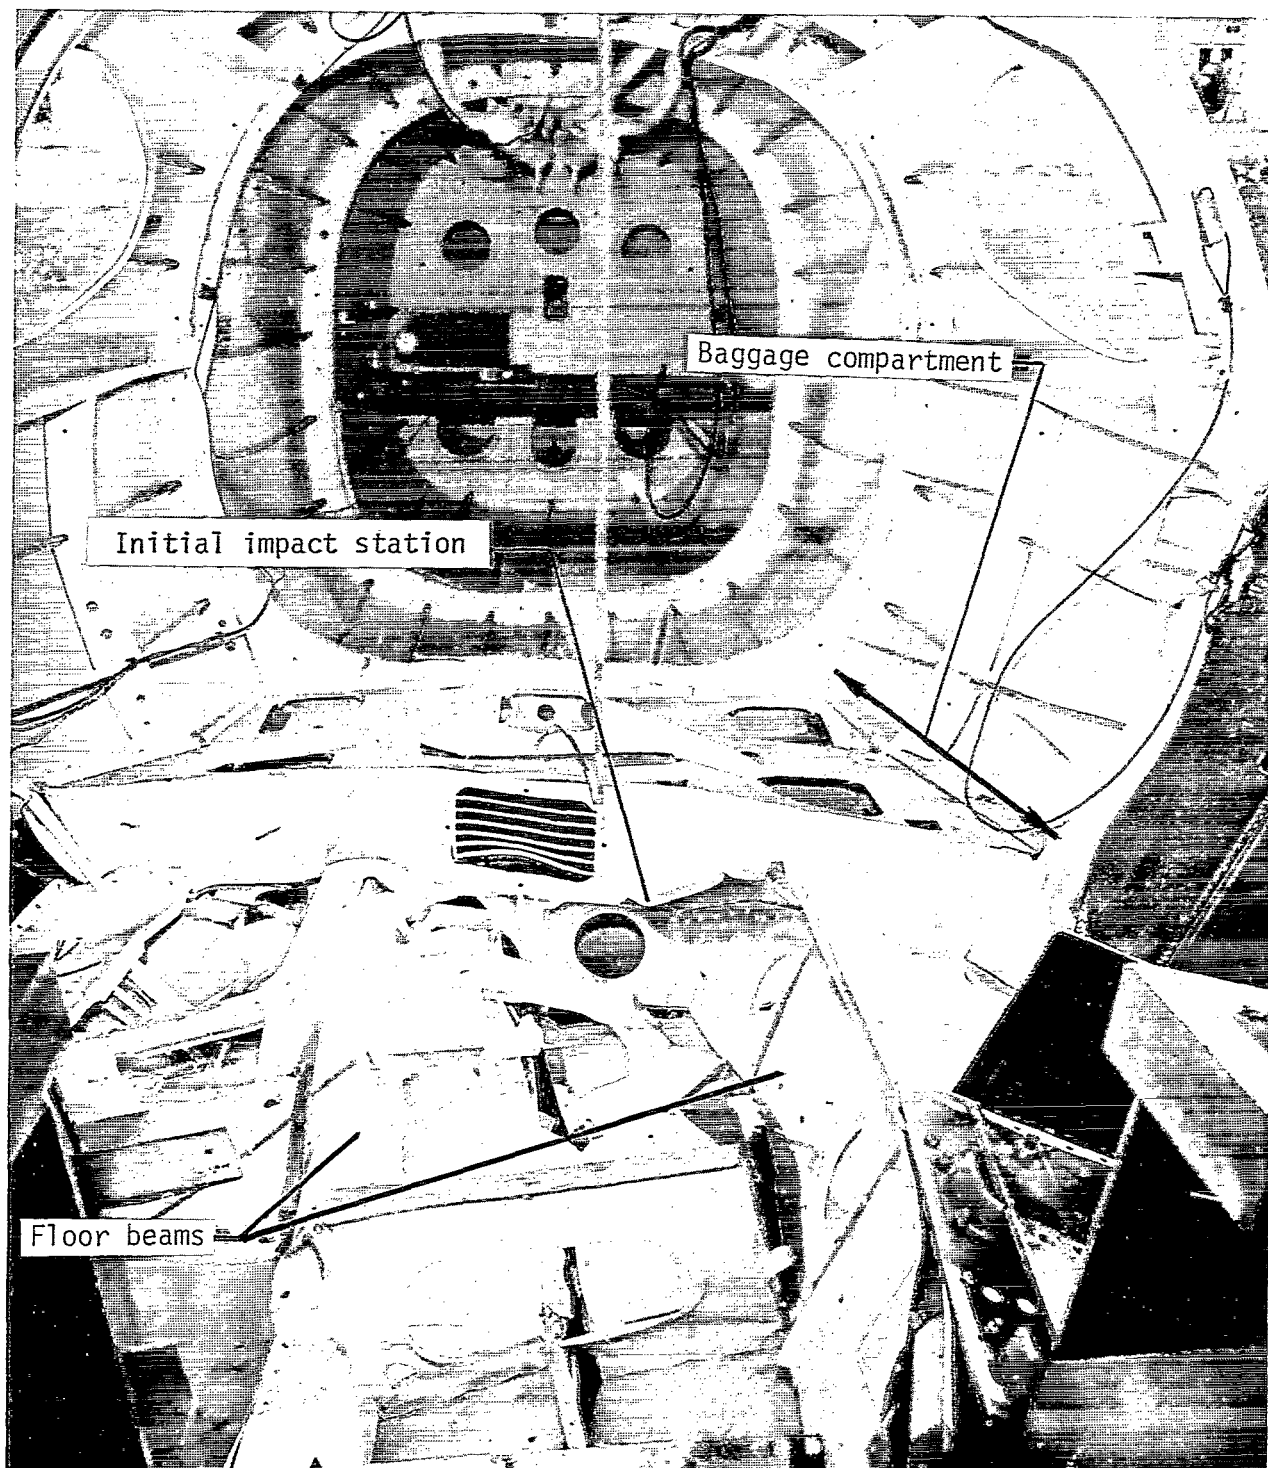
L-79-306

(c) View looking aft.

Figure 17.- Continued.

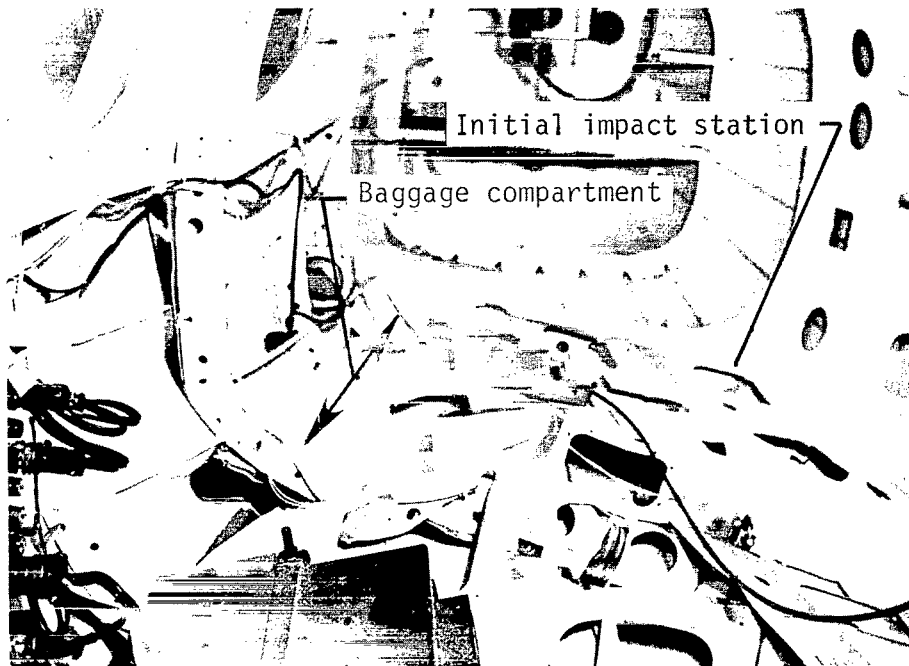
(b) View looking aft.

Figure 18.- Postcrash interior damage to pitch-up test specimen.

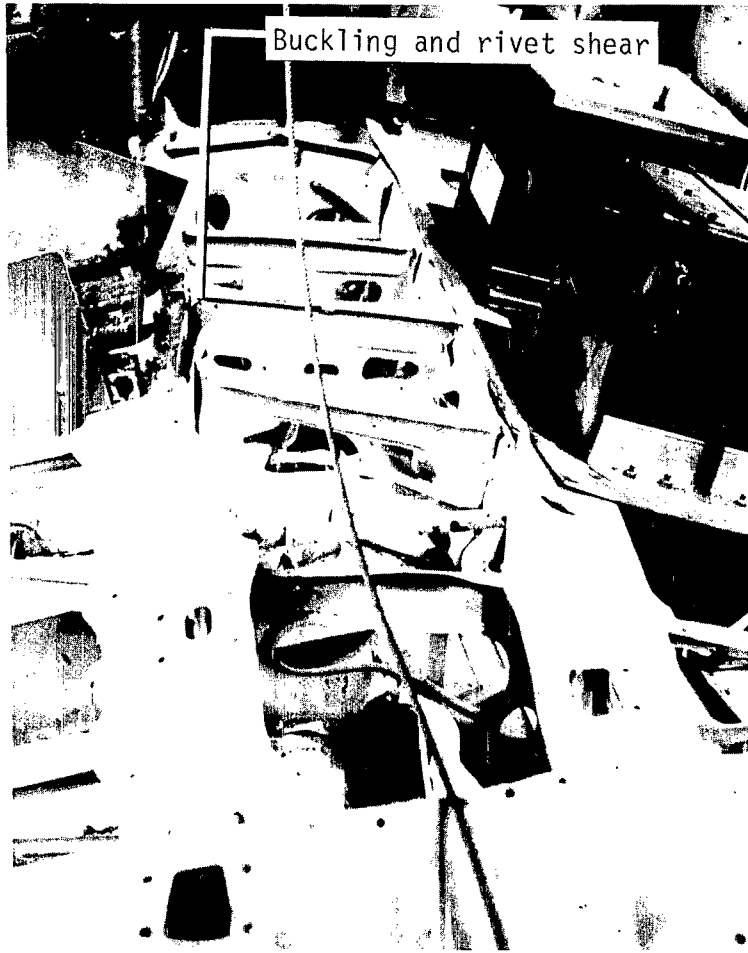
L-79-307

(c) View of floor in aft section of cabin.

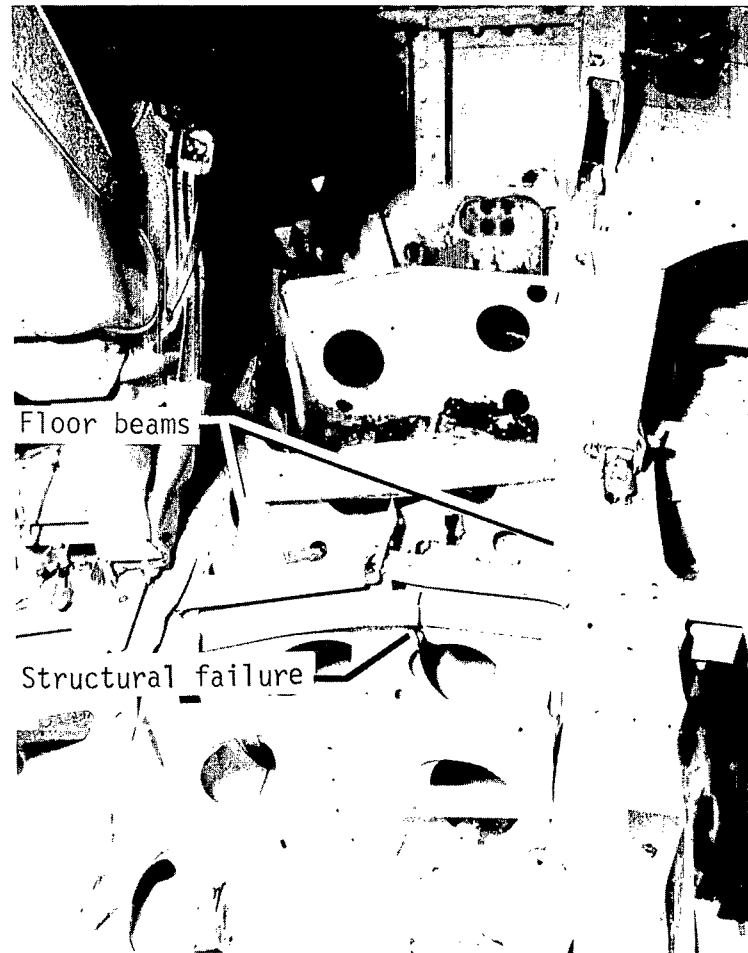
L-75-3748.1

(d) View of floor between first- and second-passenger seats.

Figure 18.- Concluded.

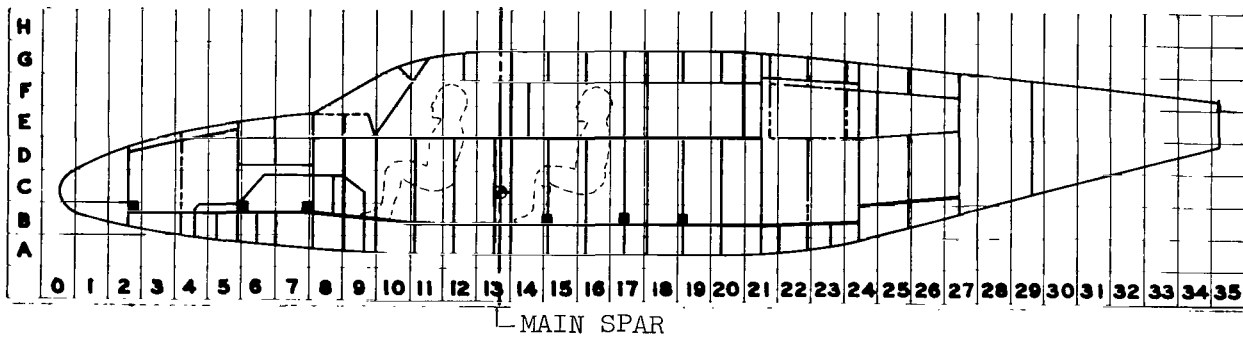
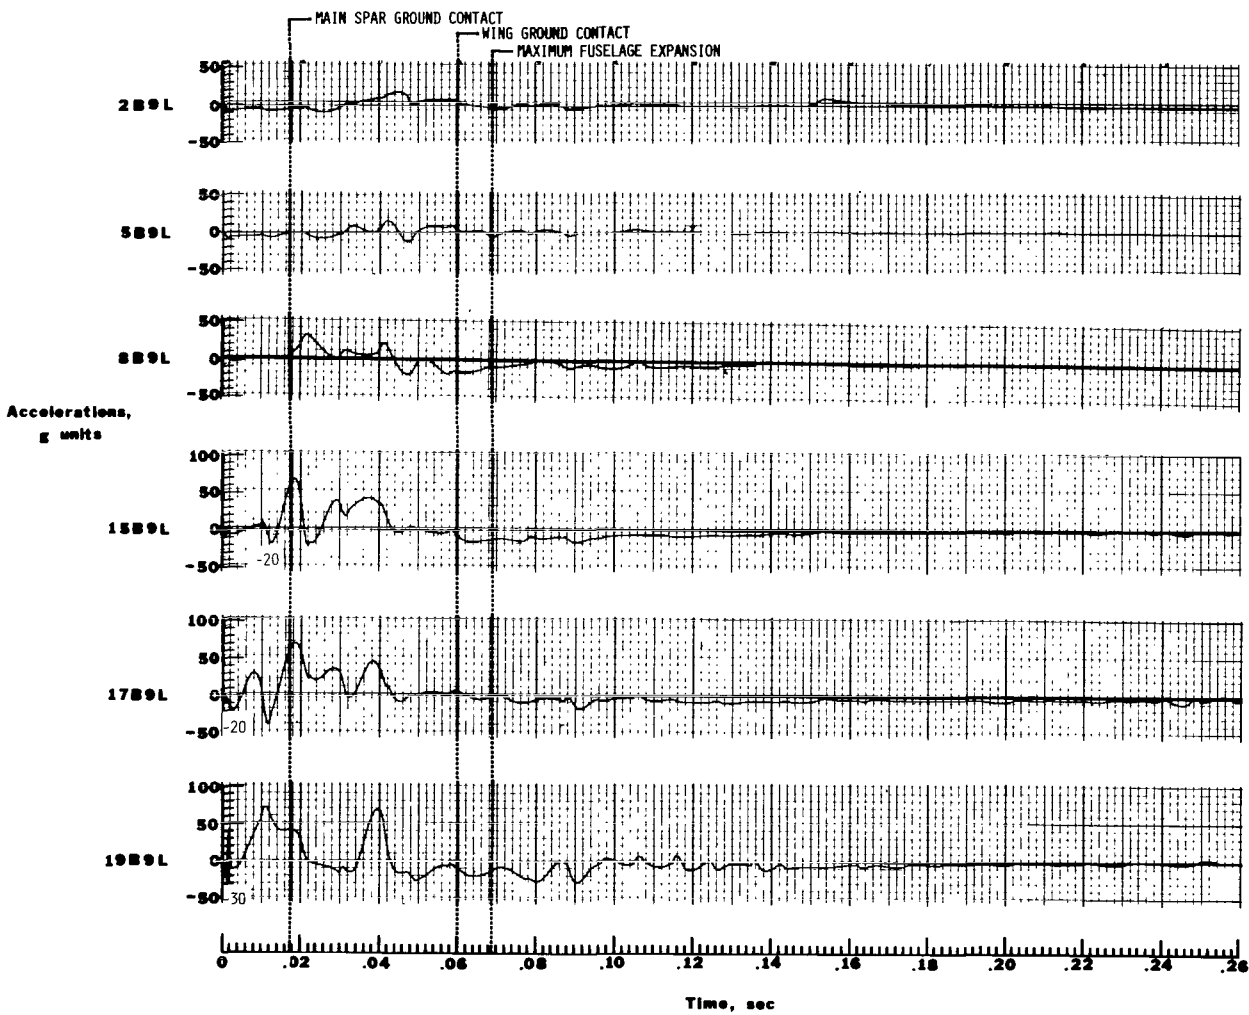
Figure 20.- Histories of the floor-beam longitudinal accelerations.

Six longitudinal accelerometer traces along the floor beam are presented in figure 20 for each test specimen. The accelerometers are located at major structural frames in the nose of the specimen and in the passenger compartment. These accelerometers were mounted at the same locations as the normal accelerometers presented in the previous section.

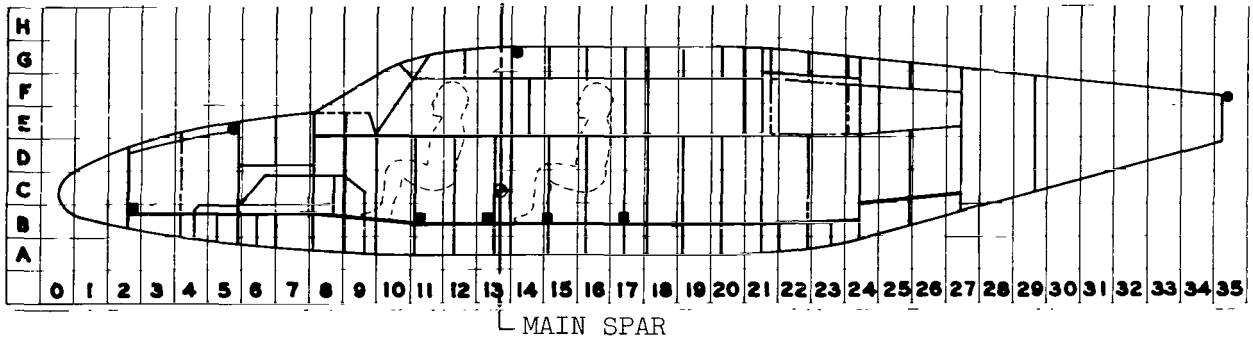
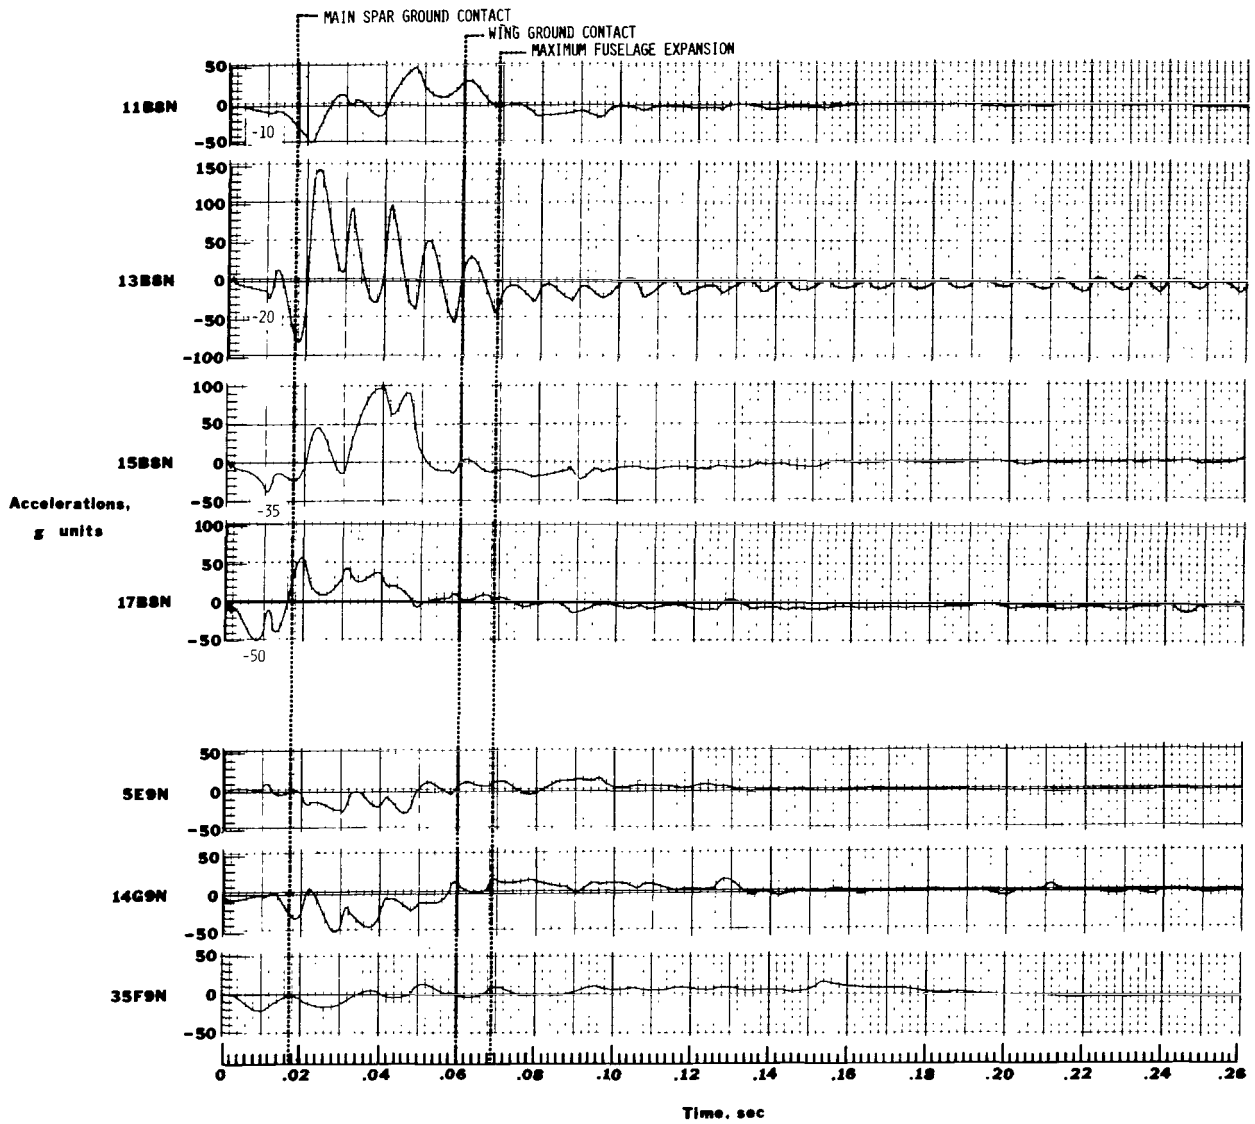
Figure 21.- Histories of roof and floor normal accelerations.

Accelerations on the floor (other than the floor beam) and along the roof are presented in figure 21 in the normal direction and in figure 22 in the longitudinal direction. The accelerometers at frames 11B8 and 13B8 were mounted on the aluminum floor boards between the pilot's fore and aft seat legs. As a result of this mounting, the acceleration traces show an oscillatory behavior that is typical of a local vibration. The large acceleration peaks are a result of the impact superimposed on the oscillatory traces. The window side

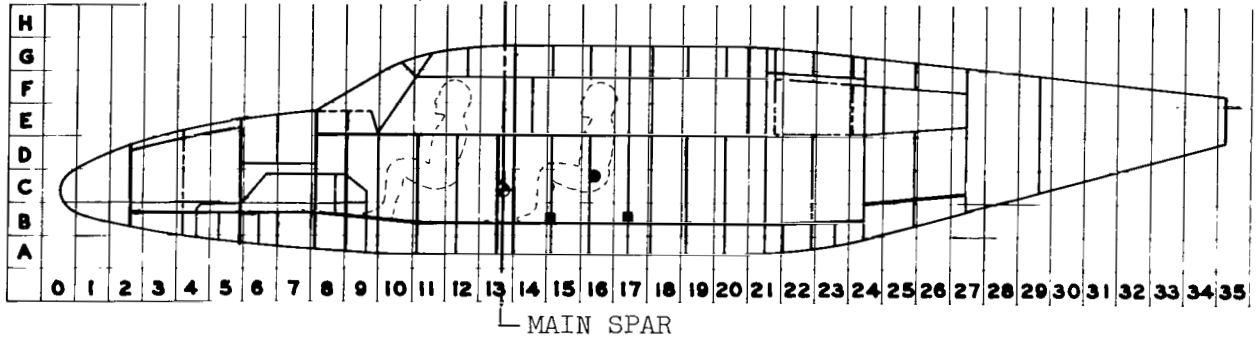
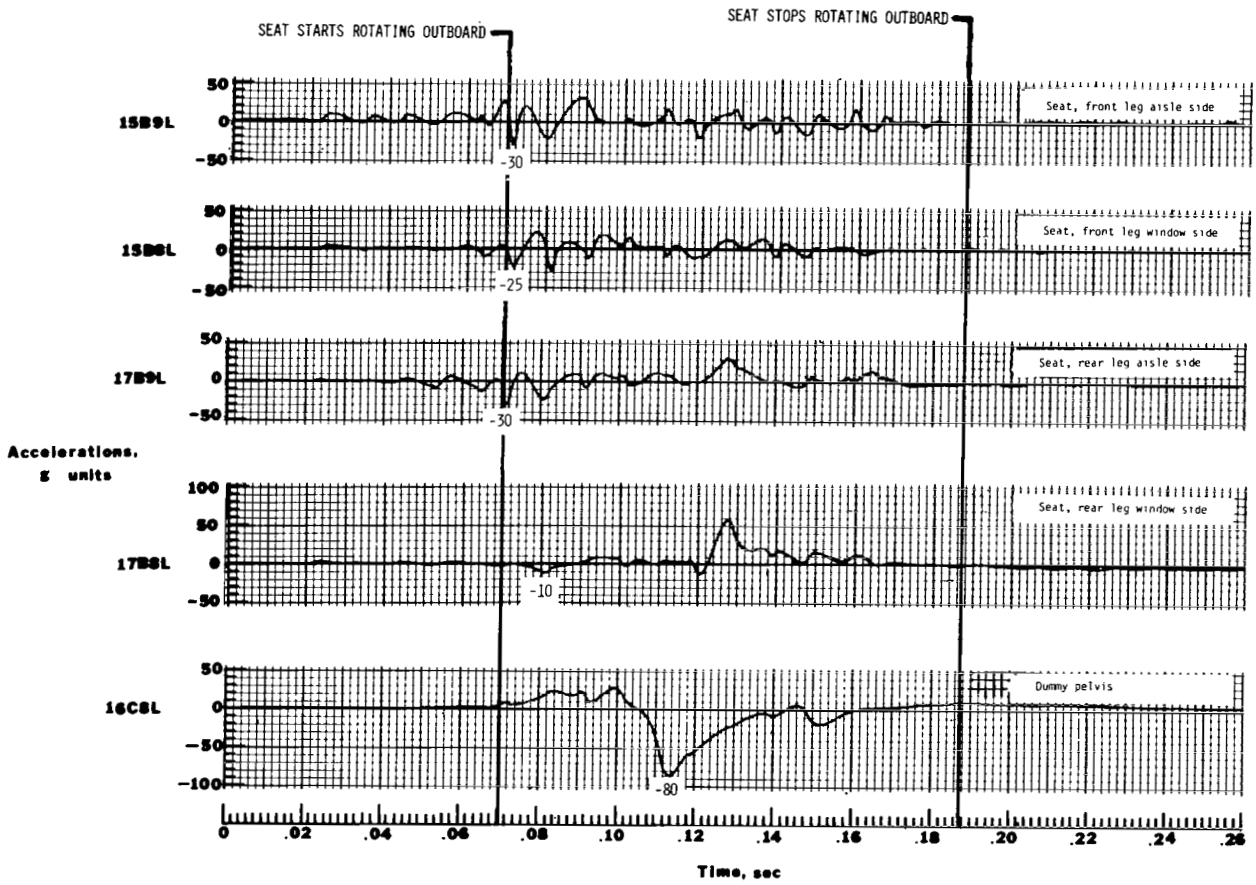
Figure 23.- Histories of normal accelerations on floor at first-passenger seat legs and in dummy.

Pitch-down test.- The normal and longitudinal acceleration histories at the seat legs and in the dummy are presented in figures 23(a) and 23(b), respectively, for the pitch-down test. After the main spar contacted the impact surface (see fig. 19(a)) at 0.05 sec, the floor beam under the dummy experienced normal accelerations of -80g and -30g at the seat front and back legs, respectively. The floor on the window side experienced normal accelerations of -30g and -25g at the seat front and back legs, respectively. The accelerations peaked at about 0.073 sec into the impact. The dummy started to sink into the seat and move forward into the five-point harness restraint system within 0.02 sec after initial ground contact. The dummy experienced only small accelerations as he sank into the seat. The harness system began to tighten at about 0.08 sec into the impact, and the dummy's downward and forward motion was stopped at about 0.114 sec. The resulting delayed pelvic normal acceleration of -55g in the dummy is shown by the peak in the normal direction (fig. 23(a)) and to a greater extent in the longitudinal acceleration of -80g (fig. 23(b)) at 0.114 sec. The seat started to rotate outboard following the deformation of the floor structure at about 0.07 sec, and continued for 0.117 sec. The seat-leg and dummy accelerometers showed negligible accelerations after the seat stopped rotating.

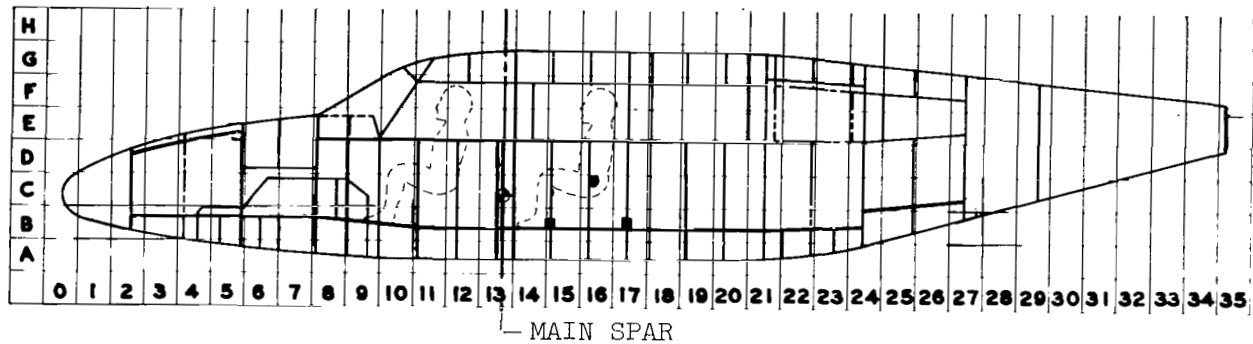
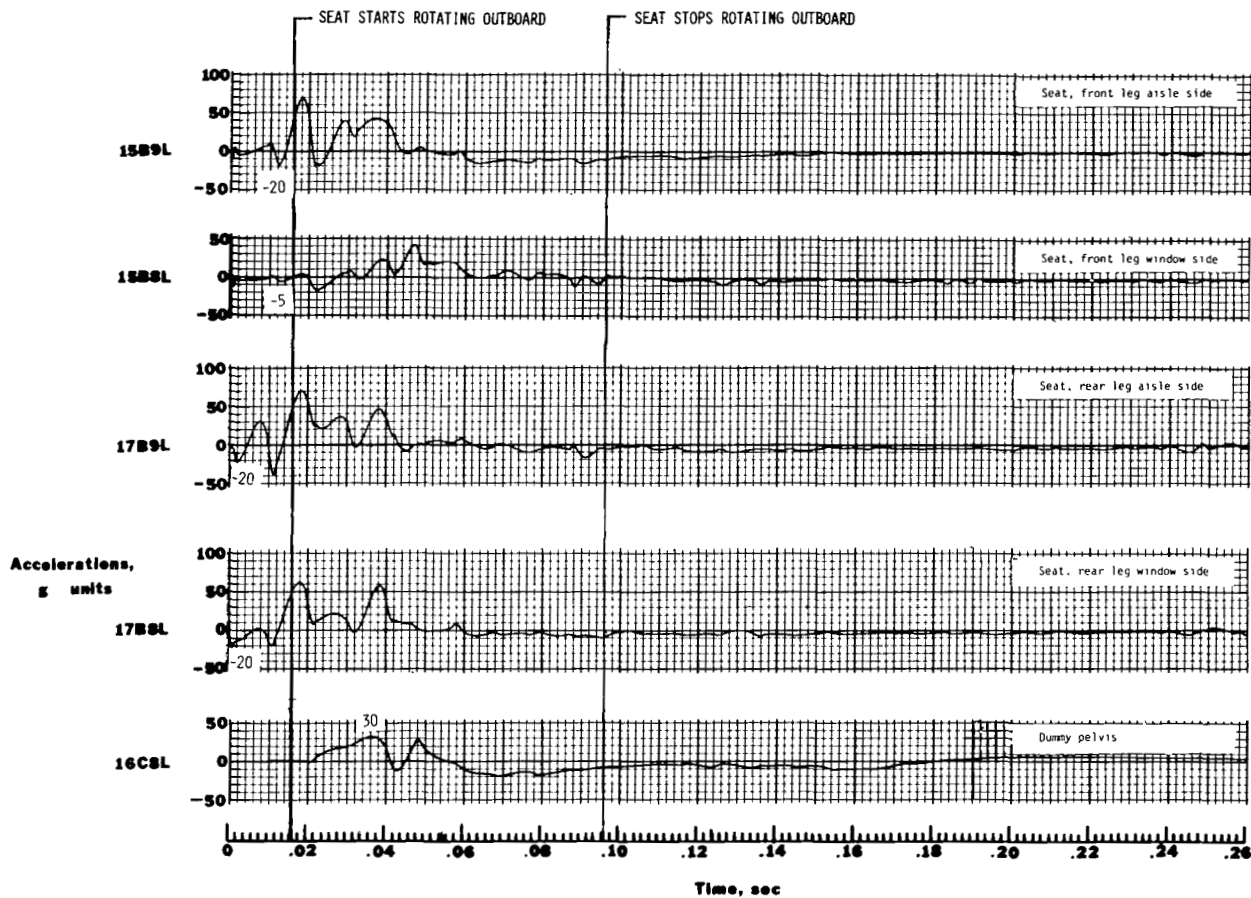
Figure 23.- Continued.

Flat test.- The normal and longitudinal acceleration histories at the seat legs and in the dummy are presented in figures 23(c) and 23(d), respectively, for the flat test. Since the airplane contacted the impact surface at a 4° pitch attitude, the impact acceleration in the first-passenger dummy was felt before the main spar contacted the impact surface. The floor beam under the seat experienced normal accelerations of -80g and -50g at the seat back and front legs, respectively. The floor on the window side experienced normal acceleration of -50g and -35g at the seat back and front legs, respectively. The dummy experienced normal accelerations of -40g and 0.02 sec after those

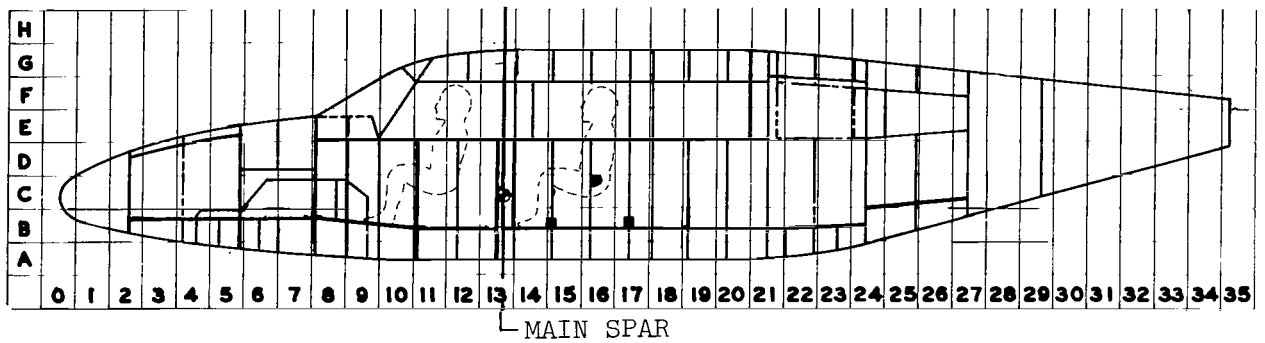
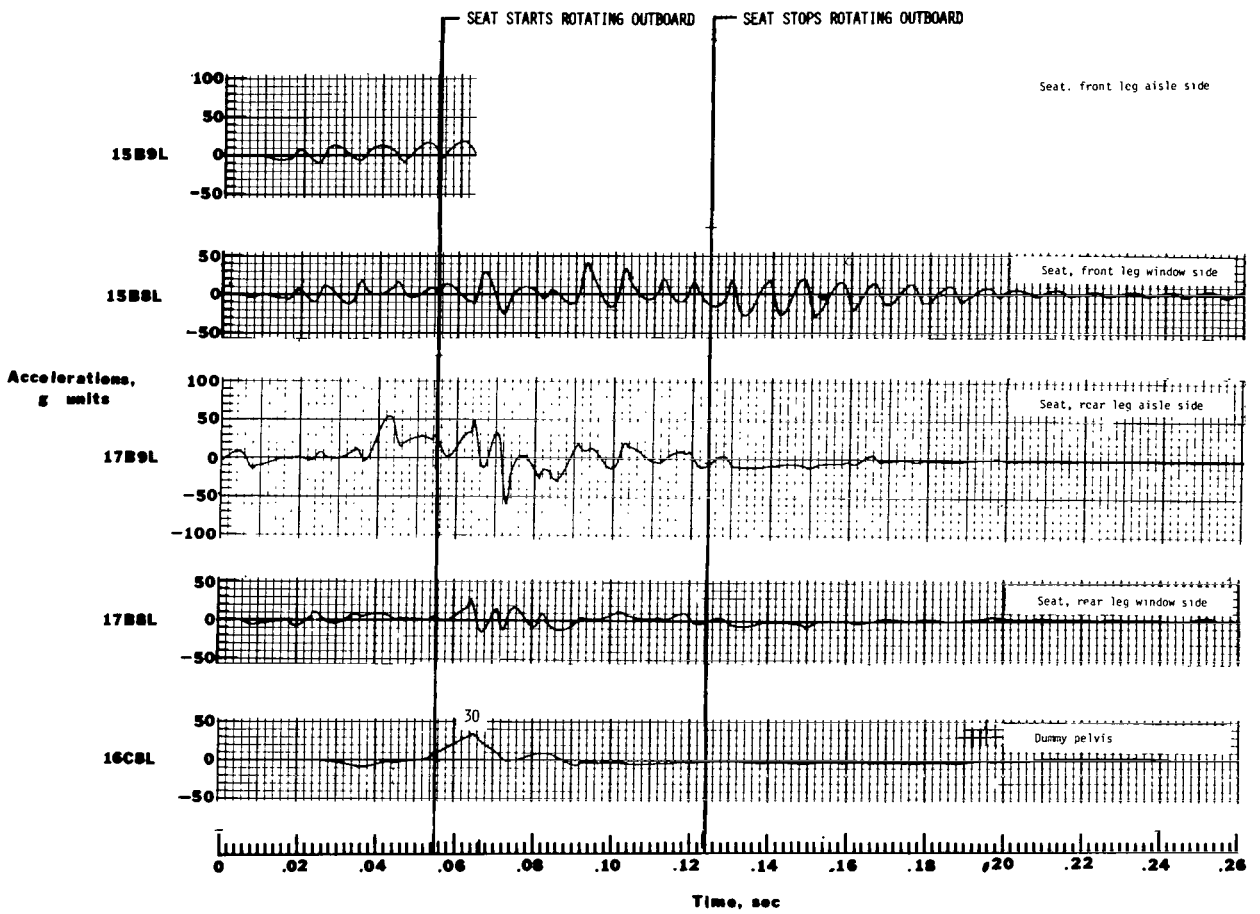
Figure 23.- Continued.

Pitch-up test.- The normal and longitudinal accelerations at the seat legs and in the dummy are presented in figures 23(e) and 23(f), respectively, for the pitch-up test. The effect of the 14° pitch-up angle at ground contact is shown by the greater acceleration at the back legs of the seat than at the front legs. The floor beam under the seat experienced normal accelerations of -50g and -20g at the back and front seat legs, respectively. The floor on the window side experienced normal accelerations of -40g and -20g at the back and front seat legs, respectively. The first-passenger dummy started to move down into the seat within 0.01 sec after ground contact on the aft lower surface of the airplane. The forward rocking motion of the fuselage caused the dummy to move backward into the seat at the same time that he moved down into the soft seat cushion and supporting diaphragm. At 0.053 sec after ground contact, the dummy stopped his downward motion. At the same time, the normal accelerations at the seat legs peaked (negative magnitude, fig. 23(e)). As the dummy's sinking motion stopped, the dummy started to submarine under the lap belt which was attached to the seat at the floor. At the same time, the seat started to rotate outboard, causing a positive response to the dummy's longitudinal accelerometer (fig. 23(f) and accelerometer 16C8L). The accelerometer was oriented along the longitudinal axis of the dummy (perpendicular to the spine); however, the submerging caused the accelerometer to rotate into an orientation almost parallel to the airplane normal axis (see fig. 24). Consequently, response of the longitudinal accelerometer was due to the stopping motion along the normal axis of the airplane. The acceleration of 30g peaked at about 0.065 sec into the impact. At 0.067 sec after ground contact, the airplane downward velocity was arrested, and rebound of the floor beams started as the airplane continued to rock forward. The reversal of direction caused positive normal acceleration peaks on the floor beam at the base of the seat. The seat continued to rotate outboard until 0.124 sec, after which time all accelerations were negligible.
