NASA Technical Paper 1477

# Light Airplane Crash Tests at Three Roll Angles

Claude B. Castle and Emilio Alfaro-Bou

OCTOBER 1979

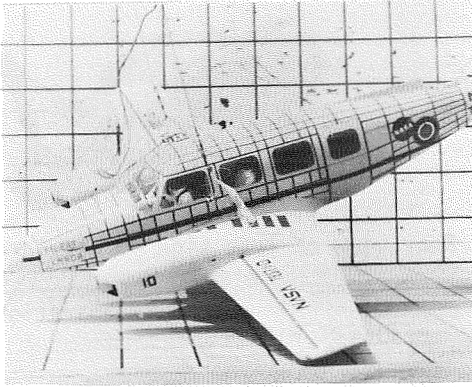
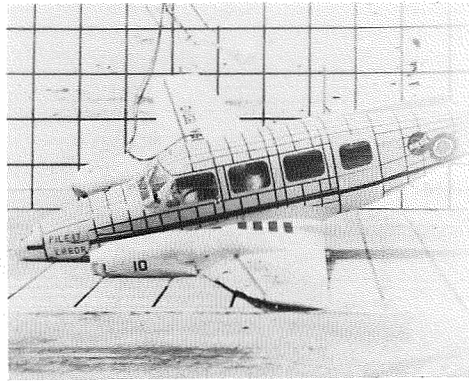
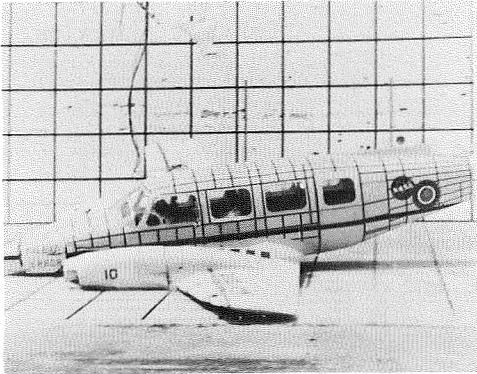
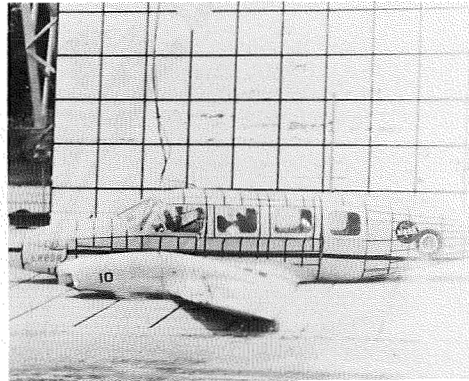
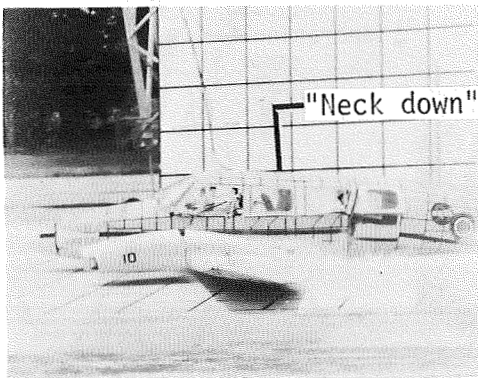
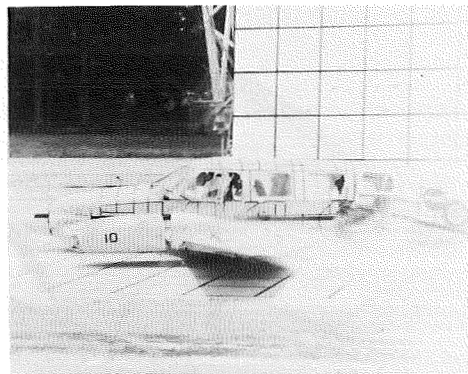
Figure 12.- Photographic sequence of  $-15^\circ$  roll test. L-79-295

Roll test at -15°.— Sequence photographs of the airplane during a -15° roll impact test are shown in figure 12. The photograph (fig. 12(a)) shows the cable separation and free-flight attitude prior to impact. Figure 12(b) (0.03 sec) shows the test airplane as the nose section contacts the impact surface and the left wing has impacted and begun to deform. In figure 12(c) (0.08 sec) the

fuselage in the vicinity of the fire wall has made contact, and the initial reaction of the dummy pilot and first-passenger dummy to the crash is evident. As the main fuselage contacts the impact surface (0.13 sec) and right wing, slapdown (0.18 sec, figs. 12(d) and 12(e)) has occurred, the pilot dummy impacts the instrument panel, and the fuselage has begun to separate along the window ledge on the left side of the test specimen; also, the door has started to open. In figures 12(e) and 12(f), as tail slapdown occurs (0.18 sec and 0.23 sec, respectively), the tensile loading in the top portion of the fuselage causes separation of the left and center windshield supports. This failure of the windshield supports then causes separation of the windshield and a rearward movement of the top portion of the cabin. These effects are shown by the misalignment of the painted black lines on the fuselage side representing the underlying structure. The top portion of the cabin in the vicinity of the first- and second-passenger dummies has begun to "neck down" and the first-passenger dummy has impacted the pilot seat. The engine cowling on the left side has sheared its rivets and separation has begun. Also shown is the window breakage along the left side.

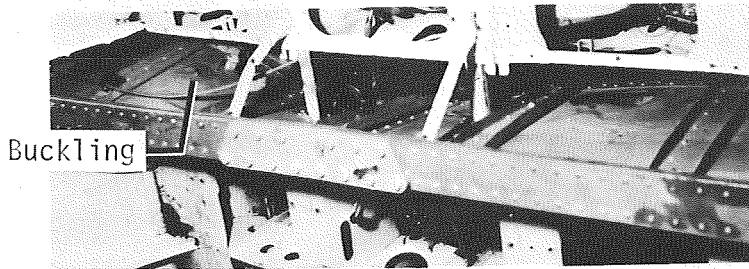
(c) Top view of main spar.

The damage done to the airplane interior in the  $-15^{\circ}$  roll test is shown in figure 14. A view looking forward in the cabin area (fig. 14(a)) shows only a slight apparently upward movement of the center floor area, as can be determined by the outward rotation of the accelerometer blocks. Figure 14(b) shows the forward cabin and cockpit area with fixtures removed. Also evident are slight apparently upward movement of the cabin floor center section and the separation of the cabin along the window ledge. The buckled left main spar near the main spar splice can be seen in figure 14(c), which is a top view of the main spar inside the cabin. A view of the floor support with small amounts of buckling of the cross-support structures is shown in figure 14(d). The torn and separated tail section shown in figure 14(e), in a view aft of the door, shows the effects of tail slapdown during impact.

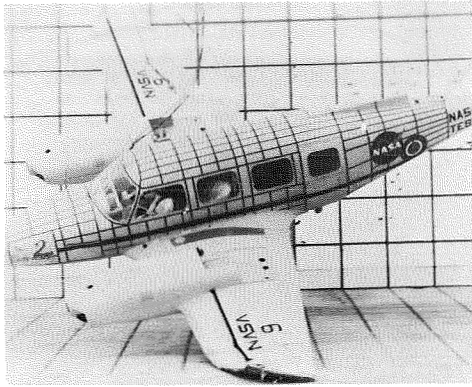
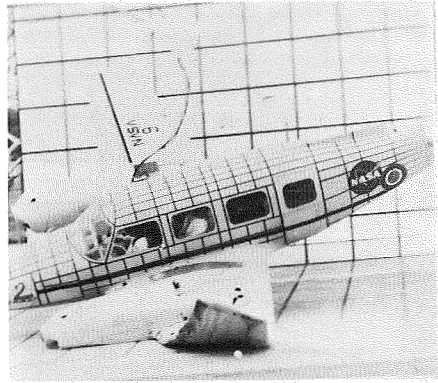
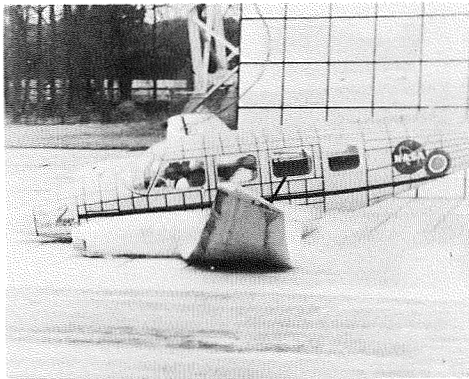
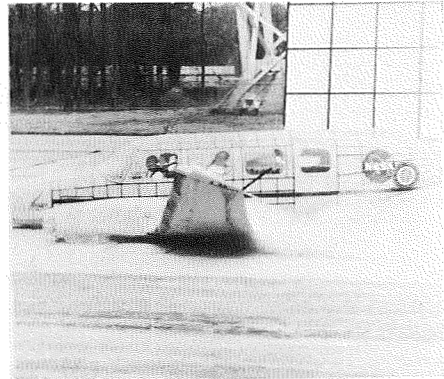
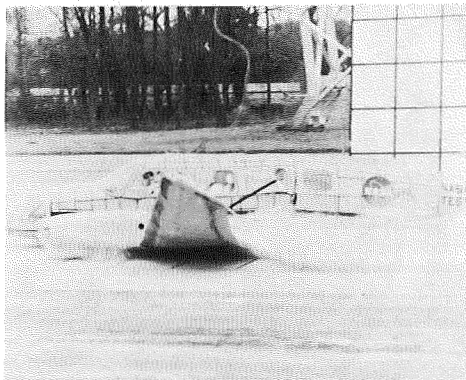
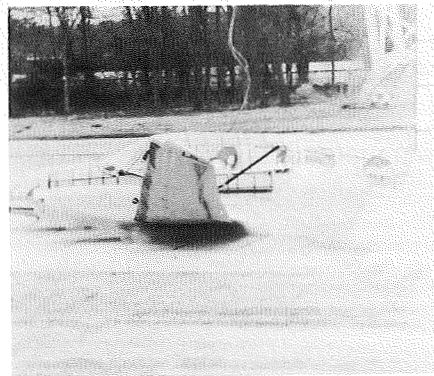
Figure 15.- Photographic sequence of  $-30^\circ$  roll test. L-79-298

Roll test at  $-30^{\circ}$ . The photographic sequence of the  $-30^{\circ}$  roll test is shown in figure 15. Wing deformation after initial impact is shown in figure 15(a). Figures 15(b) to 15(f) graphically illustrate how the left wing of the airplane bends during impact and attenuates some of the impact energy.

Movement of the pilot dummy has started and may be noted in figure 15(c). The airplane pivots about its left wing after initial impact for approximately 0.30 sec before right wing slapdown occurs. The resulting cabin deformation and slide out are shown in figures 15(d) to 15(f). It can be seen that the livable volume was maintained throughout the impact sequence.

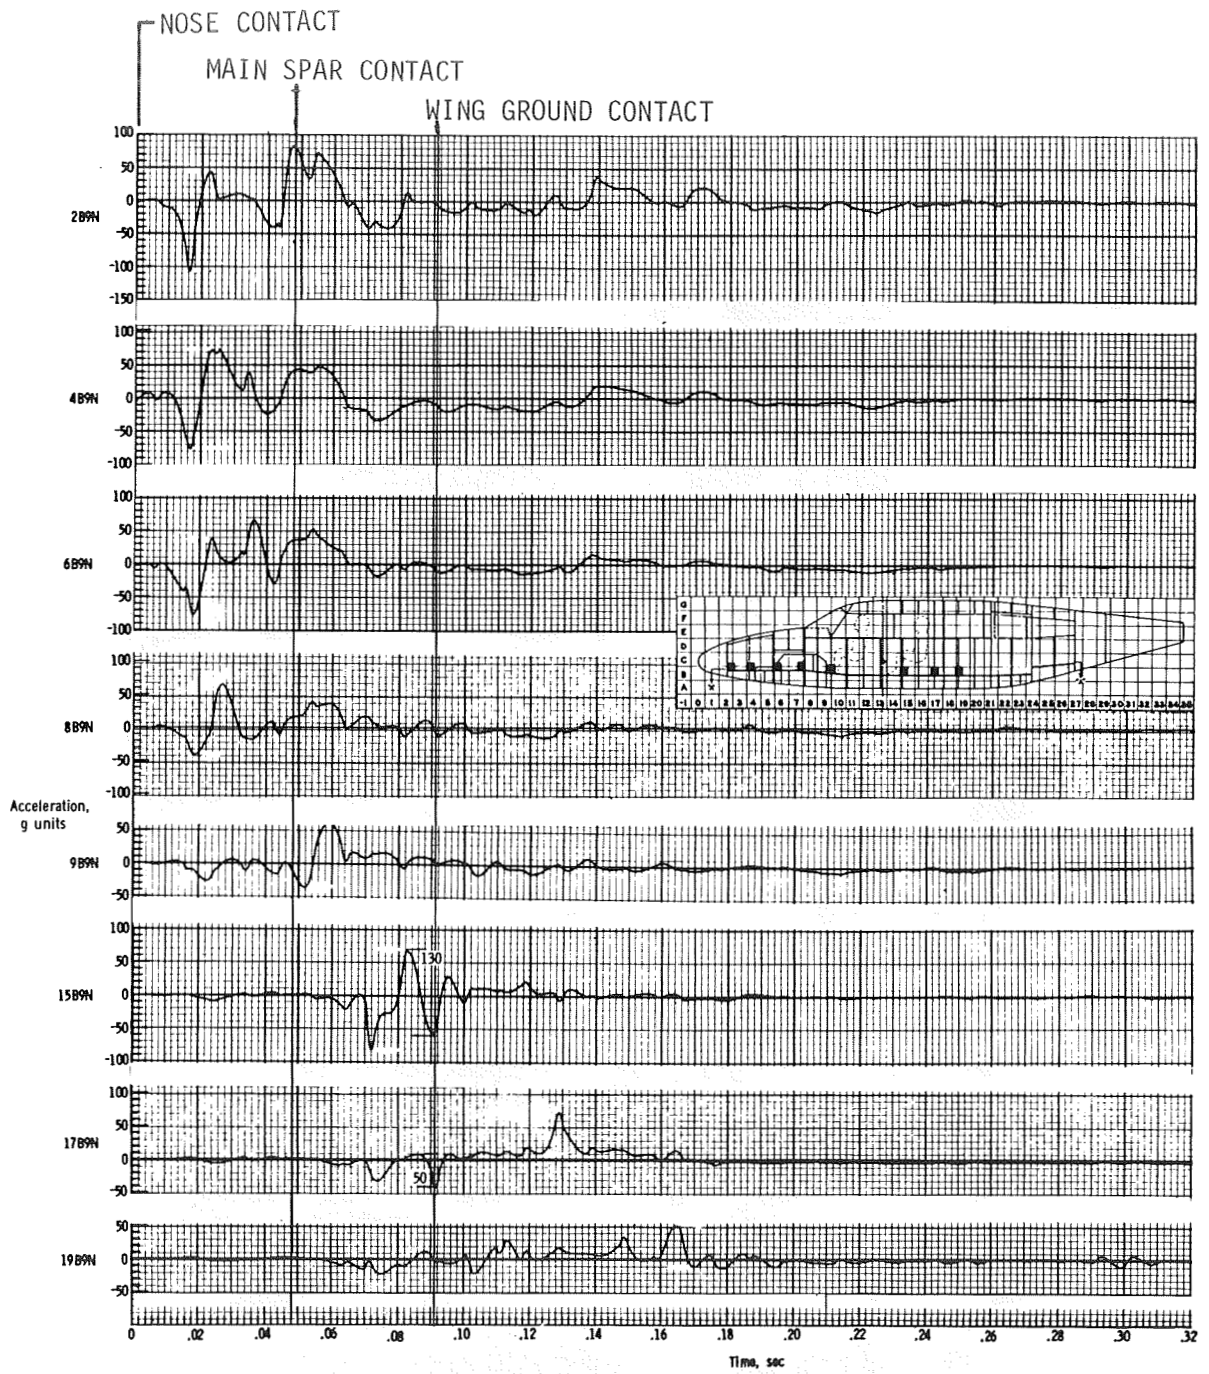
(a) 0° test.

Roll test at  $0^{\circ}$ .- In figure 19(a), eight normal acceleration traces from the  $0^{\circ}$  roll test are presented, and the times of significant events are noted. The eight accelerometers were spaced along the left floor beam of the airplane (see insert, fig. 19(a) and fig. 8(a)) from the first nose frame (2B9N) to the door of the cabin (19B9N). Accelerations in the cabin compartment reached a maximum in the vicinity of the main spar and diminished progressively from that point rearward. At 0.091 sec (fig. 19(a)) the wing made ground contact and

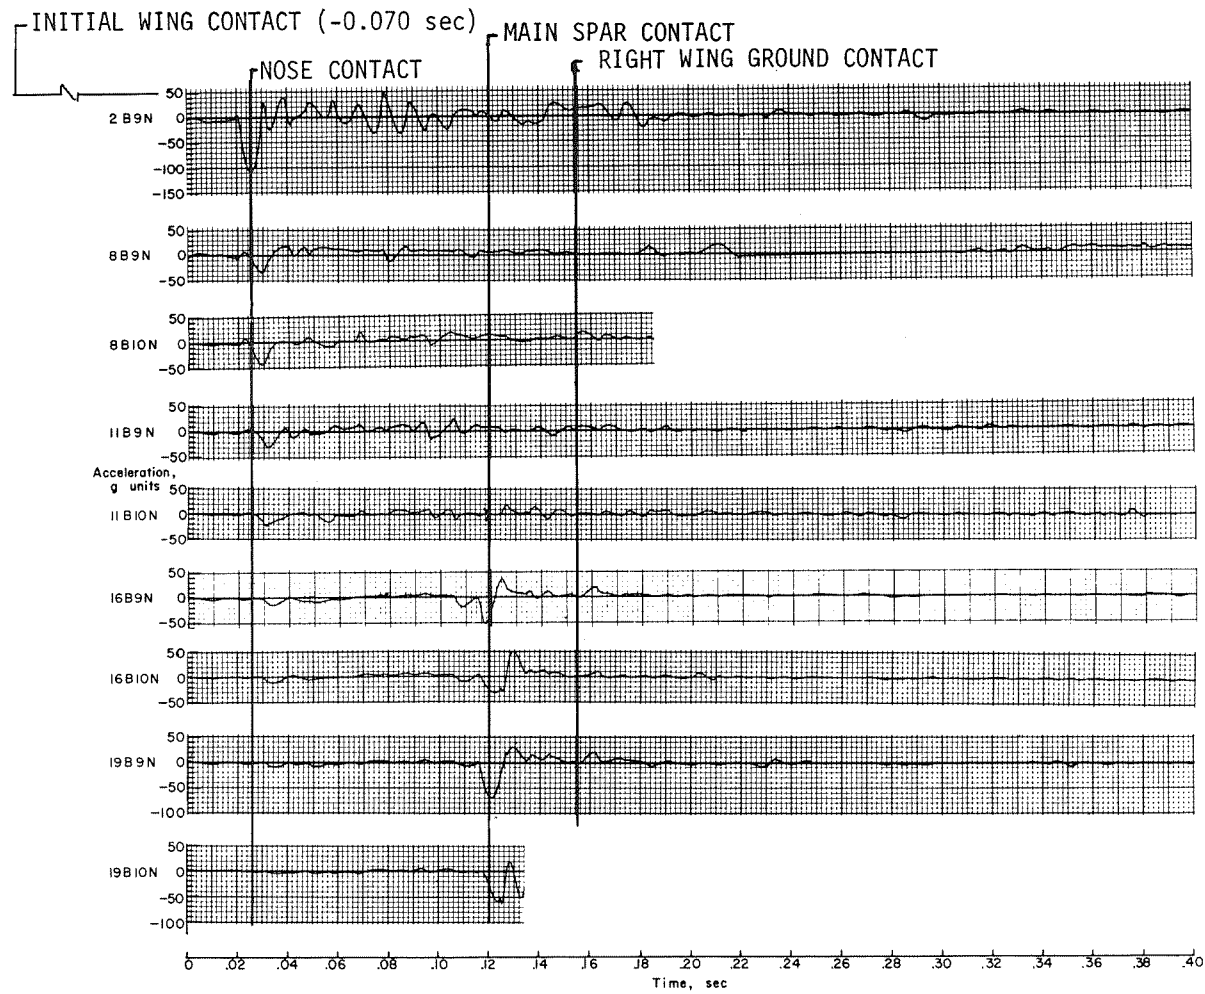
(b) -15° test.

Roll test at  $-15^{\circ}$ .— Nine normal acceleration traces along the floor structure are shown in figure 19(b) for the  $-15^{\circ}$  roll test. Only those five along the left floor beam are compared with the  $0^{\circ}$  roll test. Four additional accelerometers were added along the right floor beam for the  $-15^{\circ}$  and  $-30^{\circ}$  tests.

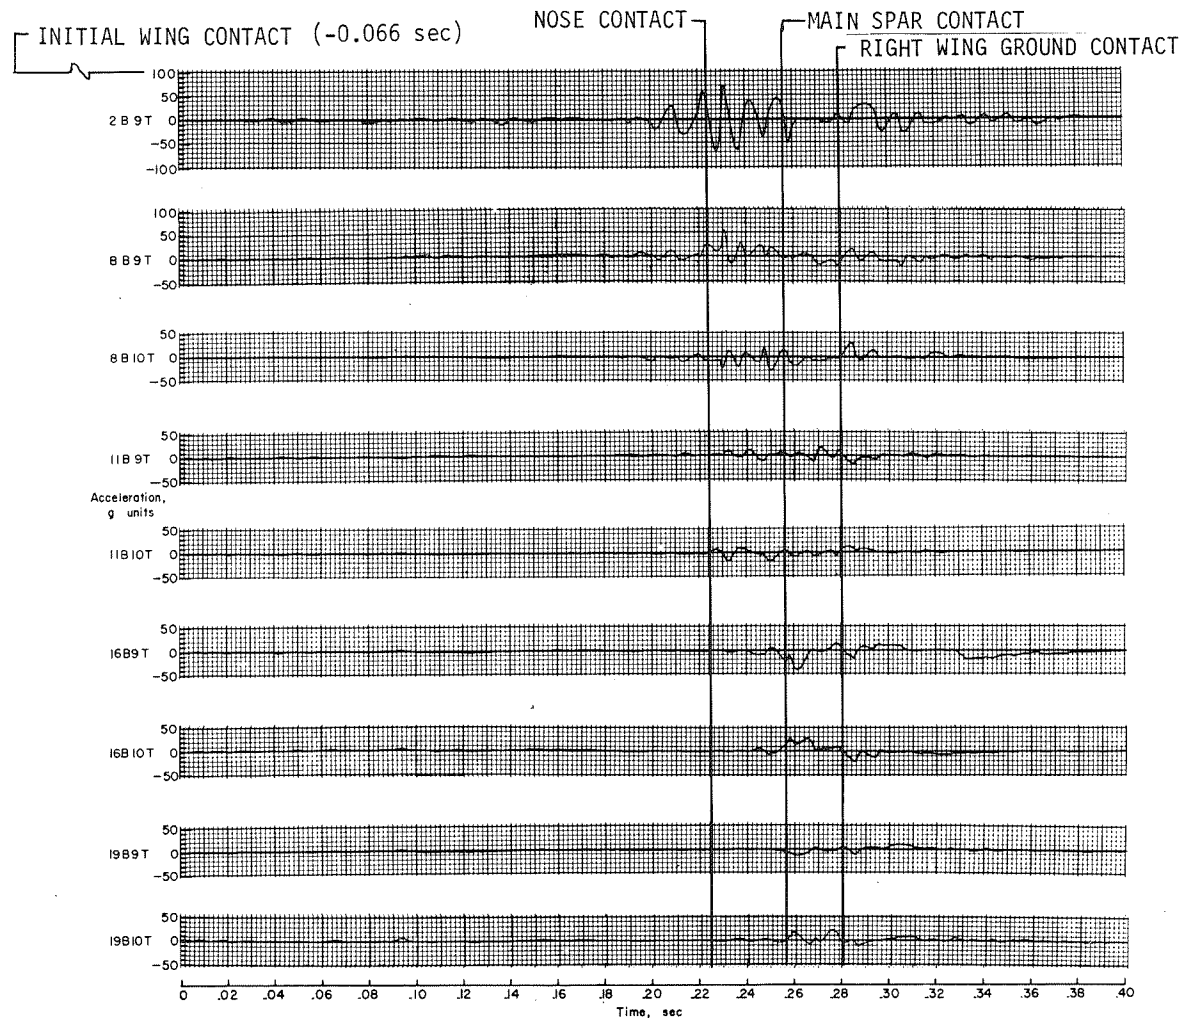
(b) -30° test.

Roll test at  $-30^{\circ}$ .- In figure 21(b), nine transverse acceleration traces are shown for the  $-30^{\circ}$  roll test and, in general, they show acceleration magnitudes similar to the  $-15^{\circ}$  roll test.

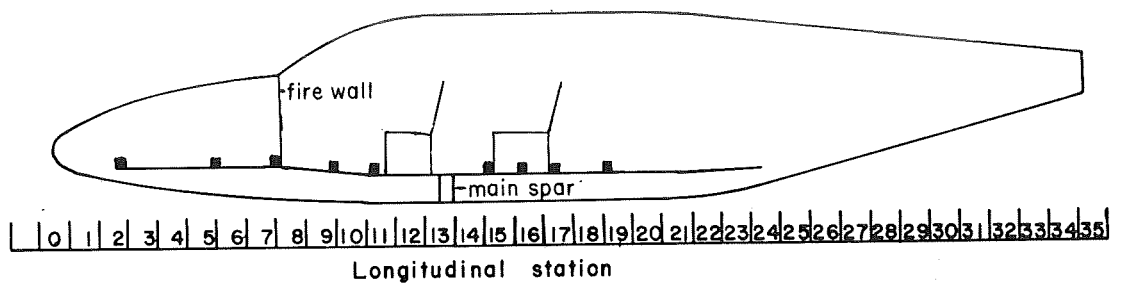
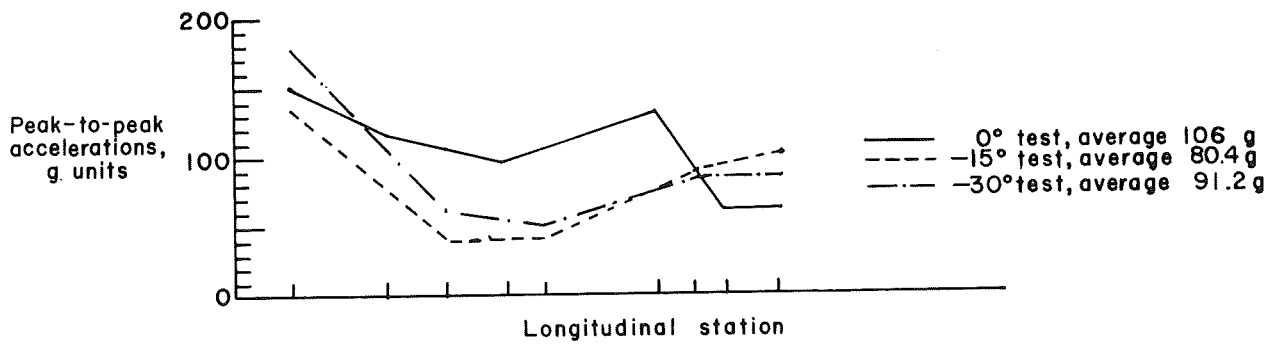
(a) Normal accelerations.

The average value of the highest peak-to-peak accelerations along the floor beam in the normal direction (fig. 22(a)) for the  $0^{\circ}$ ,  $-15^{\circ}$ , and  $-30^{\circ}$  roll tests is shown (fig. 22(a)) to be 106g, 80g, and 91g, respectively. In the longitudinal direction (fig. 22(b)), the average of the peak-to-peak acceleration values for the  $0^{\circ}$ ,  $-15^{\circ}$ , and  $-30^{\circ}$  roll tests was 47g, 43g, and 34g, respectively.

The profile of normal peak-to-peak accelerations in figure 22(a) indicates the effect of airplane roll on the floor structure accelerations during impact. The  $0^{\circ}$  roll test had the highest peak-to-peak acceleration pulses in the nose and in the vicinity of the main spar. The  $-15^{\circ}$  and  $-30^{\circ}$  roll tests had the highest normal peak-to-peak accelerations in the nose of the airplane. As opposed to the  $0^{\circ}$  roll test, however, the accelerations decreased from the nose to the vicinity of the cockpit; then they increased toward the aft portion of the airplane cabin.

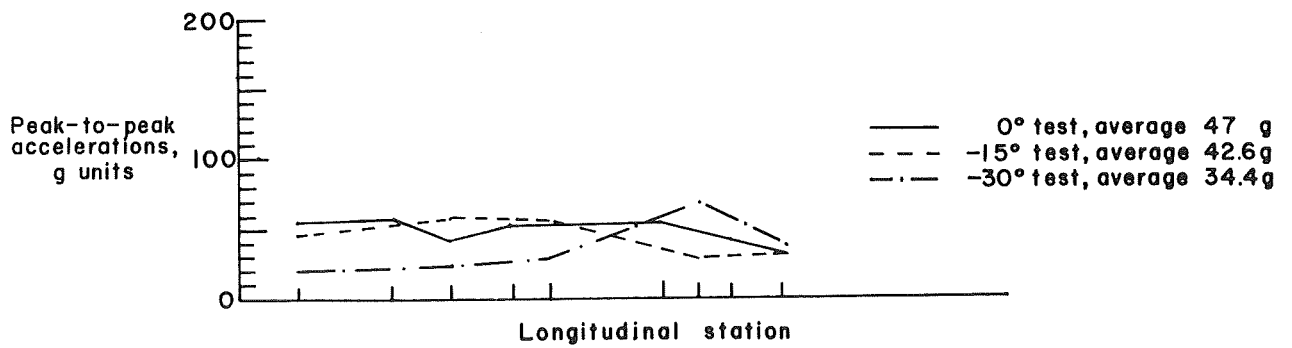
(b) Longitudinal accelerations.

As shown in figure 22(b), the  $0^{\circ}$  and  $-15^{\circ}$  roll tests had nearly constant longitudinal peak-to-peak acceleration profiles for the entire length of the floor beam.

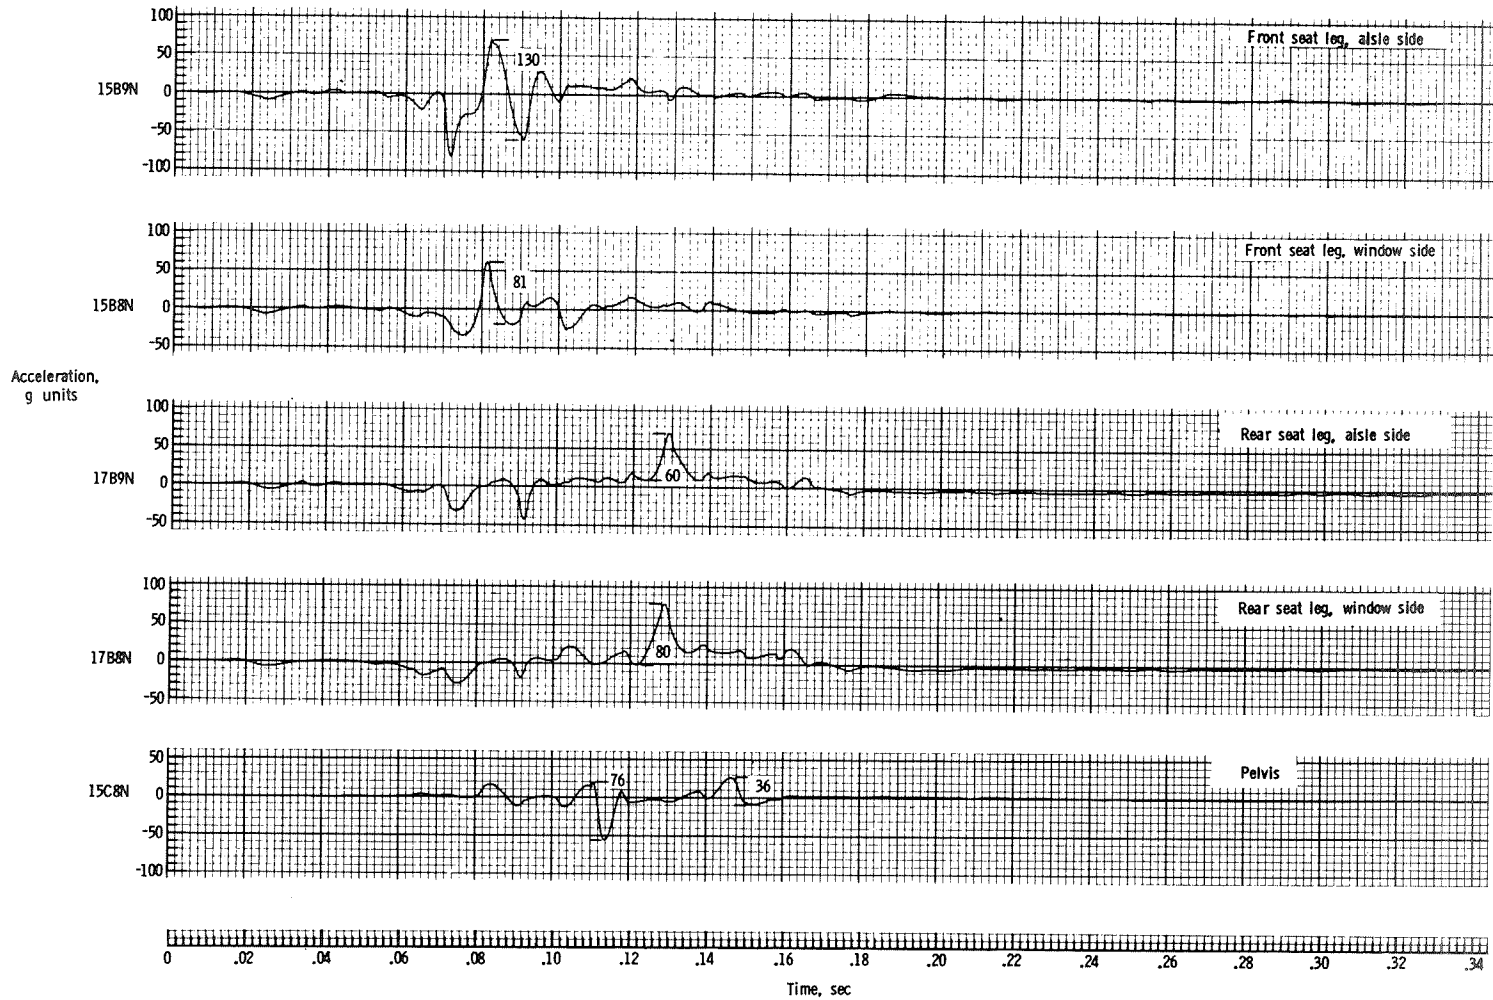
(a) 0° test.

Normal accelerations at 0° roll.- Figure 23(a) shows the normal accelerations for the 0° roll test specimen. Peak-to-peak accelerations of 130g and 81g were recorded on the floor under the two front seat legs at the first-passenger location, and accelerations of 76g were recorded in the pelvis approximately 0.024 sec later. The peak-to-peak accelerations on the floor under the rear seat legs were 60g and 80g. A 36g pulse on the pelvis occurred approximately 0.017 sec later.

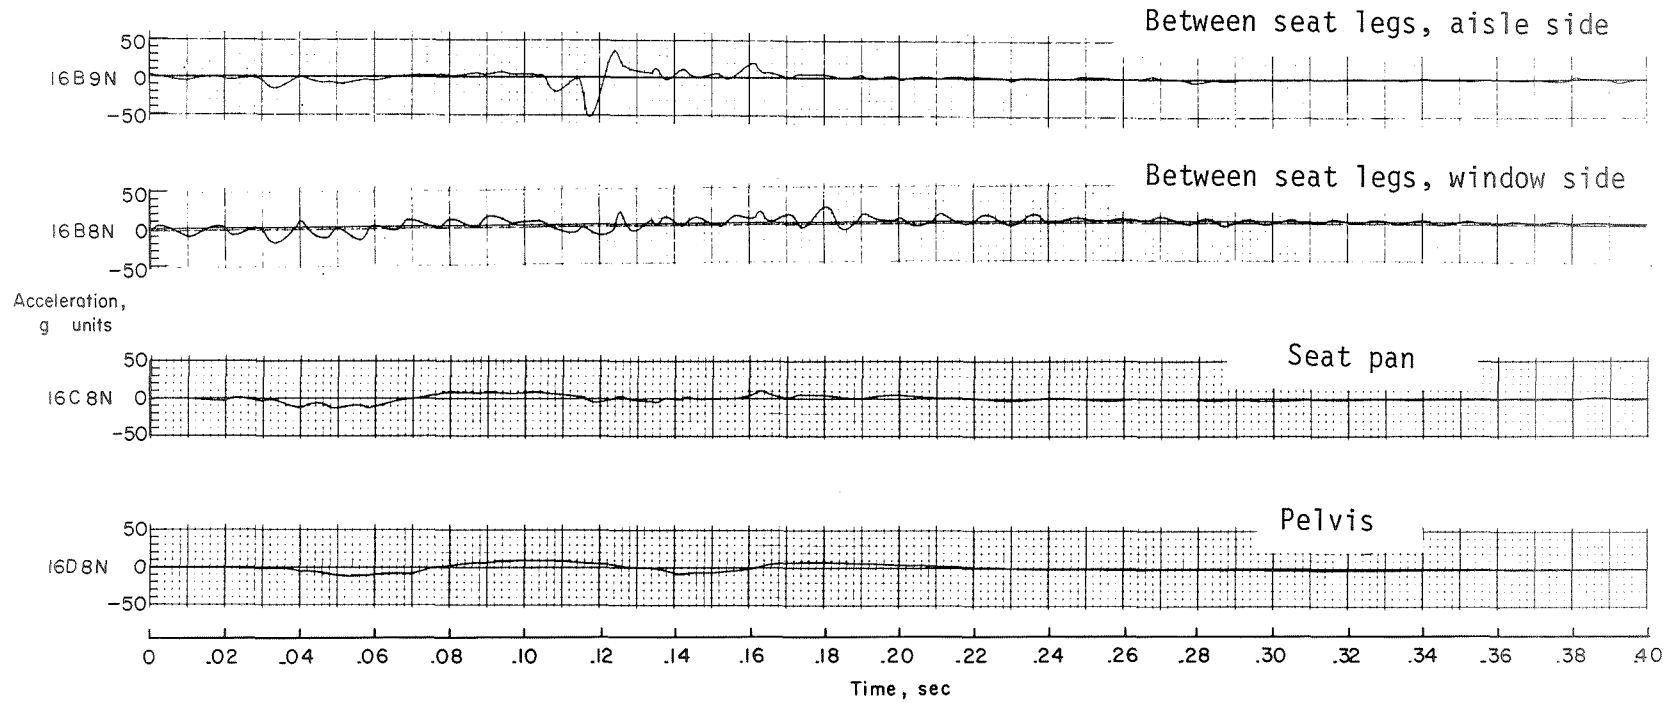
(b)  $-15^{\circ}$  test.

Normal accelerations at -15° roll.- The accelerations for the first-passenger seat, seat pan, and dummy pelvis are shown in figure 23(b). The accelerations on the seat pan and dummy pelvis show the reaction of the dummy to the impact of the nose section. Following wing impact, the dummy at the first-passenger position was forced toward the left window and then back into an upright position. This uprighting was associated with a 10g pulse on both the pelvis and seat pan (0.04 sec). During fuselage main spar contact, a positive 10g pulse caused the dummy to rebound and lift up on the seat. The primary input to the seat occurred at fuselage main spar contact (0.12 sec).

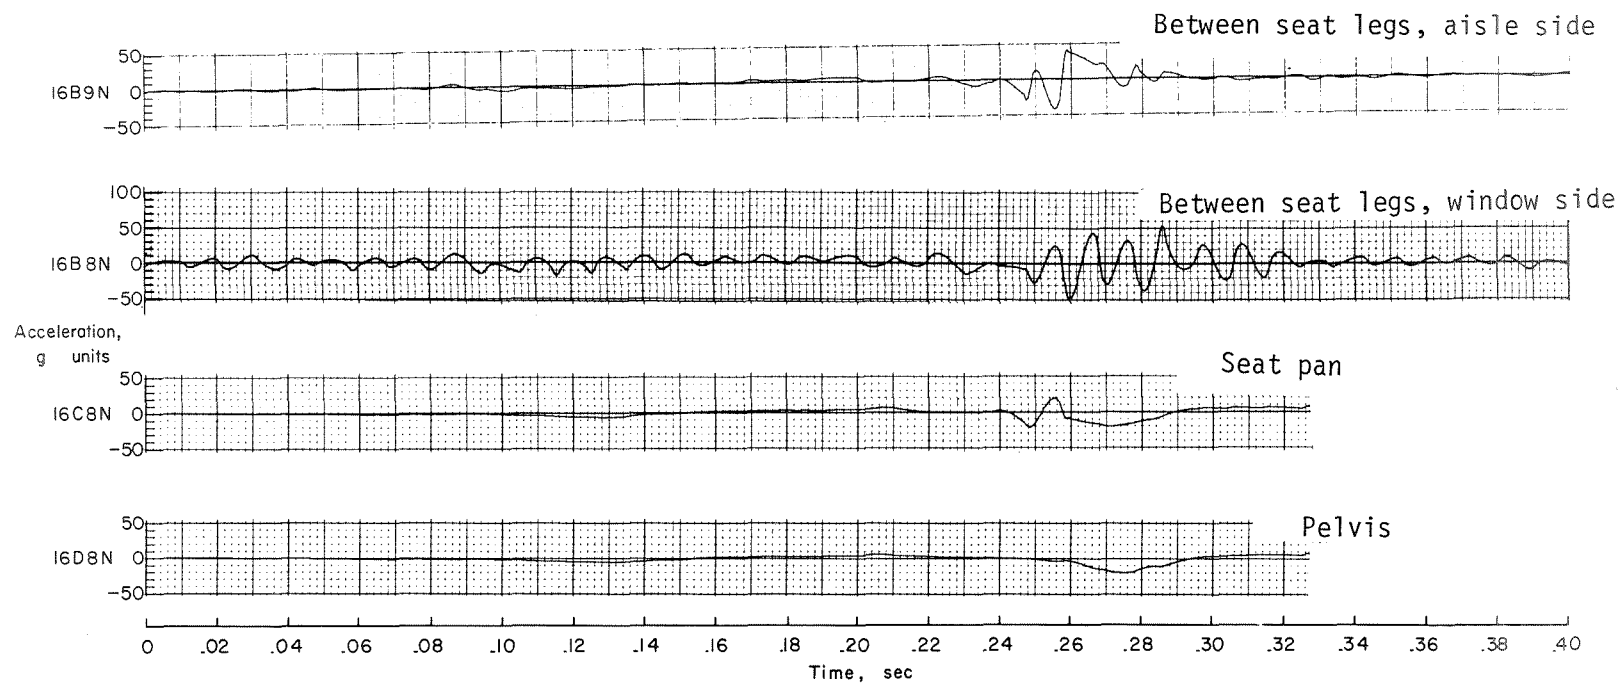
(c)  $-30^\circ$  test.

Normal accelerations at -30° roll.- Accelerations for the floor under the first-passenger seat, seat pan, and dummy pelvis for the -30° roll test specimen are shown in figure 23(c). The accelerometer on the window side of the first-passenger seat shows the same oscillatory motion as in the -15° roll test resulting from the loading of the wing aft attachment to the fuselage. Accelerations on the aisle side are low during the wing skid time as a result of the deformation and failure of the wing structure (see fig. 18), which resulted in discontinuities and less transmission of forces to the fuselage. As the fuselage at the main spar location contacts the impact surface, accelerations of about -40g and -50g on the floor under the aisle and window side seats are reflected as a pulse of approximately 20g on the seat pan at about the same time. The dummy pelvis acceleration also was approximately 20g. As in the -15° roll test specimen, the small reversing of the acceleration traces on the seat pan and dummy pelvis prior to nose contact is associated with the uprighting of the dummy in its seat. Normal accelerations on the floor at the first-passenger location and at the dummy's pelvis were highest for the 0° roll test and lowest for the -15° roll test. It should be noted that piezoelectric accelerometers were used in the dummy pelvis for the 0° roll test, whereas strain-gage accelerometers were used for the -15° and -30° roll tests.

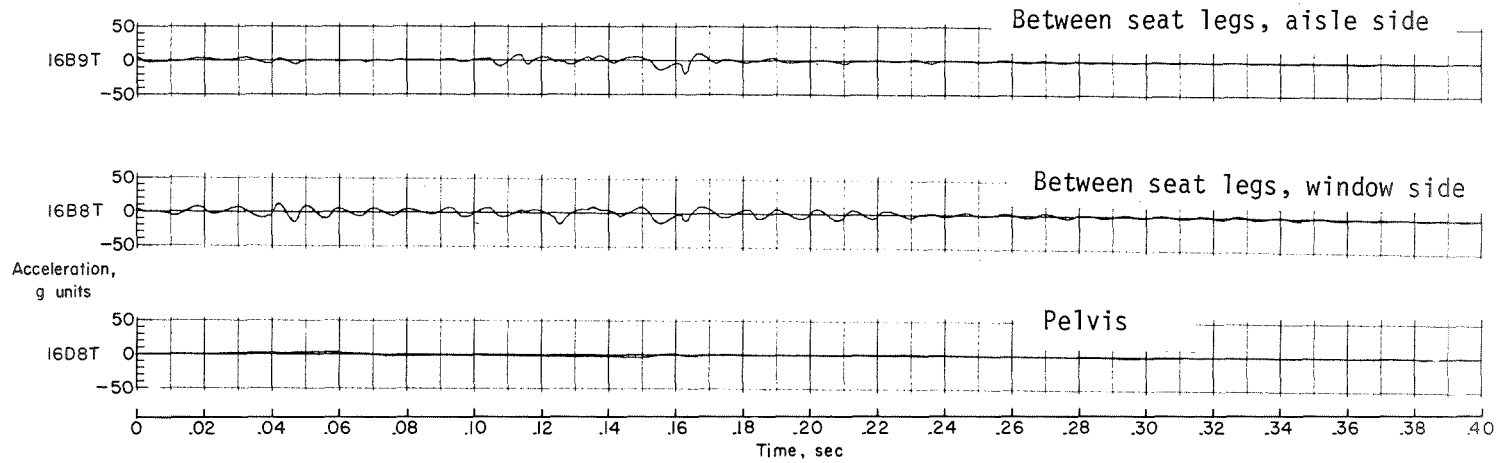
(a)  $-15^\circ$  test.

Transverse accelerations for the -15° and -30° roll tests (figs. 25(a) and 25(b)) were generally below 50g at both floor locations when the right wing of the airplane slammed onto the impact surface. Response to the impact at the dummy's pelvis was an acceleration pulse of about 5g for both tests.
