**737 GRAPHITE COMPOSITE FLIGHT SPOILER
FLIGHT SERVICE EVALUATION**

**BOEING COMMERCIAL AIRPLANE COMPANY
SEATTLE, WA**

AUG 78

737 GRAPHITE COMPOSITE FLIGHT SPOILER FLIGHT SERVICE EVALUATION

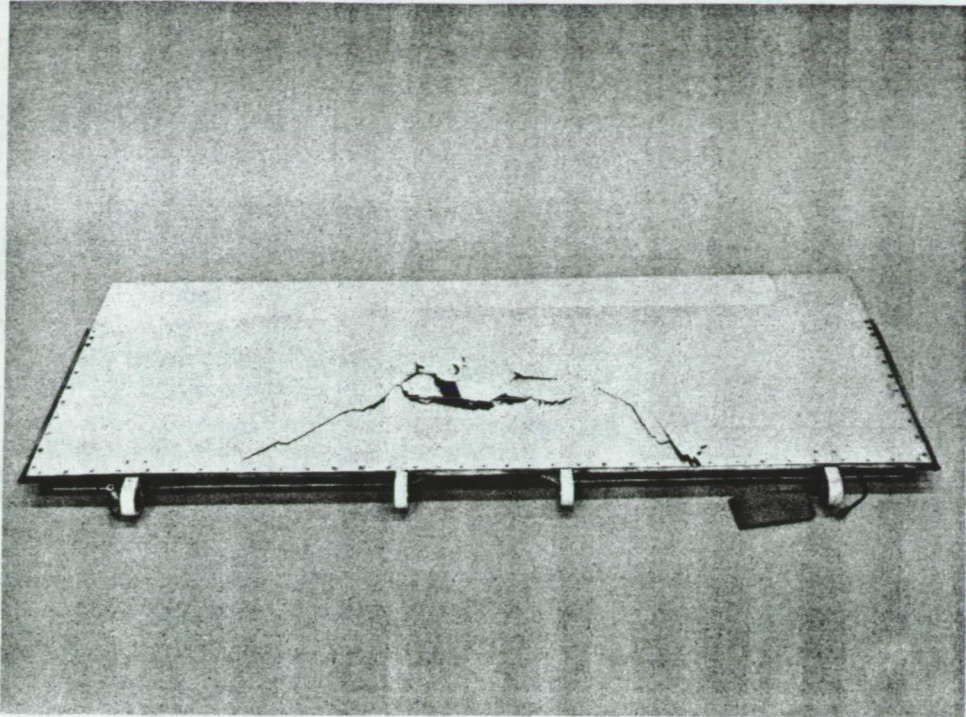
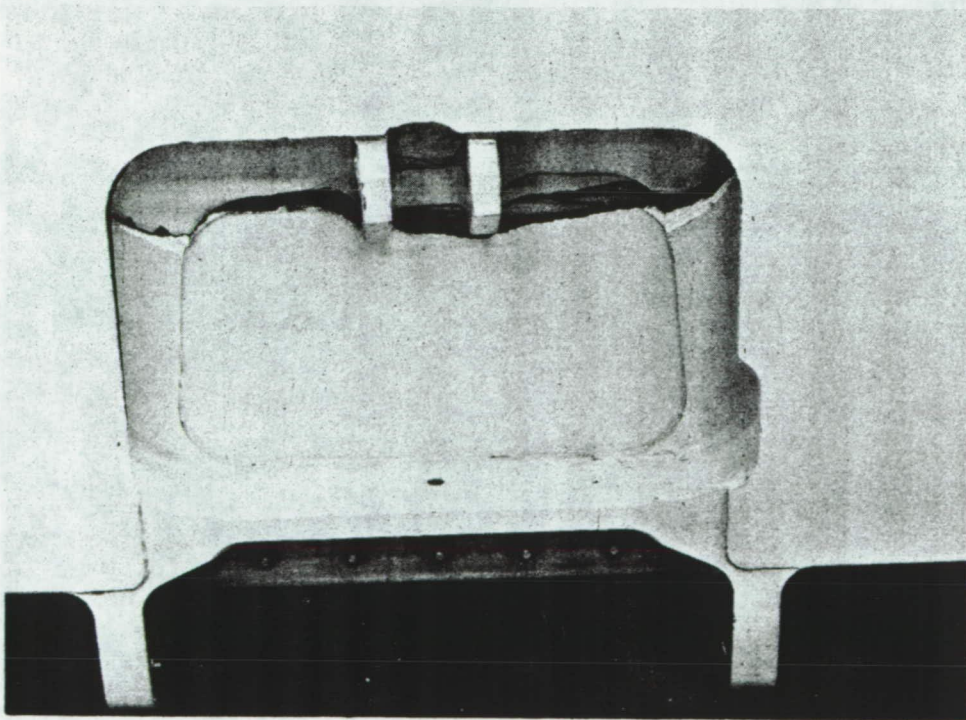
Figure 3.—Spoiler S/N 0071 Static Test

During this reporting period, a total of six spoilers were removed from the flight service program for evaluation and test. All removed spoilers (except S/N 0111 which has not yet been processed) were re-inspected using the ultrasonic through-transmission C-scan and the results compared to the records made at the time of original fabrication. No detectable differences were noted in this comparison. The sixth third-year spoiler S/N 0027, previously unreported, was processed through the ultrasonic inspection and returned to revenue service. Three of the fourth-year spoilers (S/N 0016, 0071, and 0107) were then selected to be destructively tested to measure residual static strength following the specified calendar period of exposure. Table 5 contains the residual strength and stiffness data relative to the fourth-year removals. Table 6 is repeated from reference 1 to complete the third year data. Figures 2, 3, and 4 show the spoiler panels after static testing. Figures 5, 6, and 7 are plots of the load-deflection data for these three panels.

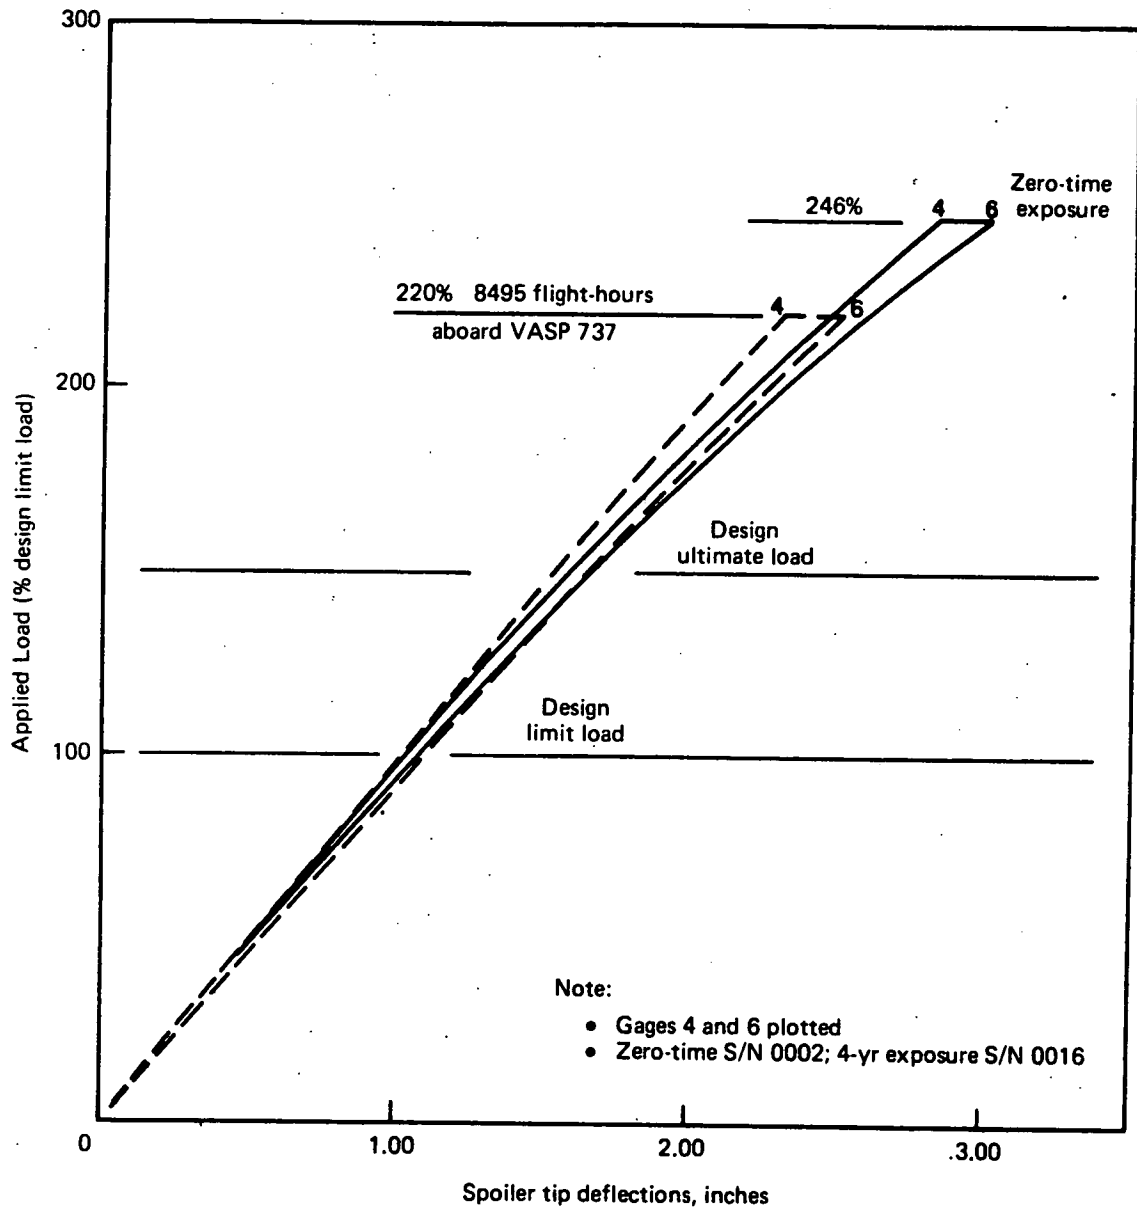
Figure 5.—Load-Deflection Curves—Zero-Time and 4-Year Exposure
(Union Carbide T300/2544 Material System)

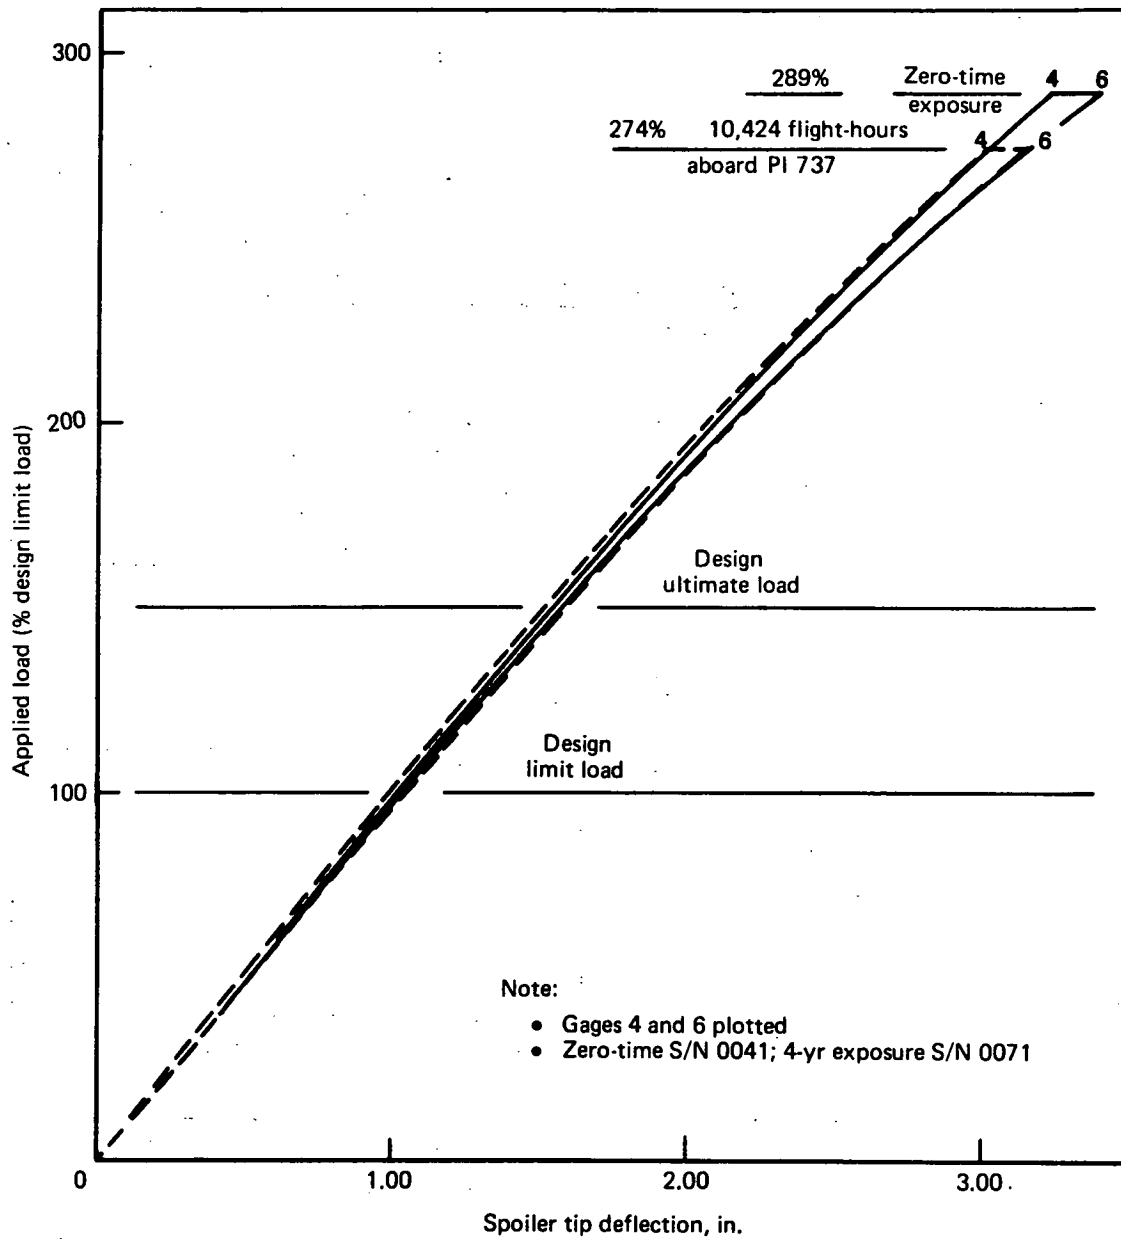
Figure 6.—Load-Deflection Curves—Zero-Time and 4-Year Exposure
(Narmco T300/5209 Material System)

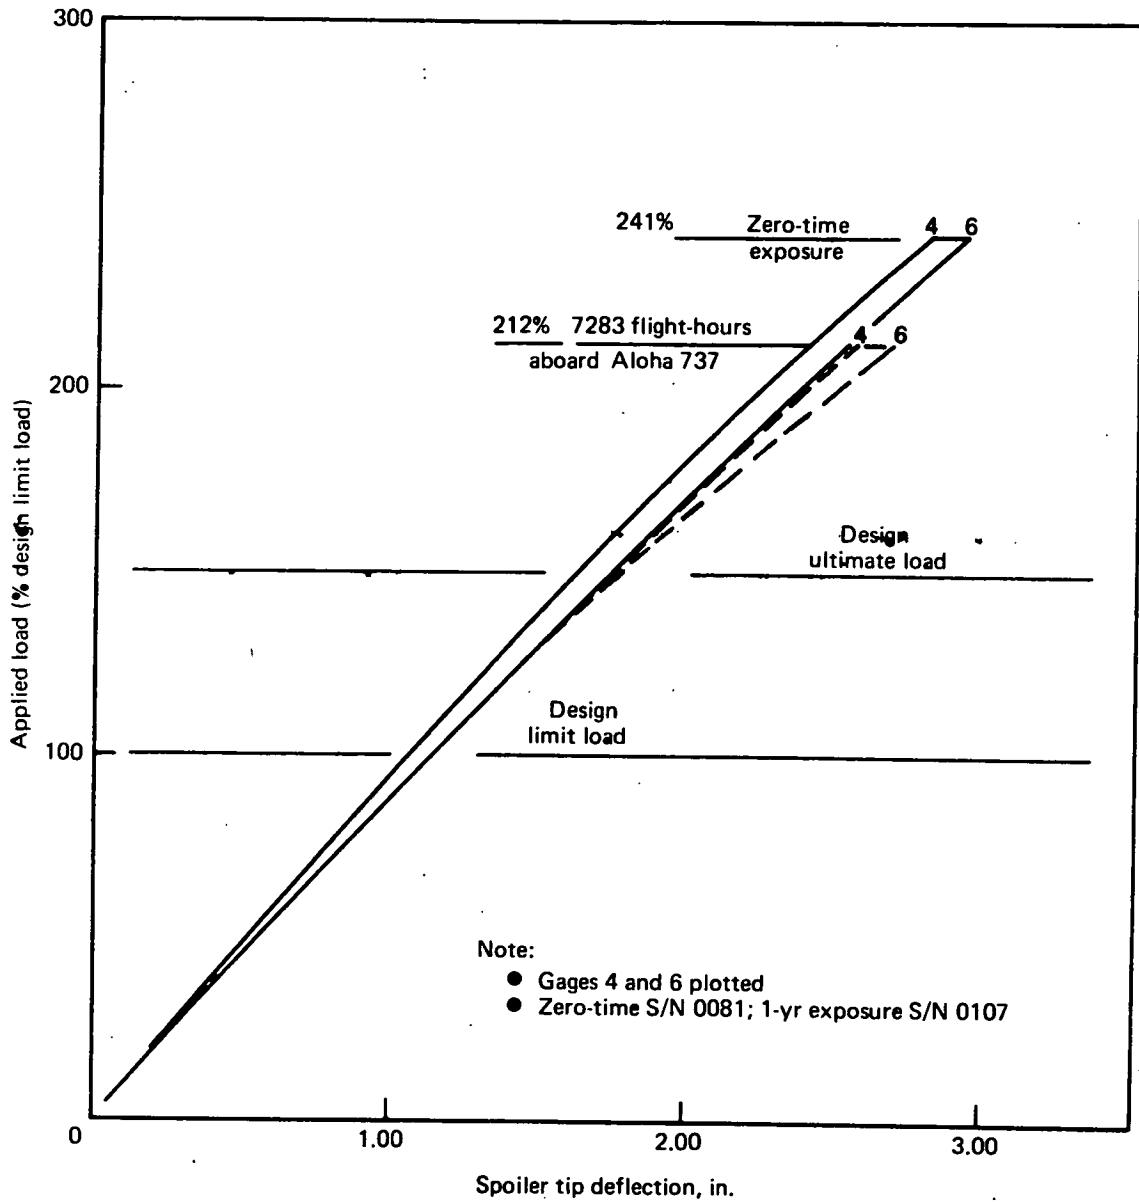
Figure 7.—Load-Deflection Curves—Zero-Time and 4-Year Exposure (Hercules AS/3501 Material System)

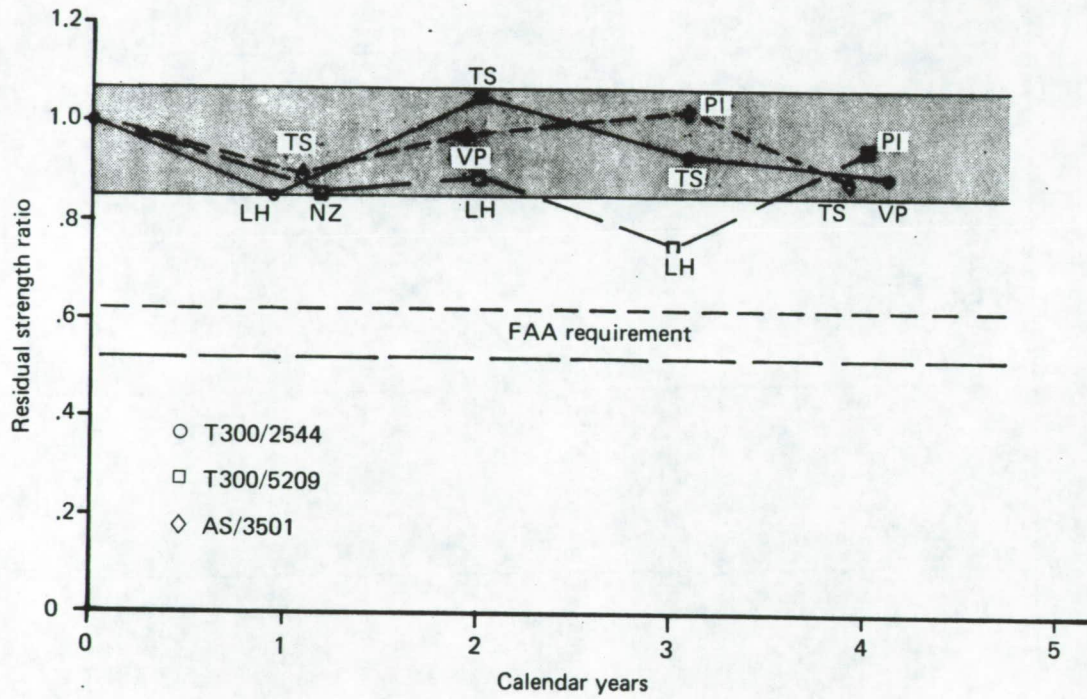
A plot of the residual static strength data accumulated to date appears in figure 8, plotted as a function of time. This data continues to illustrate the data scatter previously discussed in ref. 1, while at the same time showing a significant reversal of the downward trend previously identified for the 250°F curing resin system. Based on the available data, continued retention of static strength levels can be anticipated.

Figure 8.—Residual Strength After Exposure

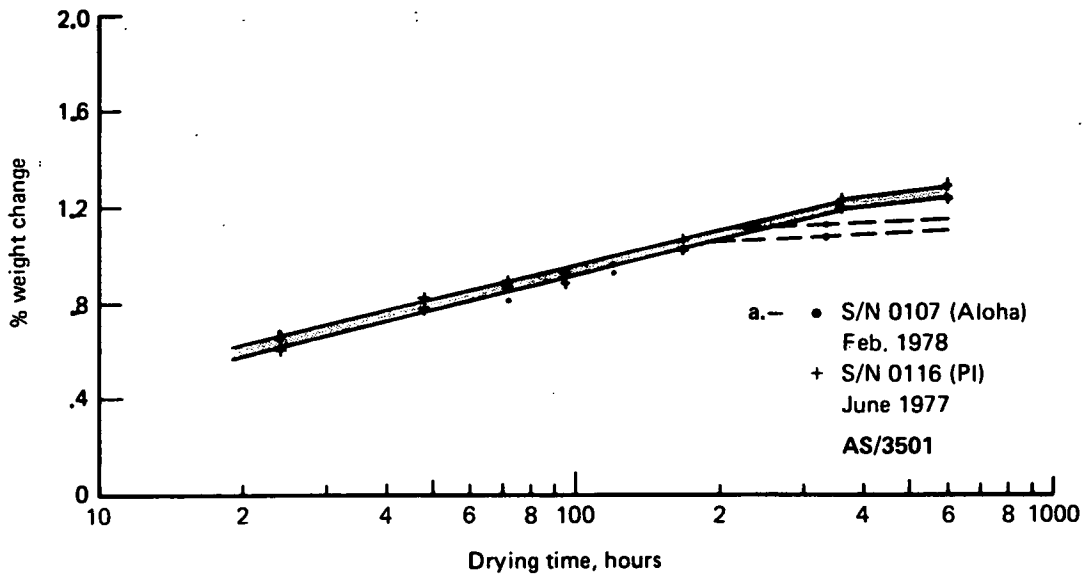
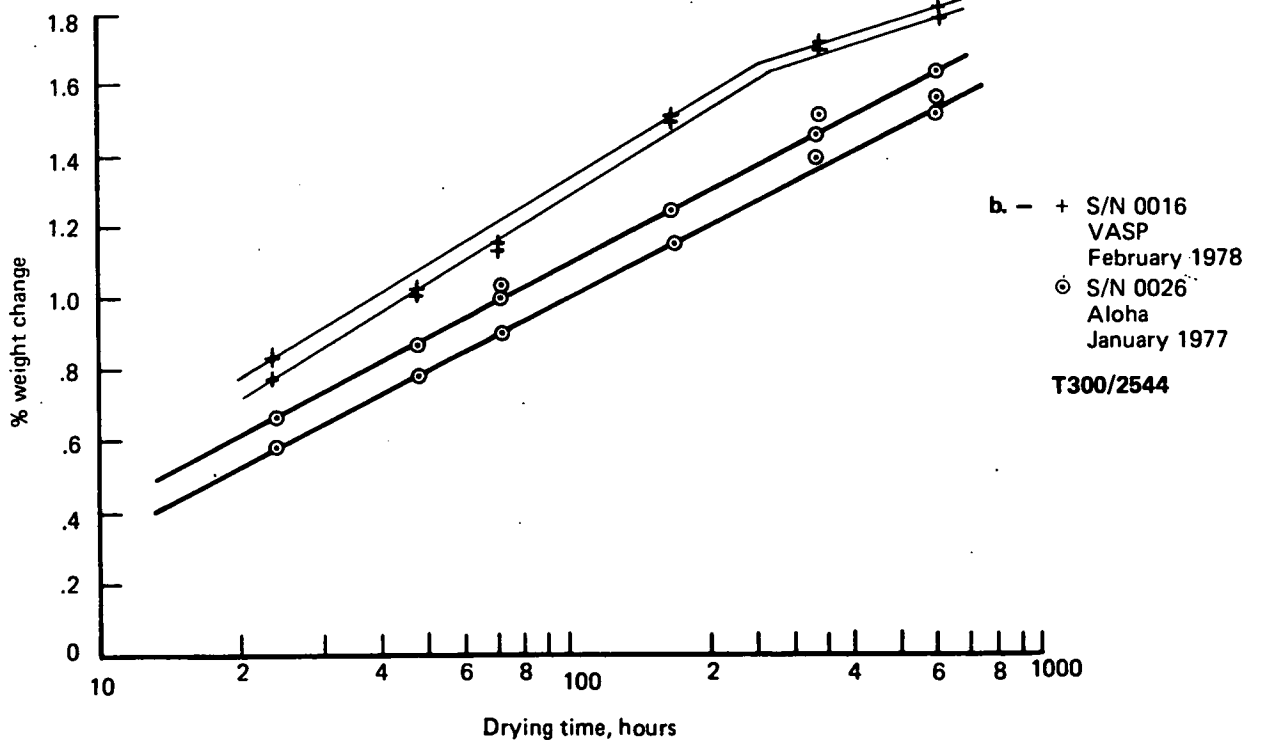
As a continuation of the moisture sampling technique initiated and described in ref. 1, additional core samples were obtained from two of the spoiler panels which were static-tested for residual strength (ref.: Static Test Results). Spoilers S/N 0016 (VASP) and 0107 (Piedmont) each had 3 core samples removed prior to static test. These six specimens were oven-dried at 160°F, with periodic measurement of weight changes. Plots of the weight changes as a function of time are shown in figure 9. This data, in conjunction with the previous core-sample data in reference 1, will be consolidated with other moisture-absorption data as it becomes available.

Comparable data from the third-year static test spoiler S/N 0116, unreported in last year's documentation due to unavailability, is also shown in fig. 9.

Figure 9.—Moisture Weight Change

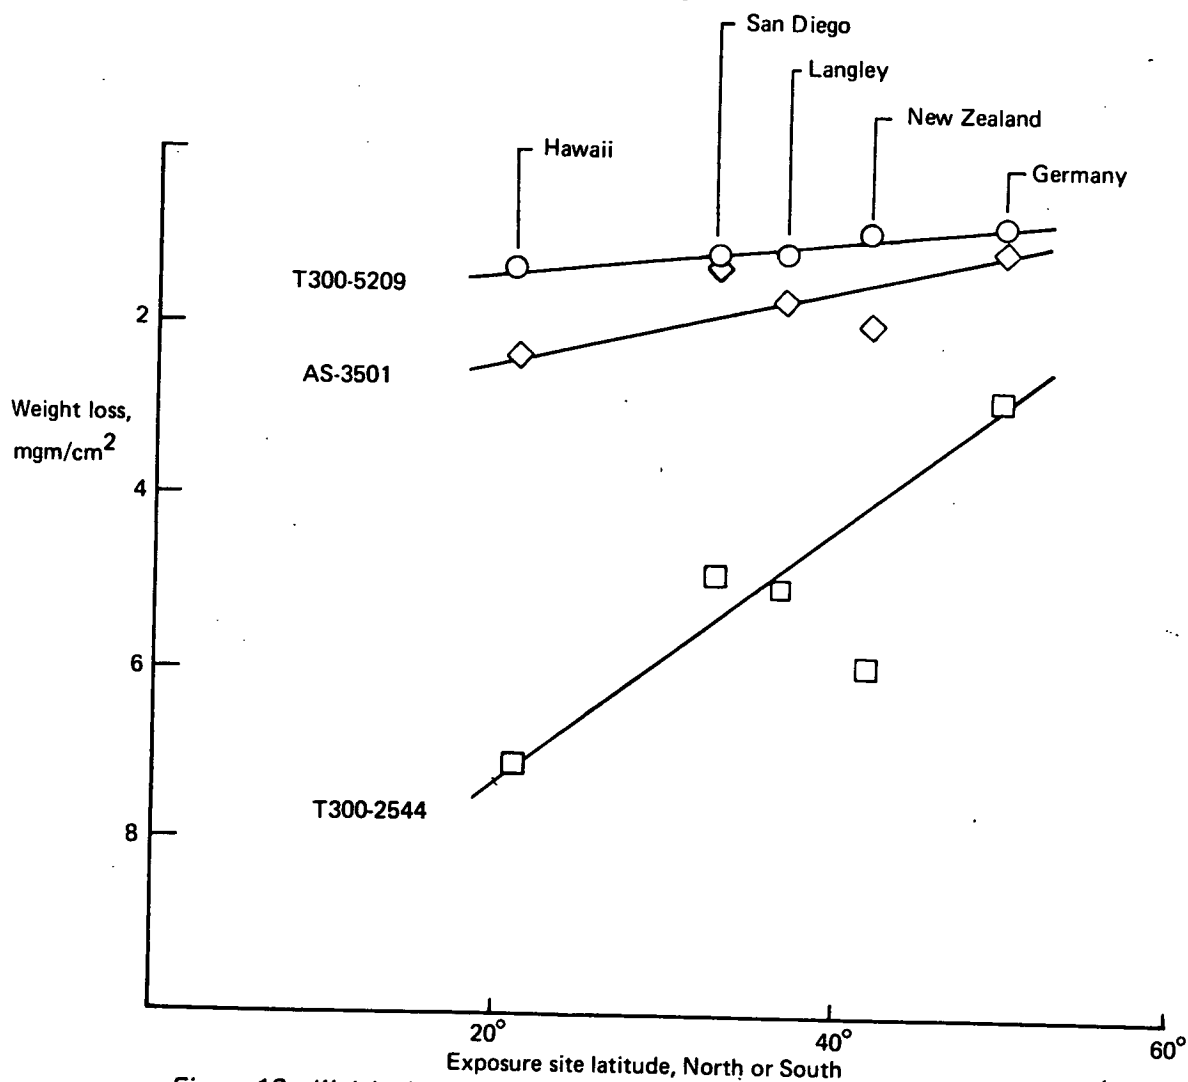
Similar data are not generated for the shear specimens because of their small size, nor for compression specimens because of the glass/epoxy tabs bonded to the specimens. Figure 16 is a plot of the weight loss data resulting from three years outdoor ultraviolet exposure for all exposure sites except Sao Paulo. The Sao Paulo specimens are still being dried after testing. The weight loss data are presented as a function of exposure site latitude. The limited data obtained to date indicates that weight loss due to ultraviolet exposure is approximately inversely proportional to the distance of the exposure site from the equator. It should be pointed out that all specimens had bare surfaces.

Figure 16.—Weight Loss From Environmental Exposure (Three Years)

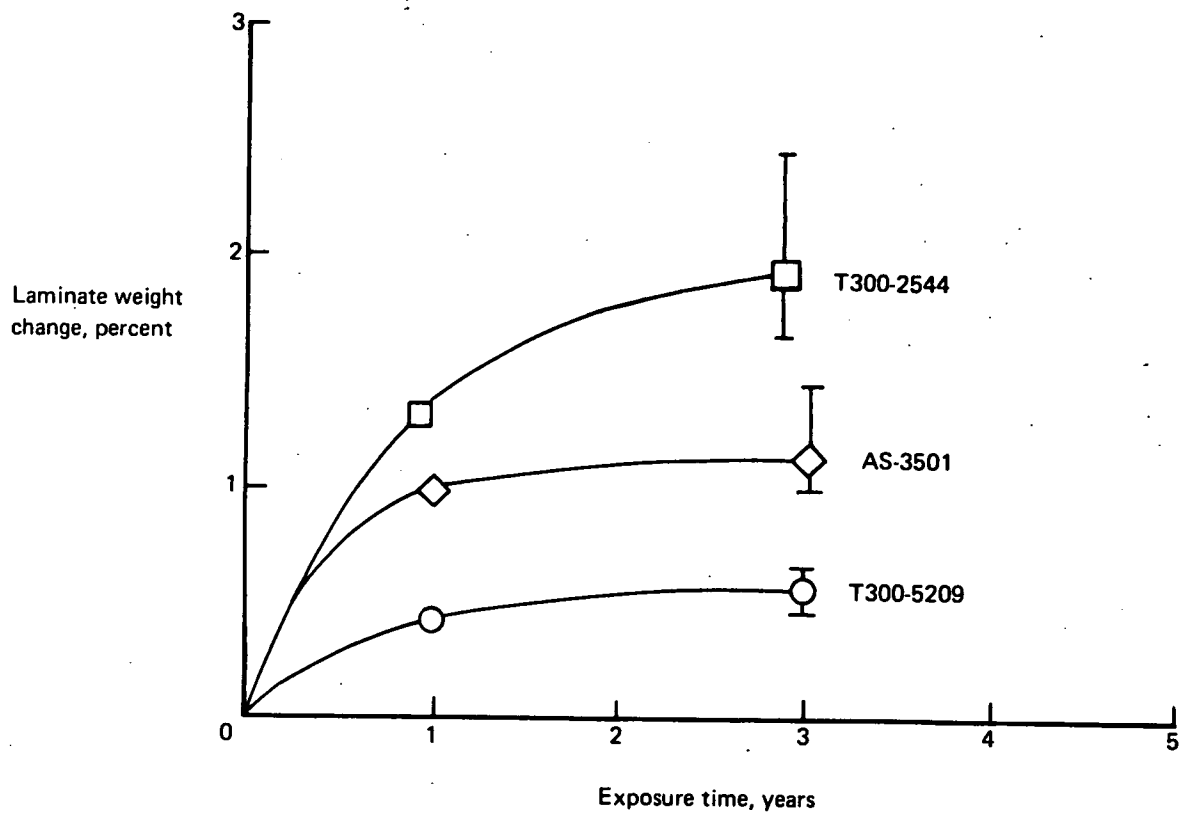
The amount of moisture absorbed by the several graphite-epoxy materials is shown in figure 18. These results represent the determinations made on flexure specimens after their worldwide outdoor exposures for times up to three years.

Figure 18.—Moisture Pickup for Composites After Worldwide Ground-Based Exposures
