NASA Technical Memorandum 79227

THE EROSION/CORROSION OF SMALL
SUPERALLOY TURBINE ROTORS
OPERATING IN THE EFFLUENT
OF A PFB COAL COMBUSTOR

G. R. Zellars, S. M. Benford,
A. P. Rowe, and C. E. Lowell
Lewis Research Center
Cleveland, Ohio

Prepared for the
Advanced Materials for Alternate Fuel Capable
Directly Fired Heat Engines Conference
cosponsored by the United States Department of Energy
and the Electric Power Research Institute
Castine, Maine, July 30 - August 3, 1979

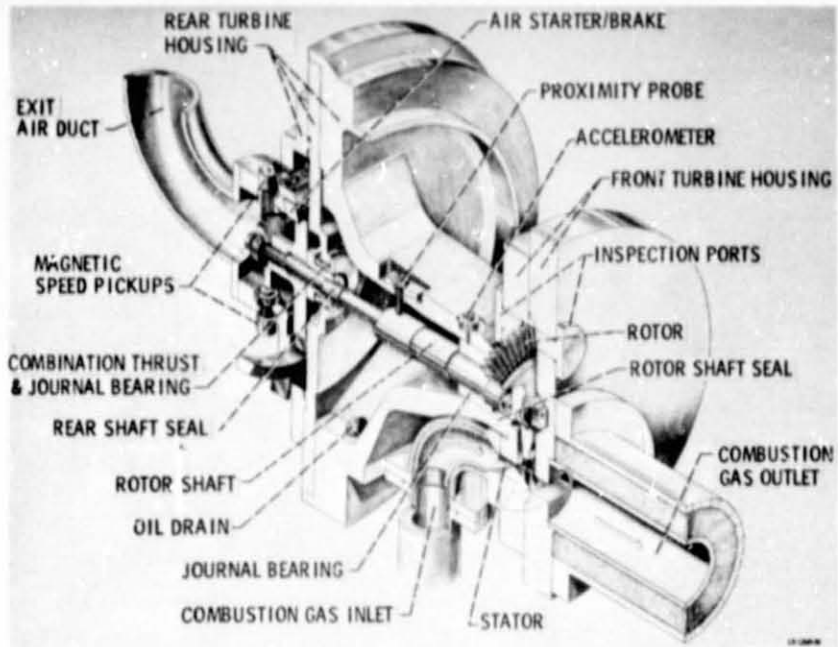
Figure 4. - Isometric sectional drawing of turbine.

The shaft of the rotor rests on air purged journal and thrust bearings (Figure 4). The relative position of the rotor disc and shaft in the automotive design is inverted from usual construction, so that the leading edge of the blades face the shaft. The stator opening is located in the housing near one of the bearings. In order to reach the stator inlet, the combustion gas line (5 cm dia) rising from the bed makes a 90 degree turn near the center of the shaft. A second turn of about 65 degrees in the stator and a reduction in flow area to about 1.3 cm^2 generates design velocities ($\approx 500 \text{ m/s}$) at the stator exit. Assymetric erosion of the stator indicated that considerable heavy particle separation occurred at these turns.

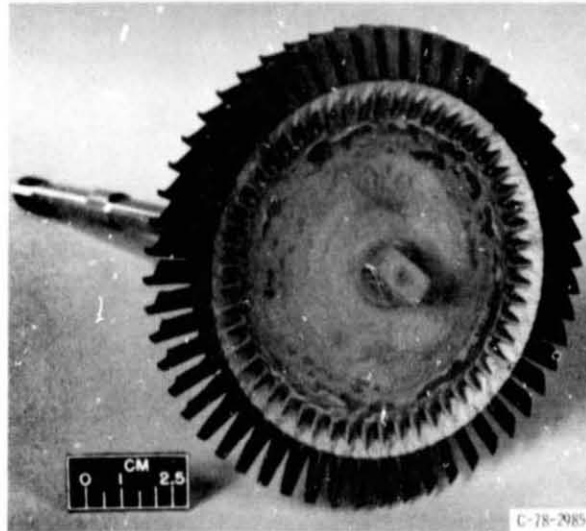
Figure 5. - Cast rotor with shaft.

The rotors were cast with nickel based alloys in shell molds (Figure 5). Two of the three rotors were IN792+Hf (12% Cr, 6% Al, 4.5% Ti) and one was Alloy 713LC (12% Cr, 3% Al, 0.6% Ti). Both of these alloys form predominantly chromium and nickel oxides and spinels at test temperatures (690-780 C) in air. Gas flow conditions in the stator are shown in Table 2. The two high velocity (560 m/s), temperature (780 C), and loading (2700 ppm) tests were run with IN792+Hf rotors; the lower velocity (490 m/s), loading (600 ppm), and temperature (690 C) test was run with an Alloy 713LC rotor. Average cyclone efficiency ranged from 60 to 70% and was much higher at times during R3. Because of the difference in alloy composition, a direct comparison of high and low velocity erosion rates requires the assumption that the alloys behave similarly. This assumption, based on previous Lewis wedge test results, may be correct only if the erosion surfaces are similar or if a significant amount of loss is generated by the erosion of bare metal.
