NASA-CR-135447

DEFINITION OF MUTUALLY OPTIMUM NDI
AND PROOF TEST CRITERIA FOR
2219 ALUMINUM PRESSURE VESSELS

VOLUME III APPLICATIONS TO RAIL DEFECT EVALUATION

MARTIN MARIETTA CORPORATION

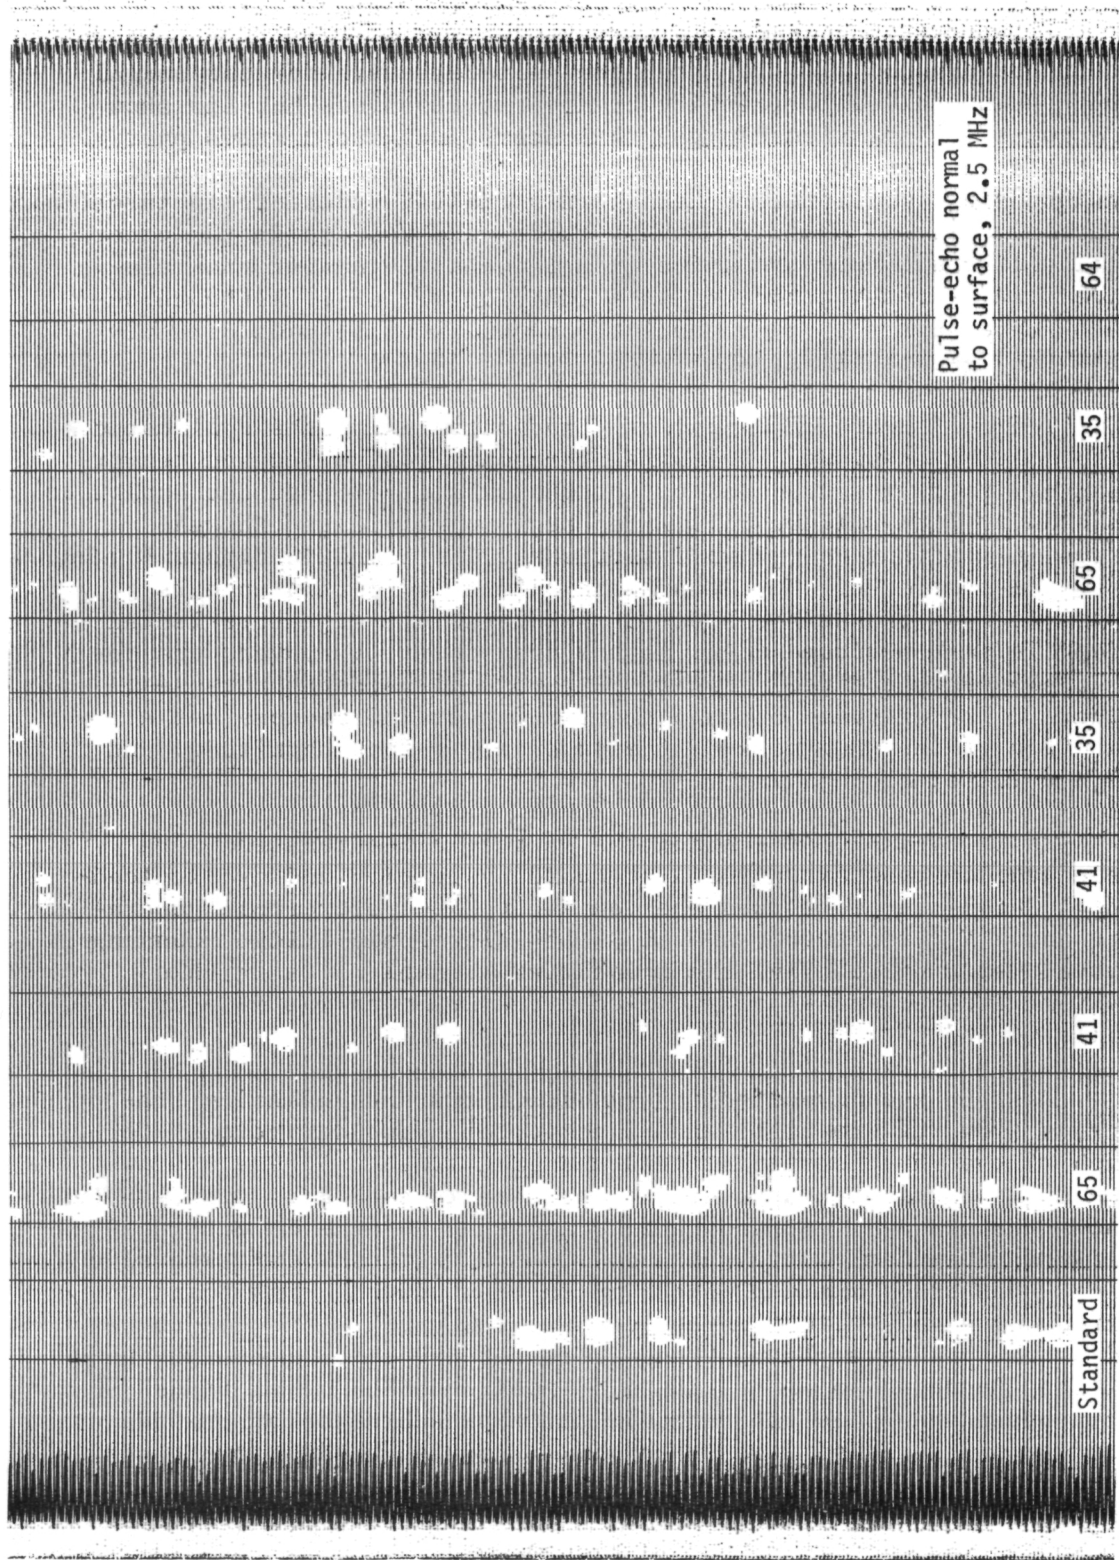
Figure 3. - Pulse-echo scan of DOT rails (side of head).

Rails containing defect location markings were cut into 0.7-m (2-ft) lengths and the heads parted from the web section. Side faces were inspected using the pulse-echo technique with the transducer oriented 90° and 70° from the surface. Data for the normal (90°) scans failed to identify transverse fissures, but did show the numerous inclusions in the rail steel. Figure 3 shows part of the scans for the various sections. Scans made at 70° inclination using two different gain levels indicated defects in three sections. It was unclear whether there were defects in the other rail sections. Note the difference between the number and relative size of the indications as a function of gain. Although defects were apparent, characterization could not be made directly from the C-scans illustrated.

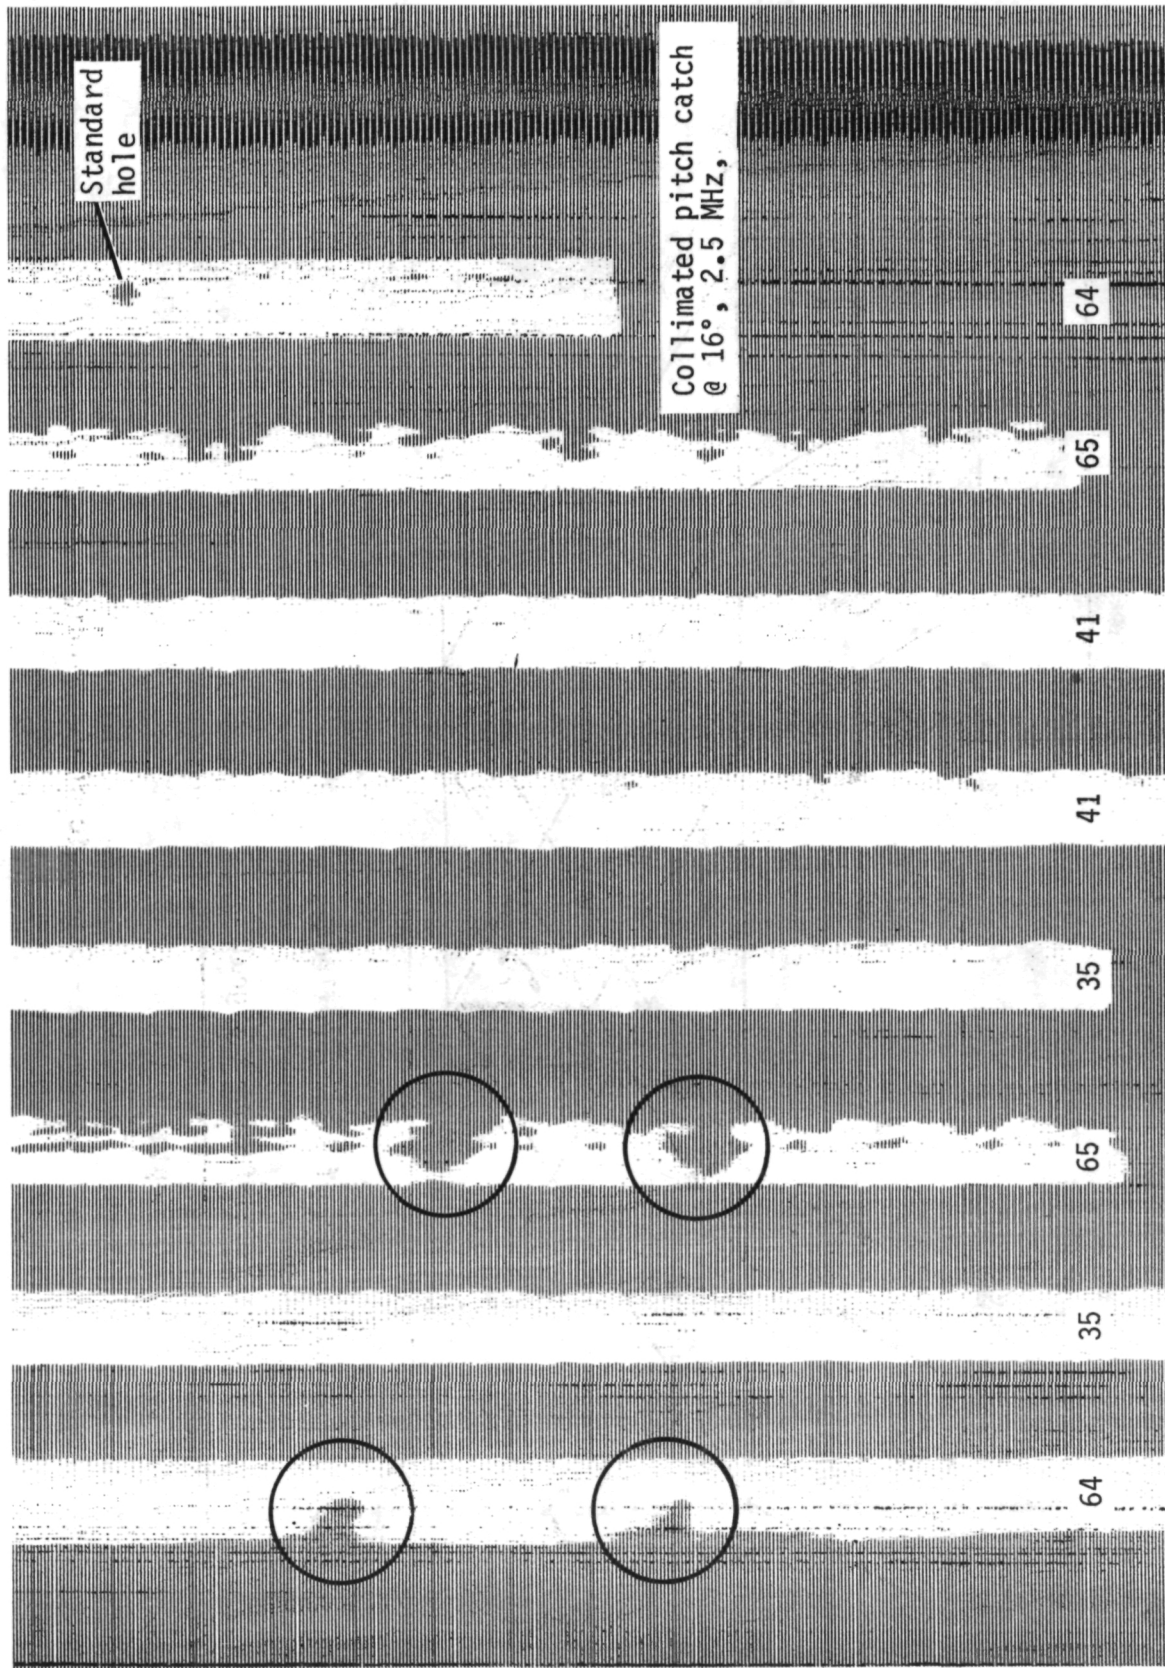
Figure 4. - Collimated pitch-catch scan of DOT rails (side of head).

The rails were ultrasonically inspected using the collimated pitch-catch technique. The same ultrasonic monitoring and traversing apparatus was used except for the substitution of the dual transducer head. These collimated beam scans clearly showed large indications in two rail sections. The scans in figure 4 show these defects. Note that each defect indication appears twice because the defect blocked the ultrasonic signal reflected from the back surface; then, as the transducer was moved, the defect blocked the direct signal. Figure 5 illustrates this sequence. The distance between the two defect indications was a function of the thickness of the material, defect magnitude, and defect location.

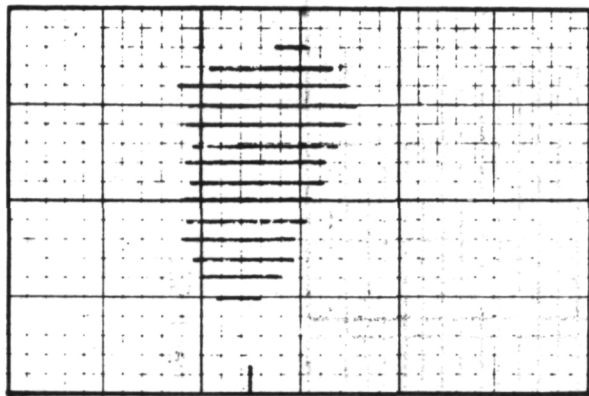
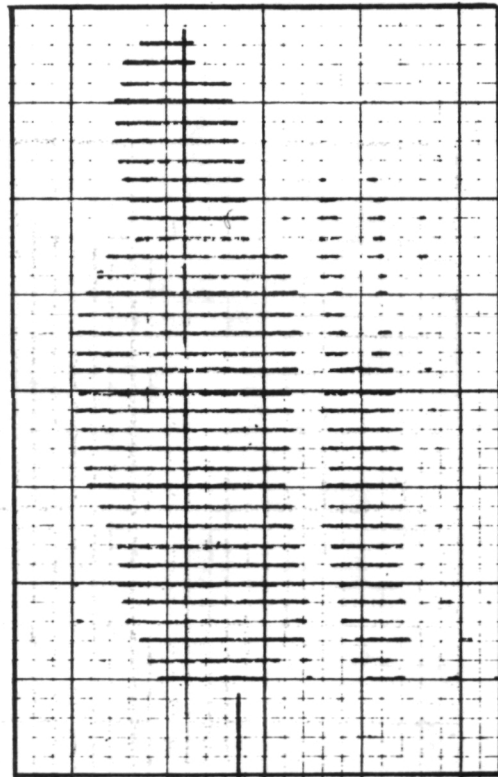
Figure 6. - Pulse-echo scans of top surface of rail 65.

Rail 65 was inspected in six directions, representing traverses from left to right and right to left (two directions) for each of the three surfaces (head and each side). Figure 6 shows the scans obtained by traversing the head in each direction. Note the significant difference in size and shape of the defect indications. Similarly, figures 7 and 8 show the scans for each side face. One trace was duplicated on the next day and was found to agree quite well with the previous result. Such scans had to be adjusted for the angle of transmission of the signal through the metal. By doing so and making a composite of the seven scans (six directions plus one repeat), the representation of the defect shown in figure 9 was obtained. Experience has shown that a better correlation with actual defect size was obtained by incorporating a correction for beam width. Figure 10 illustrates the reduction in size of the indicated defect by half- and full-beam-width correction and compares actual defect size and shape.

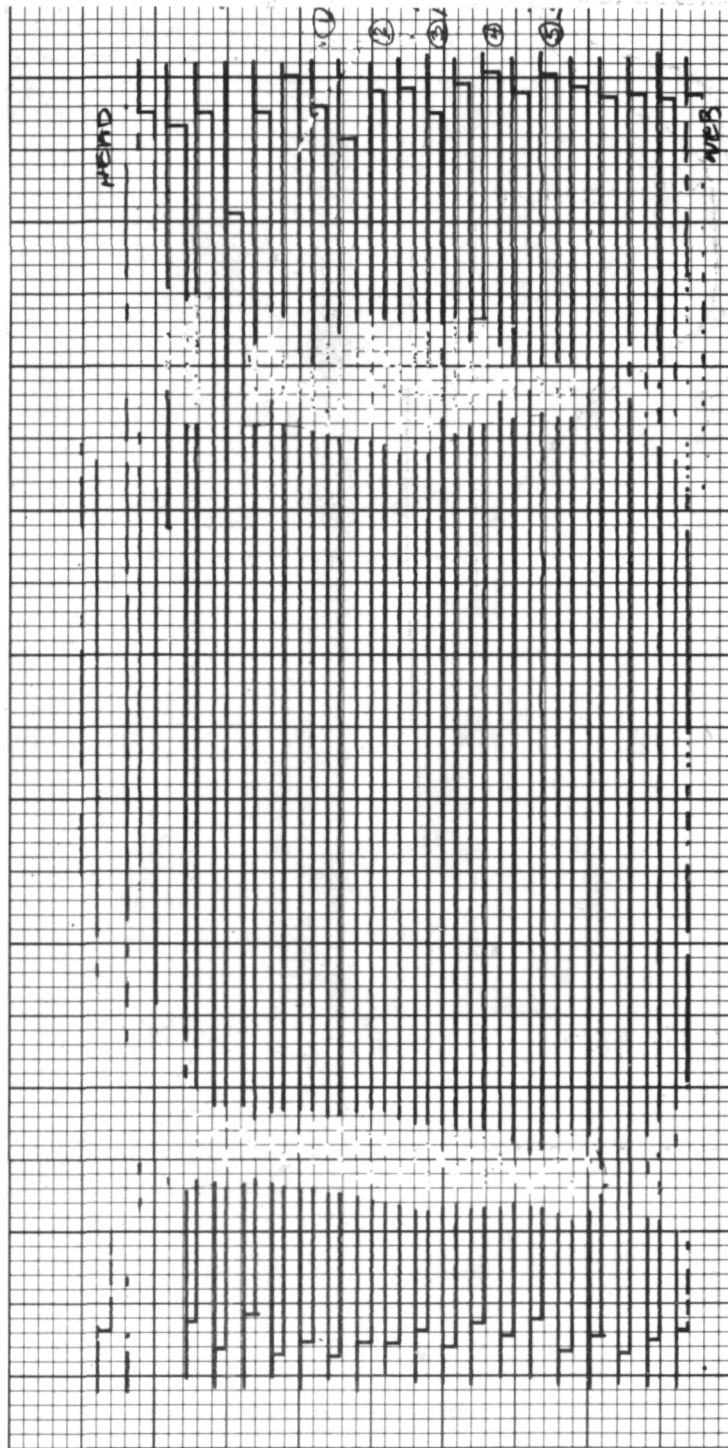
Figure 15. - Collimated pitch-catch data for rail 64 after cyclic loading.

To enlarge the defect, the specimen was then subjected to a series of cyclic loadings at 172 MN/m^2 (20 ksi). After each cyclic loading, the rail section was reinspected. The growth band was marked by cycling at a lower stress to produce a small growth band of different appearance. The marking cycle was 5000 reversals at a stress of 138 MN/m^2 (20 ksi). Five growth and inspection sequences were performed. Figure 15 is an ultrasonic record after cycling in which depth growth was apparent. For additional clarity, ink blots have been removed, and a flaw map of these data transformed to true shape. Figure 16 shows a fracture-face photograph.

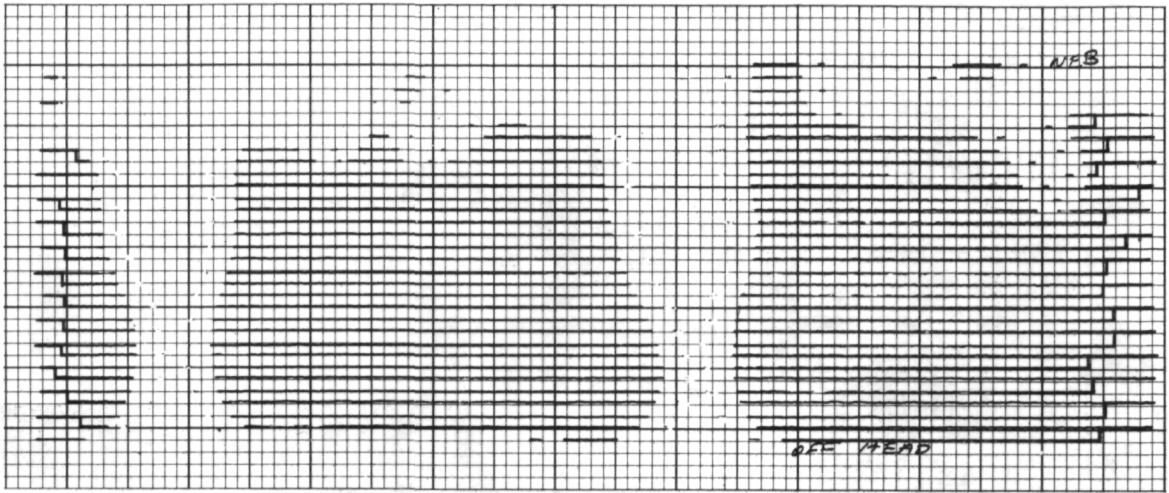
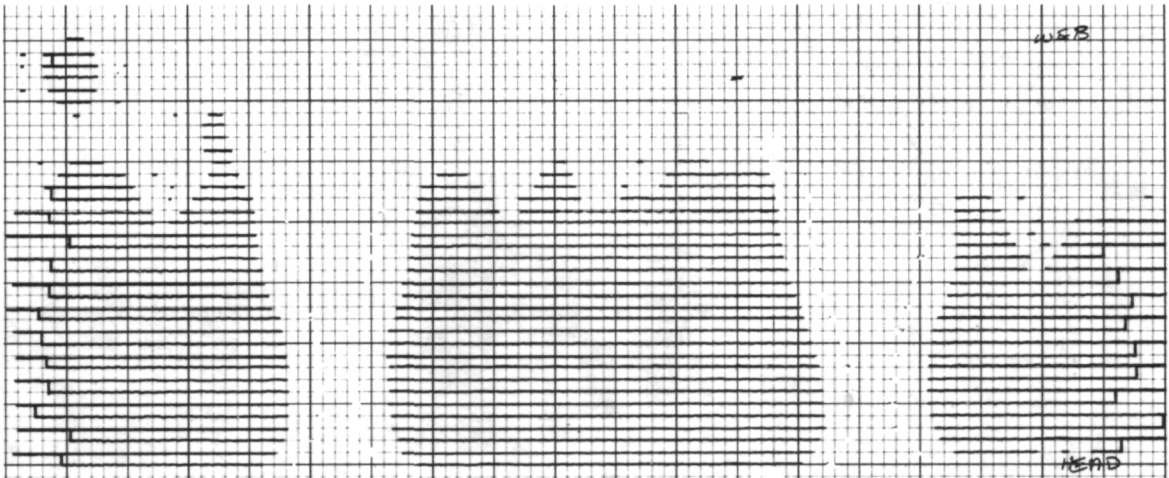
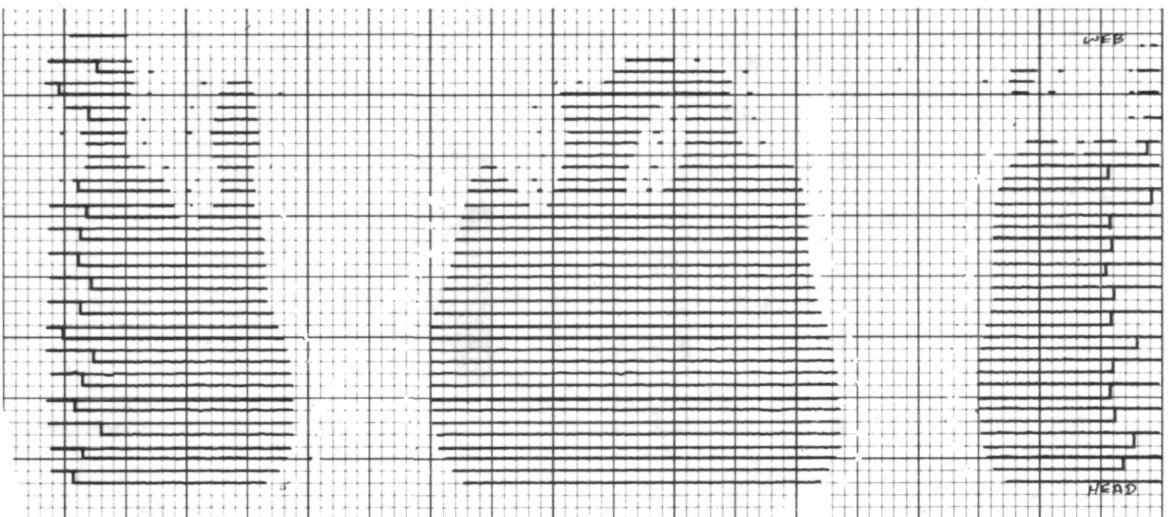
Figure 17. - Collimated pitch-catch data for rail 65 in as-received condition and after cycling.

Rail 65 was similarly inspected, cycled, and reinspected using the collimated pitch-catch ultrasonic technique. Actual data traces are combined in figure 17 to illustrate growth resulting from cycling. The data traces suggest that the defect extends

through the entire section from head to web. The traces also suggest an hourglass shape for the defect. The fractograph in figure 18 shows the defect to be totally embedded; a flaw map constructed from the data is also shown.

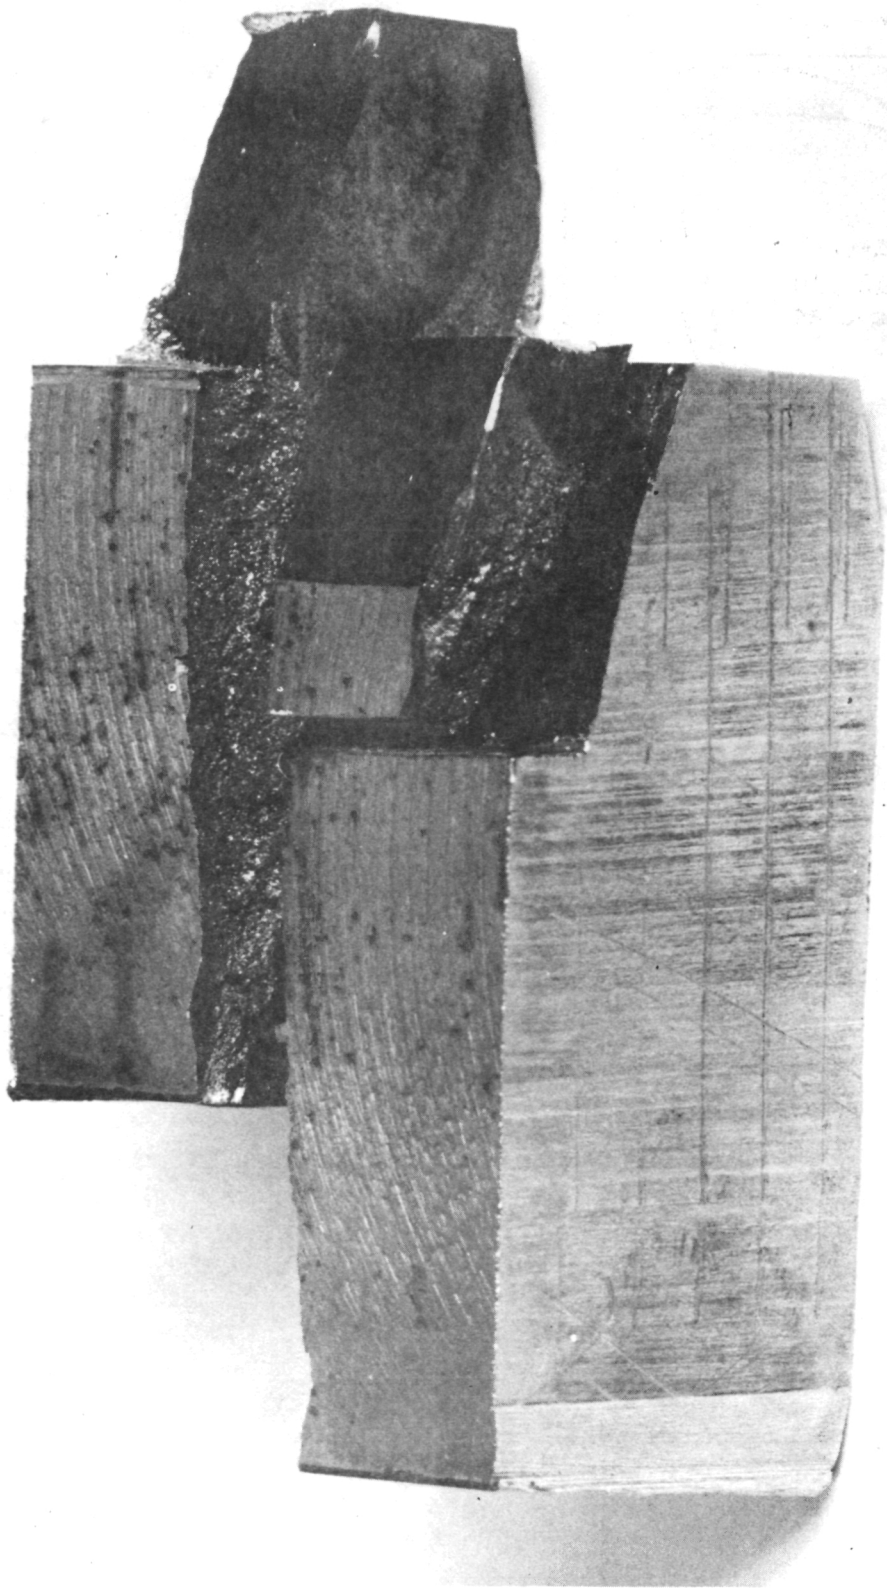
Figure 22. - Photograph of multiple defects in rail 3.

blocked the ultrasonic signal. Figure 21 shows the flaw map and views of the two transverse fracture faces. The flaw map identifies defects A and B. Defect A narrowed as it extended into the center of the rail, then suddenly widened. The widening was probably caused by detection of the detail portion of the fracture and is shaded in the flaw map. As anticipated, the detail portion of the defect was skewed and would mask the ultrasonic signal. Figure 22 is a photo of the two defects in rail 3 showing their relative proximity.
