NASA Technical Memorandum 79112

SOME EFFECTS OF CYCLIC INDUCED
DEFORMATION IN ROCKET THRUST CHAMBERS

N. P. Hannum, R. J. Quentmeyer, and H. J. Kasper
Lewis Research Center
Cleveland, Ohio

TECHNICAL PAPER to be presented at the
Conference on Advanced Technology for Future Space Systems
sponsored by the American Institute of Aeronautics and Astronautics
Hampton, Virginia, May 8-11, 1979

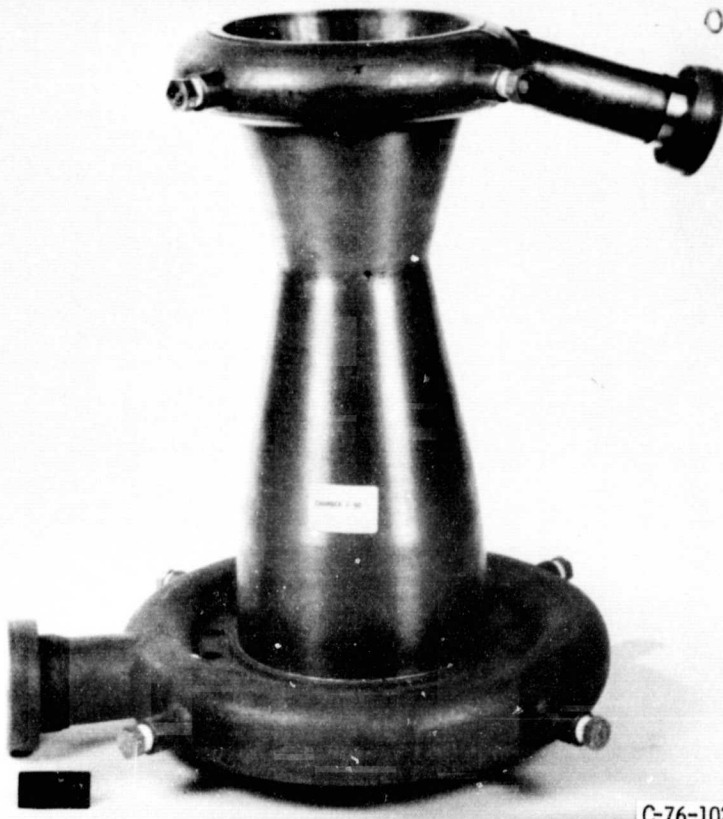
(a) COMPLETED FATIGUE CHAMBER.

The details of the thrust chambers used in the fatigue life investigation are shown in Fig. 1. The completed chamber is shown in Fig. 1(a). The chambers, which had a contraction ratio of 3.70, were 38.1 cm (15 in.) in length overall with the throat located 25.4 cm (10 in.) from the injector face. The throat was 6.60 cm (2.6 in.) in diameter, and the nozzle exit was 13.2 cm (5.2 in.) in diameter. The chamber liners were made of copper or a copper alloy and had coolant passages machined into the outer surface. After machining, the coolant passages were temporarily filled with a wax, and a layer of nickel was electrodeposited onto the outer surface to close out the coolant channels and form the outer structural jacket. The coolant passage cross section thus formed is shown in Fig. 1(b), which is a section through the throat plane of the chamber. The coolant passage dimensions were selected to provide a hot-gas-side wall temperature of 811 K (1460° R) in the throat for the operating conditions of 4.14 MN/m² (600-psia) chamber pressure and 0.91-kg/sec (2.0-lb/sec) coolant flow rate.

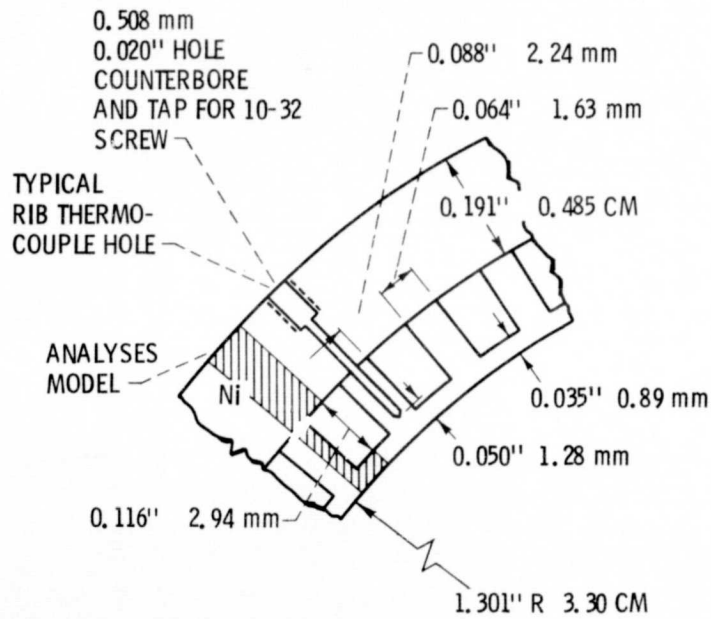
(b) WALL CROSS SECTION AT THE NOZZLE THROAT.

Much lower design temperatures were selected for other areas of the chamber to insure that the throat would be the region of highest strain. Spring loaded thermocouples were used to measure rib temperature. The location of these thermocouples is shown in Fig. 1(b). All chambers used in the testing were designed with the same coolant passage dimensions at the throat section. After electroforming, the wax was melted out of the coolant passages, the manifolds welded on, and the instrumentation attached.

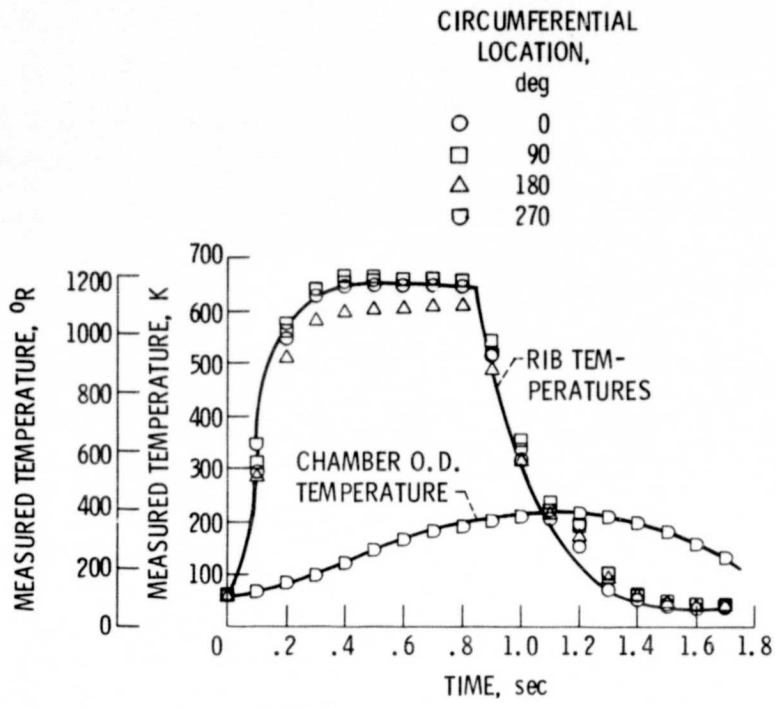
The nominal steady state combustion chamber pressure was 4.14 MN/m^2 (600 psia) and the nominal coolant flow rate was 0.91 kg/sec (2.0 lb/sec). Care was taken to insure that the combustion propellant and coolant flow rates and pressures were nearly the same for each cycle of a test series. The steady state oxidant-fuel ratio was nominally 6.0 and was held within a range of approximately ± 0.15 for all tests. Combustion chamber pressure did not vary more than $\pm 3\%$ from the nominal value. Coolant flow rate did not vary more than $\pm 2\%$ from the nominal value. Experimental data reported in Ref. 5 have shown that a $\pm 2\%$ variation in coolant flow rate is equivalent to $\pm 11 \text{ K}$ ($\pm 20^\circ \text{ R}$) variation in rib temperature. Typical rib temperature data for a single cycle are presented in Fig. 2. The data presented are typical of all chambers tested in terms of transient response and the range of data between the four thermocouples. The difference in temperature between the hottest and the coldest circumferential locations was approximately 69 K (125° R) at the end of the transient and less toward the end of the firing. The rise time for the chamber pressure transient was approximately 50 msec. The rib temperature transient occurred in approximately 0.4 sec. Also shown in Fig. 2 are typical chamber outer surface temperature data as a function of time for one cycle. It can be seen

Figure 2. - Measured rib temperatures and chamber O. D. temperature as function of time for one firing cycle. Chamber S/N 70.
