NASA-CR-159486
PWA-5615-3

STRAIN GAGE SYSTEM EVALUATION PROGRAM
FINAL REPORT

UNITED TECHNOLOGIES CORPORATION
PRATT & WHITNEY AIRCRAFT GROUP
COMMERCIAL PRODUCTS DIVISION

March 1979

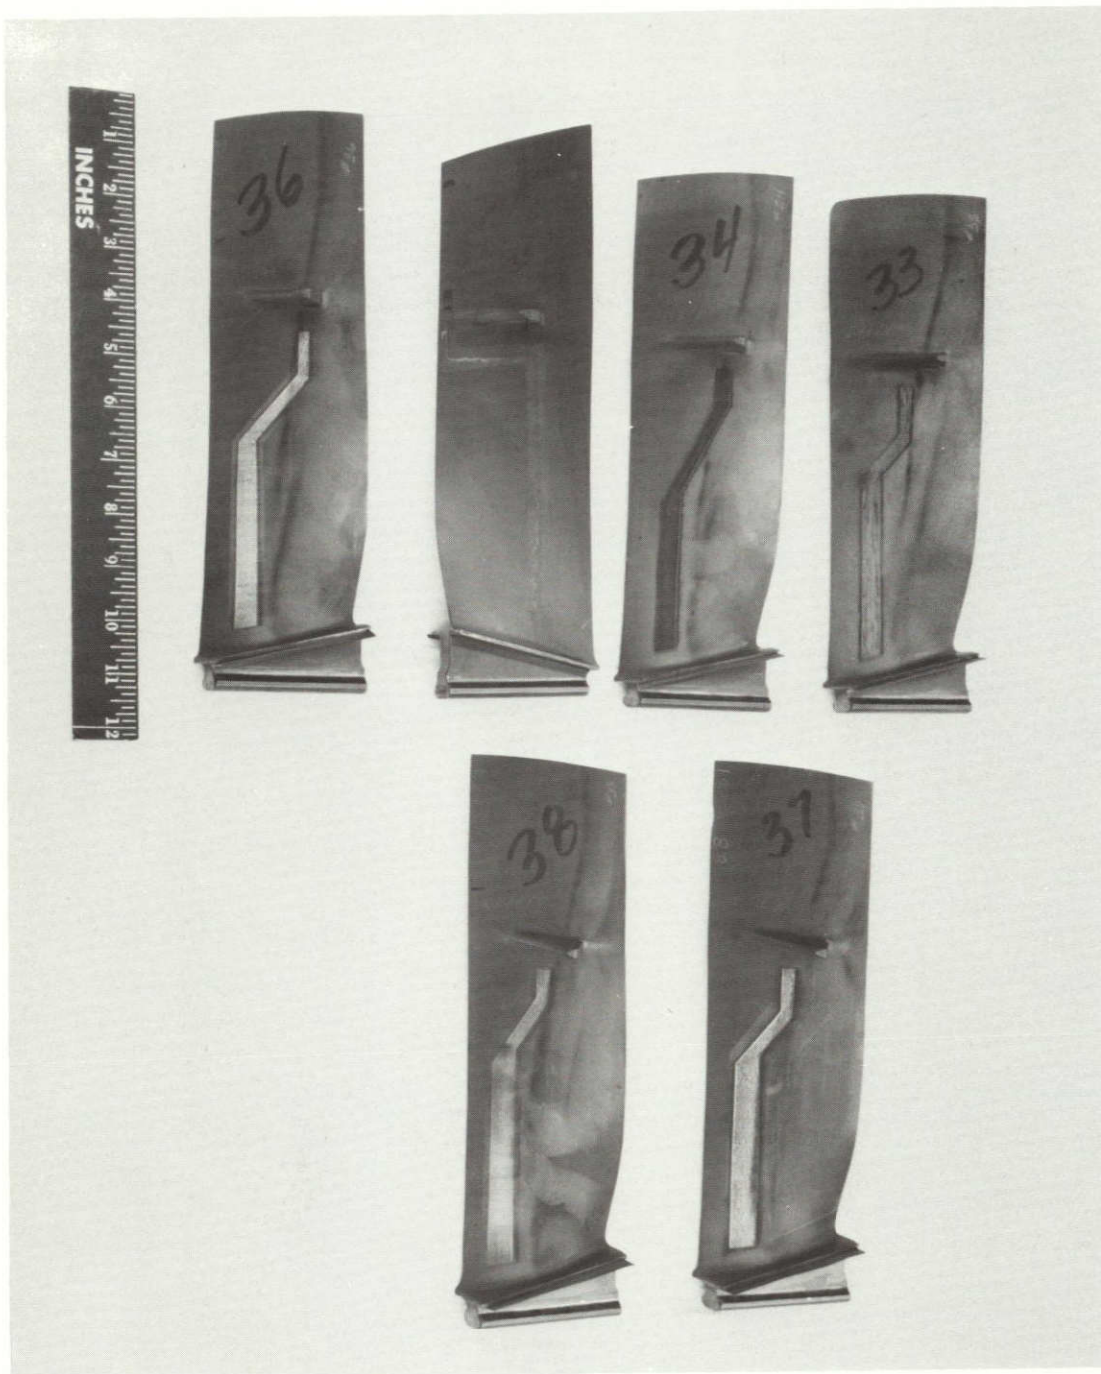
Figure A-15 Erosion Patch First Stage Blades S/N 33 Through 38 After Testing (78-444-4233-E)

Erosion was severe on the concave surface of the first stage blades, but no gage failures were attributed to erosion damage. Results indicated that Rokide rod, used as a precoat and overcoat, was the best material used in gage installations with respect to erosion resistance. Gages and leadwires should be located away from high erosion areas, if possible.

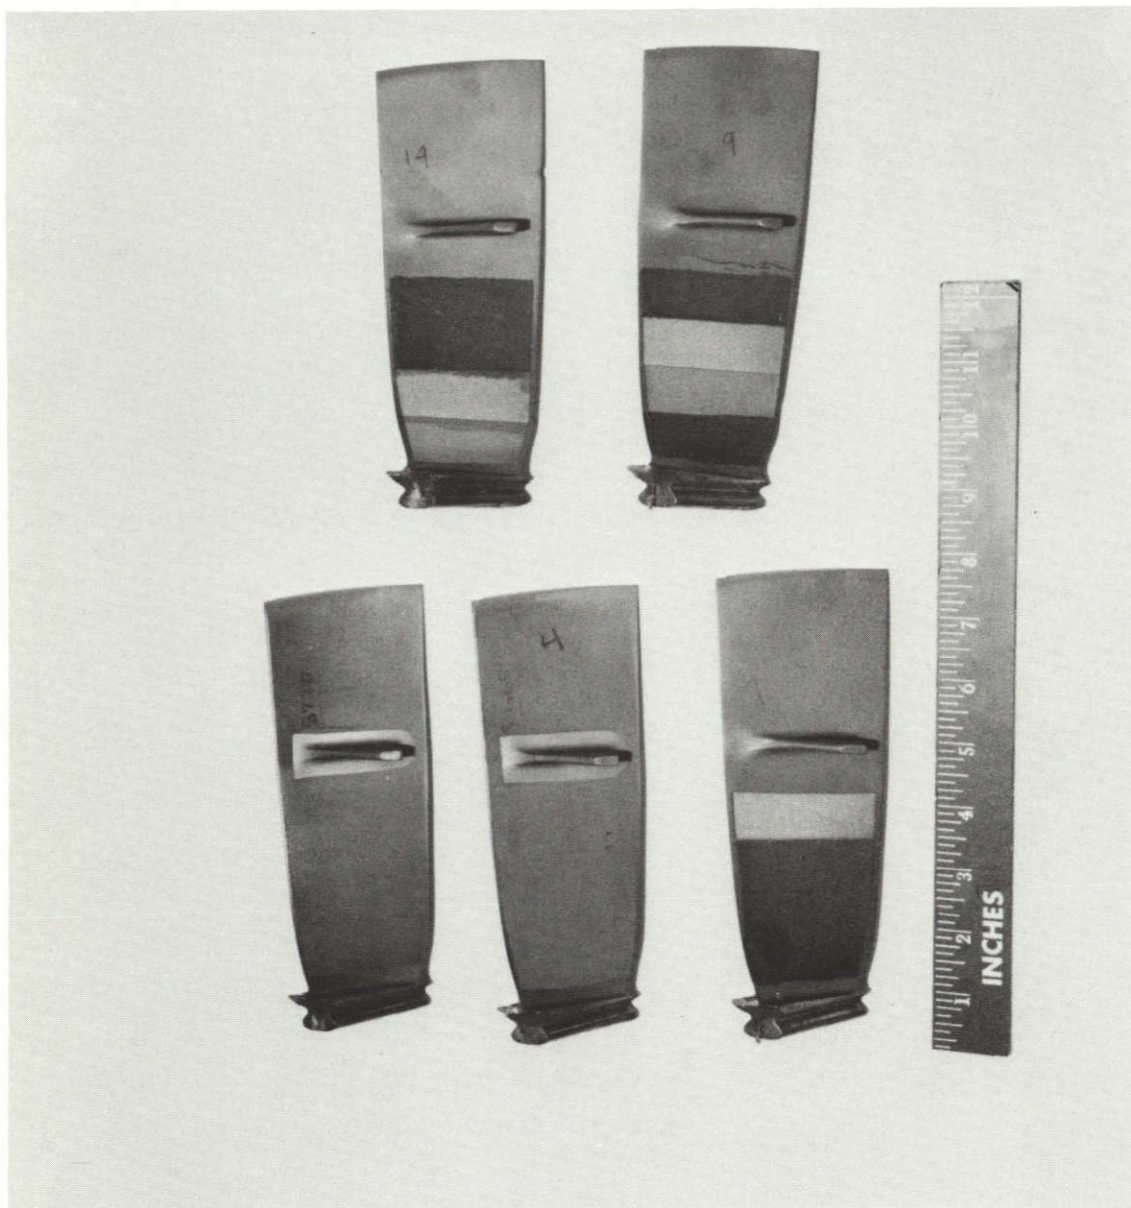
Figure A-33 Erosion Patch Third Stage Blades S/N 2, 4, 7, 9, 14
After Testing (78-444-0374-E)

Blade Serial Number	Patch* Location	Patch* Type	Measured Thickness (mm)				Post Test Condition and Comments
			25% From Trailing Edge Before Test	Trailing Edge After Test	75% From Trailing Edge Before Test	Trailing Edge After Test	
THIRD STAGE							
7	1	1	0.33	0.31	0.15	0.10	Good
7	2	2	0.31	0.28	0.23	0.20	Good
7	5	5	0.34	0.34	0.33	0.31	Good
7	6	6	0.10	0.10	0.20	0.18	Good
9	1	7	0.41	0.38	0.46	0.43	Good
9	2	1	0.41	0.41	0.51	0.48	Good
9	5	4	0.56	0.55	0.71	0.66	Good
9	6	5	0.84	0.75	0.71	0.66	Good
14	1	6	0.18	0.15	0.15	0.13	Good
14	2	7	0.25	0.25	0.38	0.38	Good
14	5	3	0.38	0.34	0.38	0.33	Good
14	6	4	0.38	0.34	0.46	0.46	Good
16	1	5	0.66	0.58	0.56	0.64	Good
16	2	6	0.13	0.13	0.13	0.08	Good
16	5	2	0.66	0.65	0.55	0.48	Good
16	6	3	0.74	0.71	0.38	0.31	Good
18	1	4	0.20	0.20	0.20	0.18	Good
18	2	5	0.38	0.38	0.38	0.28	Good
18	5	1	0.20	0.18	0.38	0.33	Good
18	6	2	0.46	0.46	0.46	0.34	Good
20	1	3	0.56	0.53	0.38	0.41	Good
20	2	4	0.64	0.58	0.64	0.56	Good
