**EVALUATION OF SHUTTLE TURBOPUMP BEARINGS**

By K. D. Dufrane and J. W. Kannel  
Battelle Columbus Laboratories  
505 King Avenue  
Columbus, Ohio 43201

Final Report

November 22, 1978

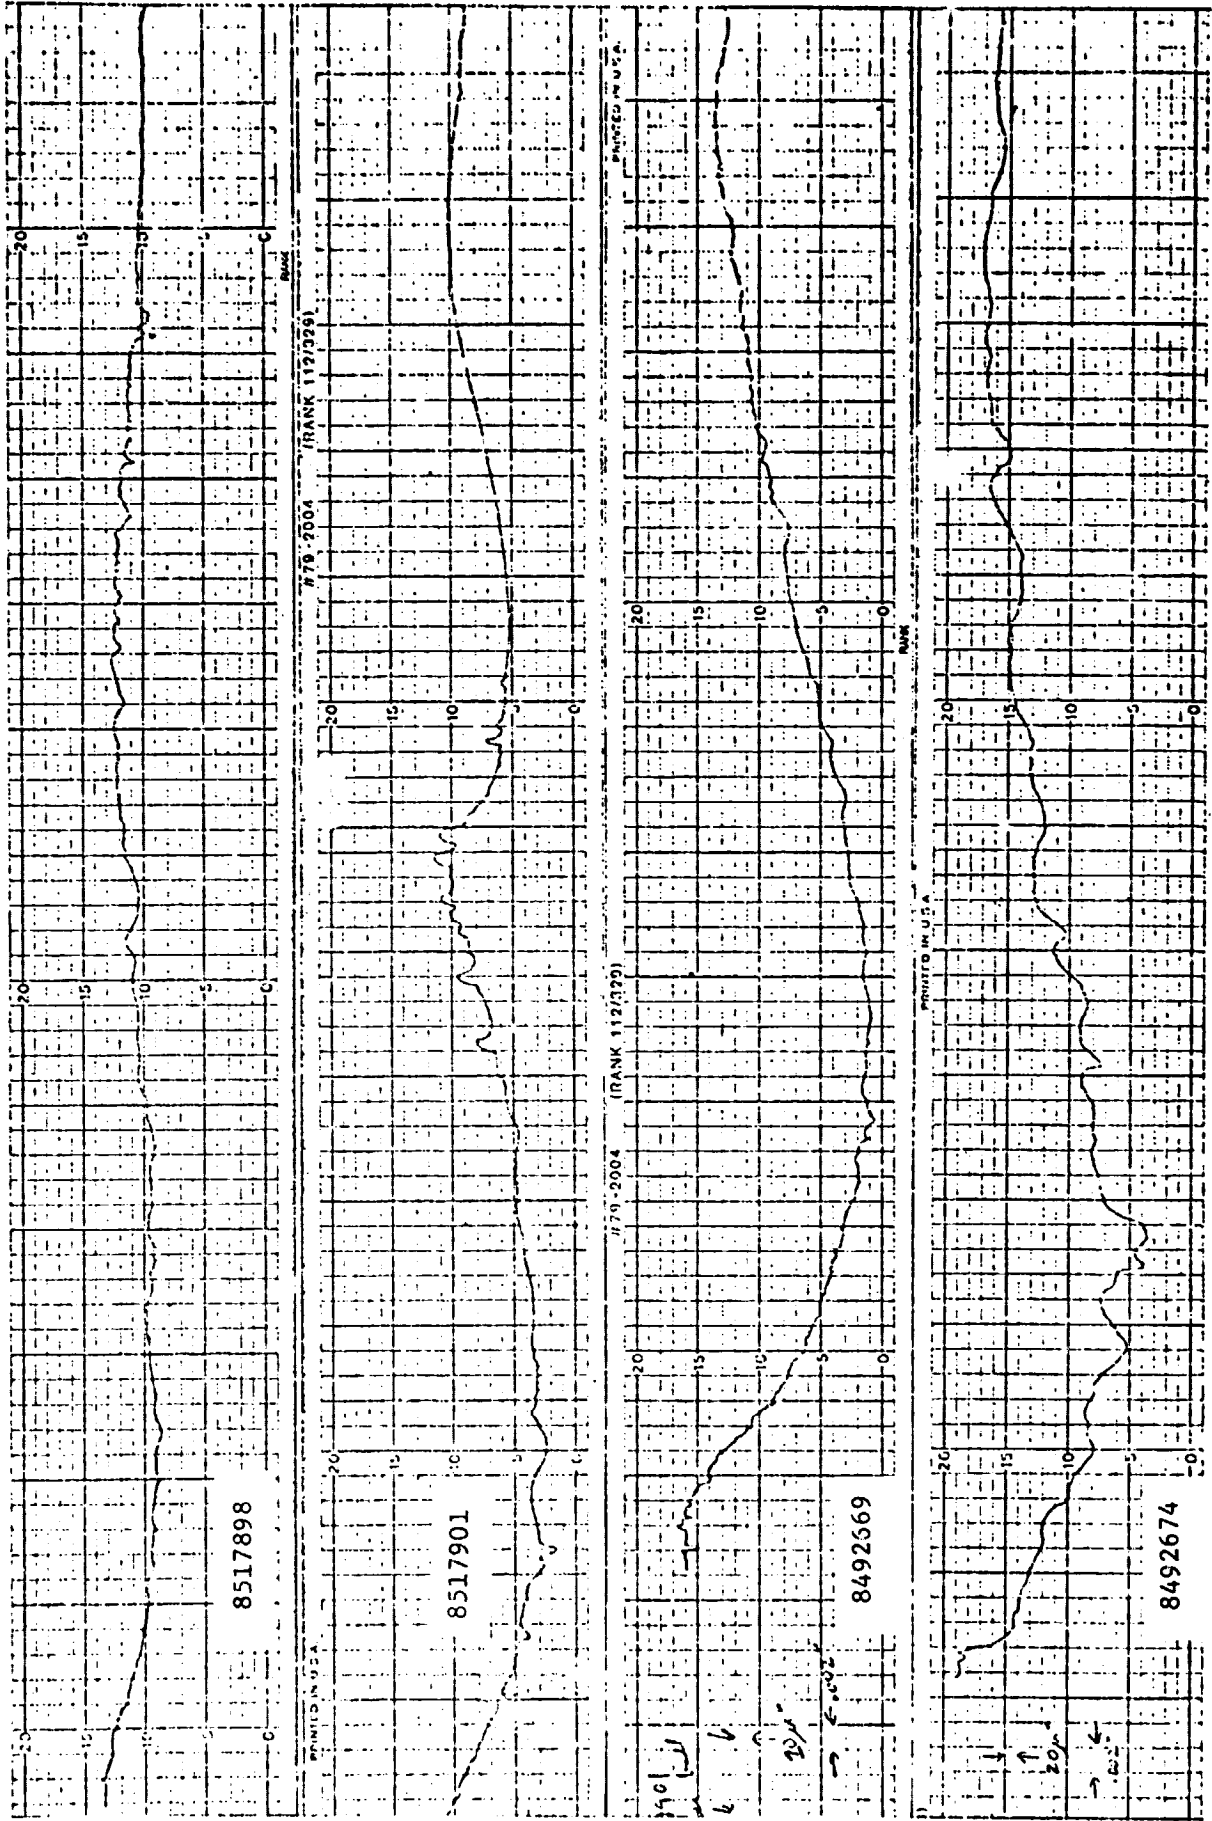
While the Talysurf profilometer cannot reliably measure profile changes over large curved areas without similar before-wear profiles for comparison, it is very useful in assessing the extent of local wear and the depth of indentations. Figure 6 presents traces across the inner race ball-contact areas of all four bearings. The general shapes of the curves are meaningless, but local dents or scratches can be seen ranging in depth from 0.5  $\mu\text{m}$  (20 microinches) to nearly 2.0  $\mu\text{m}$  (80 microinches). The buildup of soft debris on the inner race of bearing 8517901 is seen to have local peaks approximately 0.8  $\mu\text{m}$  (30 microinches) high and a possible general buildup of 2.0  $\mu\text{m}$  (80 microinches) (assuming the central raised area is all part of the deposit). The original surface finishes were probably similar to the uncontacted areas at the right end of the traces.

FIGURE 6. CURVE-MATCHING TRACES ACROSS BEARING INNER RACES. MAGNIFICATIONS, MINOR DIVISIONS,  
VERTICAL: 0.05  $\mu\text{m}$  (20 microinch)  
HORIZONTAL: 0.05 mm (0.002 inch)

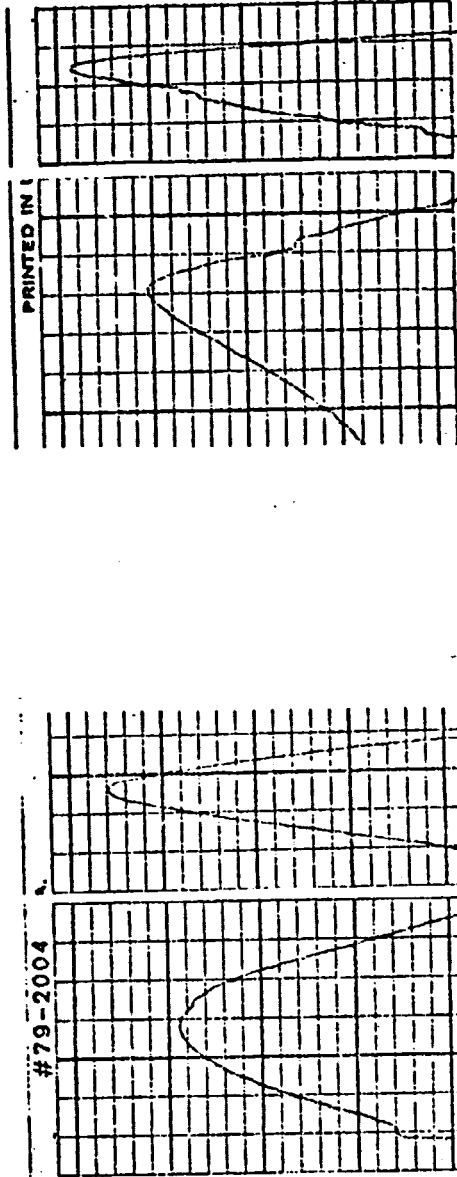
Figure 7a shows profiles of the minor-circle scratches on a ball from bearing 8517901. Scratch depths up to  $1\ \mu\text{m}$  (40 microinches) were measured. Although debris embedded in the ball pockets is generally assumed to cause such scratches, a second possible source may be the result of the sliding/rolling contact on the chamfer of the inner races during periods of very high inner-race contact angles. To explore this possibility, traces of the chamfer corners were made at the same magnification as was used on the balls, shown in Figure 7b and 7c. The radii at the tips of the chamfer corners are seen to match the radii of many of the ball scratches and could, therefore, have caused these scratches. The few scratches with sharper radii were caused by sliding against a sharper object, which was probably embedded debris.

a. Scratches in Ball from Bearing 8517901.

b. Chamfer Corners on  
Bearing 8517901.

c. Chamfer Corners on  
Bearing 8492669.

FIGURE 7. PROFILES OF BALL SCRATCHES AND CORNERS OF INNER RACE CHAMFER.  
MAGNIFICATIONS, MINOR DIVISIONS, VERTICAL: 0.5  $\mu$ m (20 microinch)  
HORIZONTAL: 0.005 mm (.002 inch)

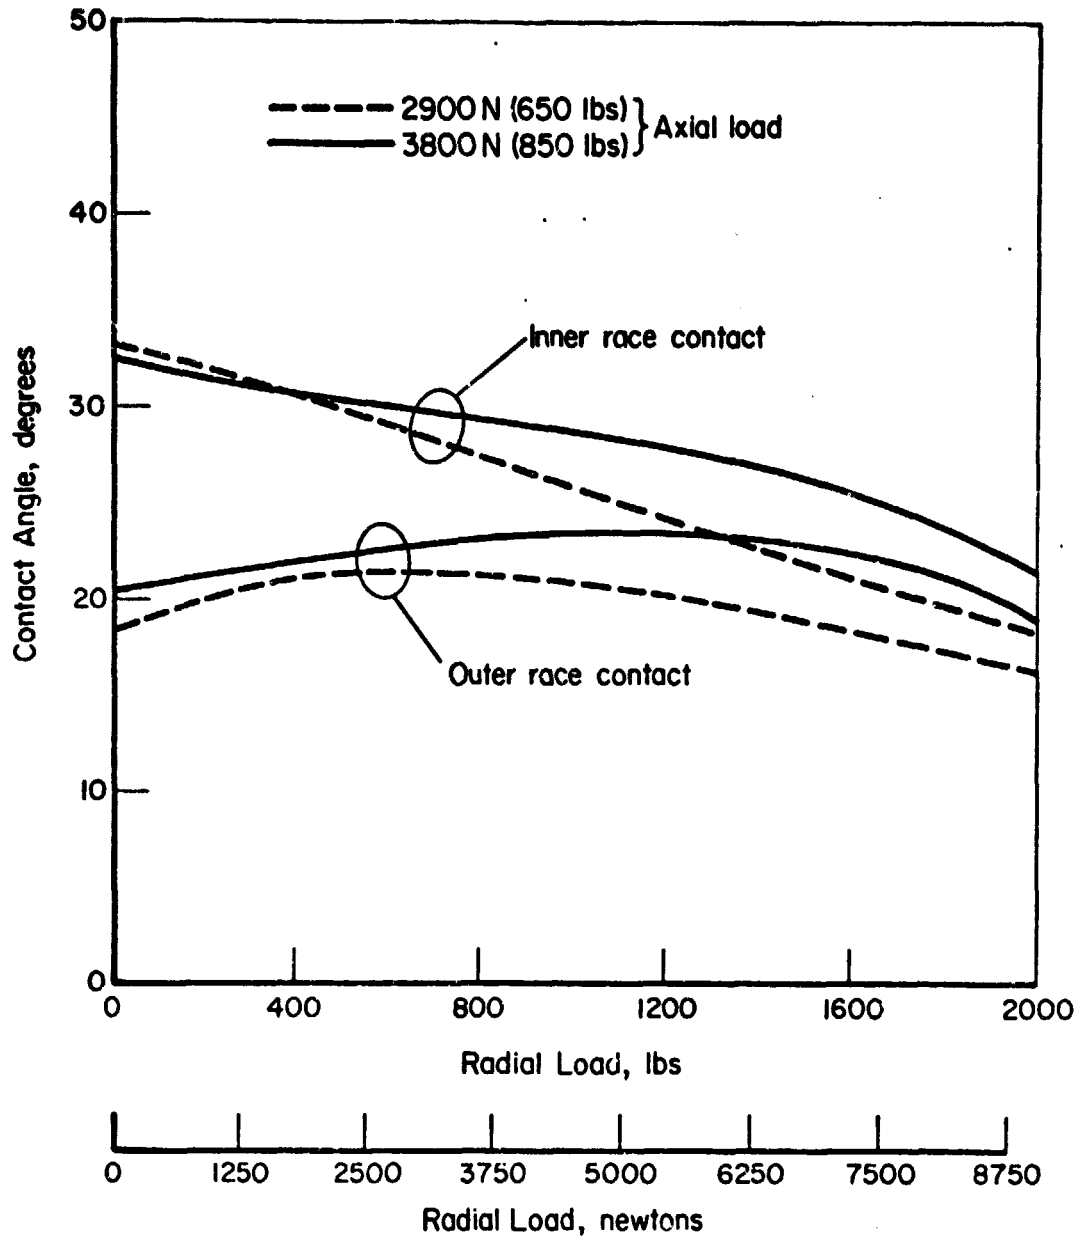
The two bearing sizes (see Table 2) were analyzed in the calculations for two axial load conditions and several radial loads. Figures 11 and 12 show the effect of radial load on predicted contact angle. Notice in Figure 12, for example, that the outer race contact angle is relatively insensitive to radial load above about 3000N, while variation by as much as 6-7 degrees occurs on the inner race.

FIGURE 11. EFFECT OF RADIAL LOAD ON OPERATING CONTACT ANGLE, BEARING TYPE 7522.

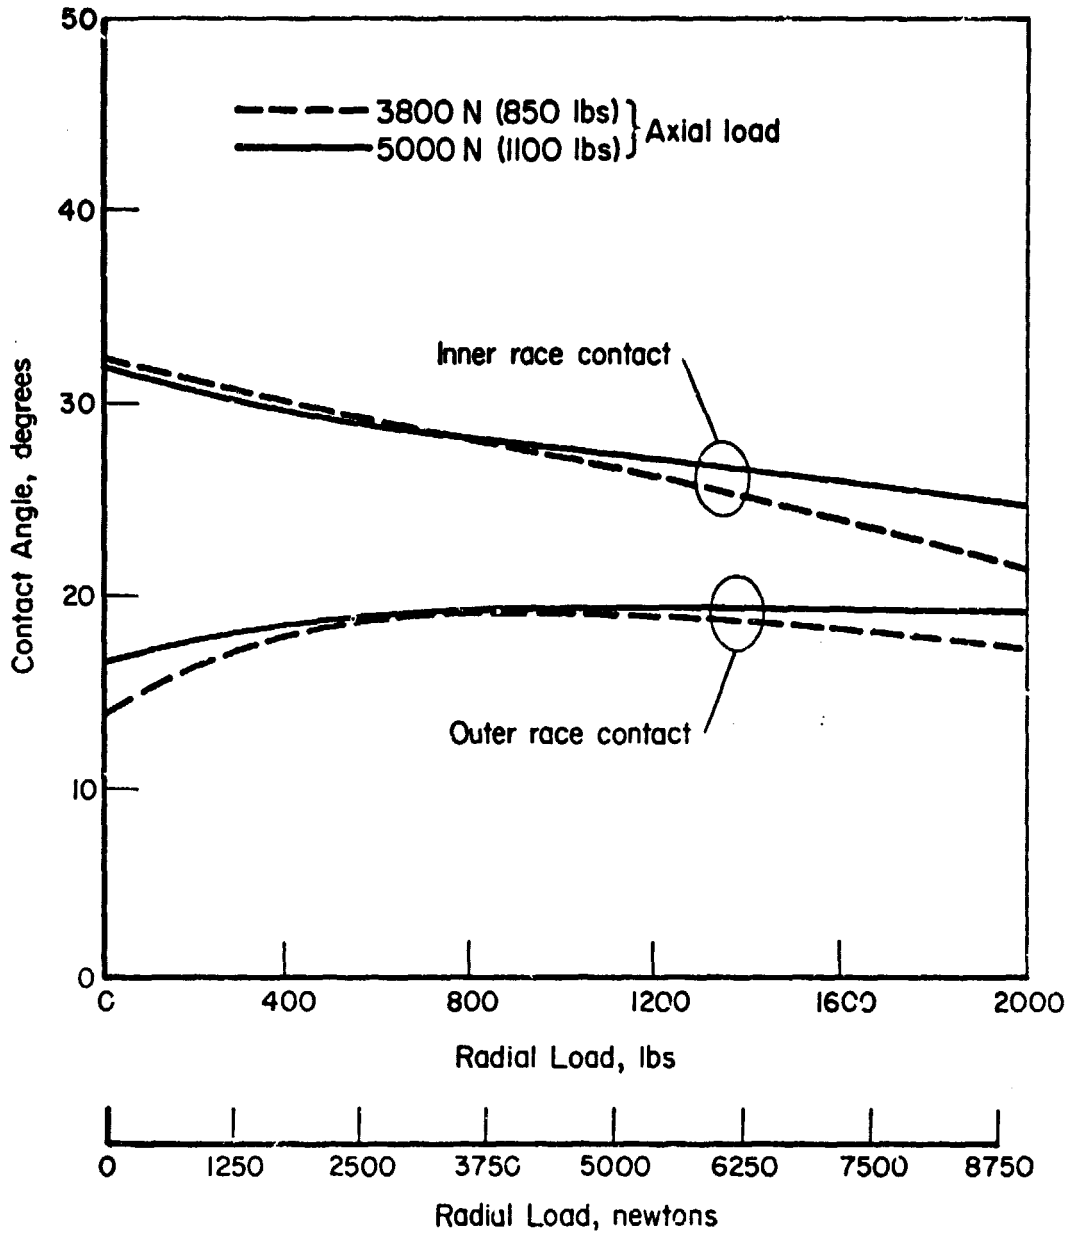
FIGURE 12. EFFECT OF RADIAL LOAD ON OPERATING CONTACT ANGLE, BEARING TYPE 7955.

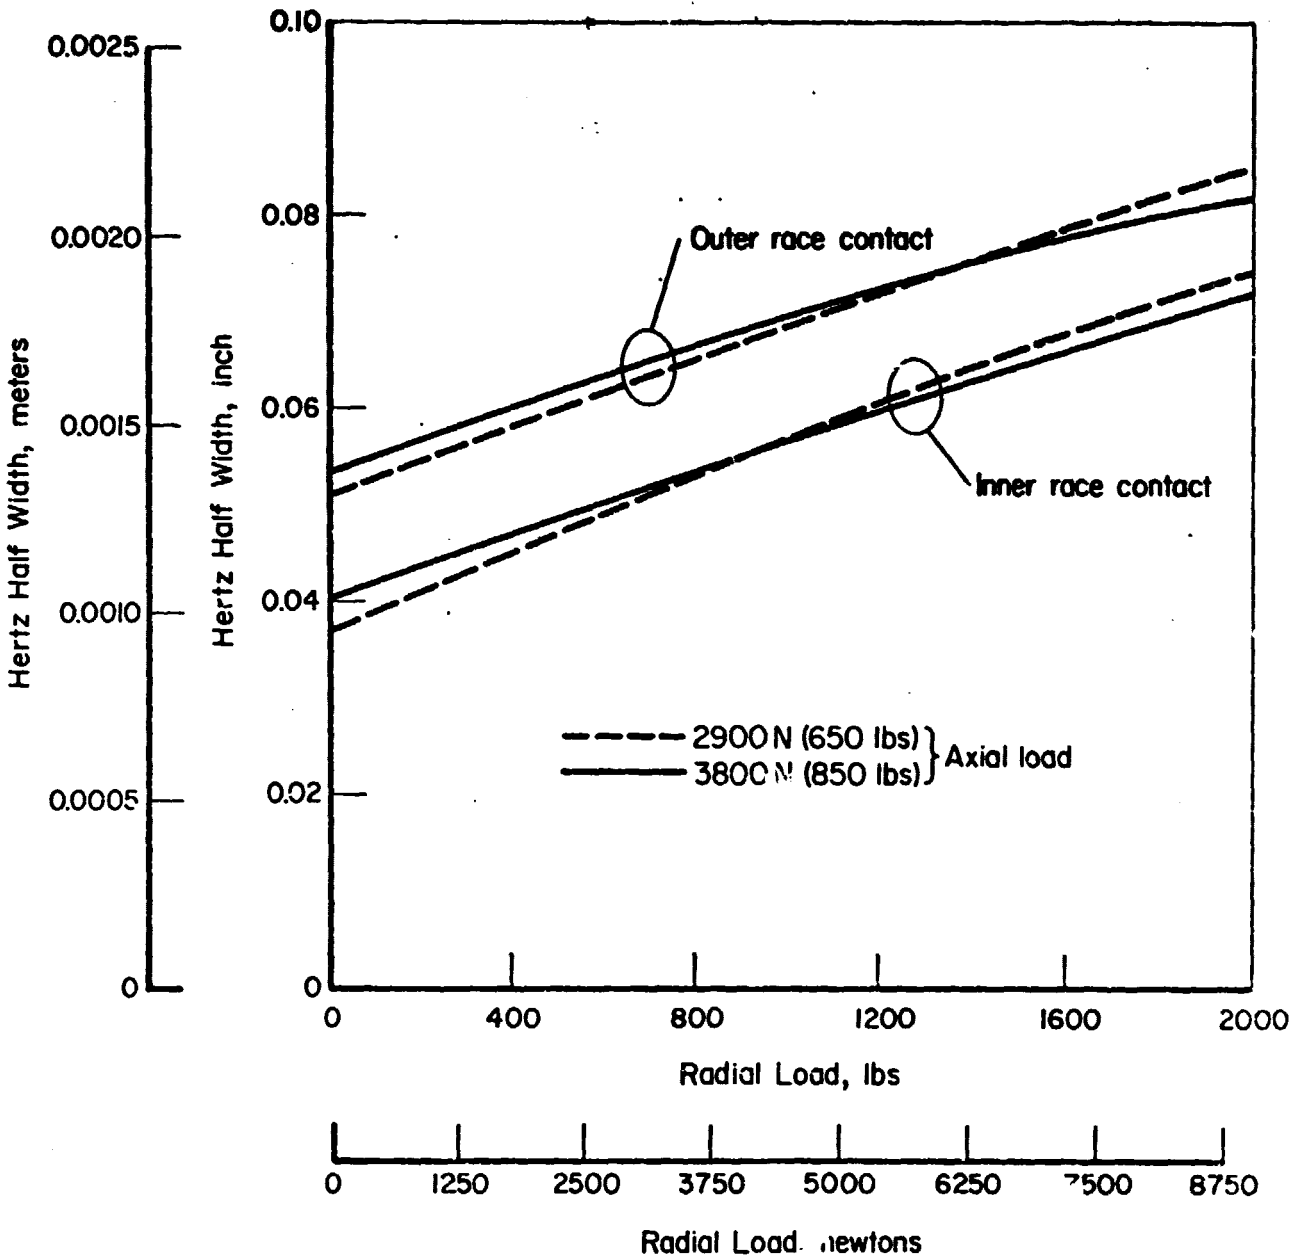
Figures 13 and 14 show the variation of Hertz half width with radial load. As the load is increased, the half width increases due to the increased ball-to-race loading. Figures 15 and 16 show the effect of radial load on maximum Hertz stress. At radial loads above about 2000N (440 lbs), the Hertz stress exceeds 2 GPa (28000<sup>0</sup>psi) which (as will be discussed in a following section) is extremely high for transfer film lubrication.

FIGURE 13. EFFECT OF RADIAL LOAD ON HERTZ CONTACT WIDTH, BEARING TYPE 7522.

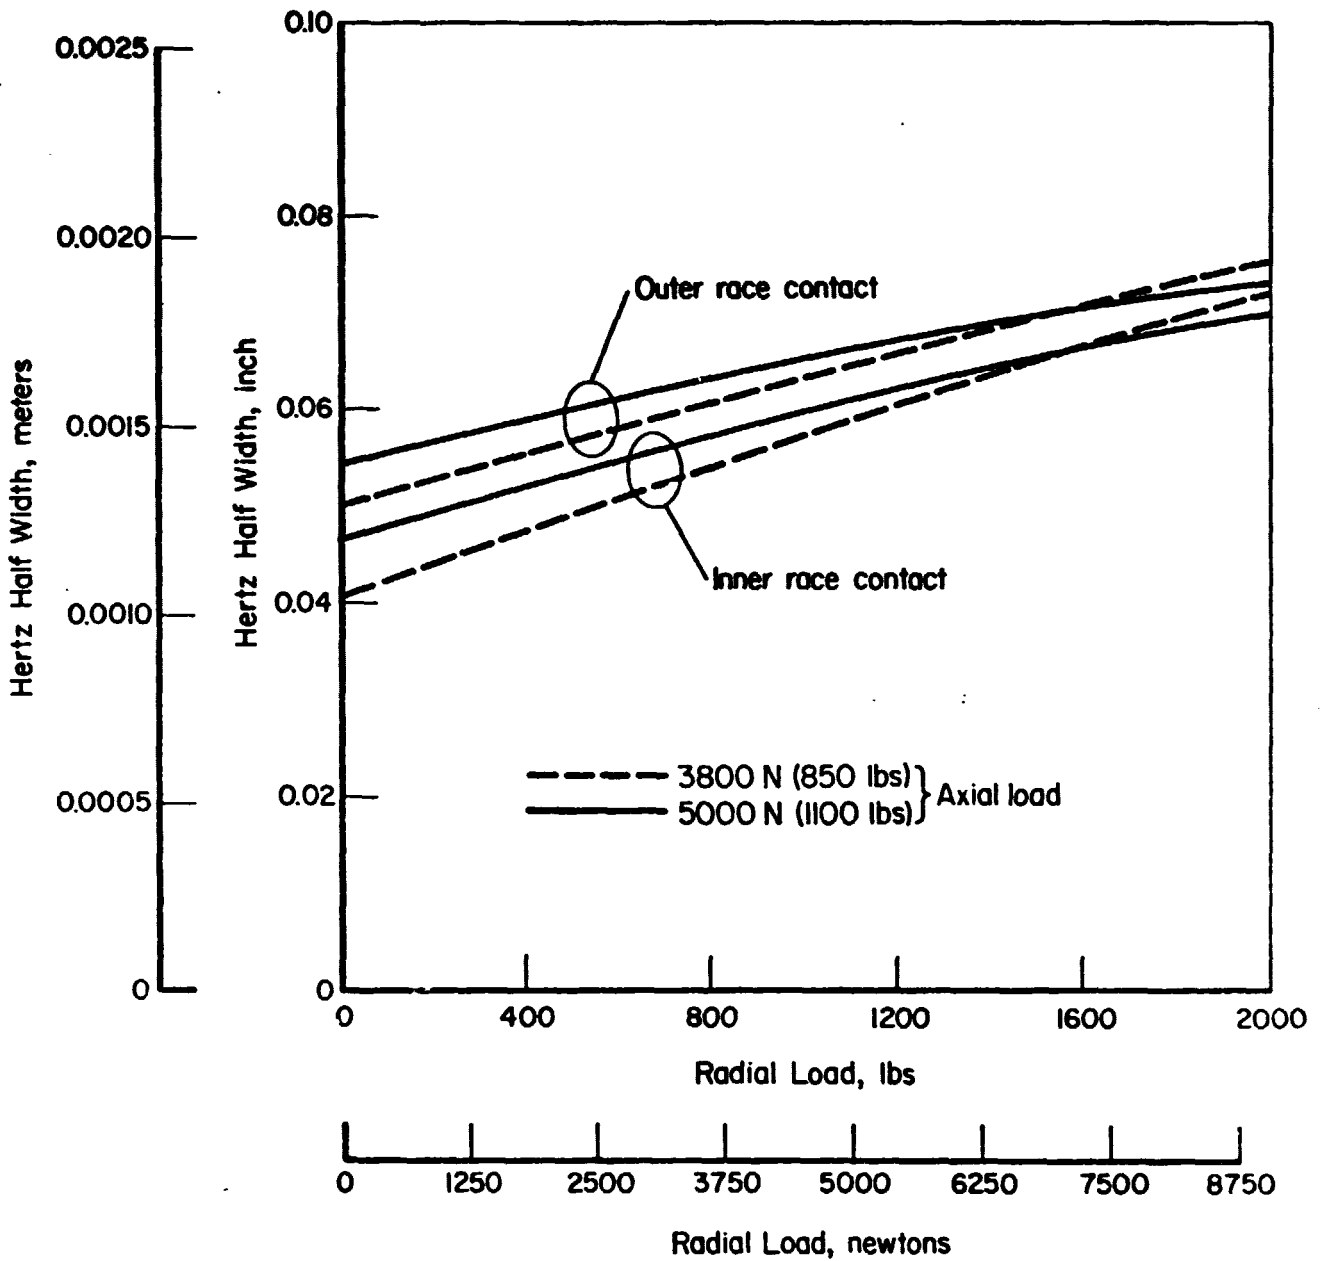
FIGURE 14, EFFECT OF RADIAL LOAD ON HERTZ CONTACT WIDTH, BEARING TYPE 7955.

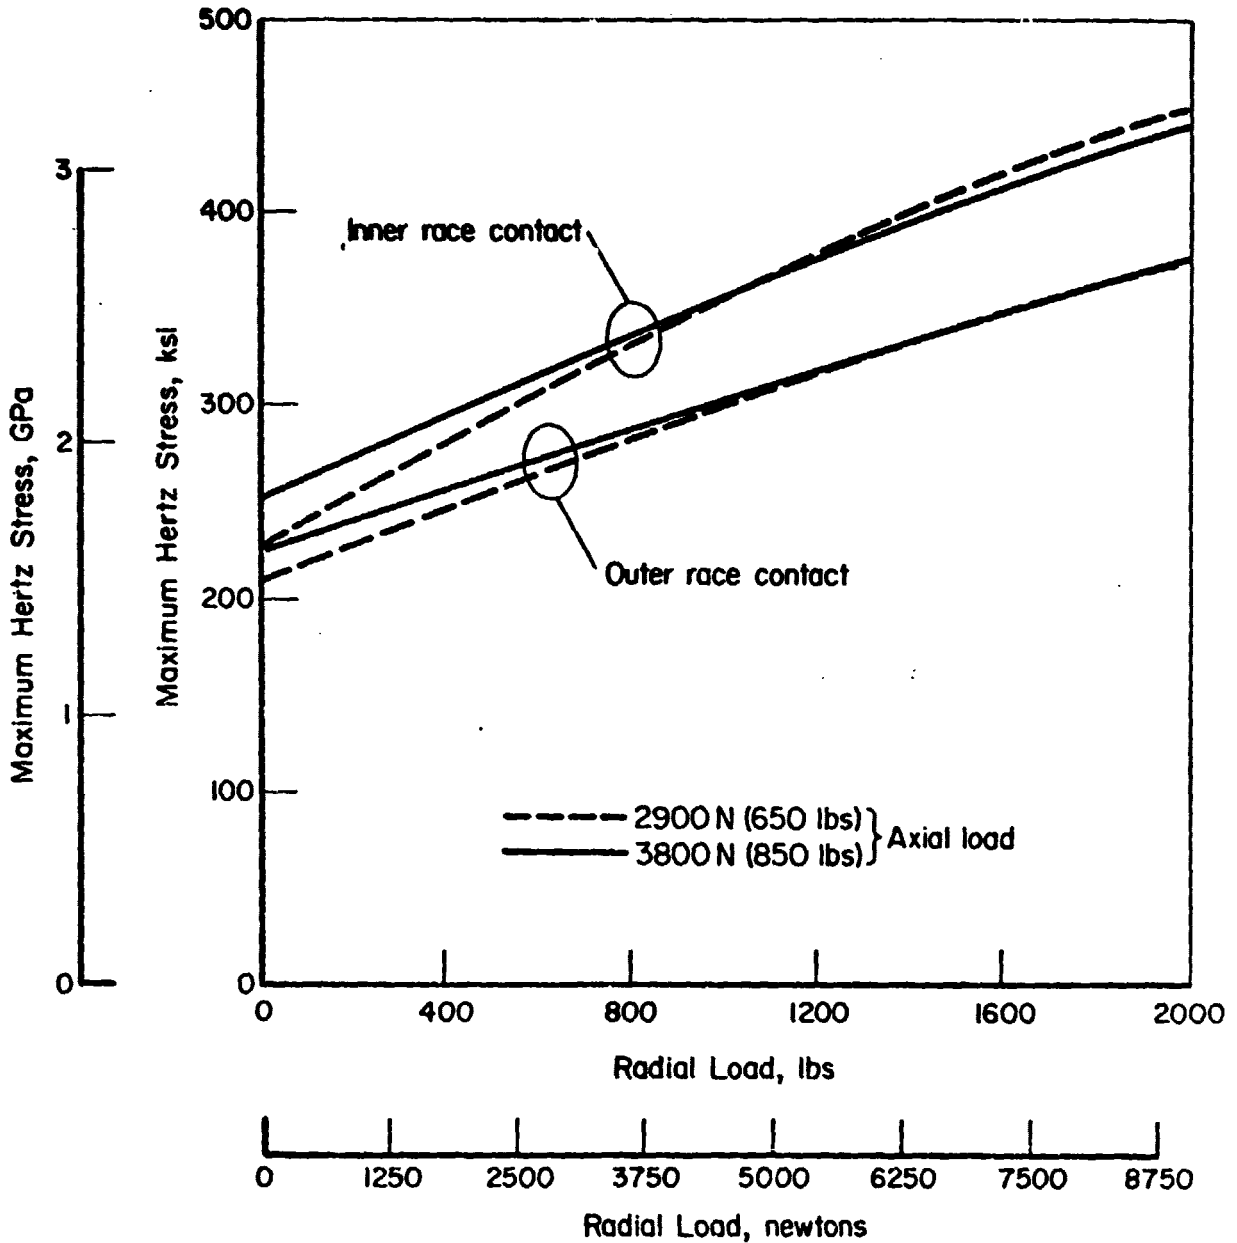
With the estimation of maximum radial load, the graphs in Figures 15 and 16 were used to estimate the maximum ball-race contact stress. These

FIGURE 15. EFFECT OF RADIAL LOAD ON HERTZ CONTACT STRESS, BEARING TYPE 7522.

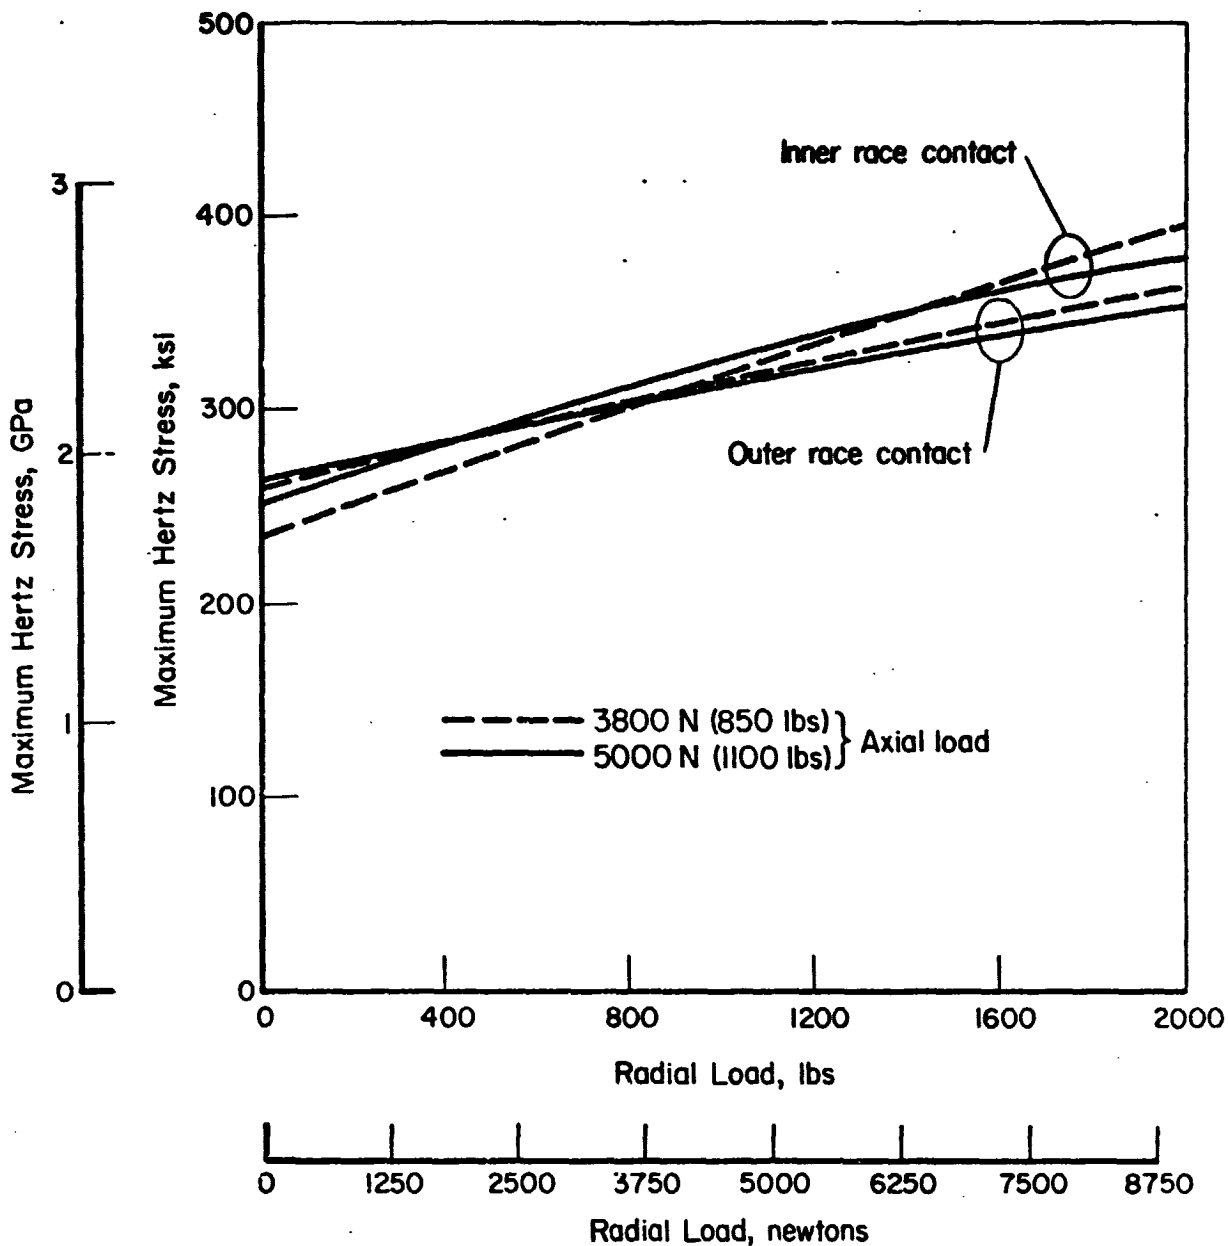
FIGURE 16. EFFECT OF RADIAL LOAD ON HERTZ CONTACT STRESS, BEARING TYPE 7955.

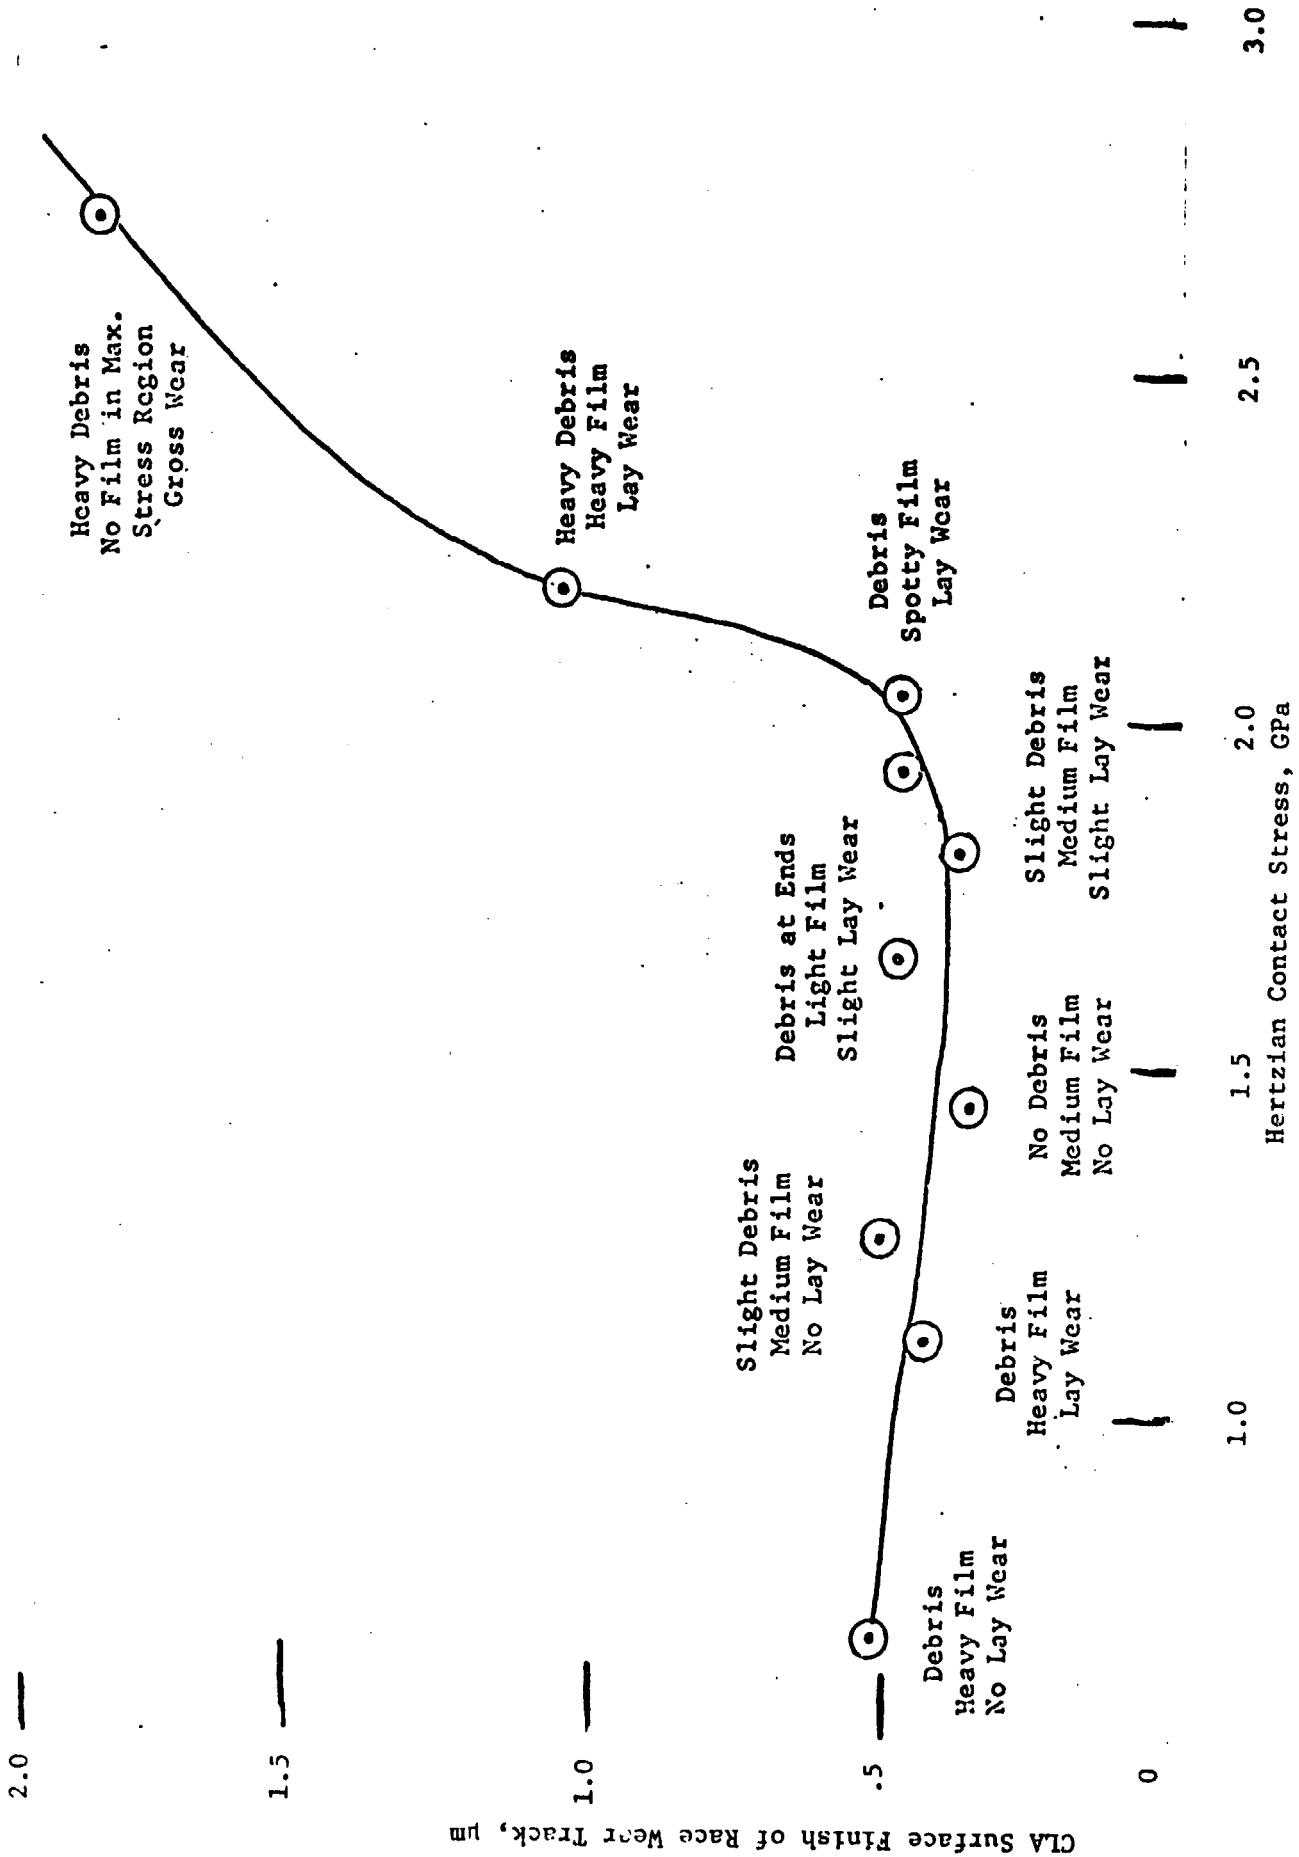
One possible problem with solid film lubrication is in the stress limitation of the film itself. Battelle has conducted some experiments in other projects to characterize solid film strength. Figure 18 shows the result of one such series of tests. It should be noted that these tests were conducted for a different solid film and under much different conditions than being encountered in this project. However, the trends shown in these data are very critical. These data indicate that above a stress of 2 GPa (230,000 psi) solid film failure may occur (as noted previously, the estimated stress for the bearings investigated here was 2.8 GPa (410,000 psi)).

In Table 3, it is obvious that if a high radial (unbalanced) load occurs, very high stresses will occur in the bearing. Not only can these high stresses greatly reduce classic fatigue life of the bearing but, in addition, it is possible (or even probable) that these stresses exceed the limit of the solid films. It is apparent, then, that tests to determine the limits of the film need to be established. It is also obvious that radial-unbalance loads must be minimized if adequate life of the bearing is to be achieved, both on the basis of the lubricant film as well as contact fatigue.

FIGURE 18. ADEQUACY OF TYPICAL TRANSFER FILM LUBRICANT
