NASA Technical Paper 1343

Lubrication and Failure Mechanisms of Molybdenum Disulfide Films

I - Effect of Atmosphere

Robert L. Fusaro

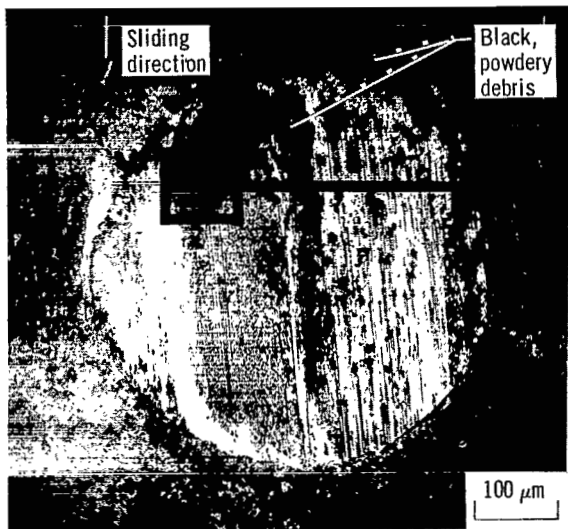
(a) Rider wear scar.

After 5 kilocycles of sliding (fig. 6), definite change had taken place on the sliding surfaces; most of the smooth, coalesced material was gone and what remained was black, powdery debris. The high-magnification photomicrographs of figure 6 show areas within the coalesced MoS₂ films that were transforming to a black, powdery material.

Figure 6. - Photomicrographs of rider wear scar and MoS₂ film wear track after 5 kilocycles of sliding in moist air (10 000-ppm H₂O) at 25° C.
